Inspection Report

Property Address:
355 Summerhill Rd.
Thomasville Ga 31792

E House' Home Inspections

Date: 5/11/2023	Time:	Report ID:
Property: 355 Summerhill Rd. Thomasville Ga 31792	Customer: Wiregrass Auction Group	Real Estate Professional:

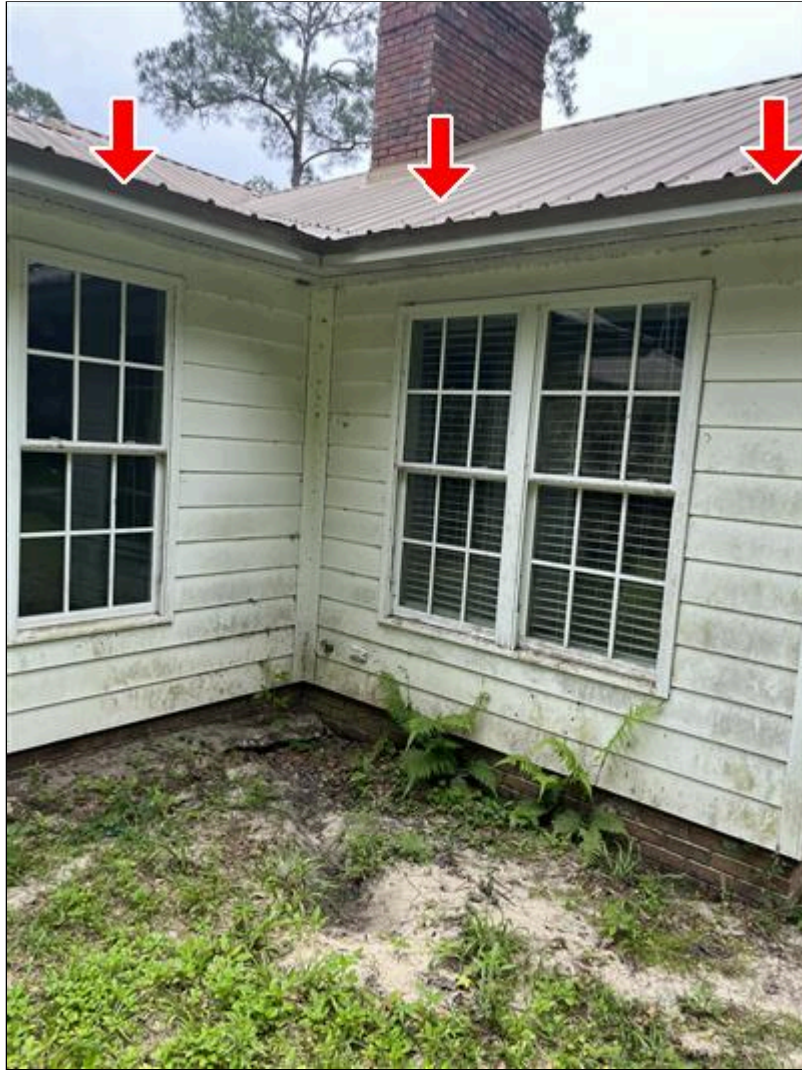
1.3 Picture 1

1.3 Gutters and drain lines are needed or erosion or water intrusion can occur at the rear of the home.

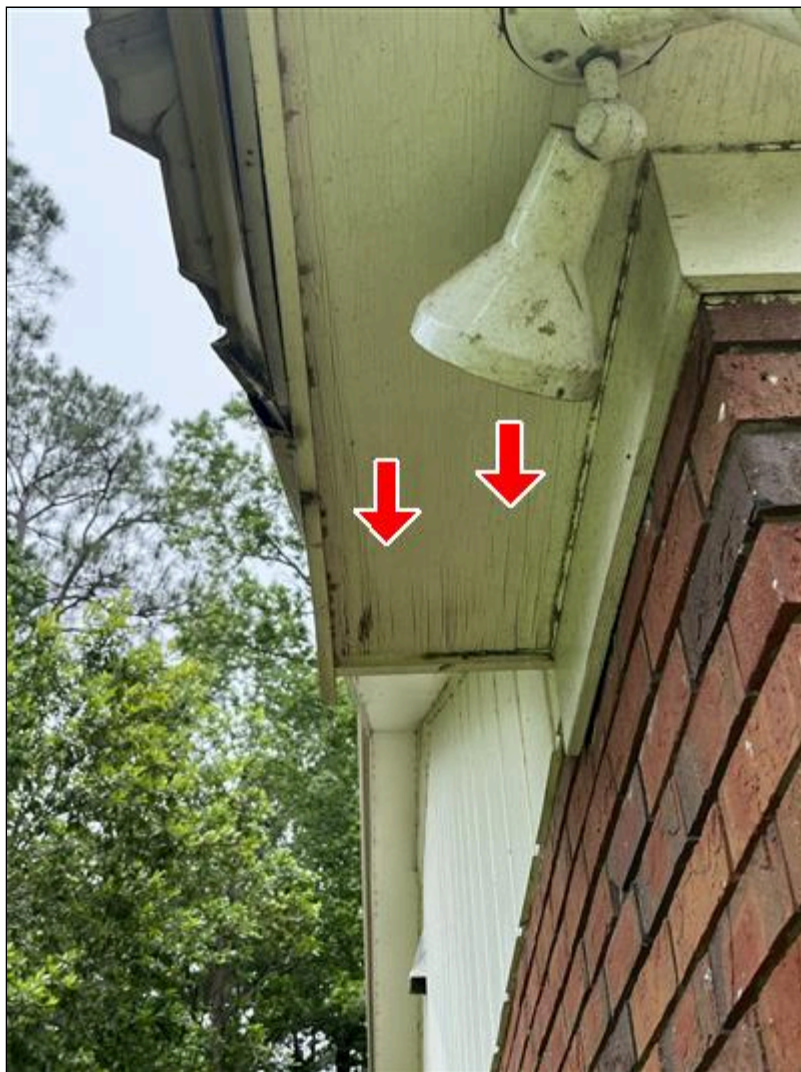
2.5 Picture 1

2.5 The soffit panel at eave on the left side (facing front) is beginning to deteriorate. Further deterioration may occur if not repaired. .

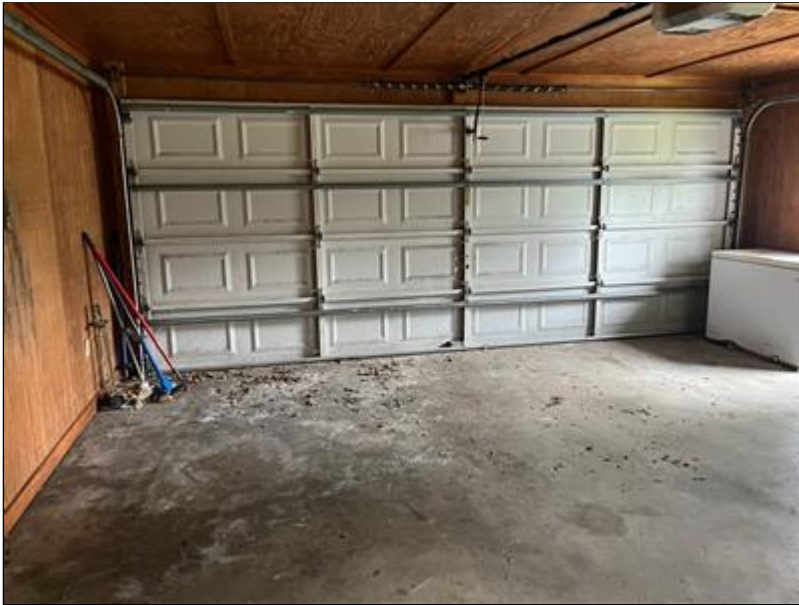
3.3 Picture 1

3.3 The garage door at the left side (facing front) does not operate properly. This is a maintenance issue and is for your information. .

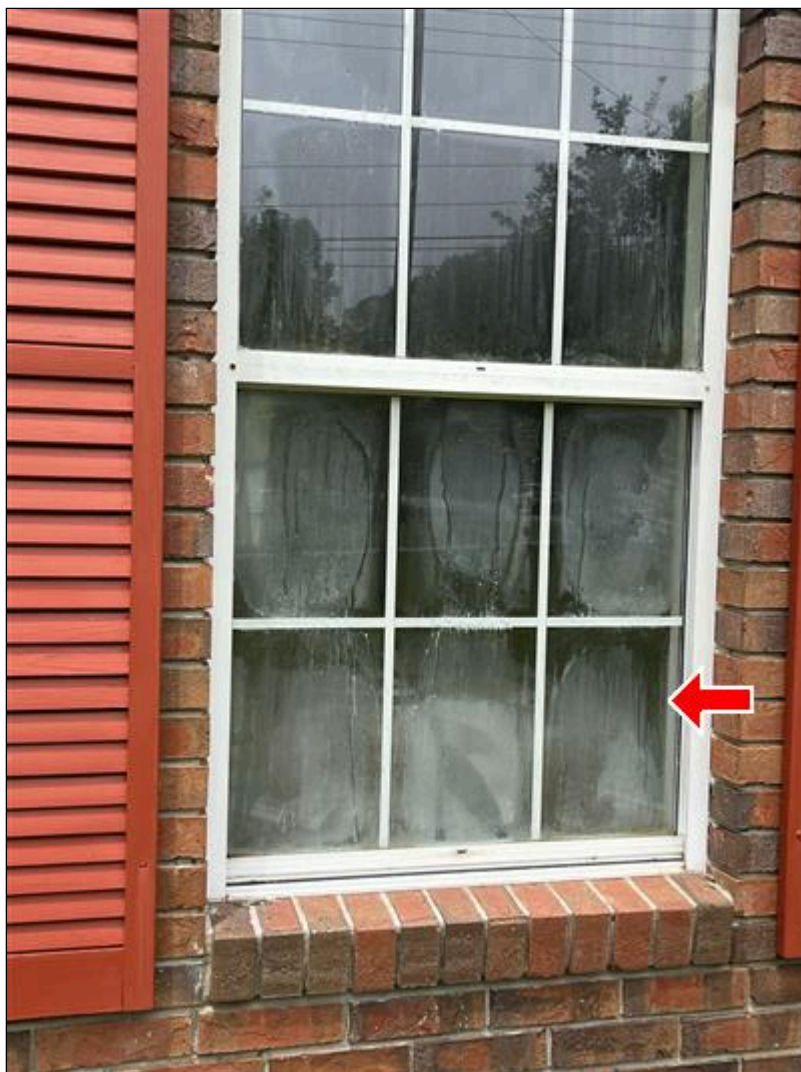
4.6 Picture 1

4.6 Two windows cloudy (lost seal) at the home. In order to correct the cloudy appearance of glass, a replacement of glass pane or the unit will be necessary. A qualified person should repair or replace as needed.

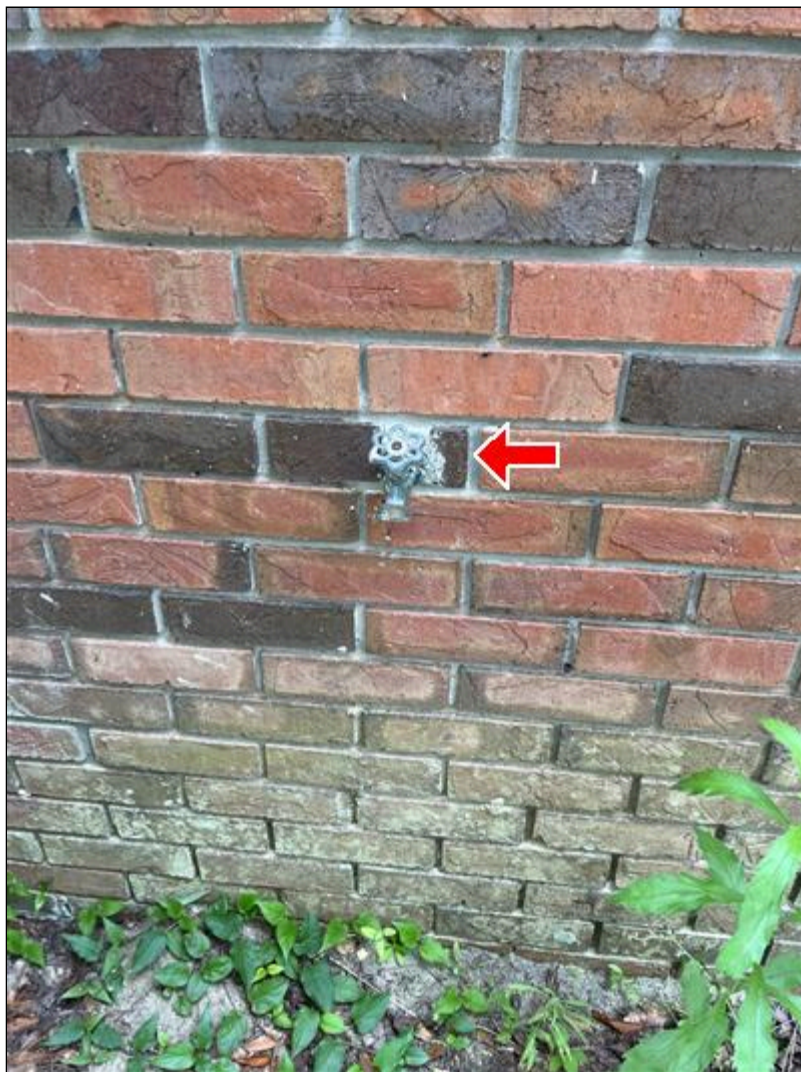
6.1 Picture 1

6.1 I could not get one of the hose bibs at the rear of the home to turn at the time of the inspection, this is for your information.

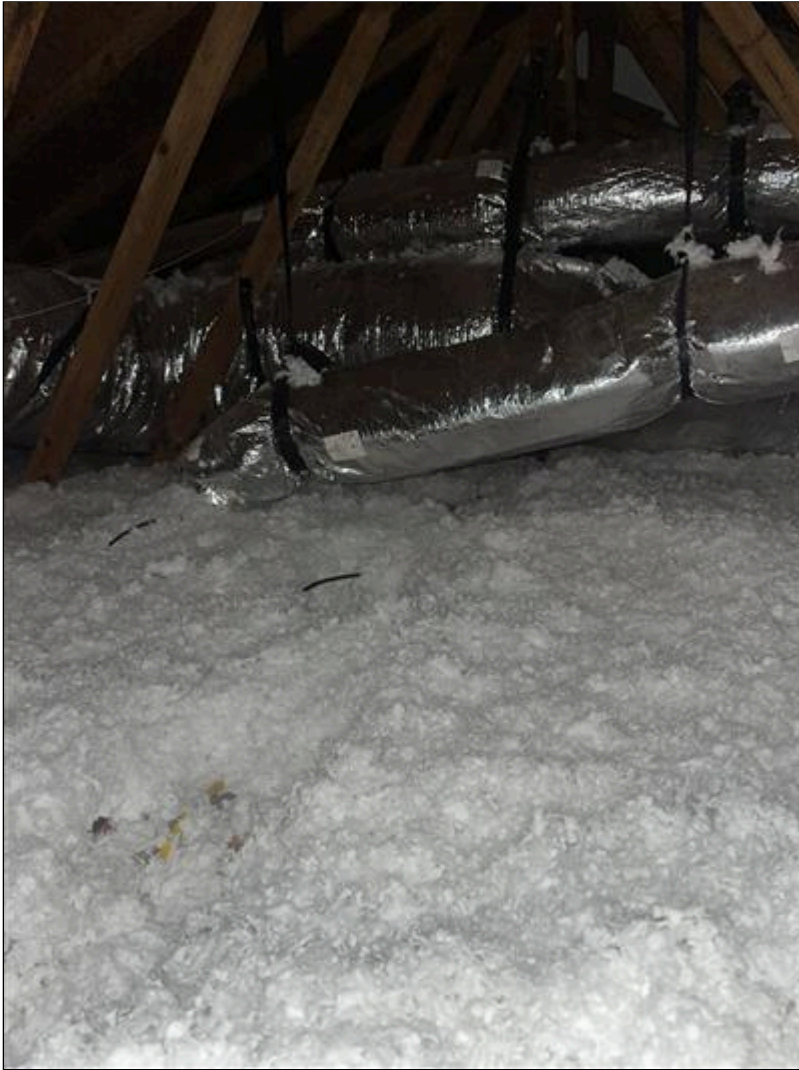
9.0 Picture 1

9.0 Cellulose insulation is about nine inches thick or just under 33 R-Value.

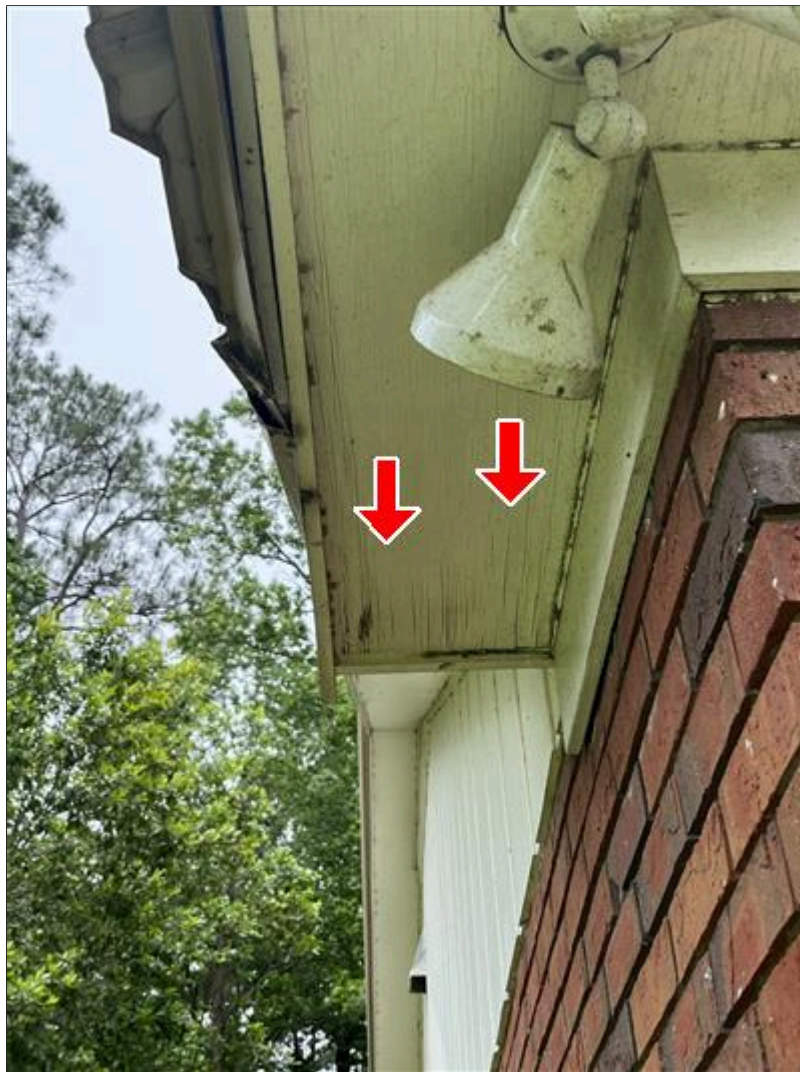
2.5 Picture 1

2.5 EAVES, SOFFITS AND FASCIAS

The soffit panel at eave on the left side (facing front) is beginning to deteriorate. Further deterioration may occur if not repaired. .

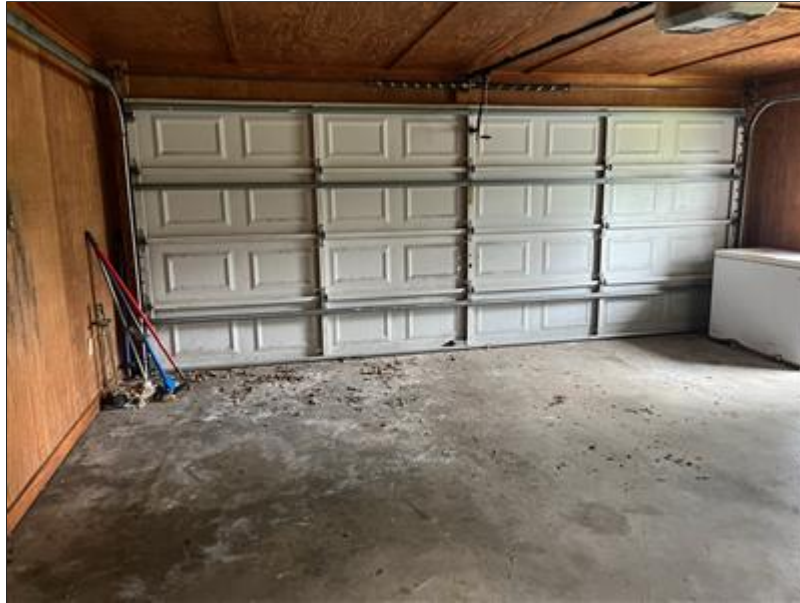
3.3 Picture 1

3.3 GARAGE DOOR (S)

The garage door at the left side (facing front) does not operate properly. This is a maintenance issue and is for your information. .

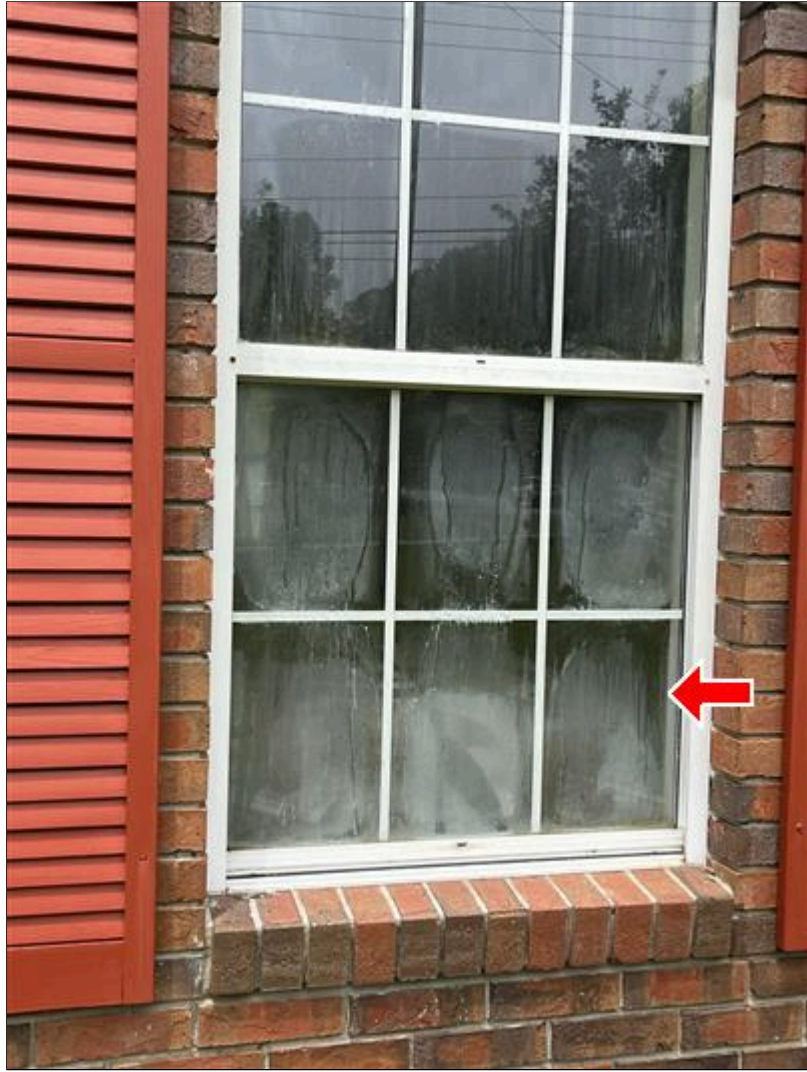
4.6 Picture 1

4.6 WINDOWS (REPRESENTATIVE NUMBER)

Two windows cloudy (lost seal) at the home. In order to correct the cloudy appearance of glass, a replacement of glass pane or the unit will be necessary. A qualified person should repair or replace as needed.

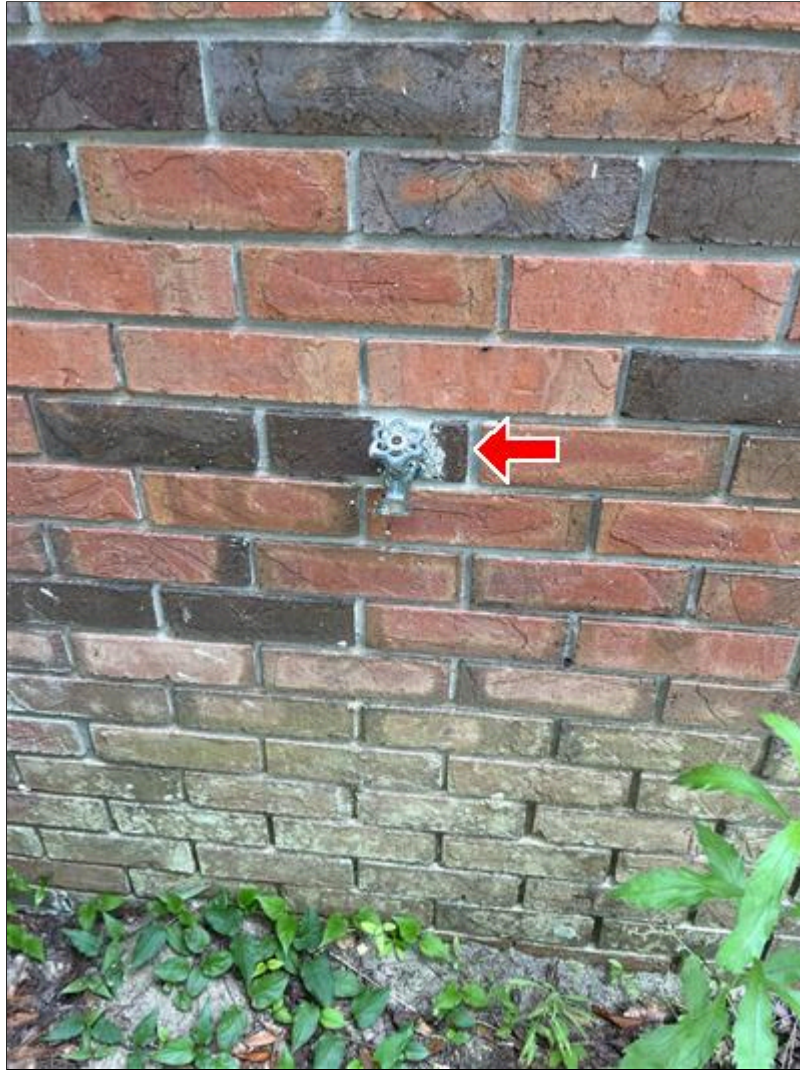
6.1 Picture 1

6.1 PLUMBING WATER SUPPLY AND DISTRIBUTION SYSTEMS AND FIXTURES

I could not get one of the hose bibs at the rear of the home to turn at the time of the inspection, this is for your information.

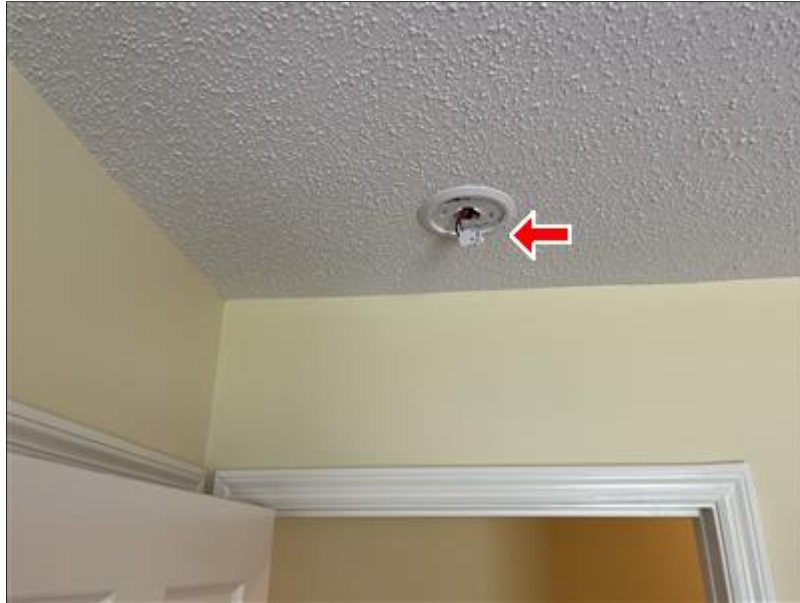
7.7 Picture 1

7.7 SMOKE DETECTORS

The smoke detector has been disconnected intentionally at the common hallway to bedrooms. Without a working smoke detector in your home you have no first alert to a possible fire. I recommend repair or replace as needed using a qualified person.
