Inspection Report

Wiregrass Auction Group

Property Address:
17 1st NE
Cairo Ga 39828

South Georgia Home Inspections

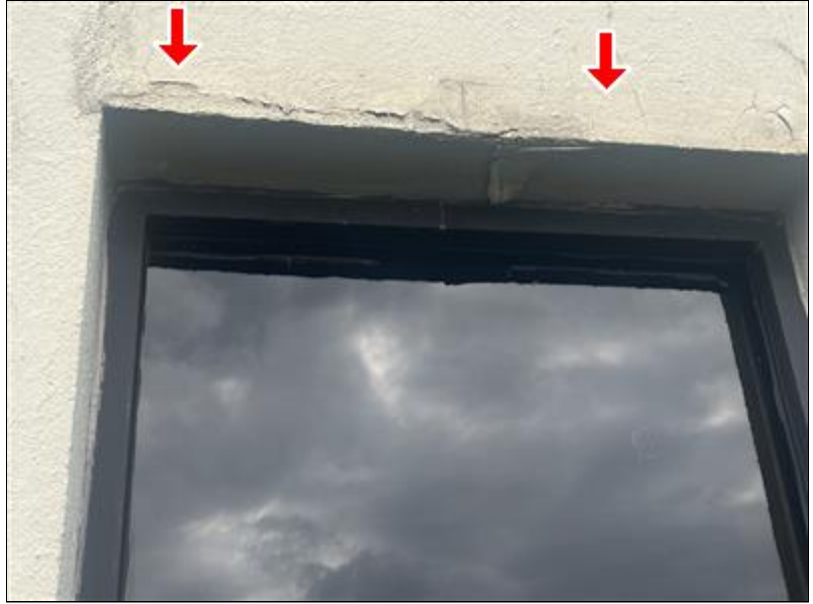
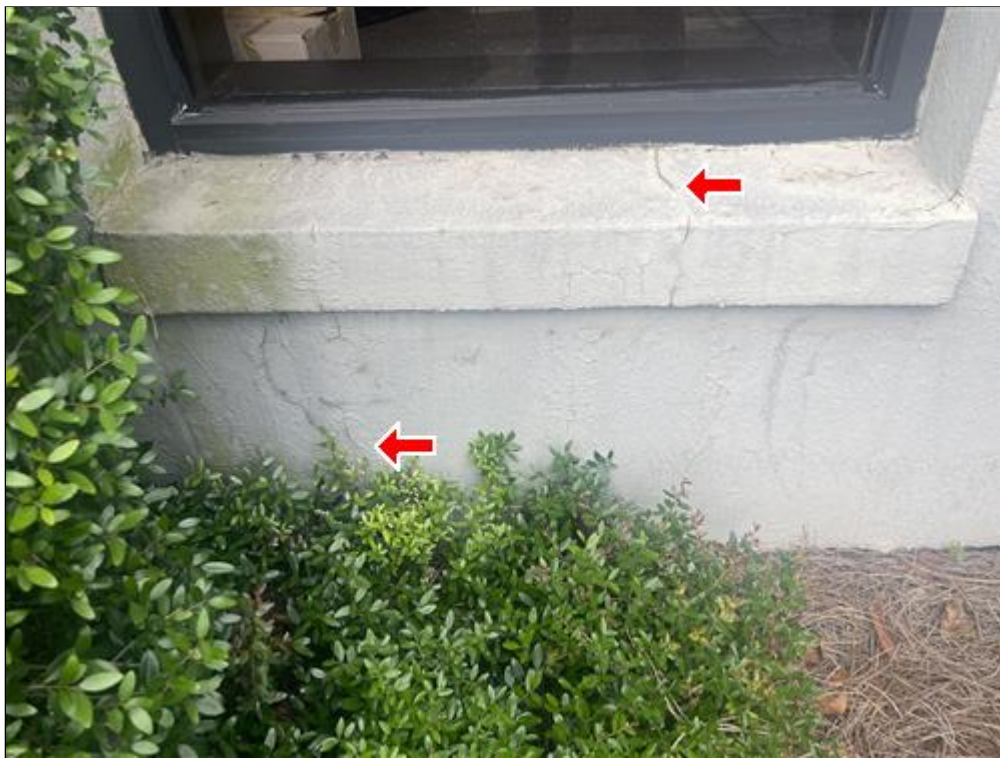
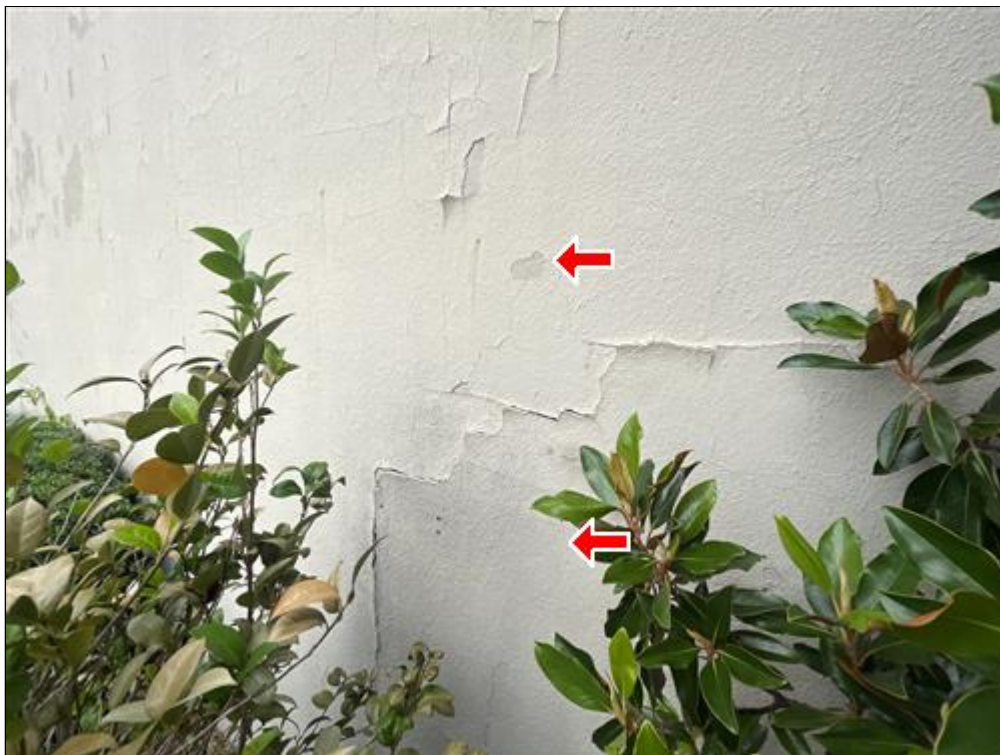
2.0 The Stucco coating at the front of building is damaged in areas (hairline cracks). This is cosmetic and for your information. A qualified person should repair or replace as needed.

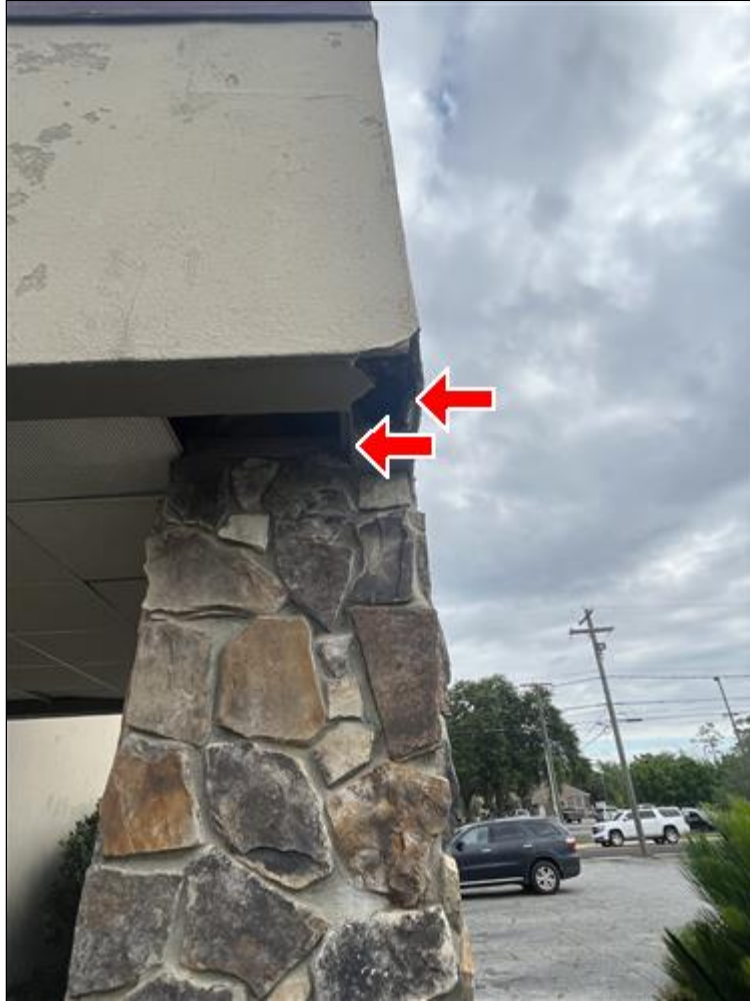
2.6 Picture 1

2.6 The at eave on the front of building is damaged. Because of the extent of deterioration it is possible for some framing in wall to be deteriorated. A qualified person should repair or replace as needed.

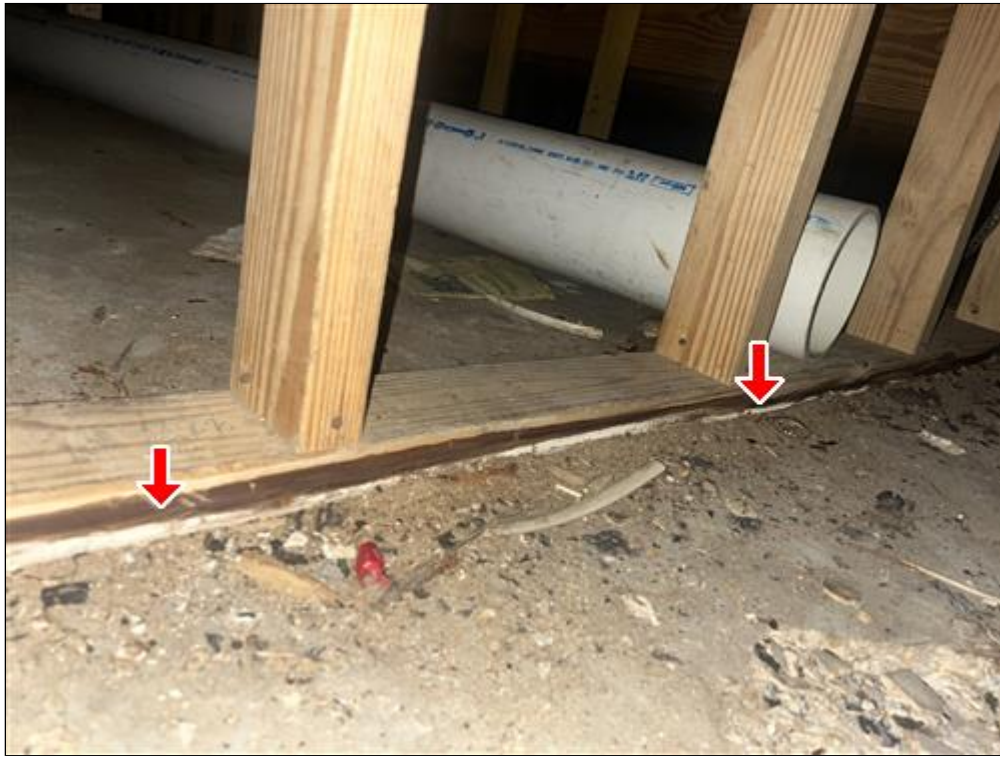
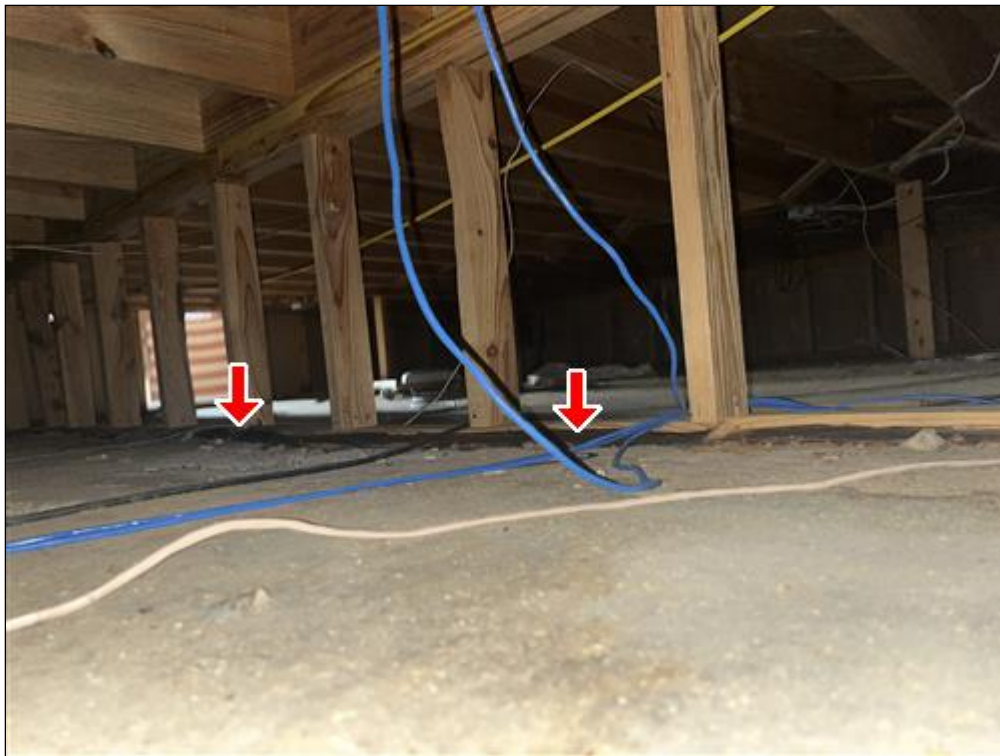
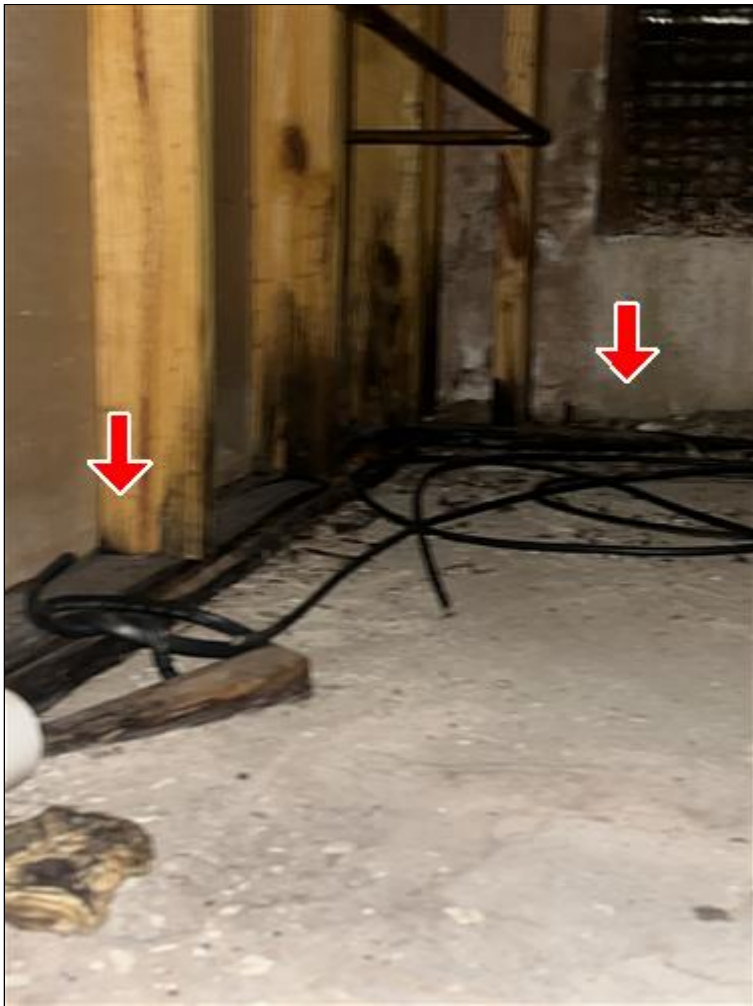
3.2 The 2x4 Bottom plate was plated with yellow pine. Pressure Treated Lumber is used to plate on a concrete slab. Some areas have started to lightly deteriorate. I recommend a certified contractor further inspect this area. Opinions on this matter often vary.

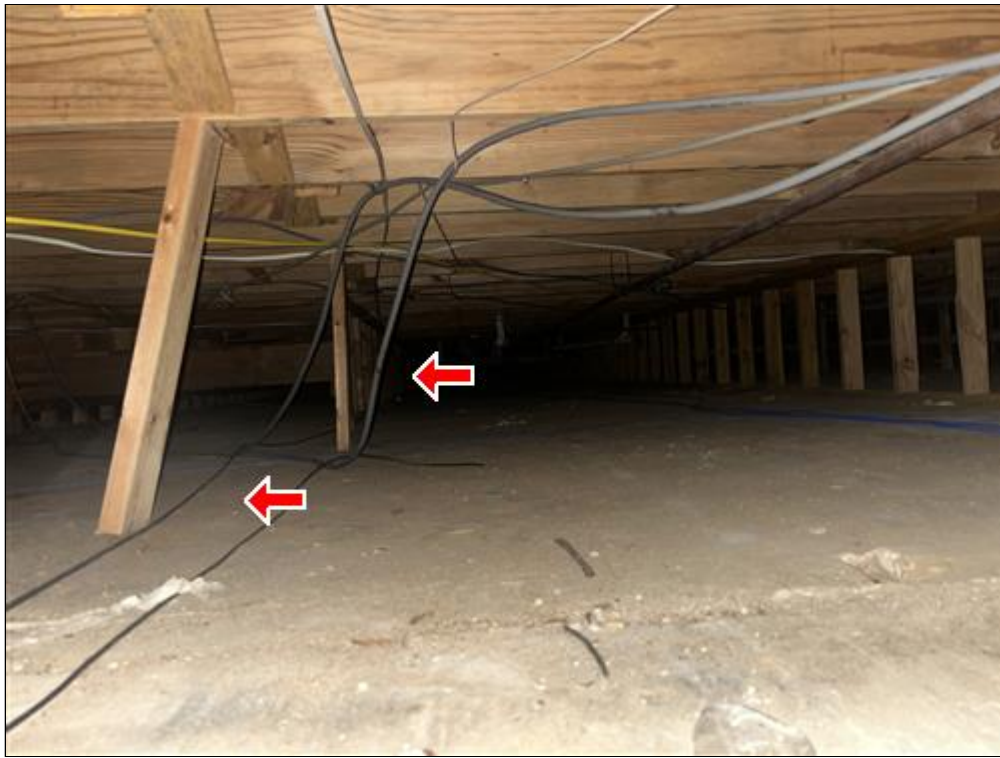
3.2 Picture 4

Some of the support braces are loose in areas, this is a small repair for your information. Picture:4

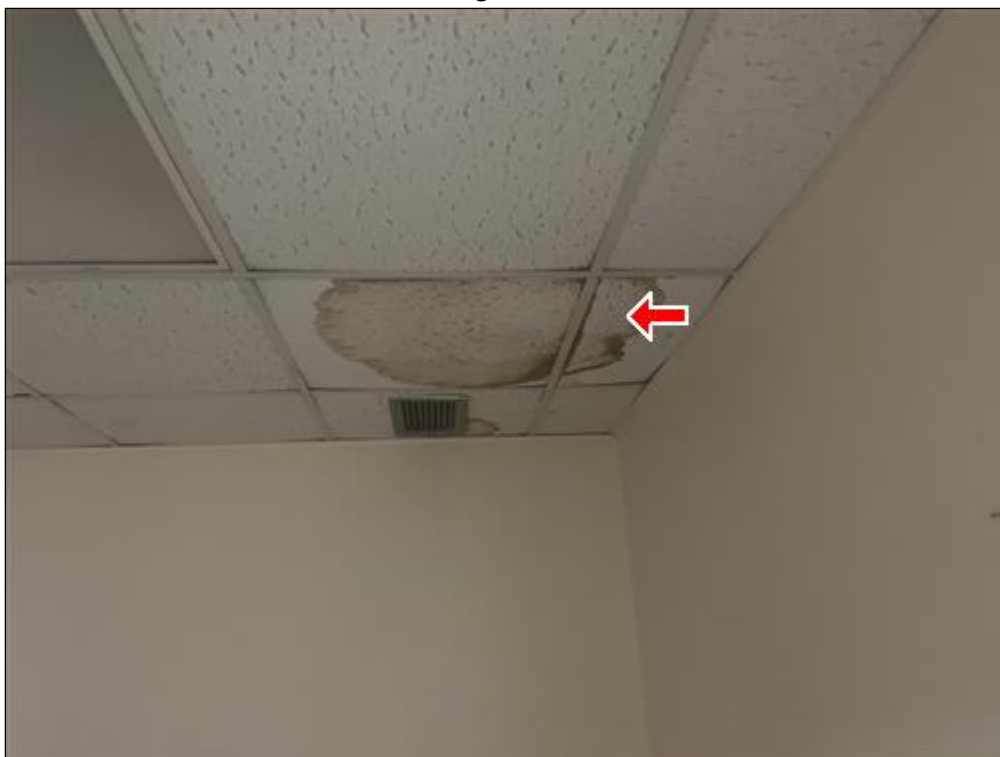
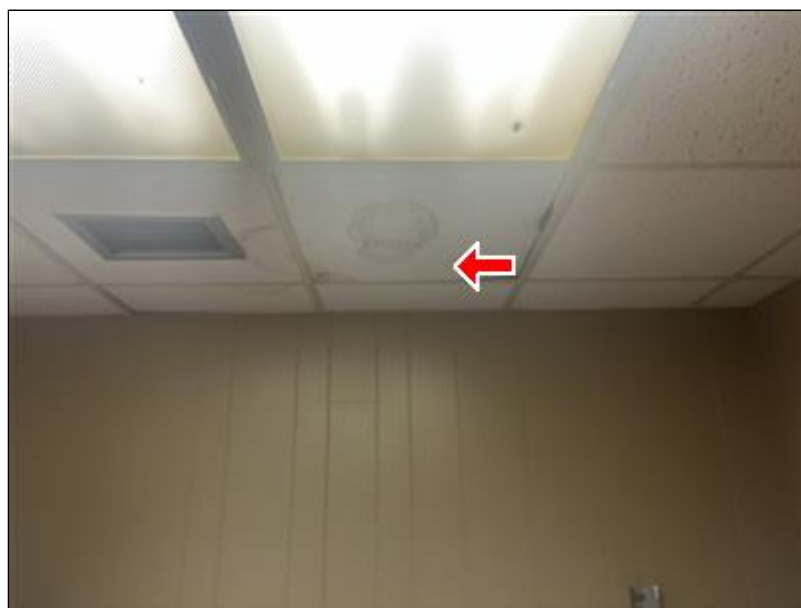
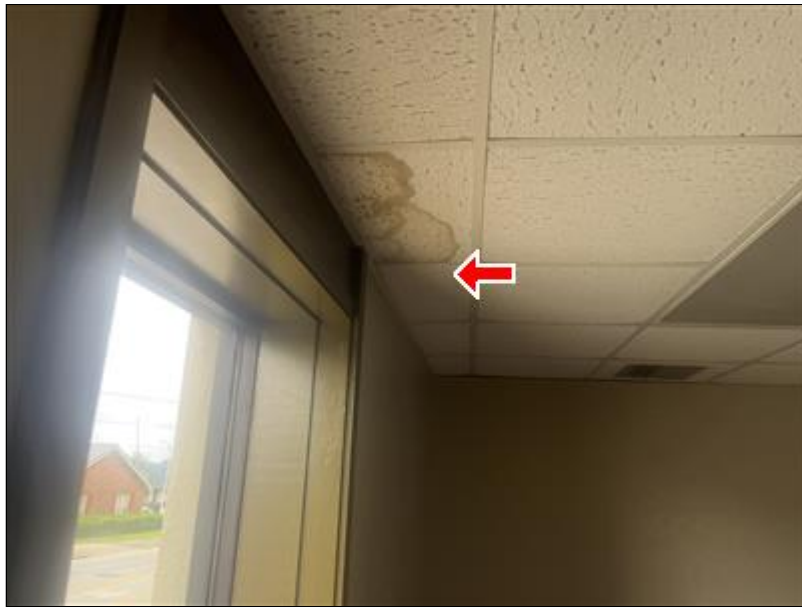
5.0 The Ceiling Tile on the ceiling reveals a light stain which appears from a water leak. Stain appears old at the building. While this damage is cosmetic, it needs to be repaired. . This is most likely due to condensation from the ductwork above in the ceiling.

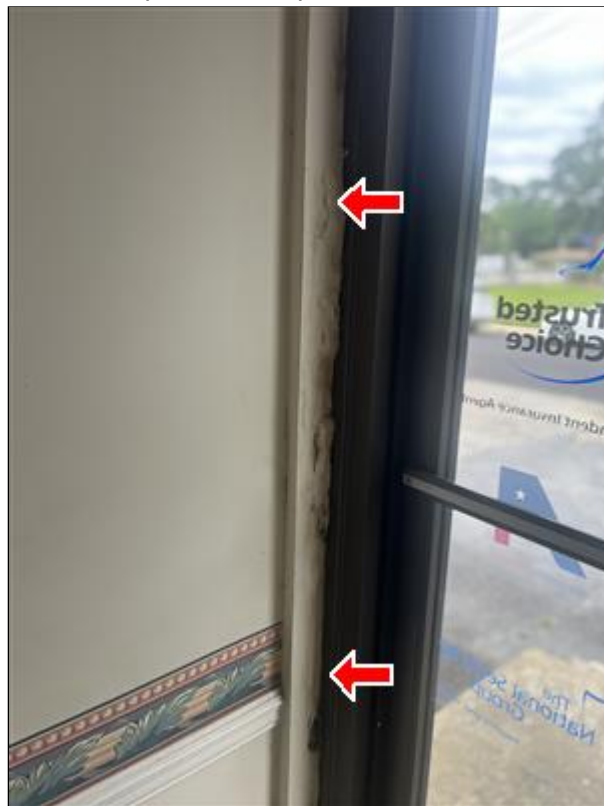
5.3 Picture 1

5.3 The Entry door at the side of the building has leaked in the past, I am not sure if this is an active leak. I recommend a qualified person further inspect and repair as needed
