Inspection Report

Property Address:
1217 Pine Park Rd.
Cairo Ga 39828

South Georgia Home Inspections

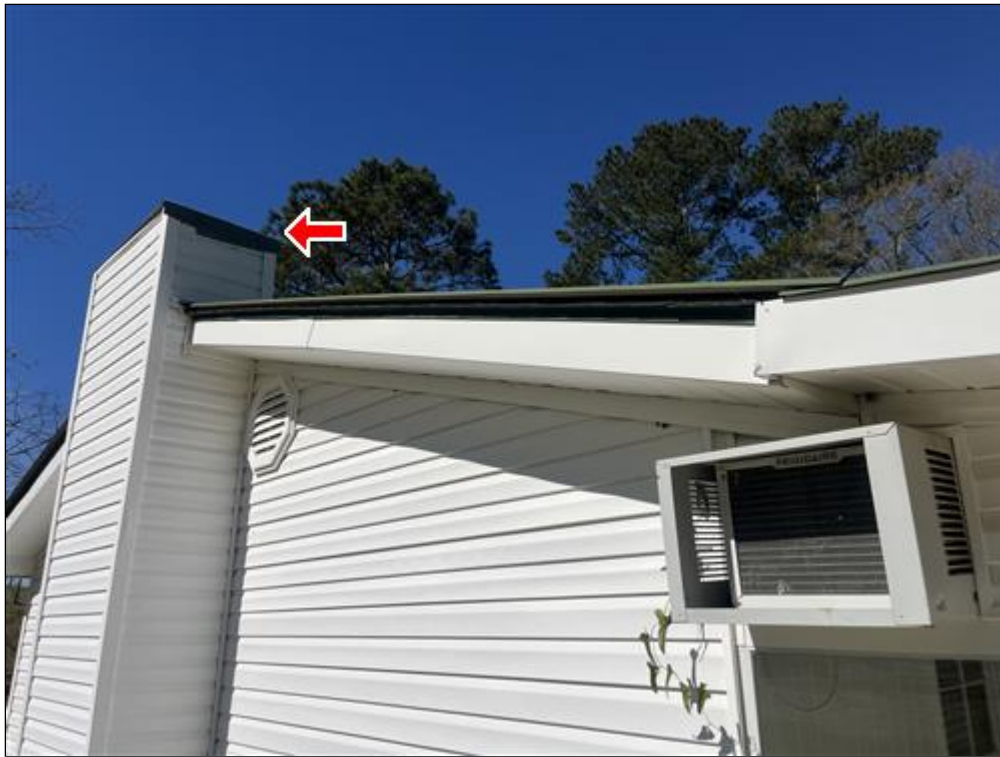
1.2 Picture 1

1.2 The chimney has been closed off at the top with sheet metal and is considered inoperable. It should not be used until inspected for safety by a qualified chimney sweep. I did not inspect for operation.

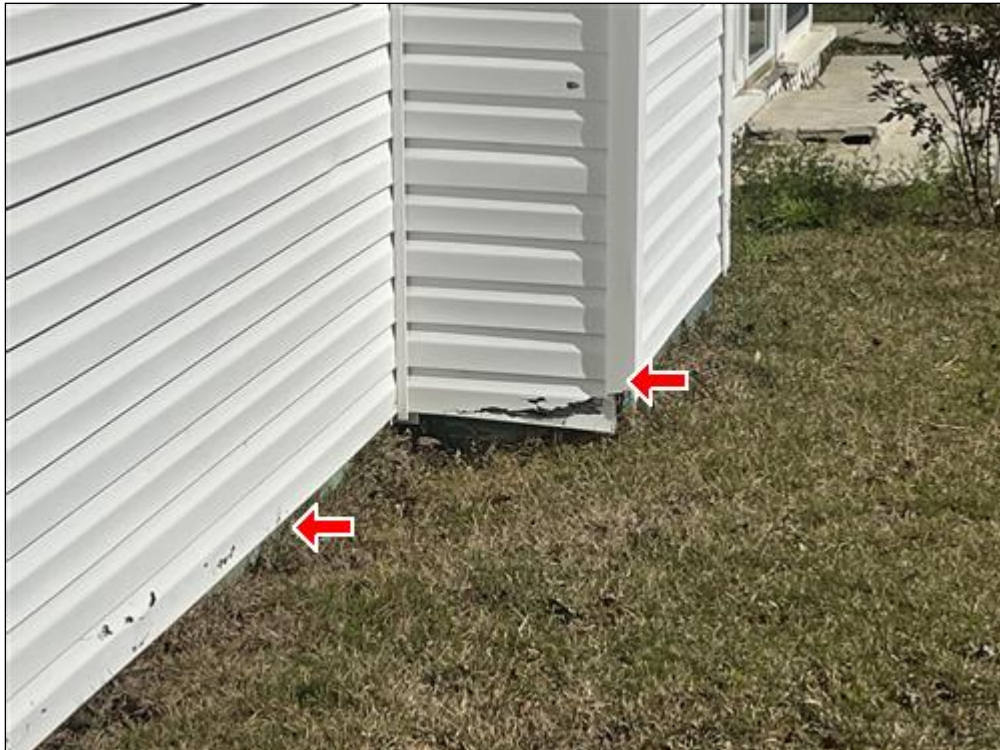
2.0 Picture 1

2.0 The Vinyl siding at the exterior in areas is damaged. . A qualified person should repair or replace as needed.

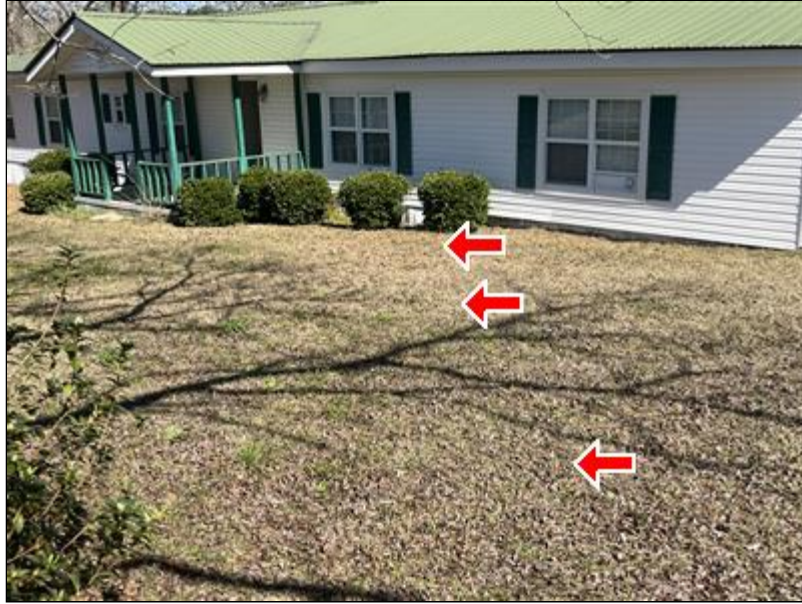
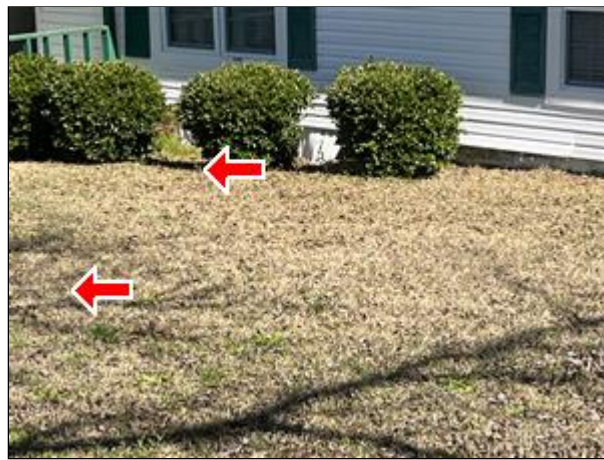
2.4 Picture 1

2.4 There is a negative slope at the front of home and can cause or contribute to water intrusion or deterioration. I recommend correcting landscape to drain water away from home.

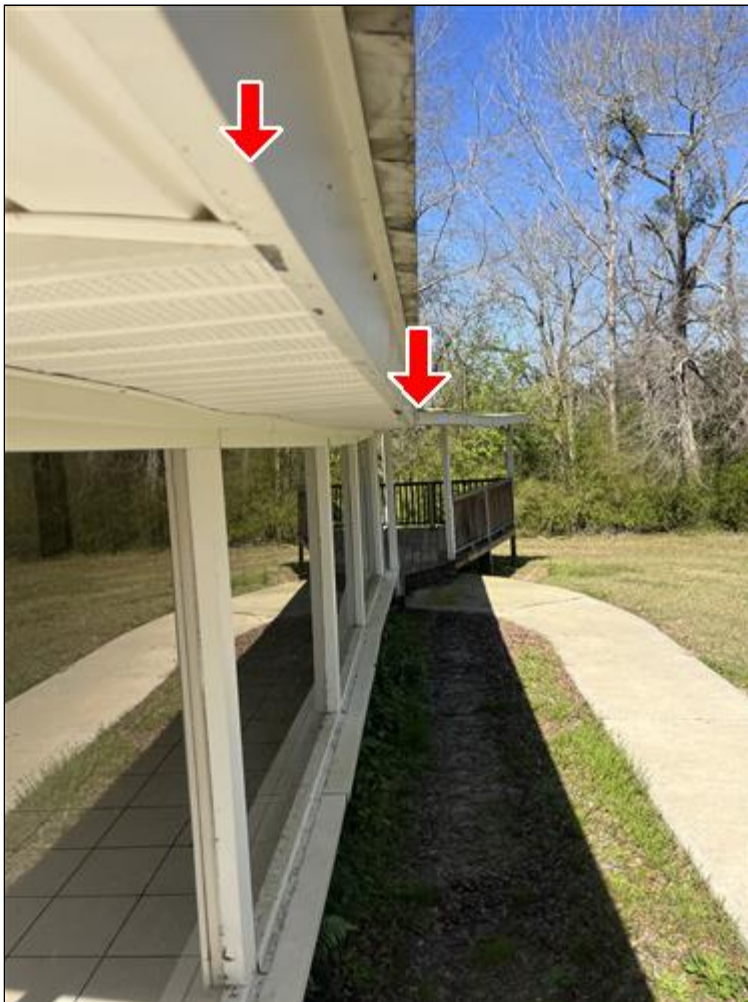
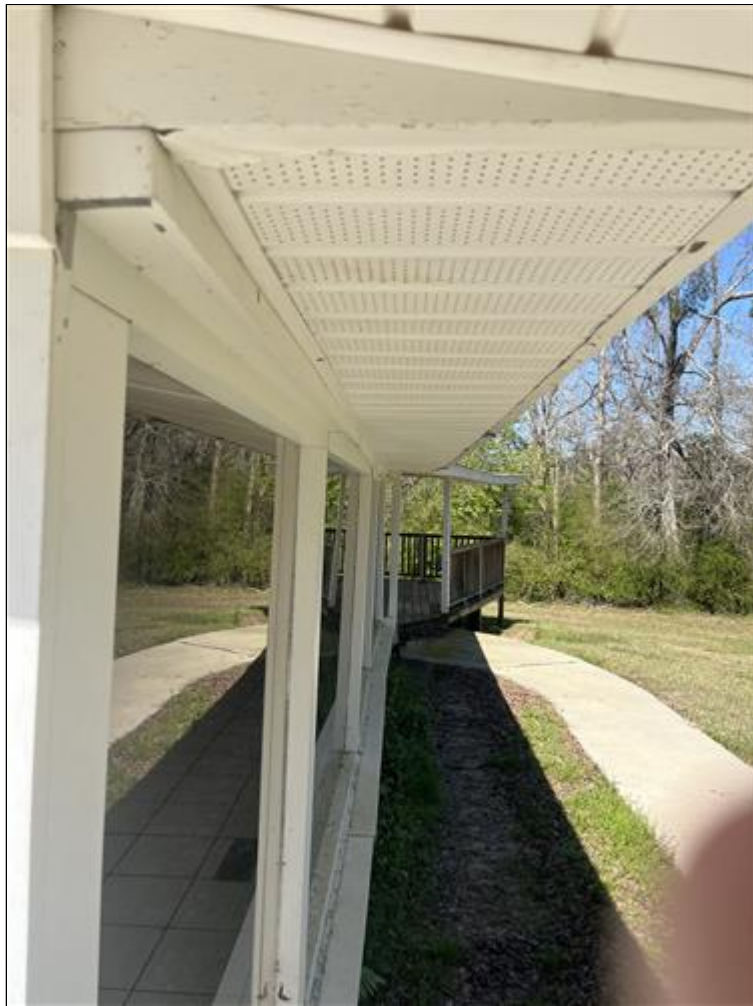
2.5 Picture 1

2.5 The fascia at the rear of the home sags in areas, this may be due to settlement at the rear of the home. I am unable to inspect the rafters in this area. This is for your information.

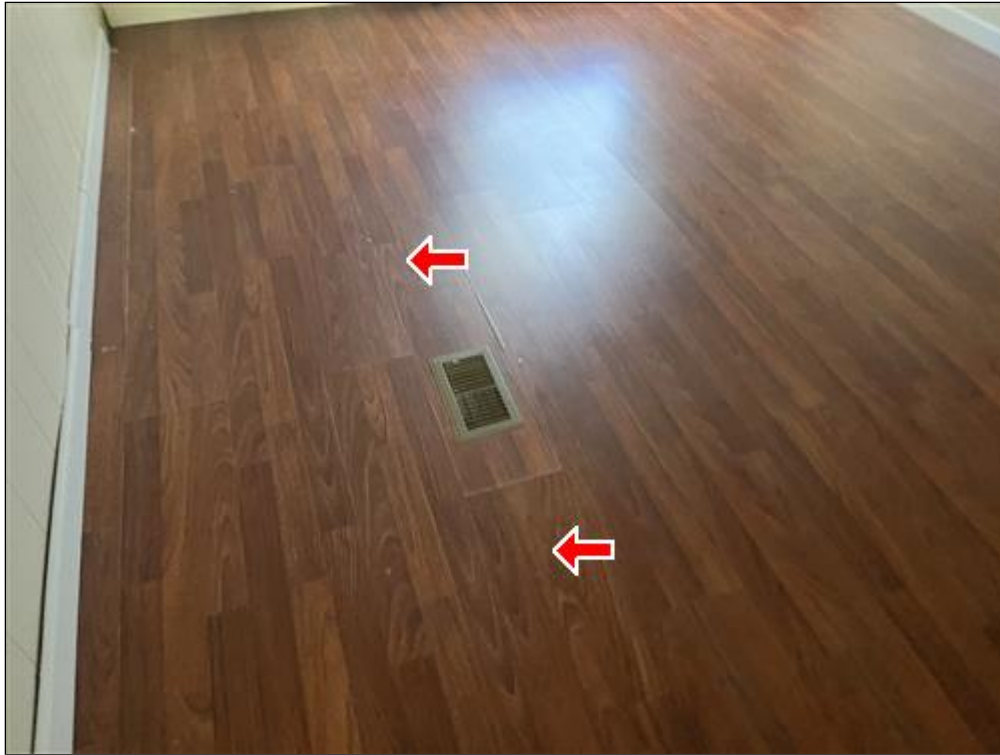
4.2 Picture 1

4.2 (1) The Sub floor is weak and not supported from underneath at the Bedroom and Guest Bedroom. While this damage is cosmetic, the repair cost should be considered due to the amount of damage. A qualified person should repair or replace as needed.

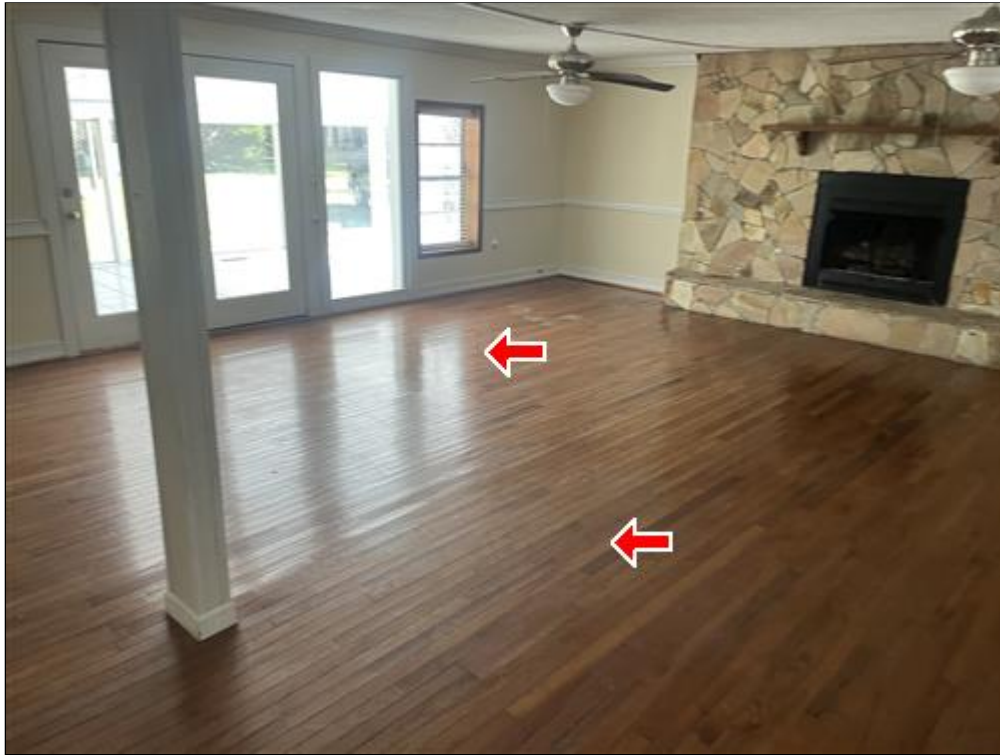
4.2 Picture 2

(2) The Wood covering is curling around edges and is not impervious to water shows wet stains indicating moisture or intrusion did or still may occur at the Living Room. While this damage is cosmetic, the repair cost should be considered due to the amount of damage. A qualified person should repair or replace as needed A qualified contractor should inspect and repair as needed.

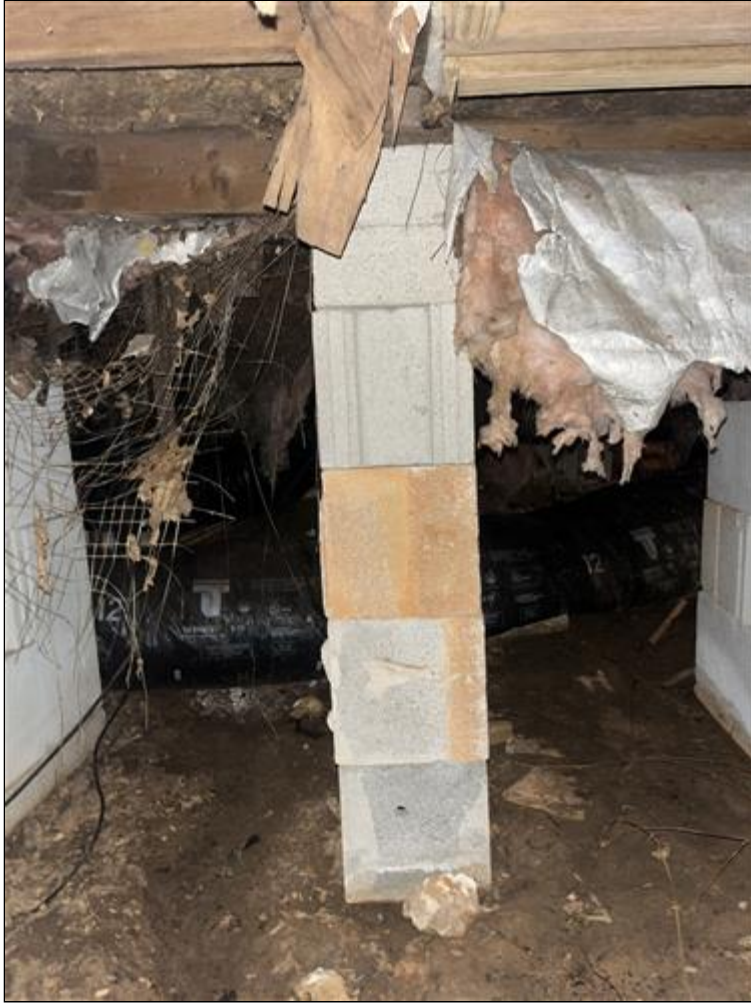
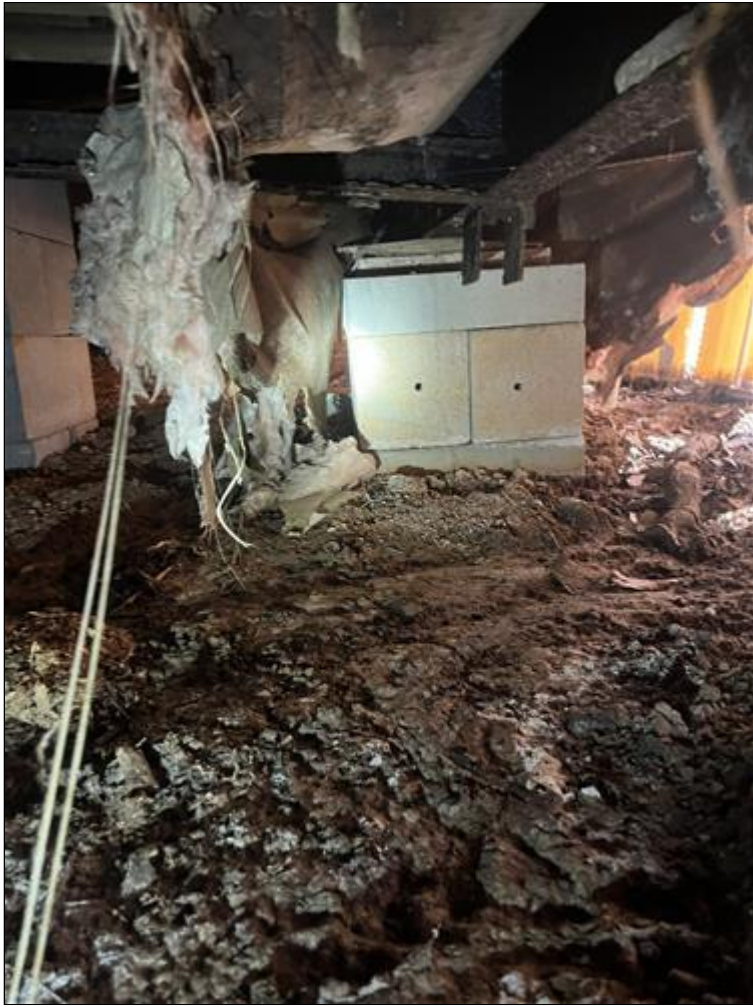
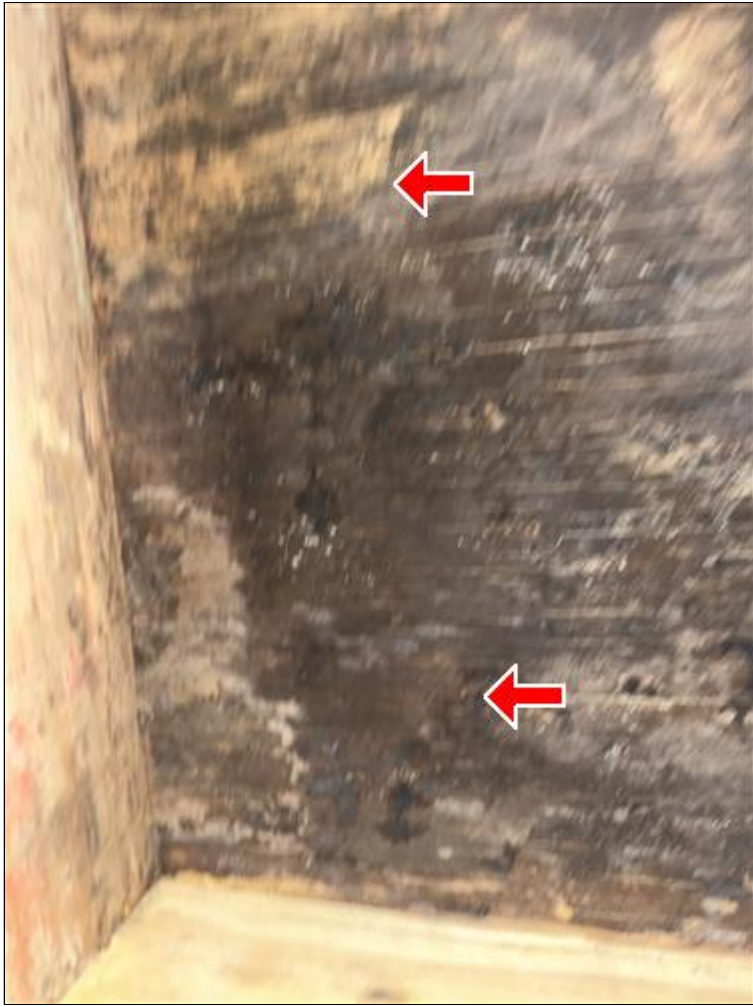
5.2 Picture 1

5.2 There has been some additional piers added since the original construction. There was no footing or mortar between blocks added to these piers when applied.

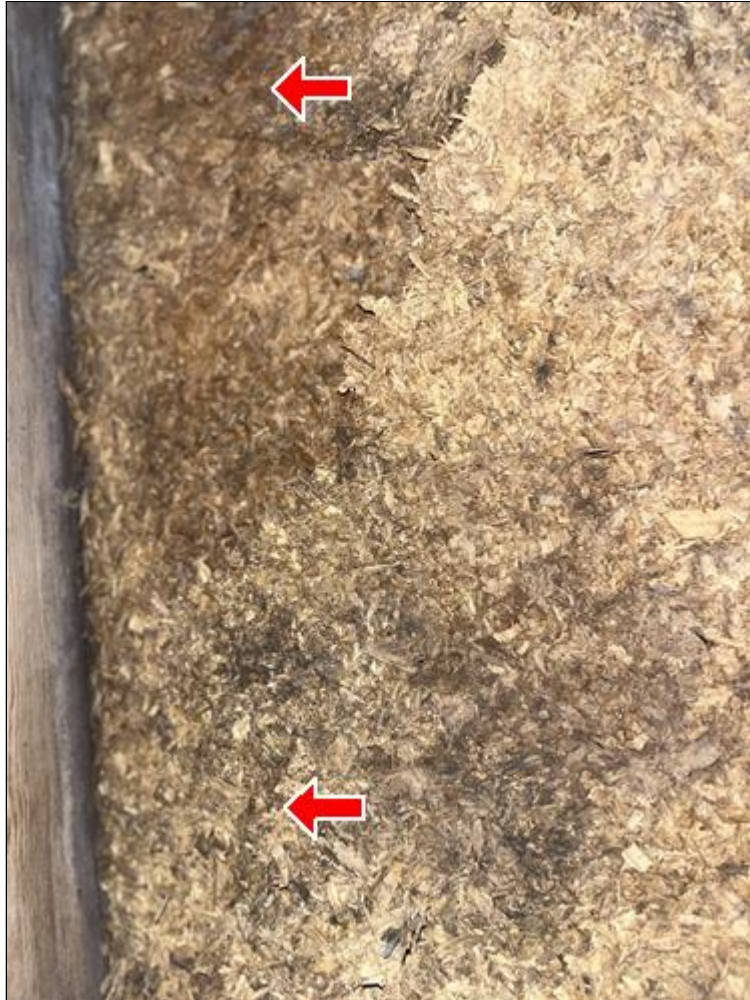
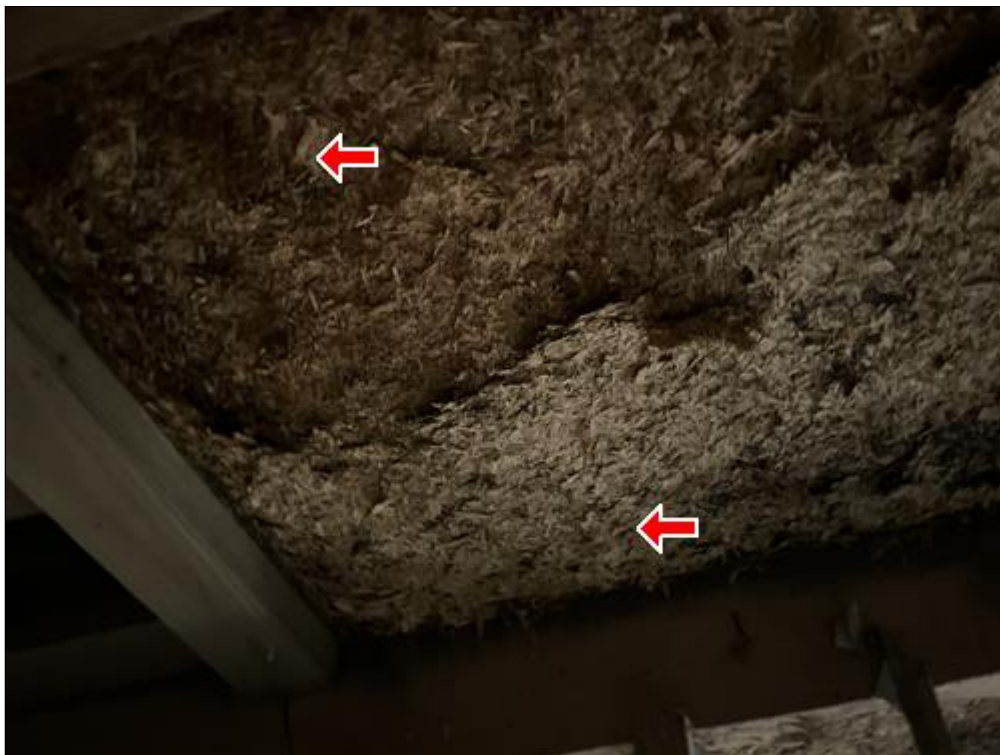
5.3 Picture 1

5.3 Sub-flooring is deteriorated from moisture absorption or water intrusion under the Guest Bedroom, Small bedroom and Hall Bath. Repairs are needed. A qualified licensed general contractor should inspect further and repair as needed. The sub-flooring underneath the Living room and Kitchen have been replaced in the past. This is for your information

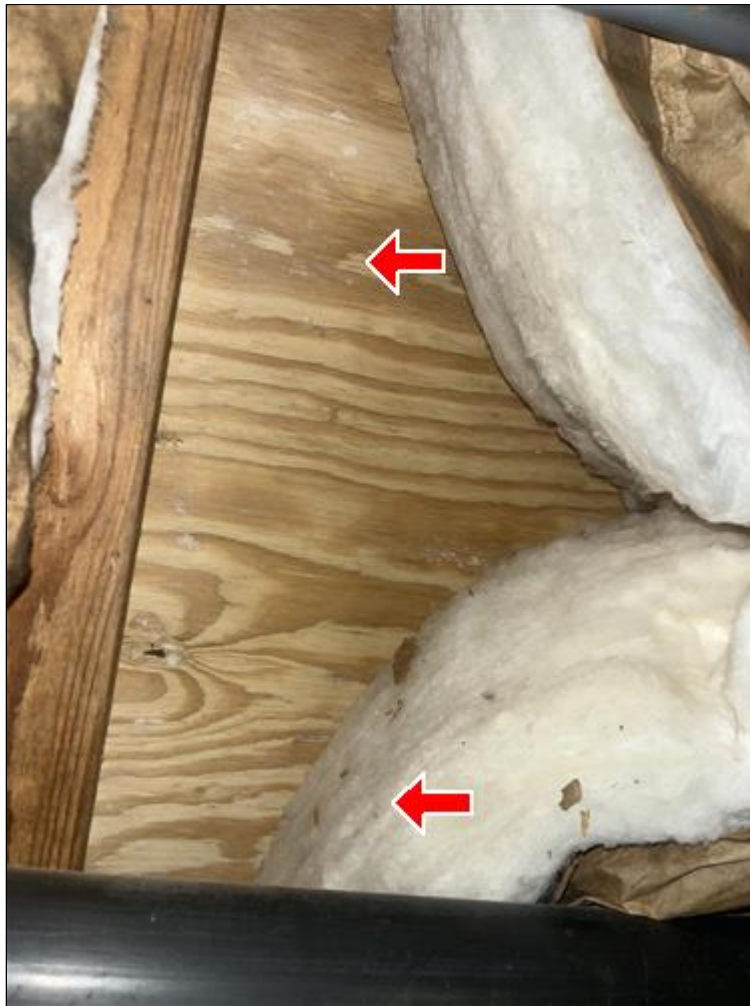
5.3 Picture 3 Past repairs made to the sub-flooring

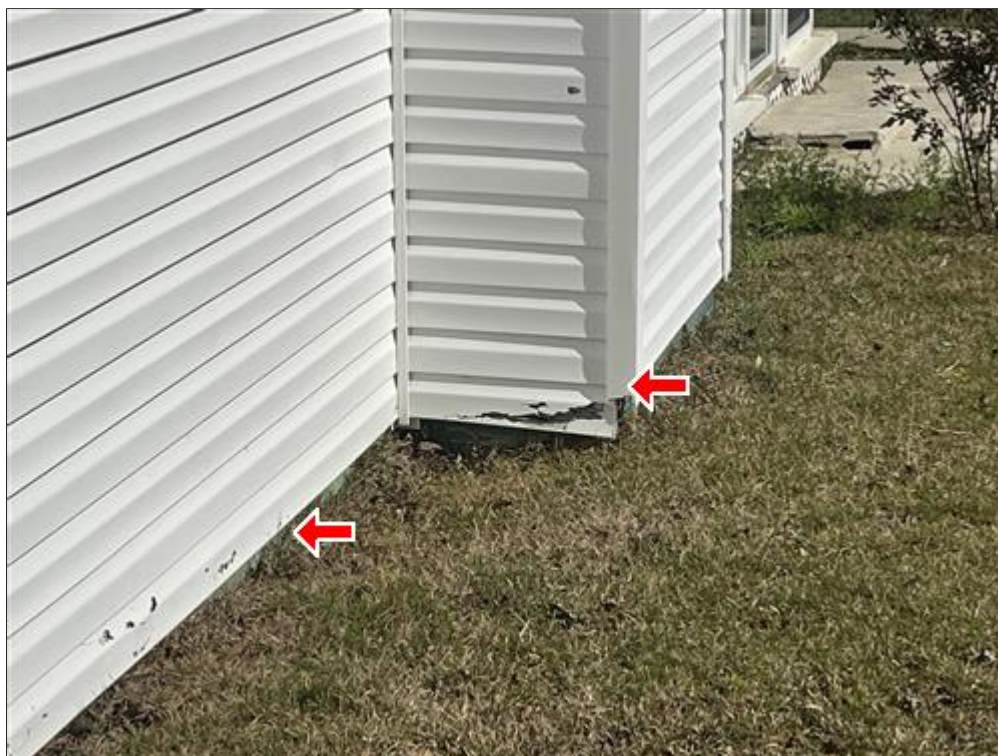
2.0 Picture 1

The Vinyl siding at the exterior in areas is damaged. . A qualified person should repair or replace as needed.

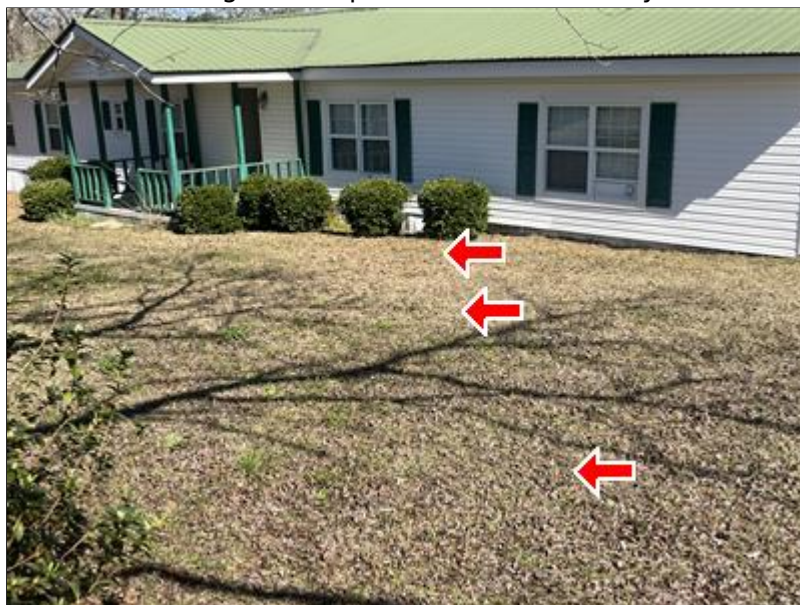
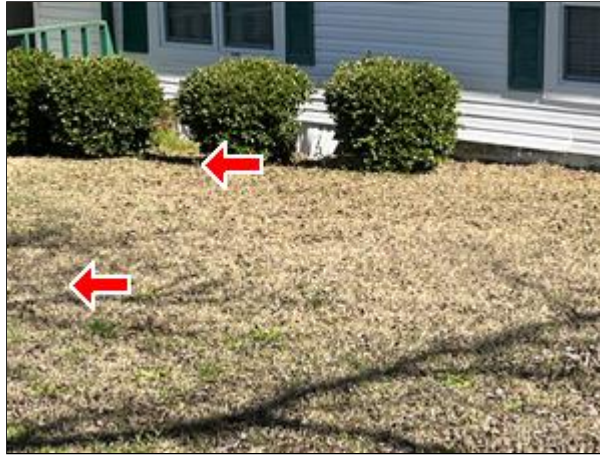
2.4 Picture 1

There is a negative slope at the front of home and can cause or contribute to water intrusion or deterioration. I recommend correcting landscape to drain water away from home.

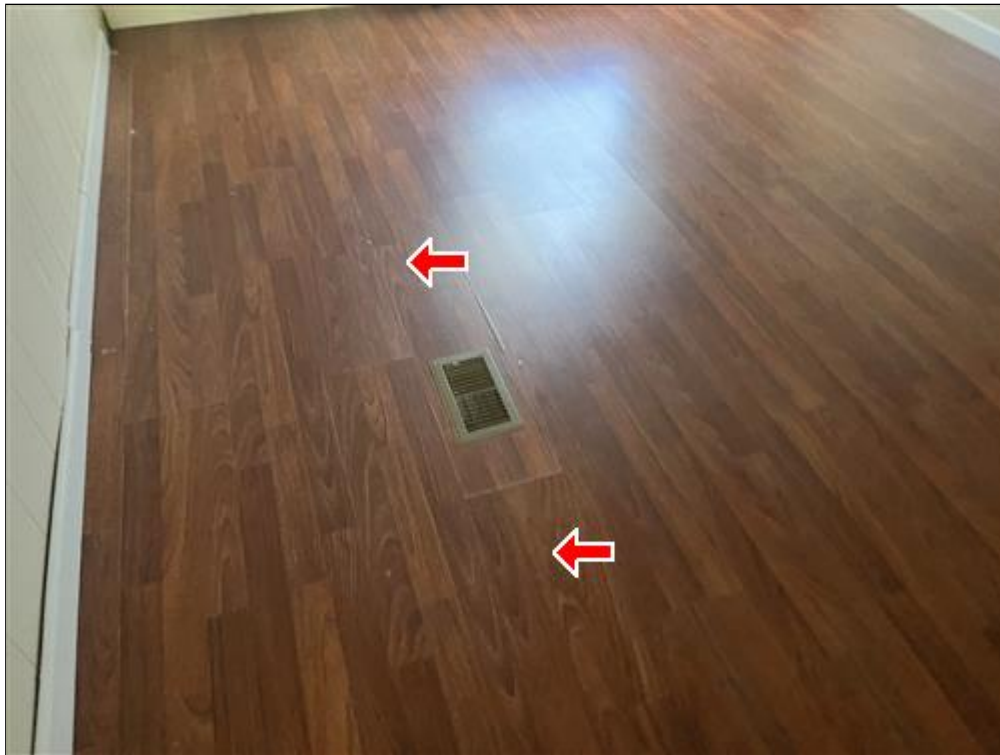
4.2 Picture 1

(1) The Sub floor is weak and not supported from underneath at the Bedroom and Guest Bedroom. While this damage is cosmetic, the repair cost should be considered due to the amount of damage. A qualified person should repair or replace as needed.

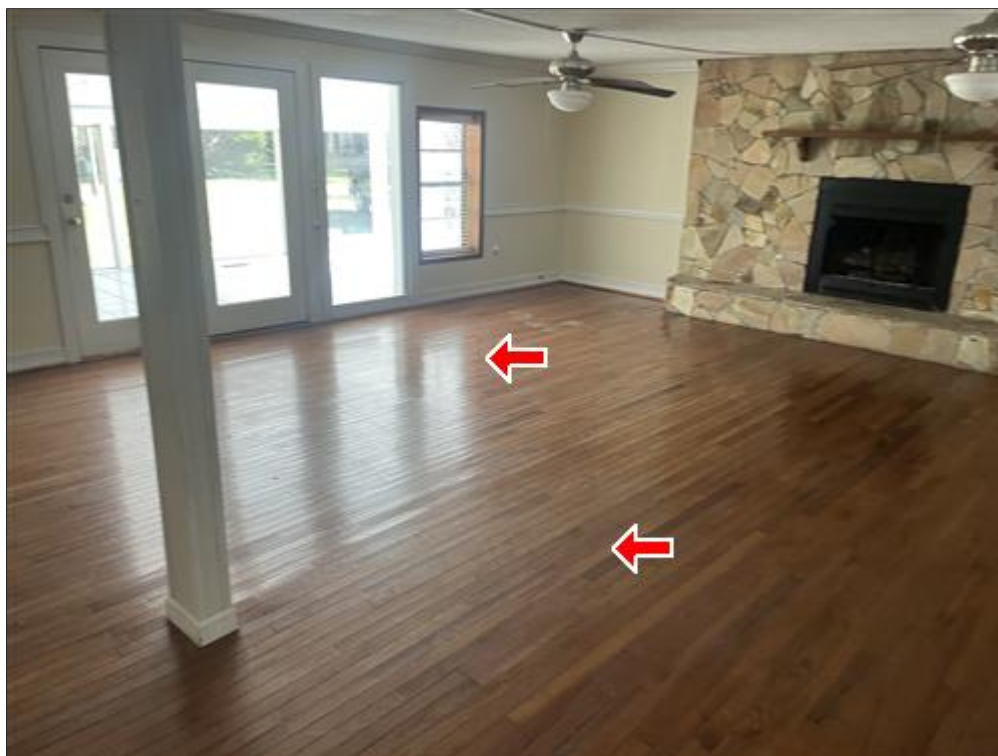
4.2 Picture 2

(2) The Wood covering is curling around edges and is not impervious to water shows wet stains indicating moisture or intrusion did or still may occur at the Living Room. While this damage is cosmetic, the repair cost should be considered due to the amount of damage. A qualified person should repair or replace as needed A qualified contractor should inspect and repair as needed.

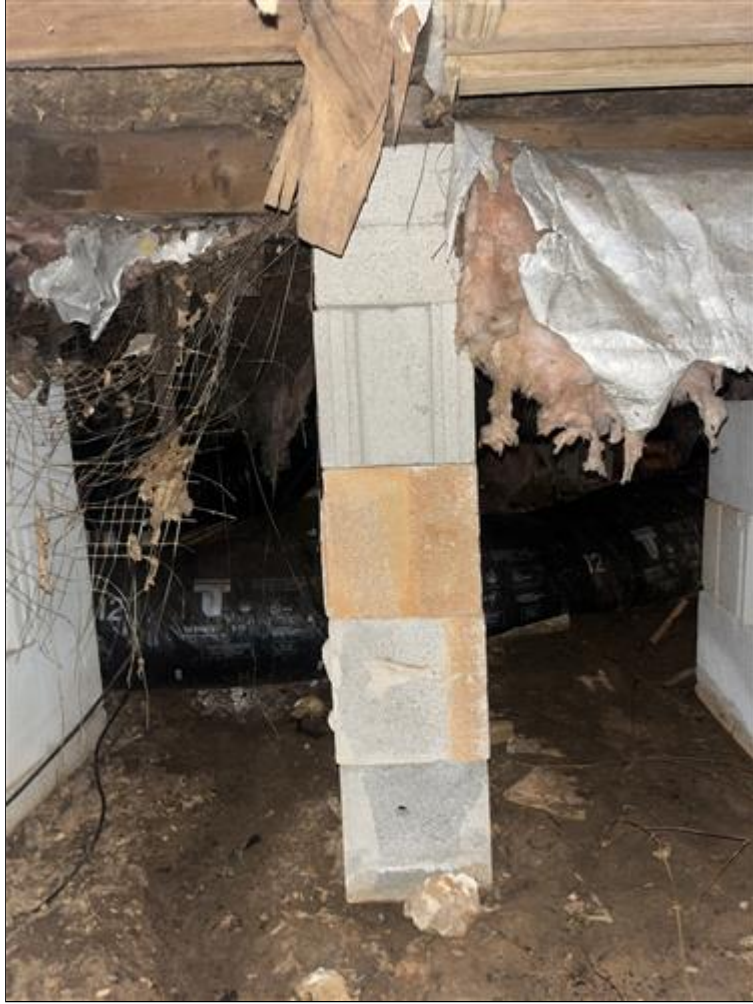
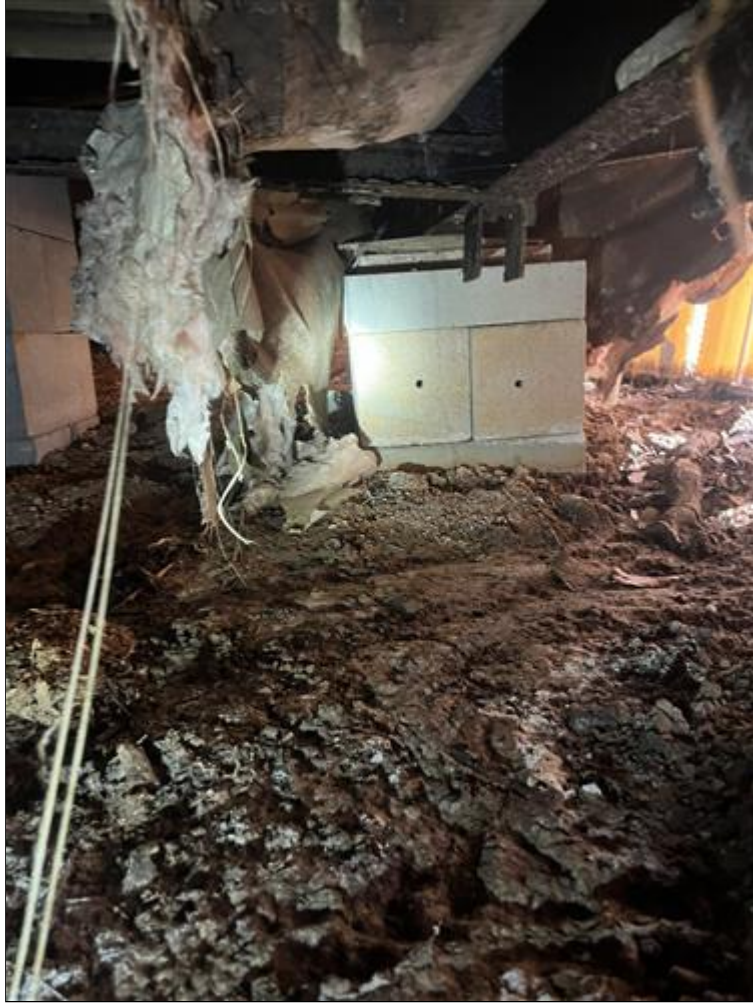
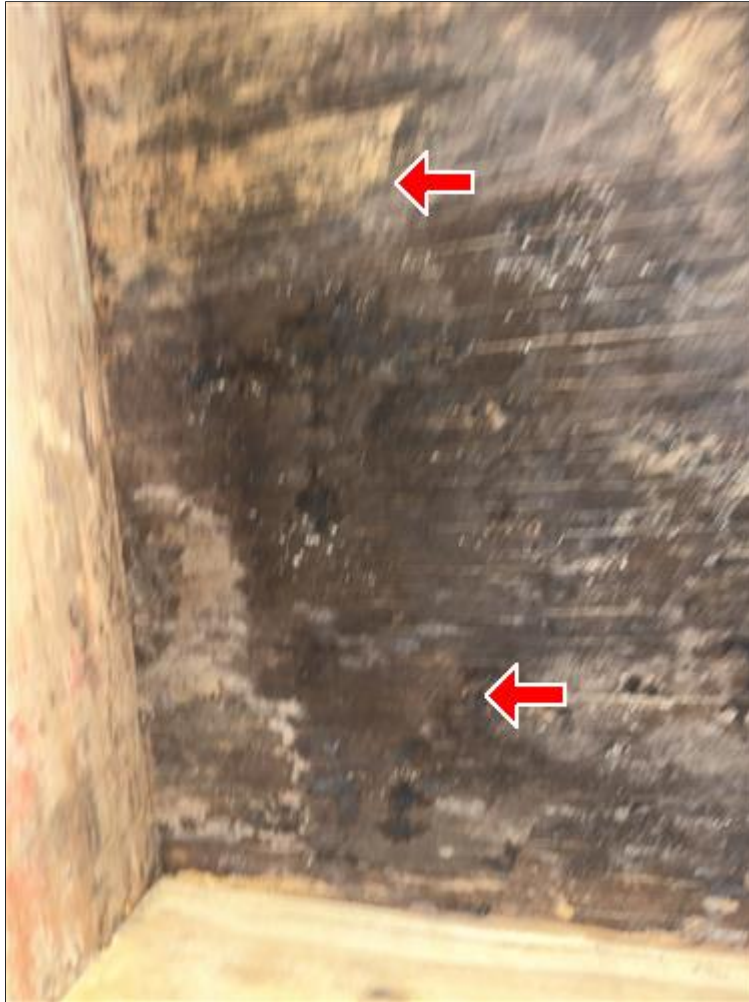
5.2 Picture 1

There has been some additional piers added since the original construction. There was no footing or mortar between blocks added to these piers when applied.
