# **Inspection Report**

# **Wiregrass Auction Group**

Property Address: 1217 Pine Park Rd Cairo Ga 39828

Eric House 105 Imperial Dr Thomasville Ga 31792

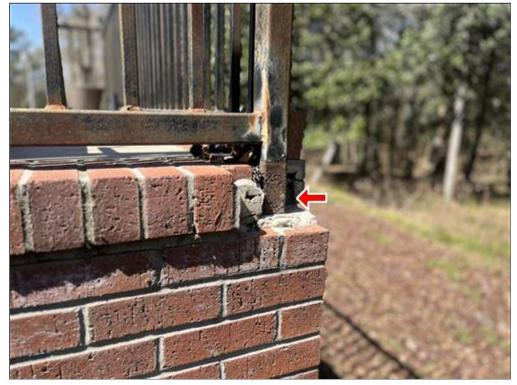
2.0 Picture 1

**2.0** (1) The brick siding is missing a piece at the rear of the home, this is a small repair for your information.

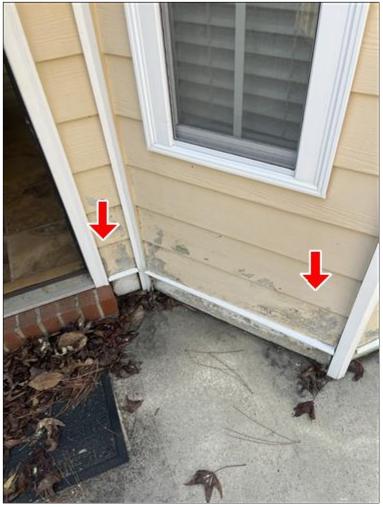
2.0 Picture 2

(2) The Cement board at the rear of home is damaged. Further deterioration can occur if not corrected. A qualified person should repair or replace as needed.

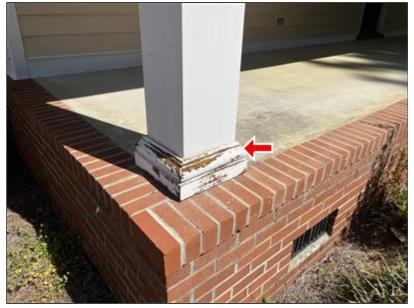
2.3 Picture 1

**2.3** The base caps at the front of the home are damaged, this is considered cosmetic and for your information.

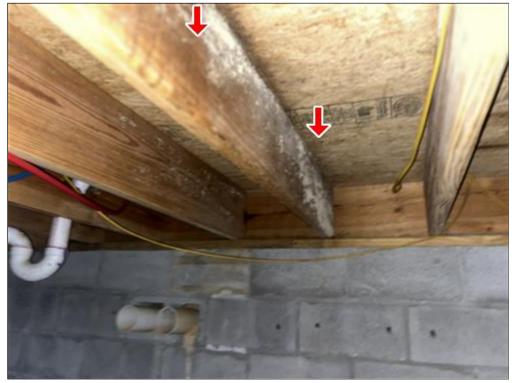
5.3 Picture 1

**5.3** Signs of fungi growth is present on the floor system in crawlspace in several areas. We did not inspect, test or determine if this growth is or is not a health hazard. The underlying cause is moisture. I recommend you contact a mold inspector or expert for investigation or correction if needed.

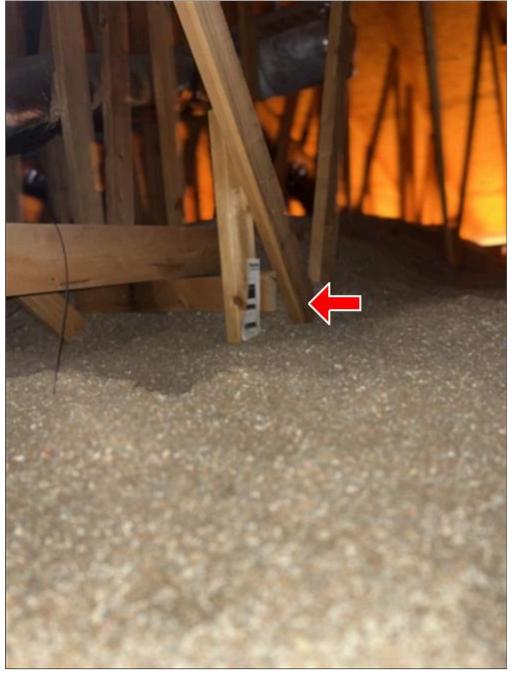
#### 9.0 Picture 1

**9.0** Cellulose insulation is about eight inches thick or just over 29 R-Value.

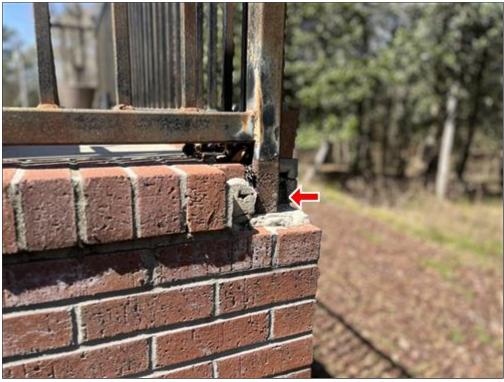
2.0 Picture 1

(1) The brick siding is missing a piece at the rear of the home, this is a small repair for your information.

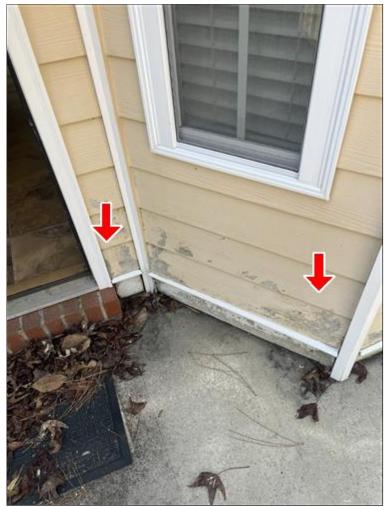
2.0 Picture 2

(2) The Cement board at the rear of home is damaged. Further deterioration can occur if not corrected. A qualified person should repair or replace as needed.

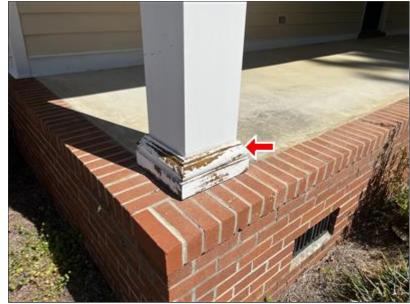
2.3 Picture 1

The base caps at the front of the home are damaged, this is considered cosmetic and for your information.

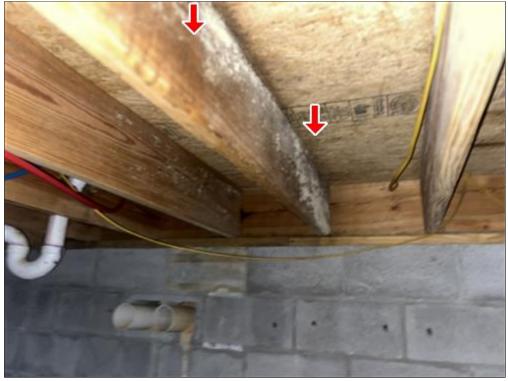
5.3 Picture 1

Signs of fungi growth is present on the floor system in crawlspace in several areas. We did not inspect, test or determine if this growth is or is not a health hazard. The underlying cause is moisture. I recommend you contact a mold inspector or expert for investigation or correction if needed.
