# **Inspection Report**

## **Wiregrass Auction Group**

**Property Address:**  
3274 Coffee Rd.  
Boston Ga 31626

**E House' Home Inspections**

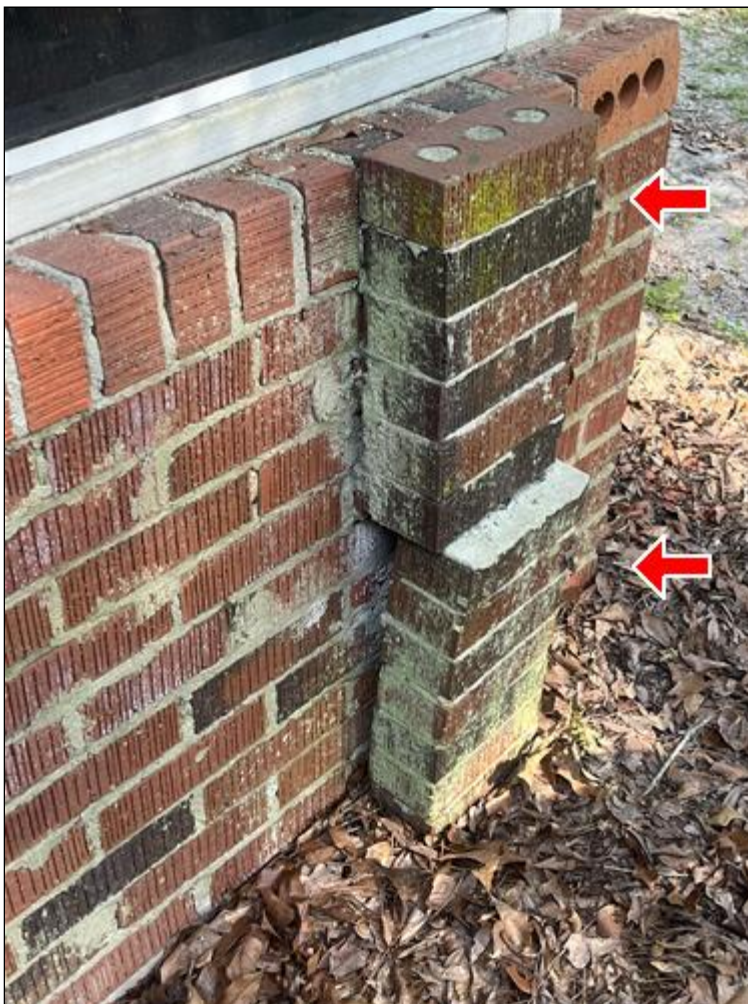
2.0 Picture 1

**2.0** The decorative brick column is loose from the wall at the rear of the home. This is not a structural issue. Cosmetic only.

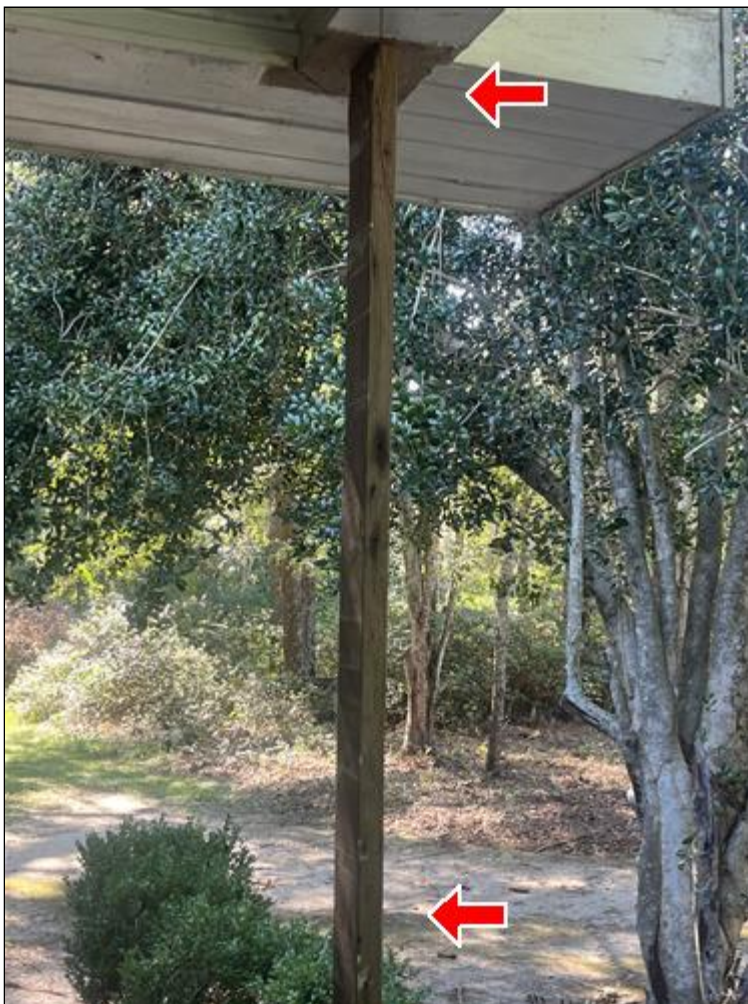
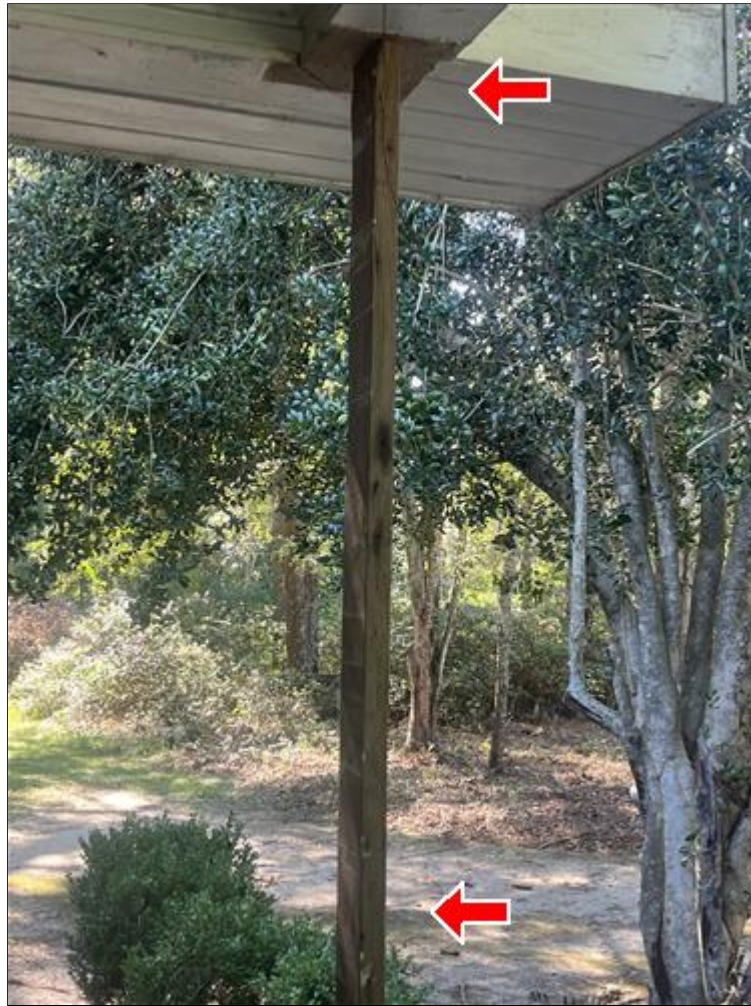
2.3 Picture 1

**2.3** The support column on covered porch at the front of home is missing. . A qualified contractor should perform the work.

The support column on covered porch at the front of home is missing. . A qualified contractor should perform the work.

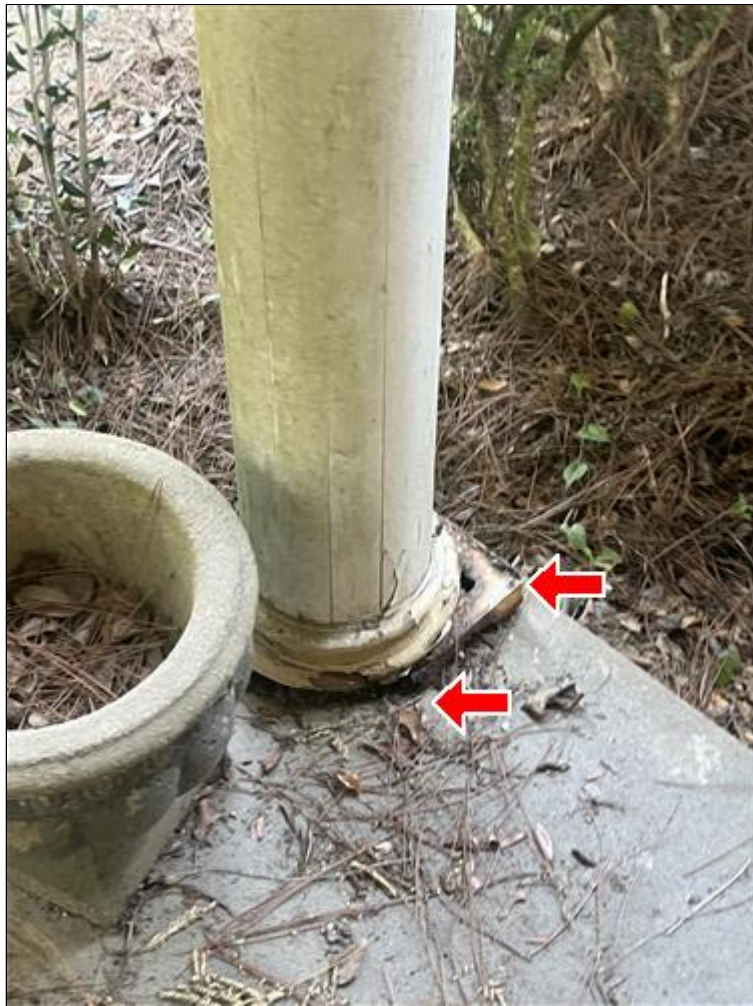
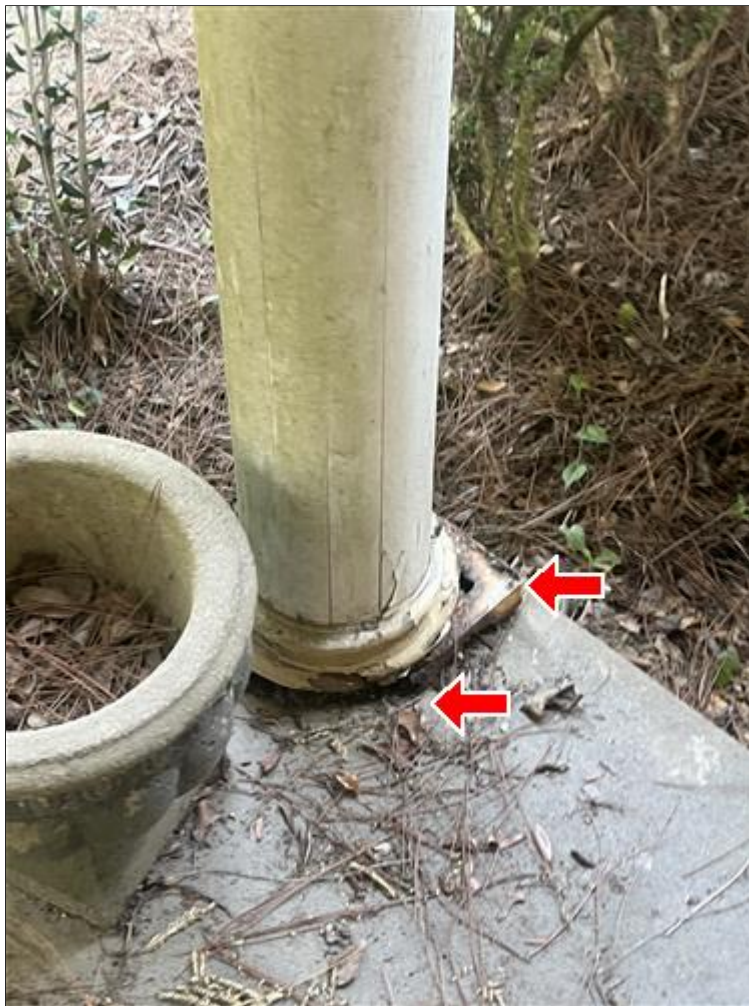
2.3 Picture 2 Trim deteriorated at bottom of column at front porch

2.3 Picture 2 Trim deteriorated at bottom of column at front porch

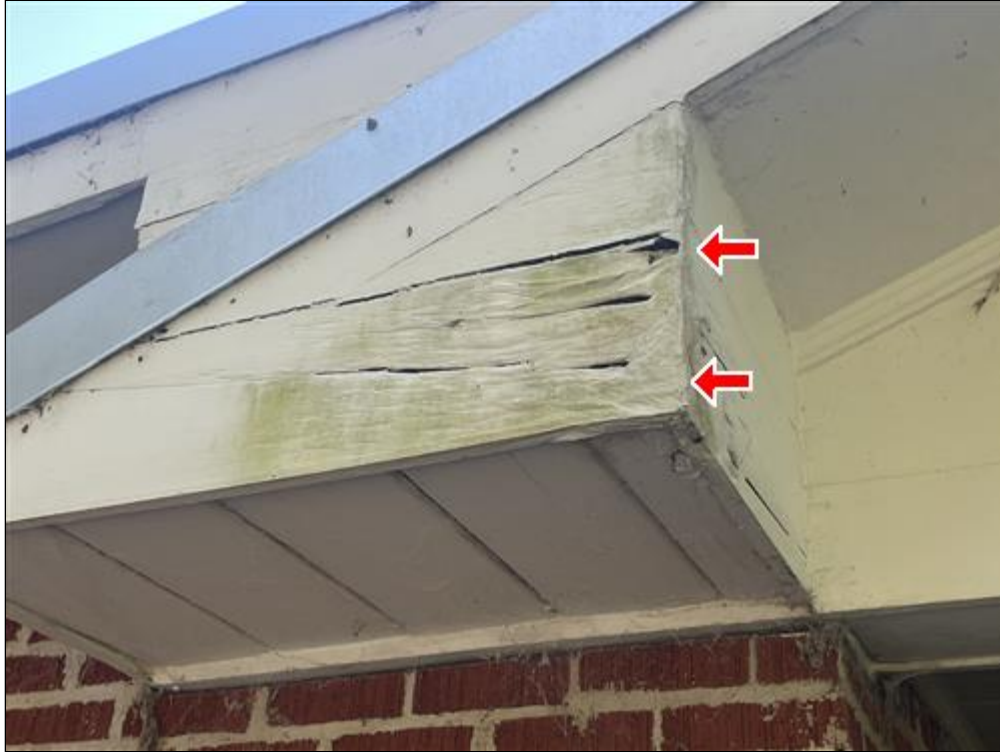
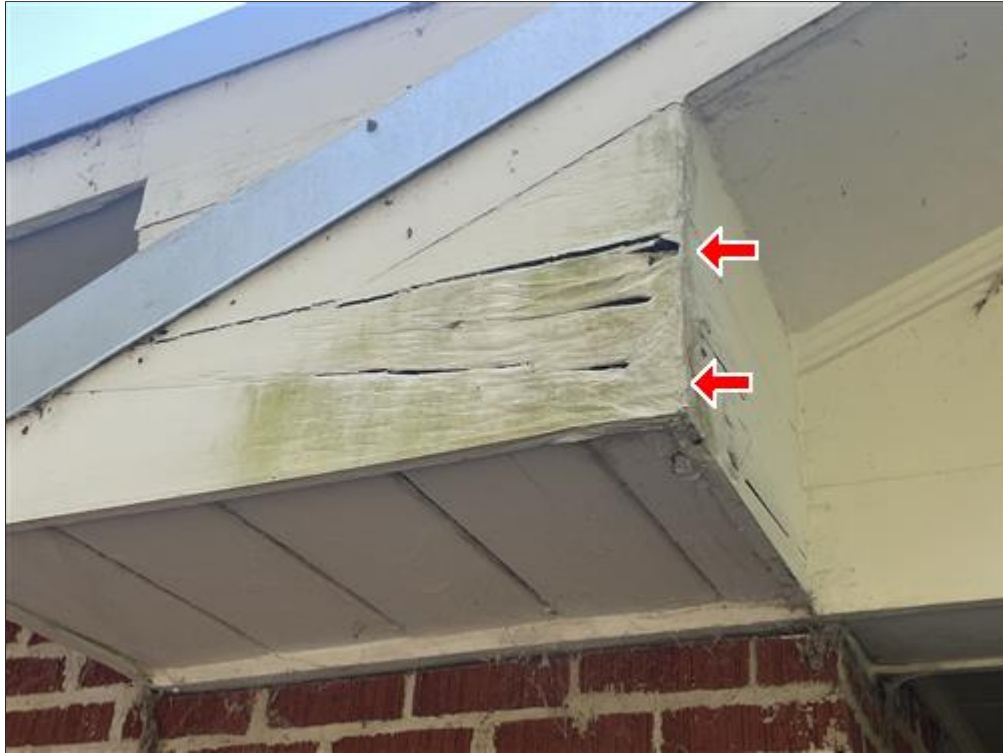
2.5 Picture 1

**2.5** The wood fascia at eave on the right side (facing front) is beginning to deteriorate. This is a small repair. A qualified person should repair or replace as needed.

The wood fascia at eave on the right side (facing front) is beginning to deteriorate. This is a small repair. A qualified person should repair or replace as needed.

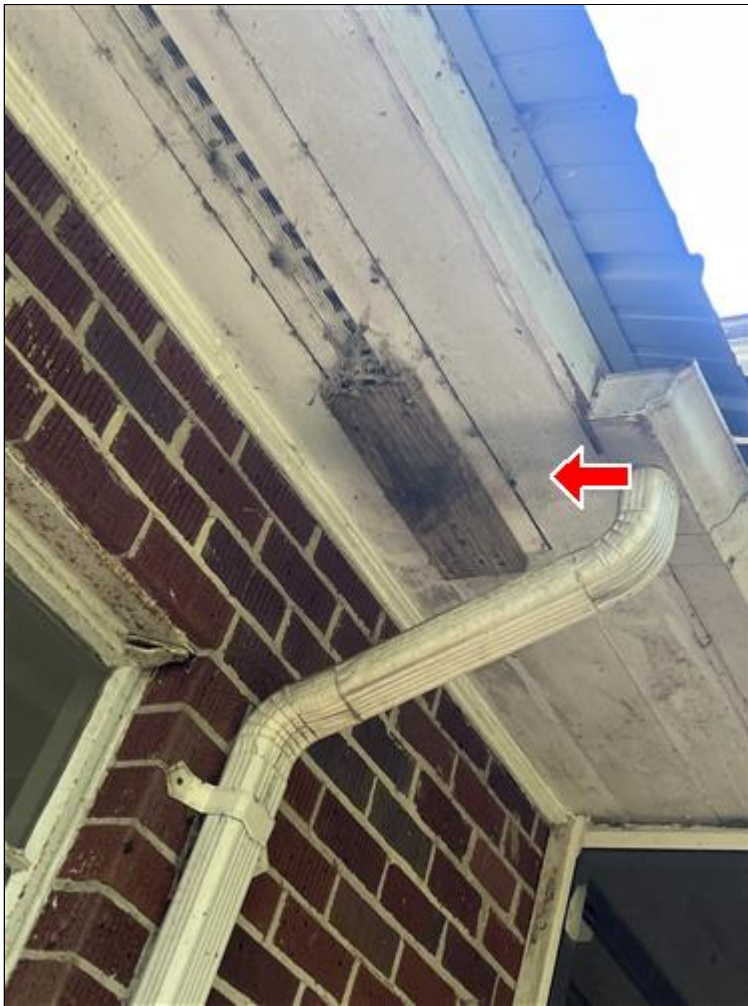
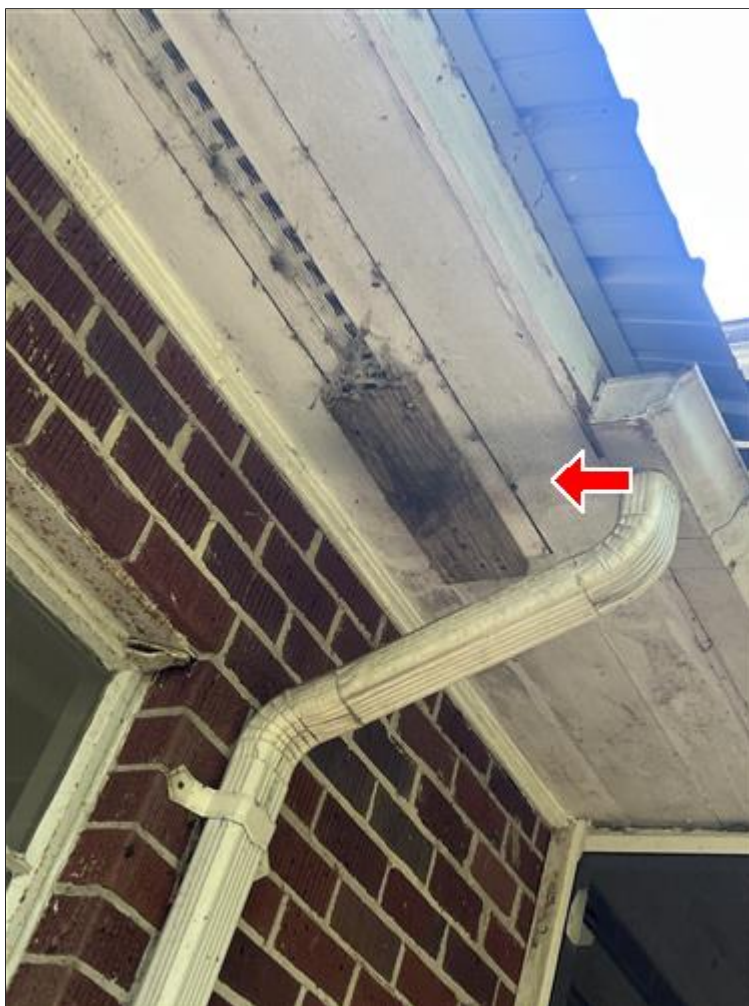
2.5 Picture 2 Repairs have been attempted at the rear of the home. This is just a patch not repaired correctly. This is for your information.

2.5 Picture 2 Repairs have been attempted at the rear of the home. This is just a patch not repaired correctly. This is for your information.

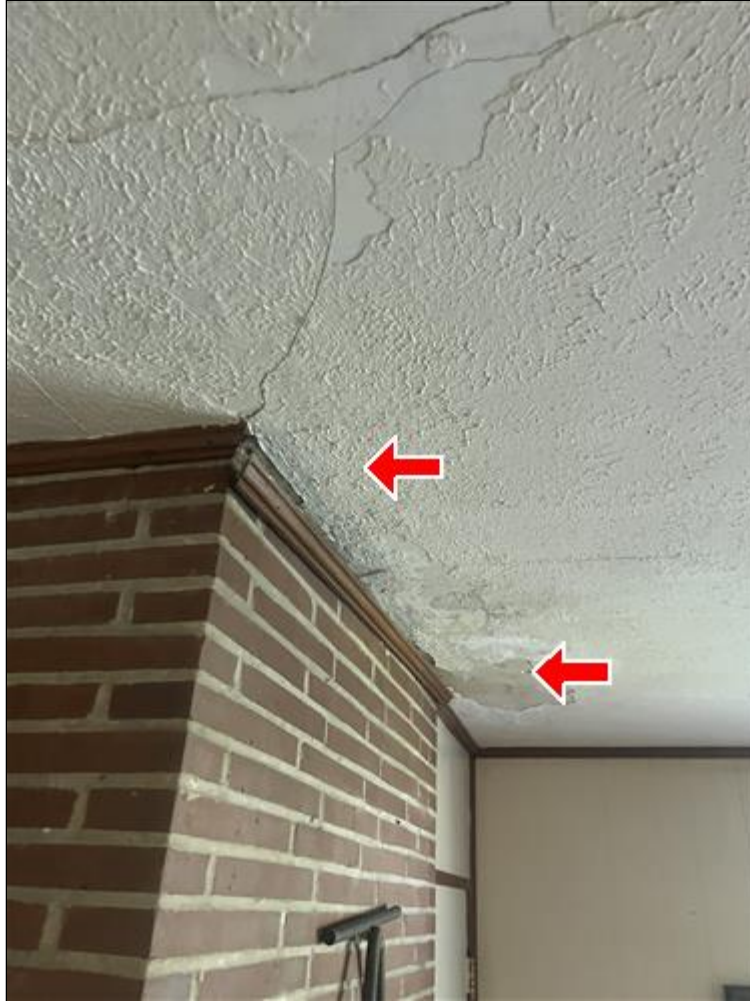
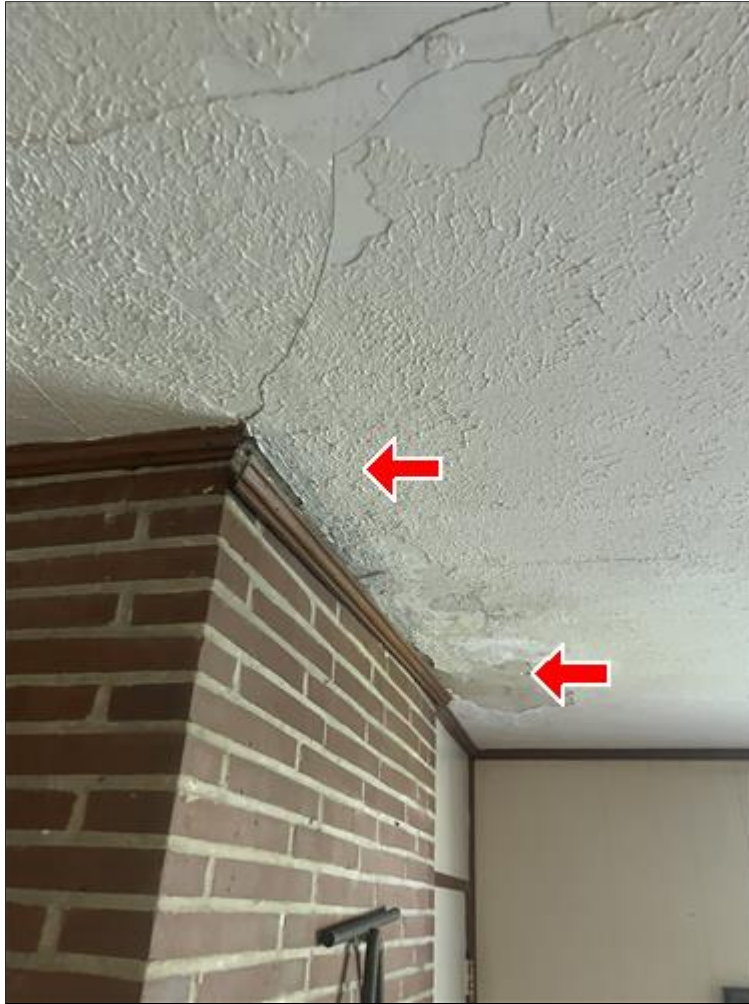
4.0 Picture 1

**4.0** The Sheetrock on the ceiling reveals a light stain which appears from a water leak. Stain appears old at the Living Room. This damage is considered cosmetic.

The Sheetrock on the ceiling reveals a light stain which appears from a water leak. Stain appears old at the Living Room. This damage is considered cosmetic.

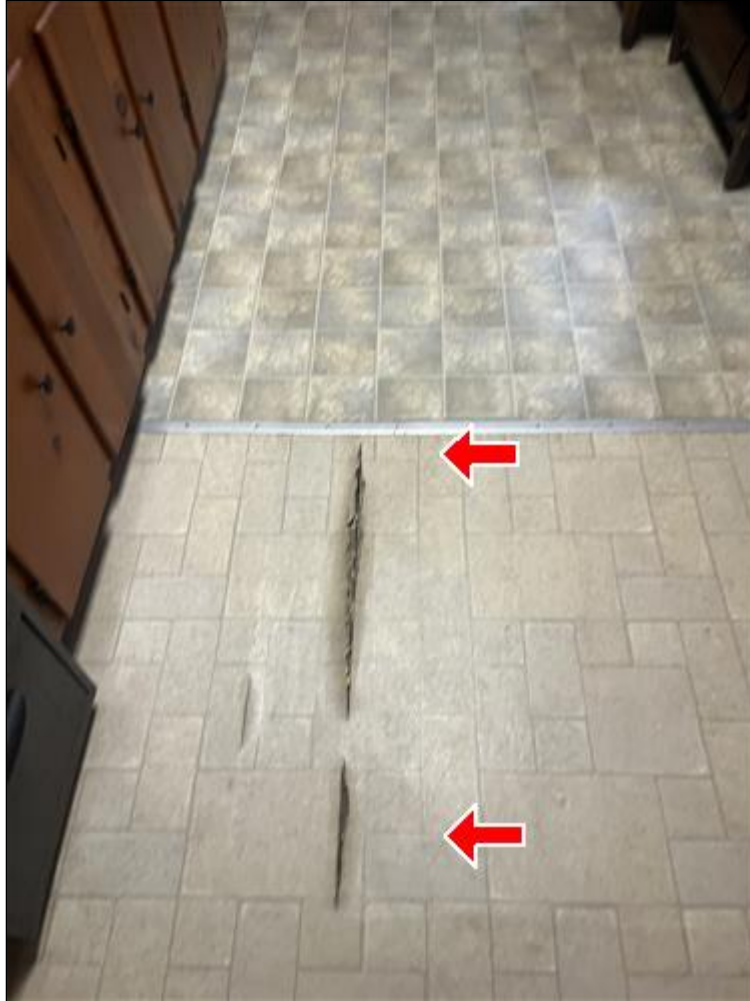
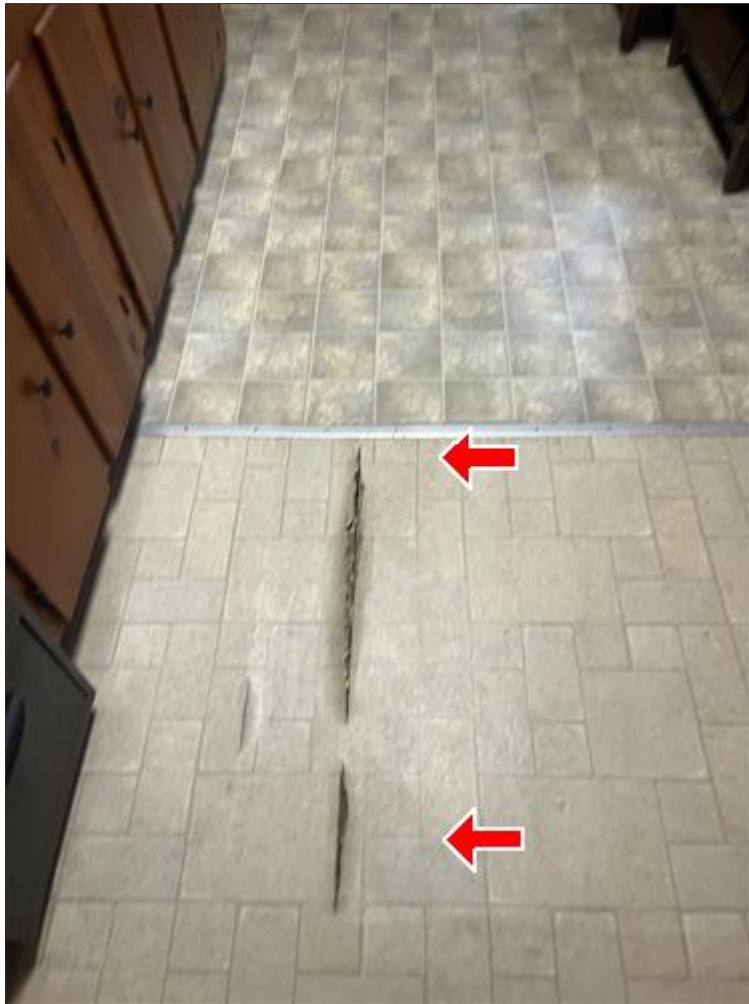
4.2 Picture 1

**4.2** The vinyl floor is damaged at the kitchen area. I recommend a qualified person repair/replace as needed. The sub-flooring below this area appears to be in good shape.

The vinyl floor is damaged at the kitchen area. I recommend a qualified person repair/replace as needed. The sub-flooring below this area appears to be in good shape.

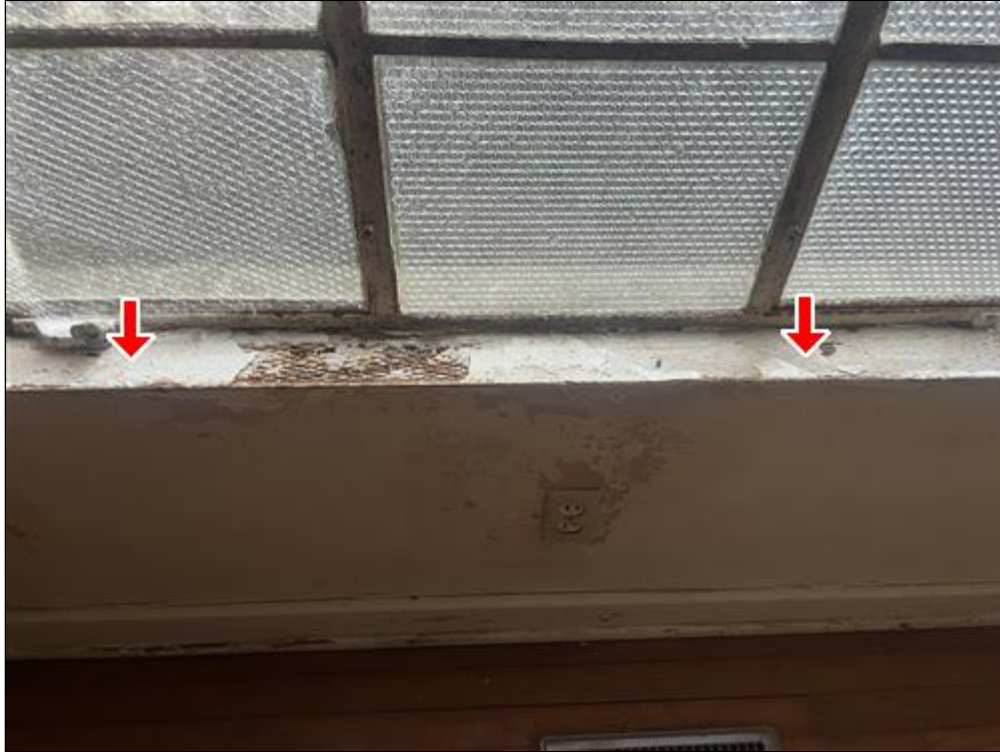
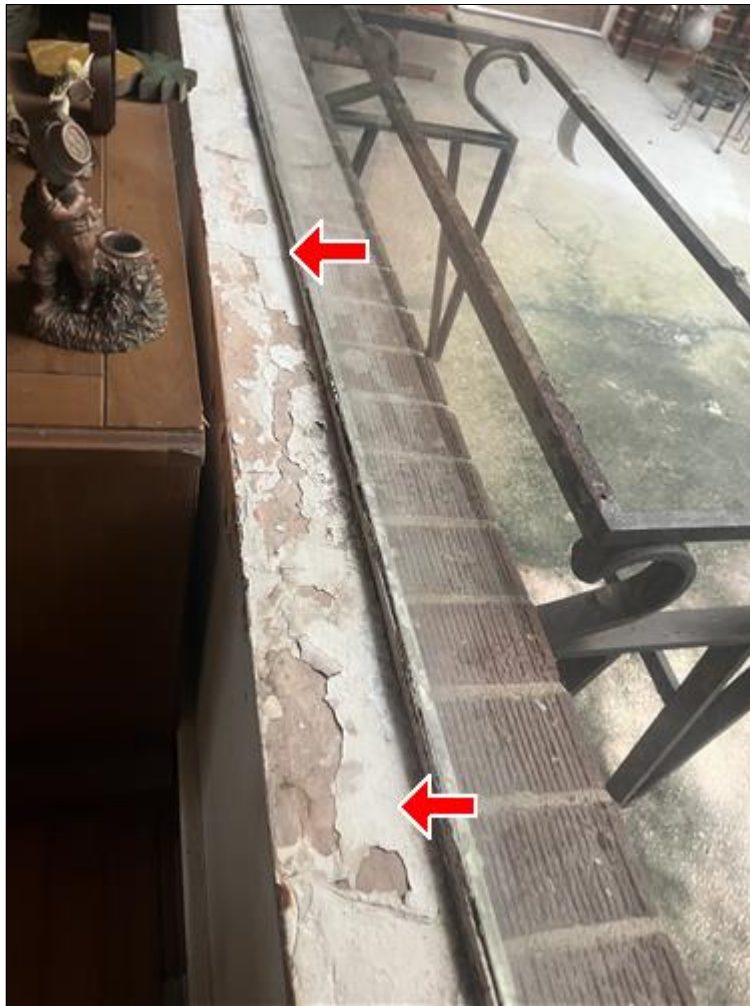
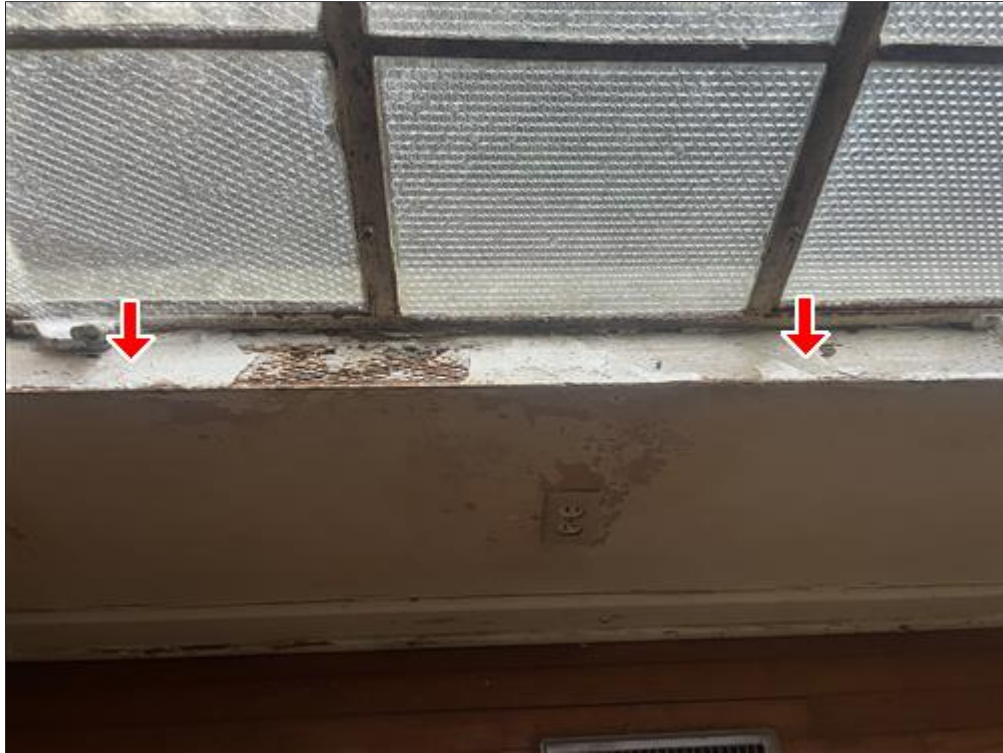
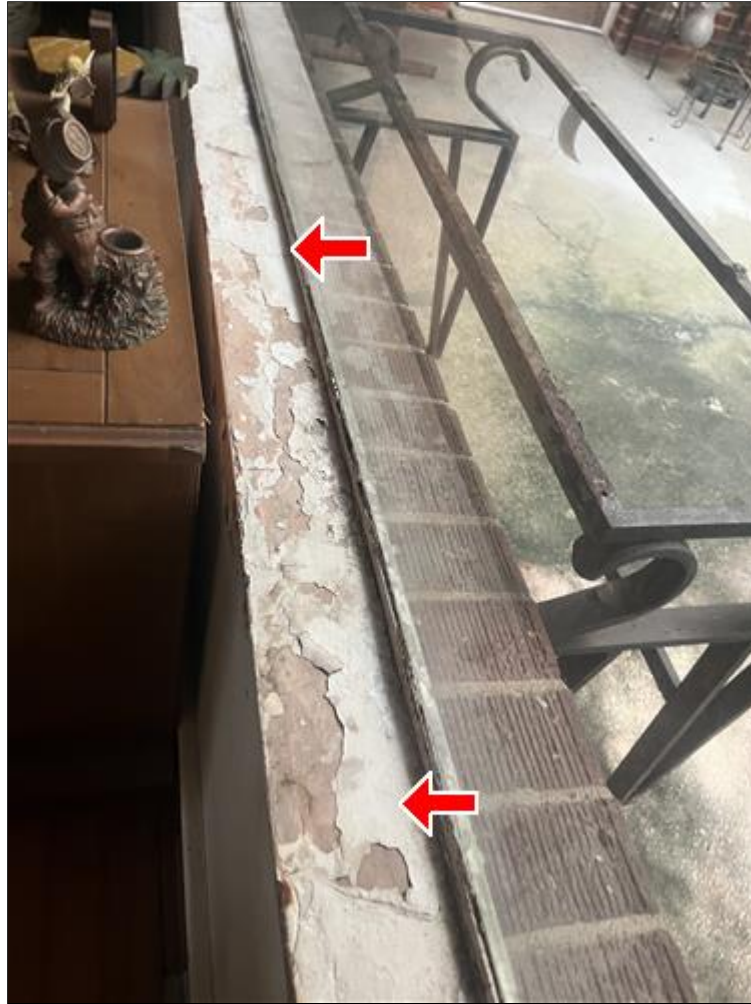
4.6 Picture 1

**4.6** The window seat at the back bedroom and living room are damaged from a leak. This is considered cosmetic and for your information.

The window seat at the back bedroom and living room are damaged from a leak. This is considered cosmetic and for your information.

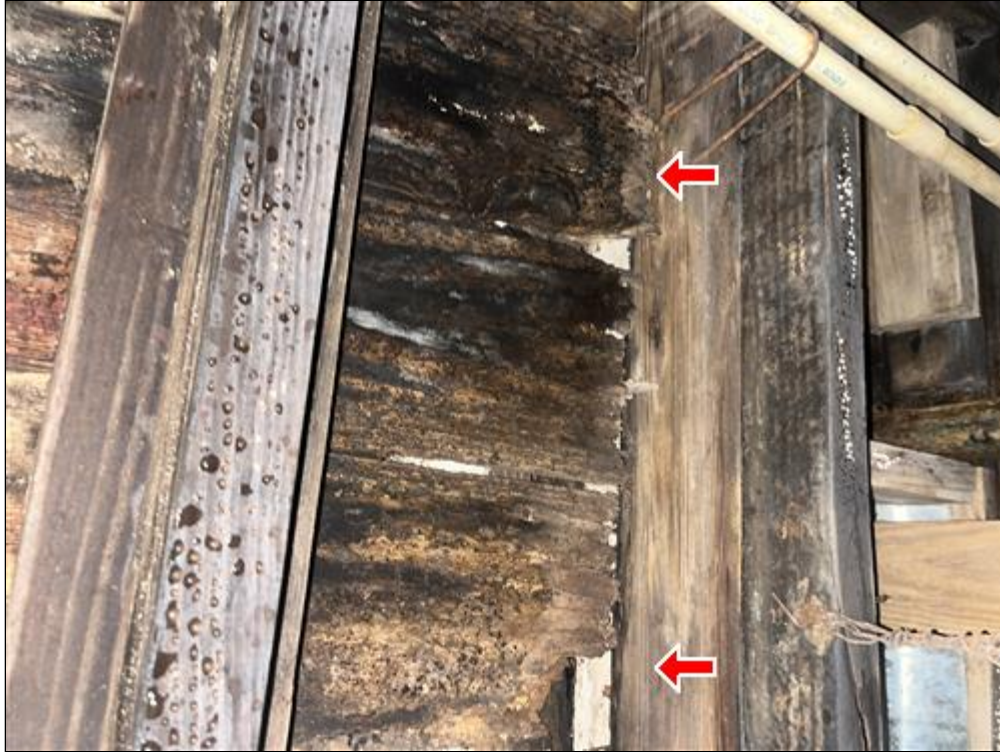
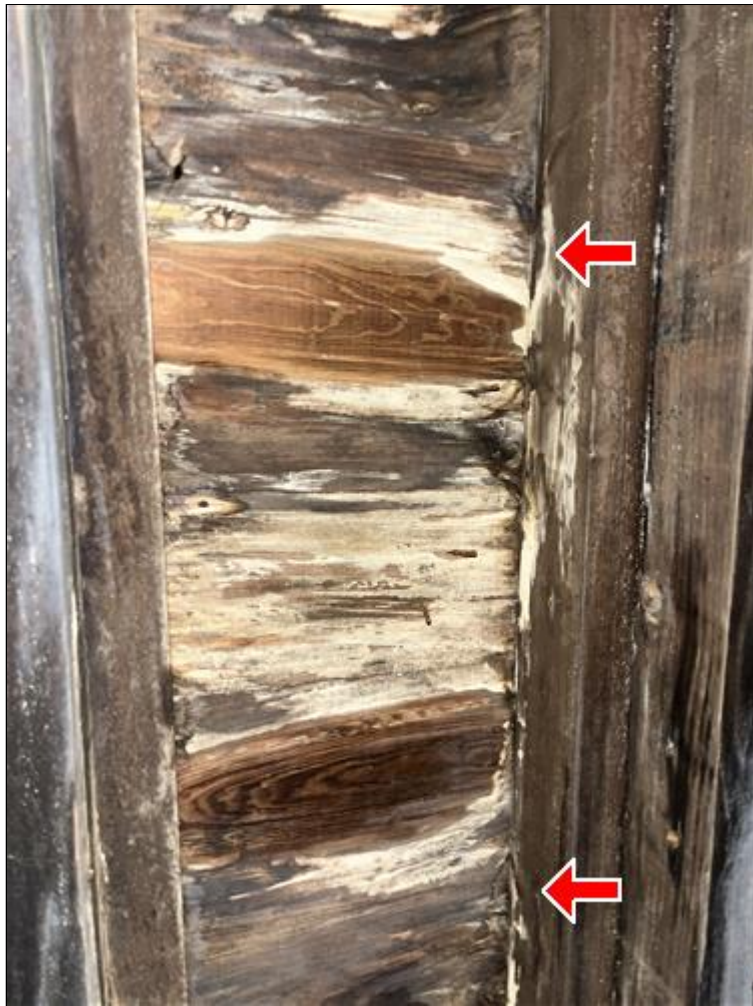
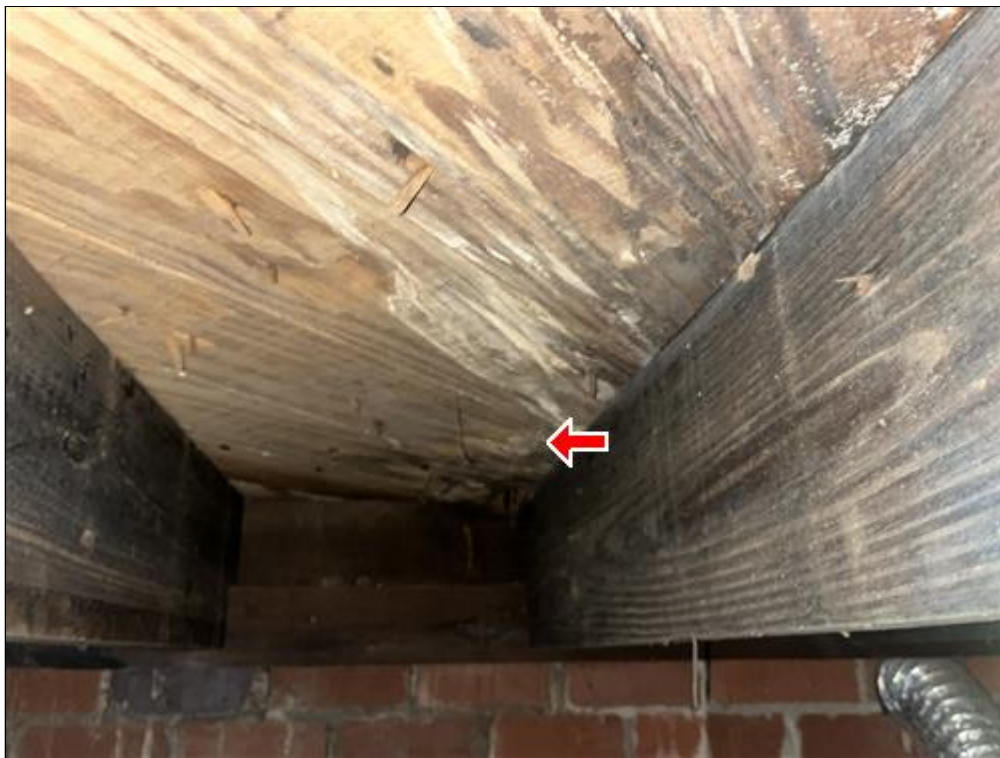
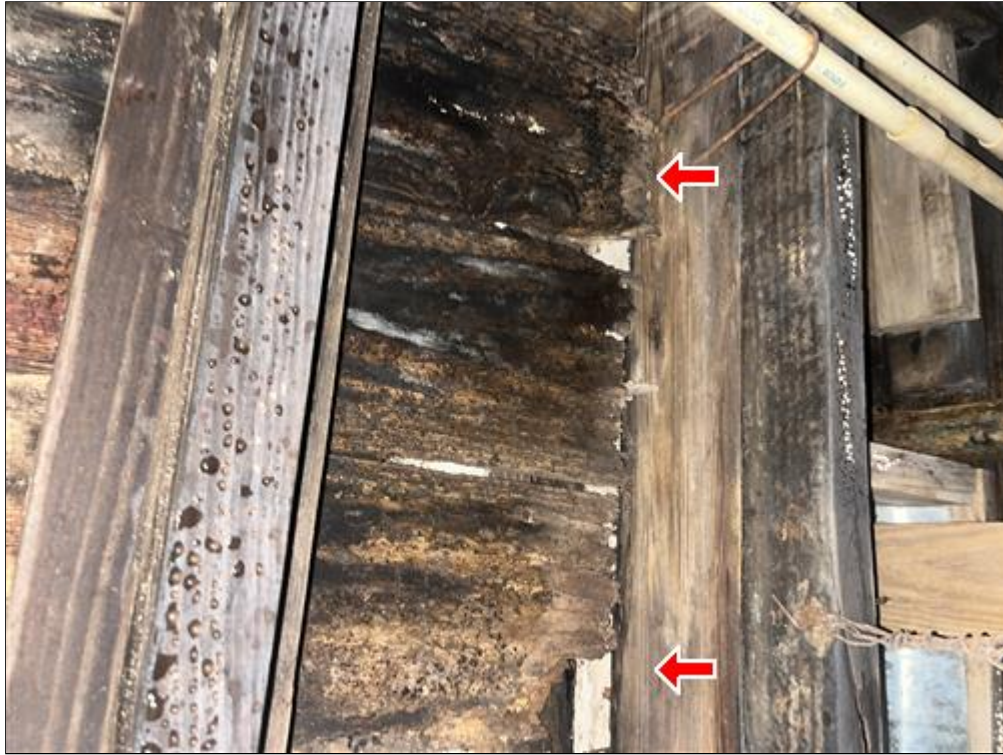
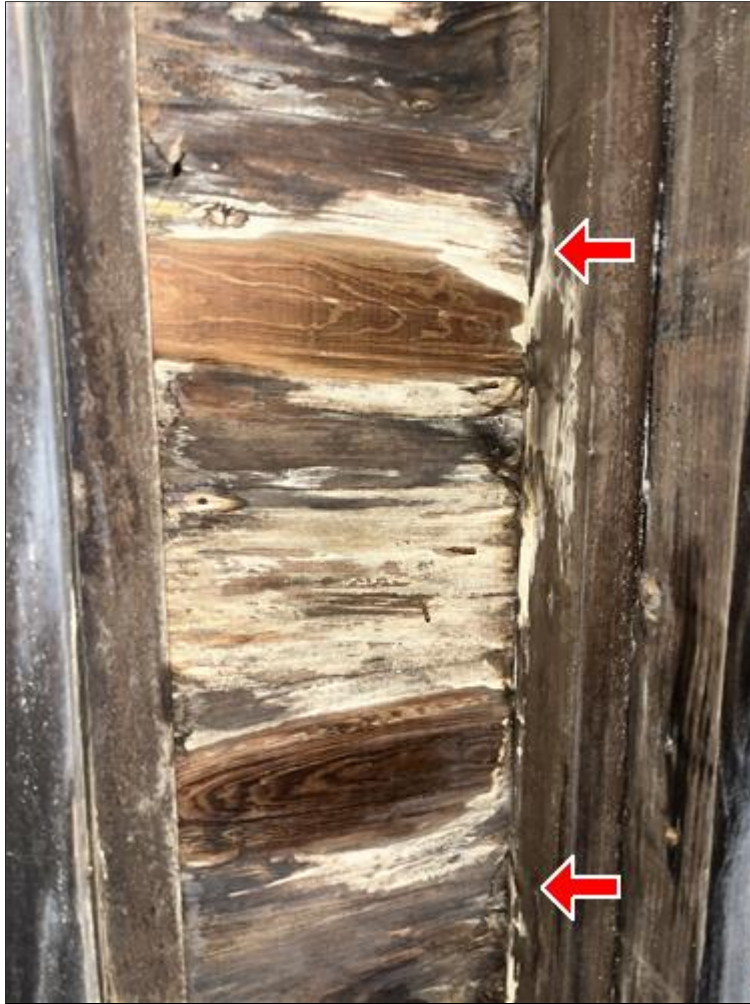
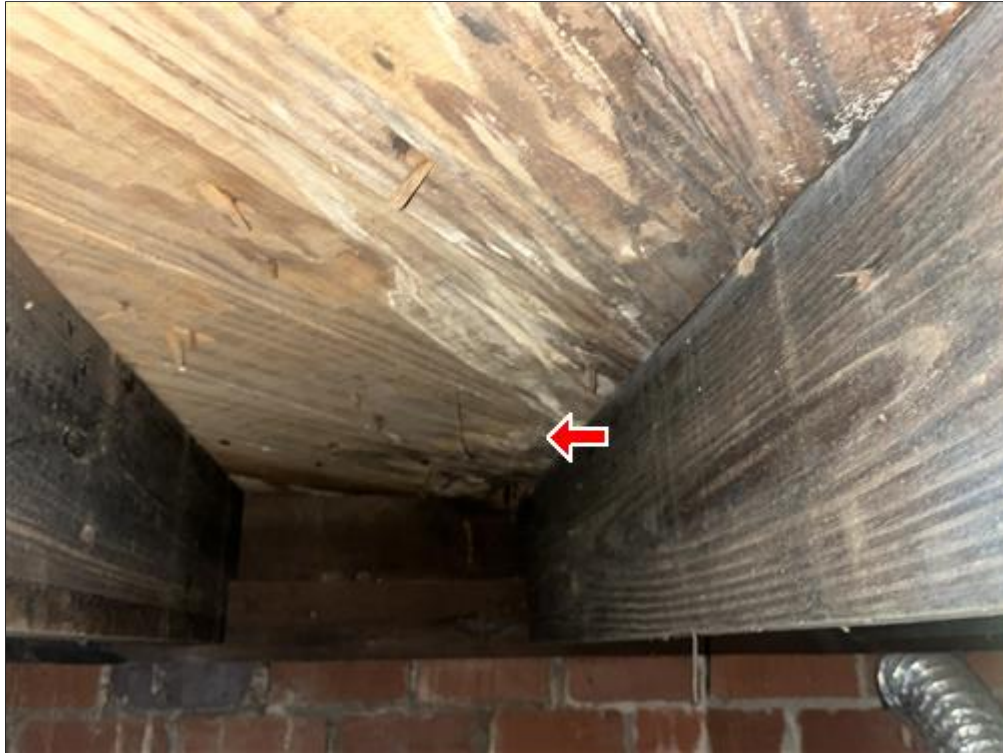
5.3 Picture 1

**5.3** Sub-flooring is deteriorated from a leak under the Master bath and Hall Bath. Repairs are needed. I recommend a qualified person further inspect and replace as needed

Sub-flooring is deteriorated from a leak under the Master bath and Hall Bath. Repairs are needed. I recommend a qualified person further inspect and replace as needed

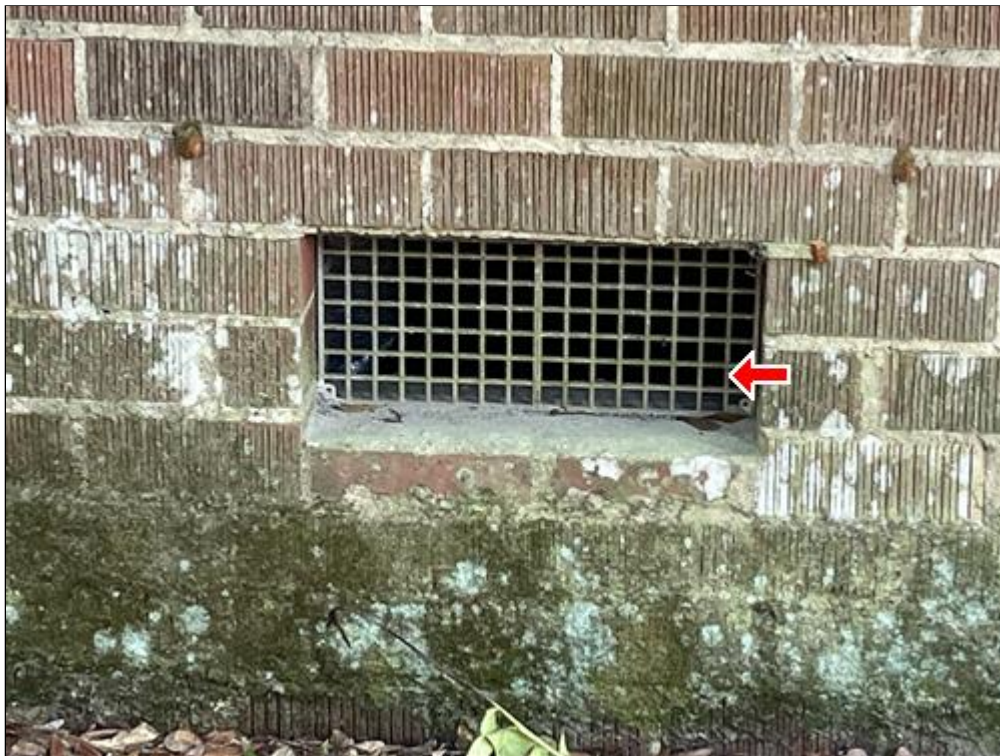
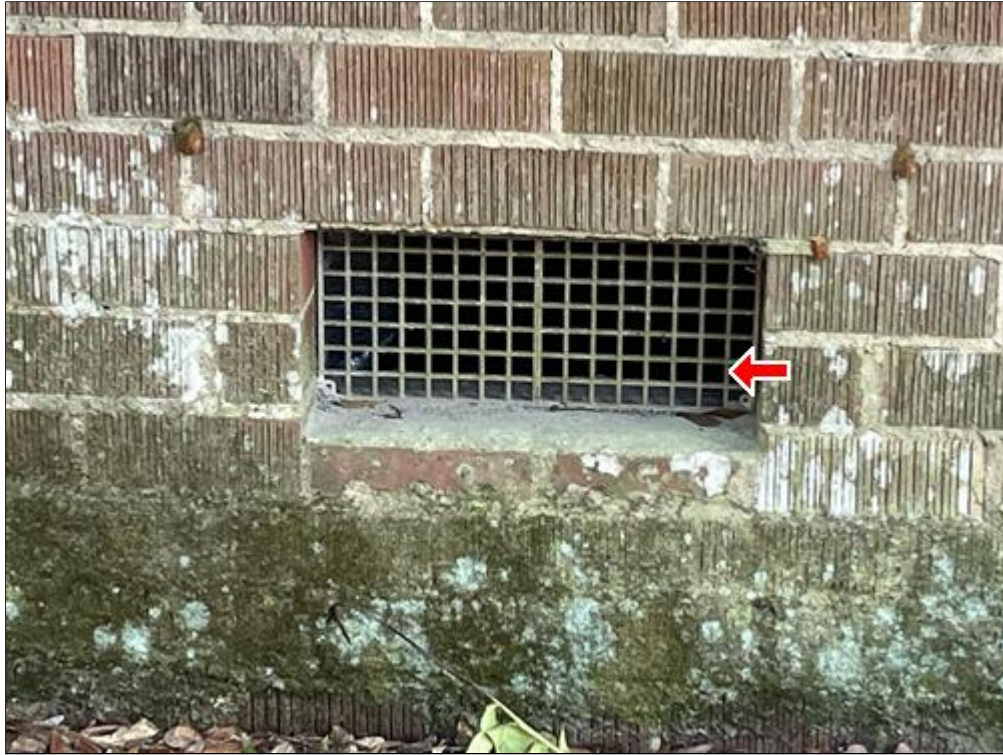
9.3 Picture 1

**9.3** Two foundation vents are missing screen at the rear of home. Rodents, reptiles or insects could enter into crawlspace. A qualified person should repair or replace as needed.

Two foundation vents are missing screen at the rear of home. Rodents, reptiles or insects could enter into crawlspace. A qualified person should repair or replace as needed.
