Inspection Report

Property Address:
121 Robin Hood Dr
Thomasville Ga 31792

South Georgia Home Inspections

Date: 9/5/2019	Time:	Report ID:
Property: 121 Robin Hood Dr Thomasville Ga 31792	Customer: Weeks Auction Group	Real Estate Professional:

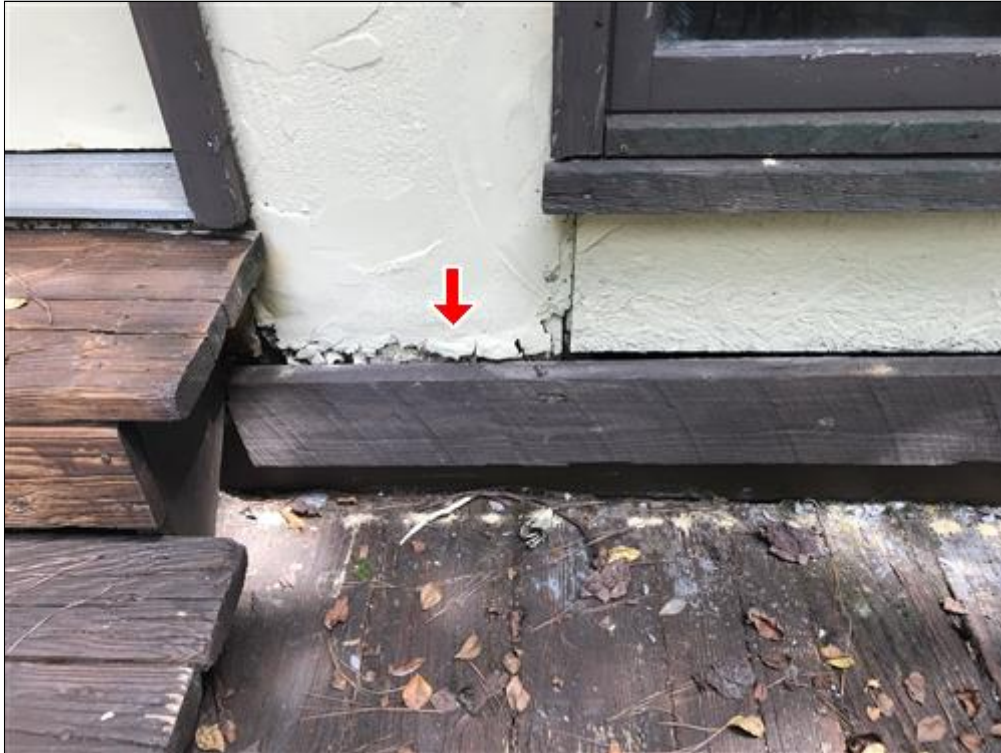
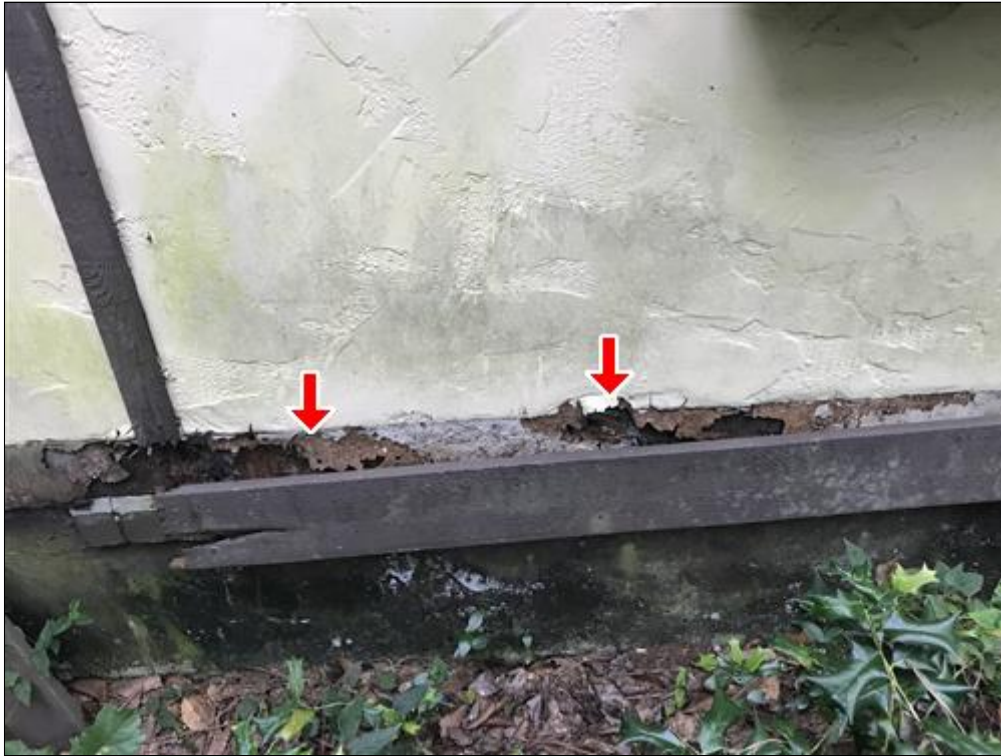
2.0 The Composite board siding at the exterior in areas deteriorated. Further deterioration can occur if not corrected. A qualified contractor should inspect and repair as needed.

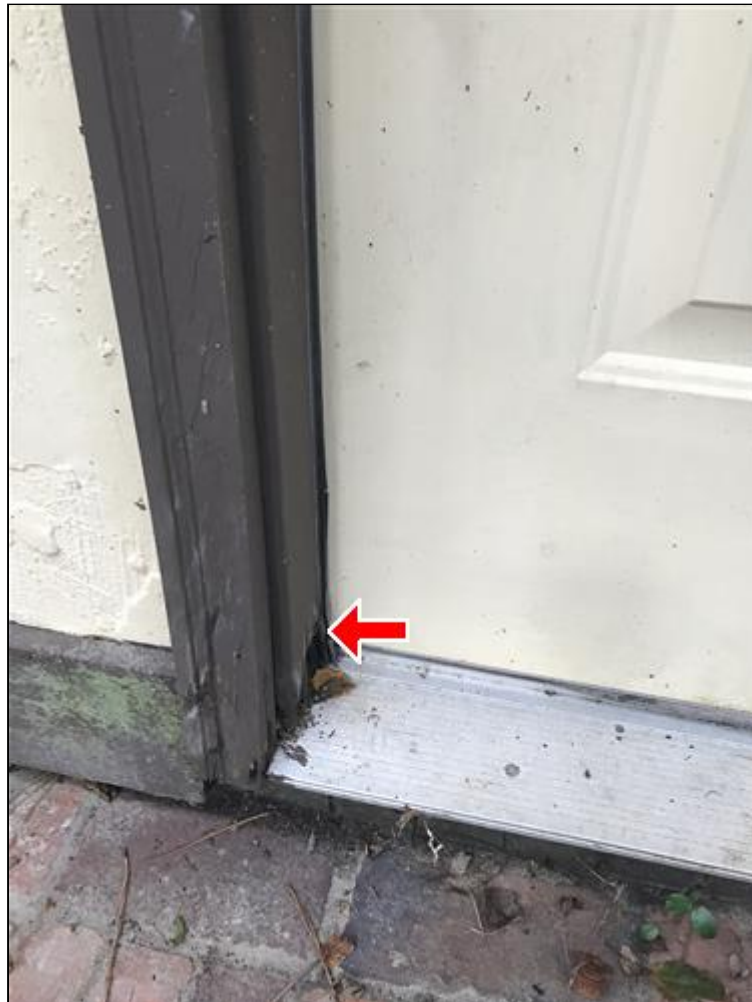
2.1 Picture 1

2.1 The entry door at the rear of home has deteriorated at brick-mold or trim (exterior). A repair or replacement is needed. A qualified contractor should inspect and repair as needed.

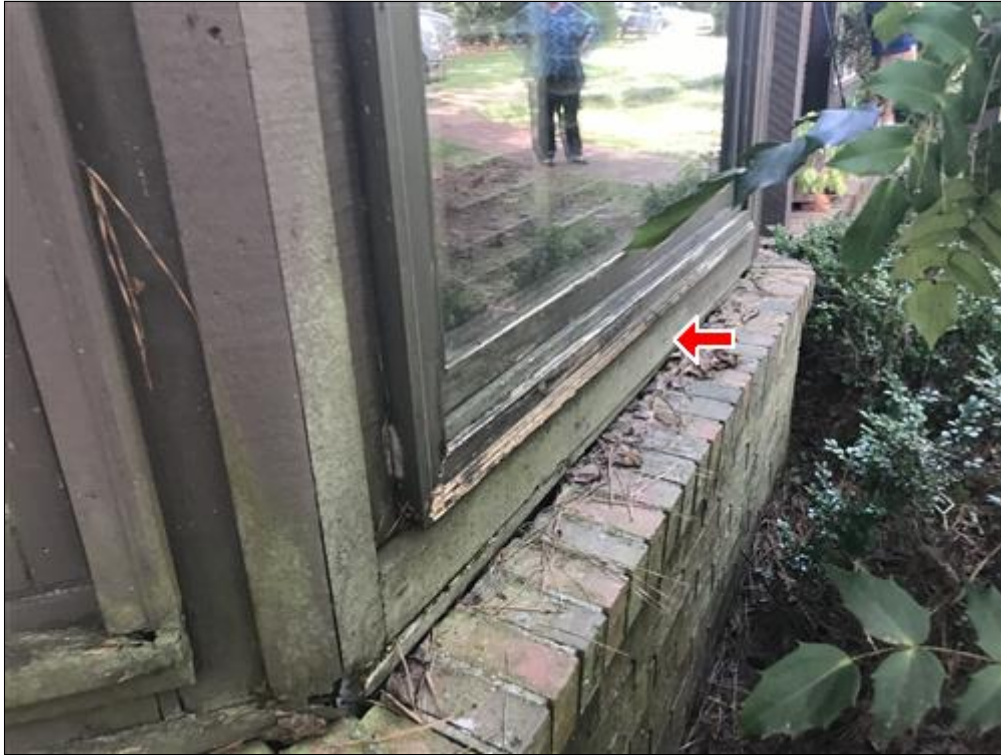
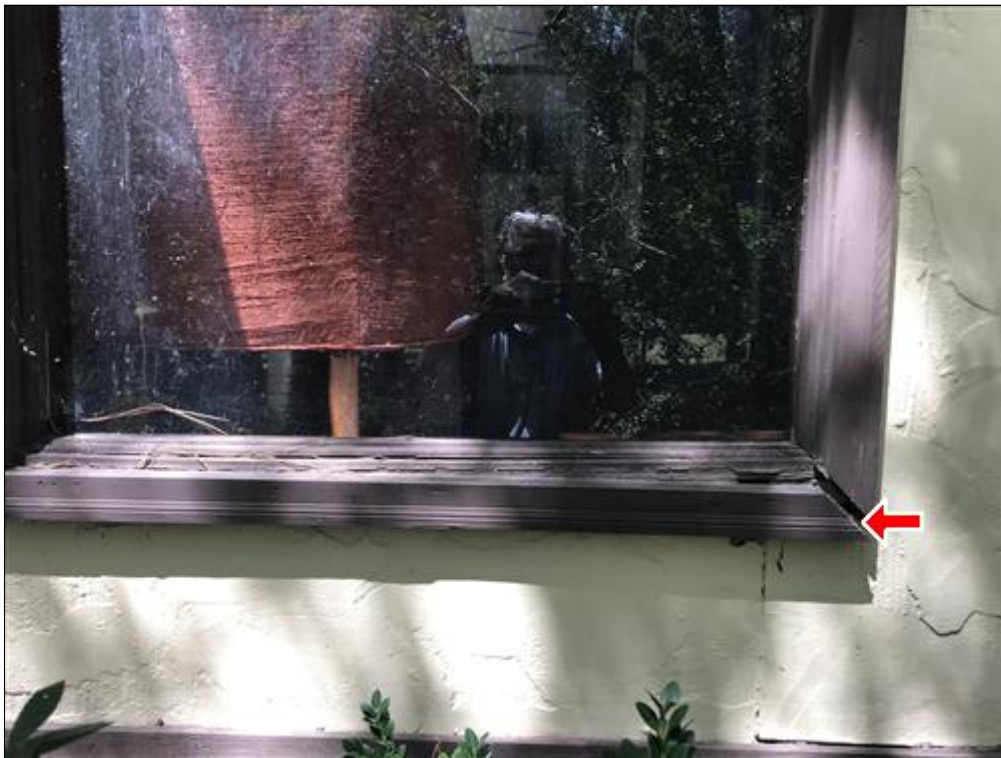
2.2 The window frame is deteriorated at front of home. Further deterioration may occur if not repaired. A qualified contractor should inspect and repair as needed.

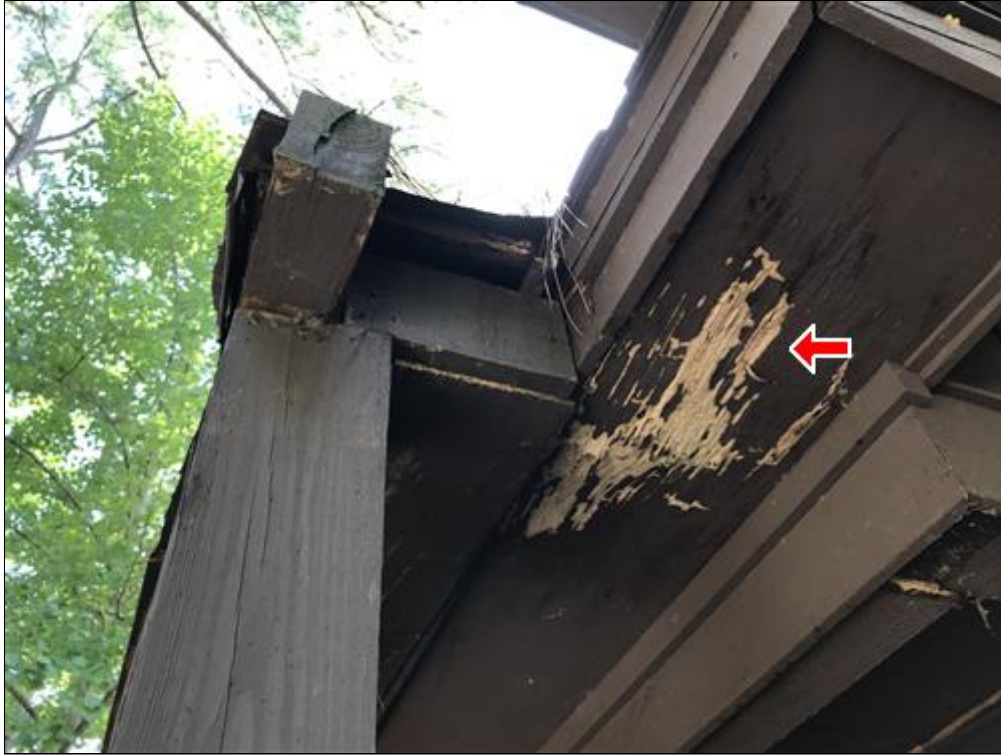
2.5 The soffit panel at eave on the front of home beginning to deteriorate. Further deterioration may occur if not repaired. .

2.5 Picture 1 (possible termites)

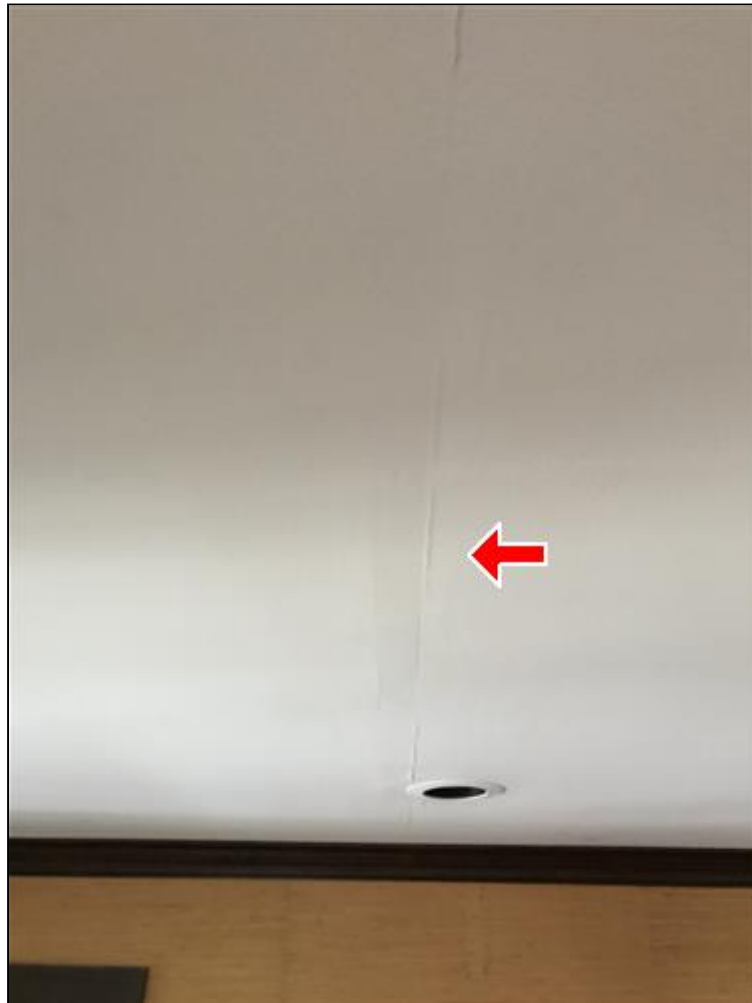
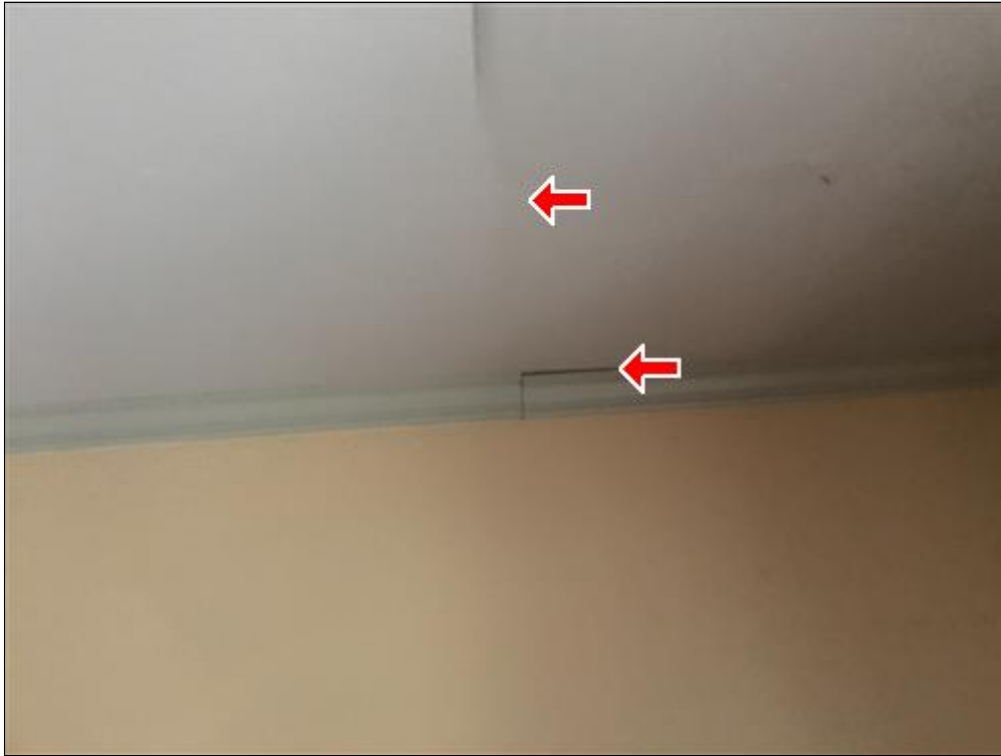
4.0 The Sheetrock on the ceiling reveals a water stain indicating a leak did or still exists at the downstairs. While this damage is cosmetic, it needs to be repaired. .

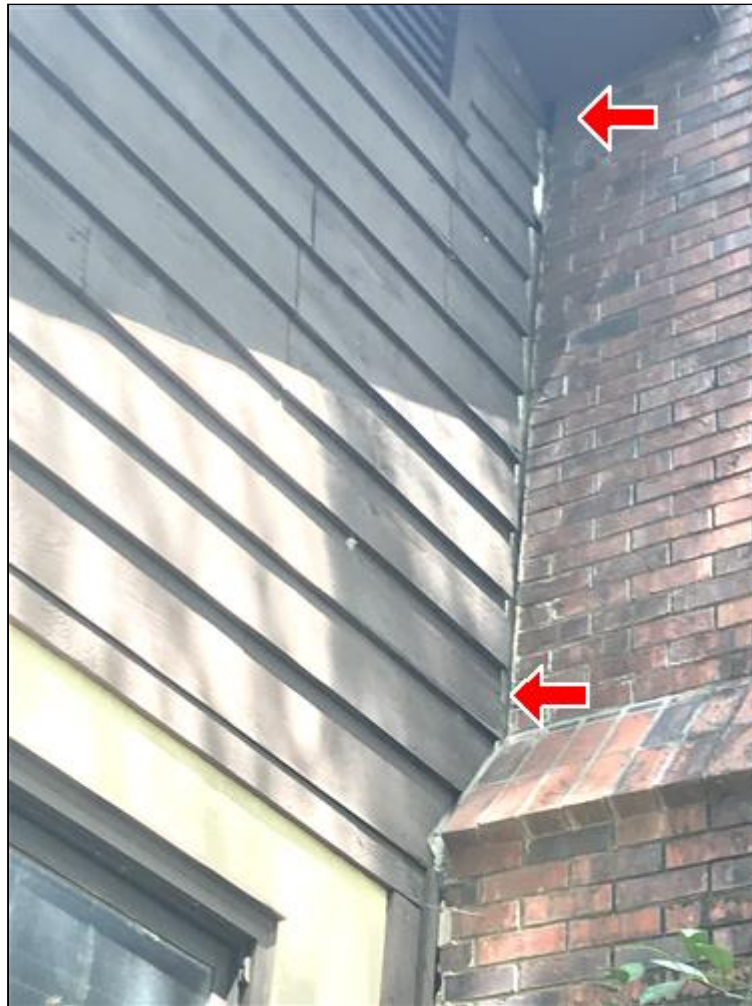
5.1 Structural crack in wall at front of home and left side (facing front). The appearance of settlement crack is large enough for concern. Recommend a"Structural Engineer" to inspect.

5.1 Picture 1 The fireplace is separating from the home, due to settlement on the left side of the house.

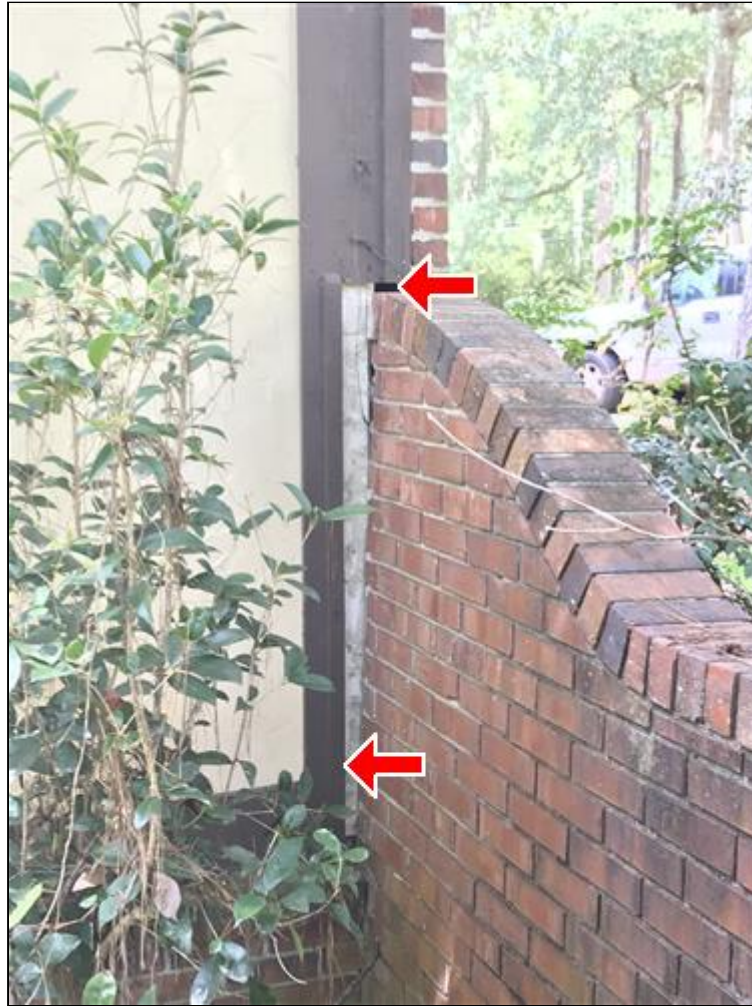
5.1 Picture 2 Brick privacy wall is operating on the left side of the home.

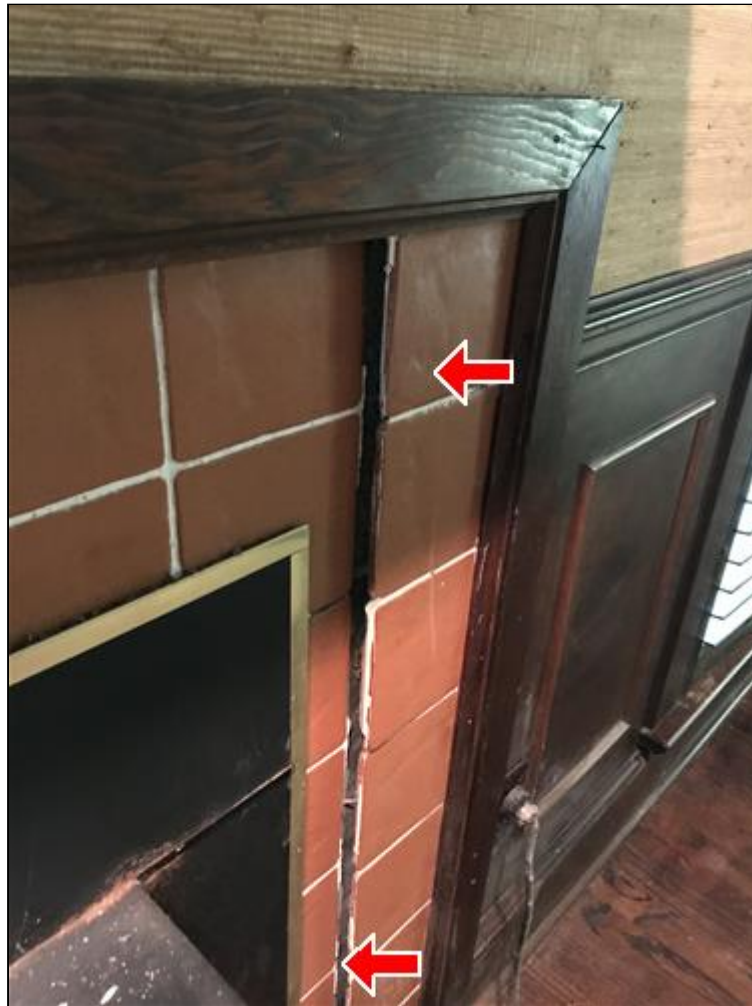
5.1 Picture 4 Signs that the fireplace is separating from the home.

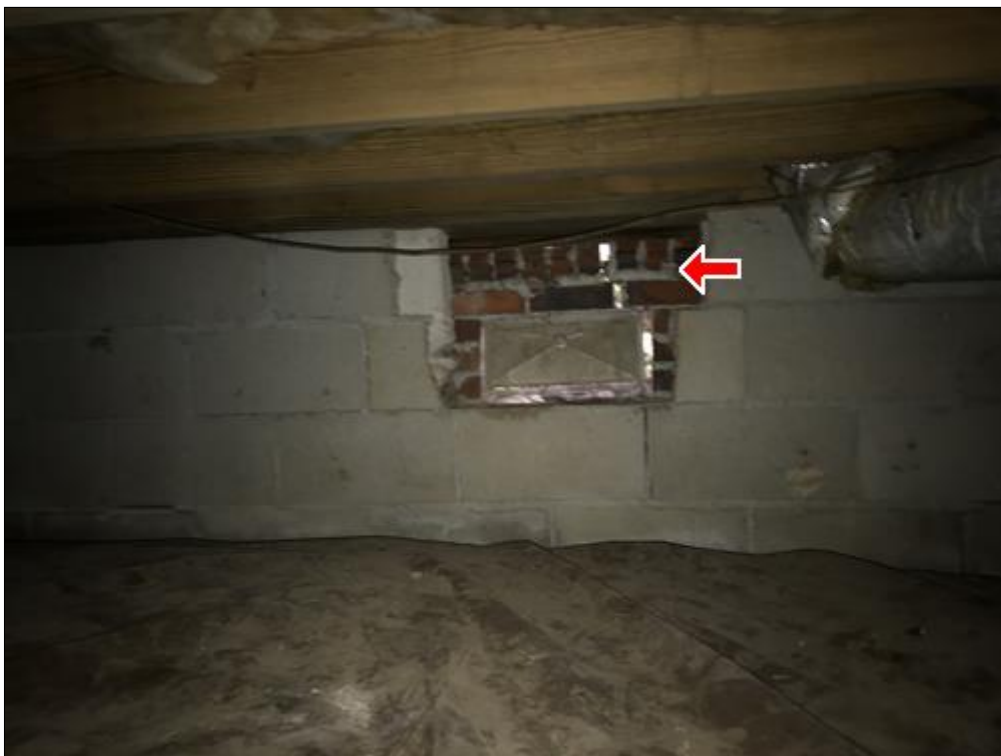
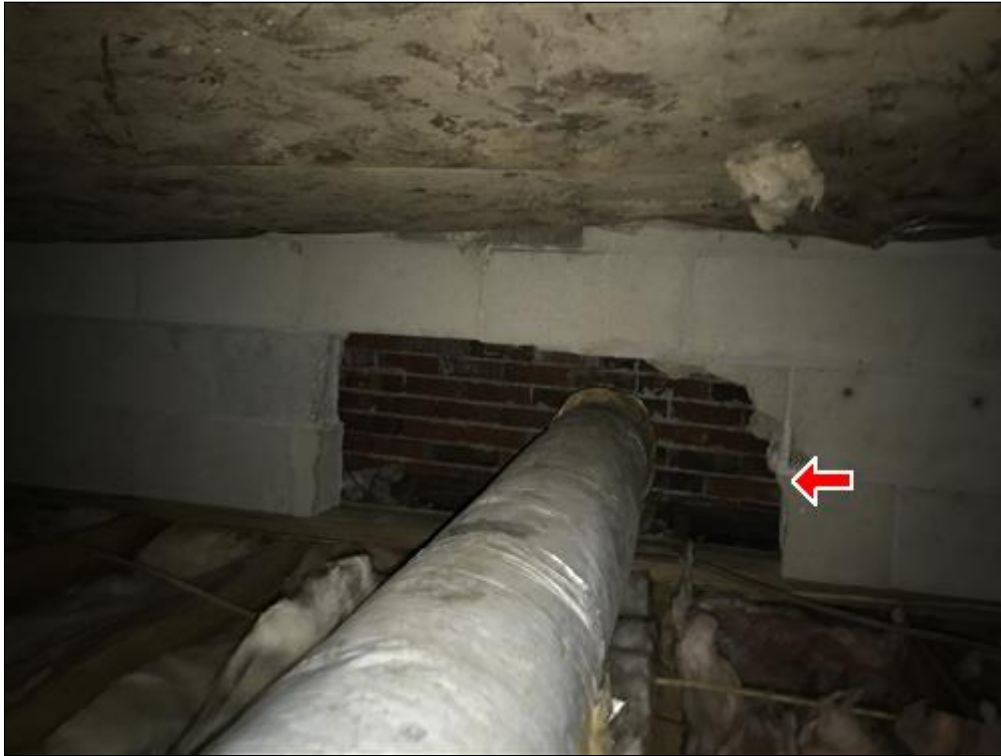
Structural components were removed in order to get ventilation and Duct work installed, in my opinion this is the cause of the settling of the walls. Pictures 5 and 6

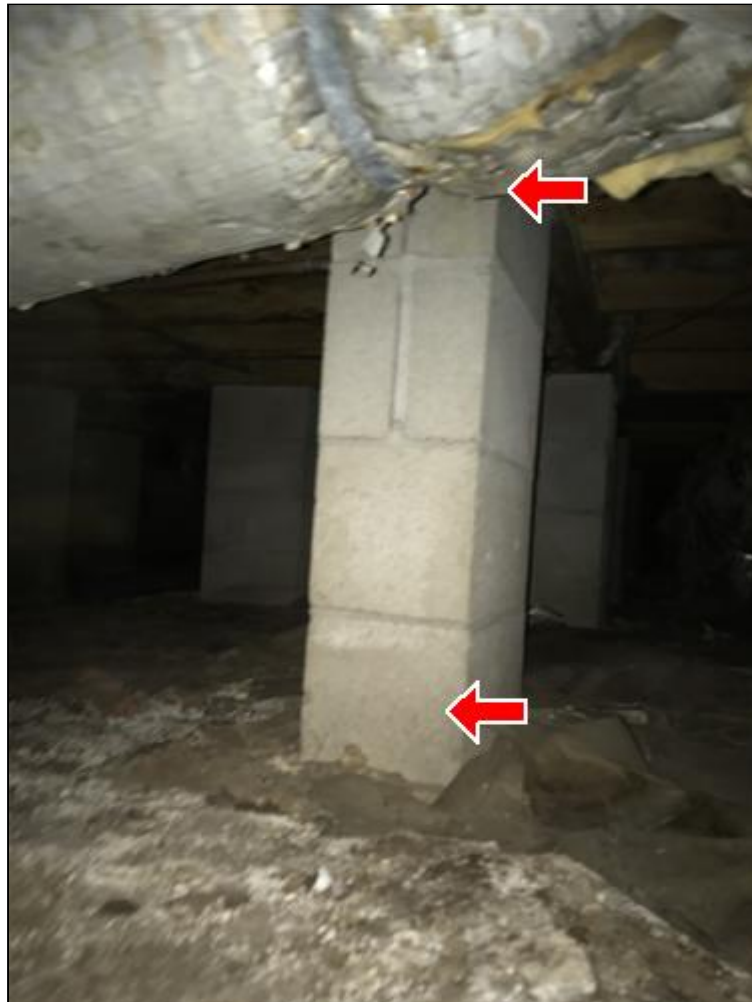
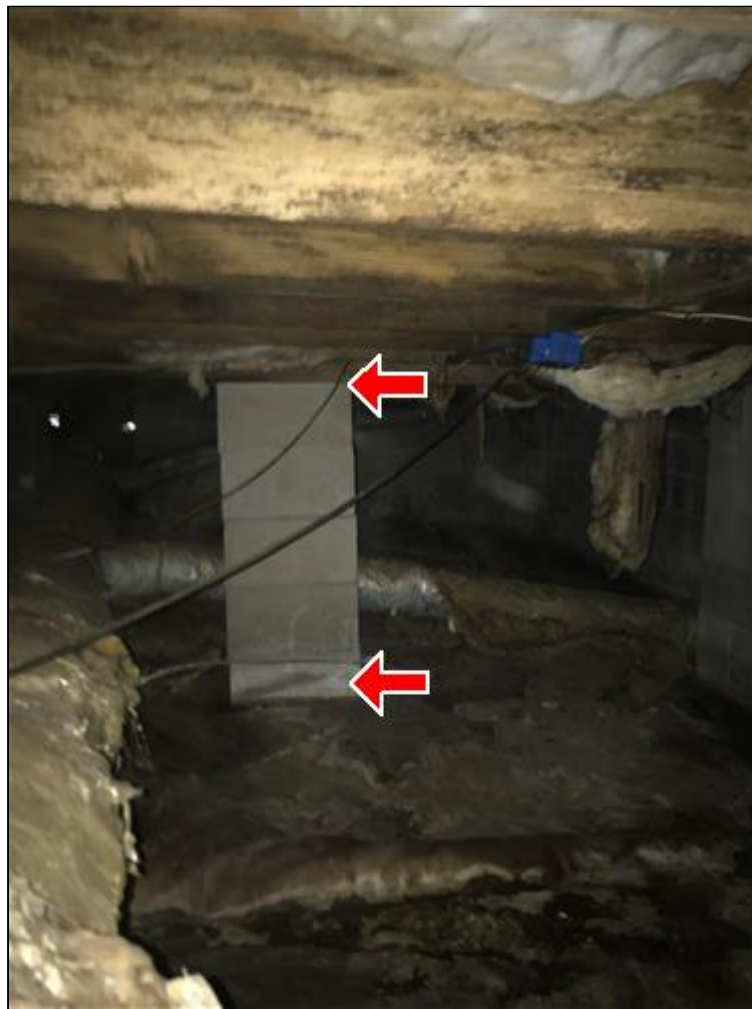
5.2 There are a couple of leaning piers underneath the kitchen area, this is causing the floor to have major humps in it, repairs are needed.

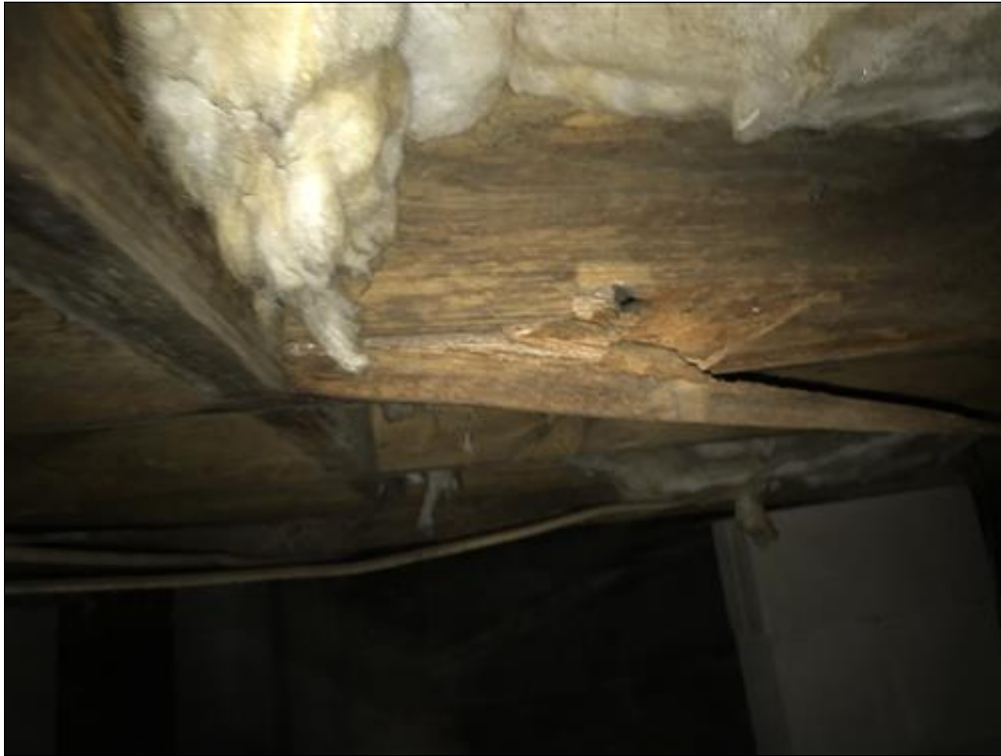
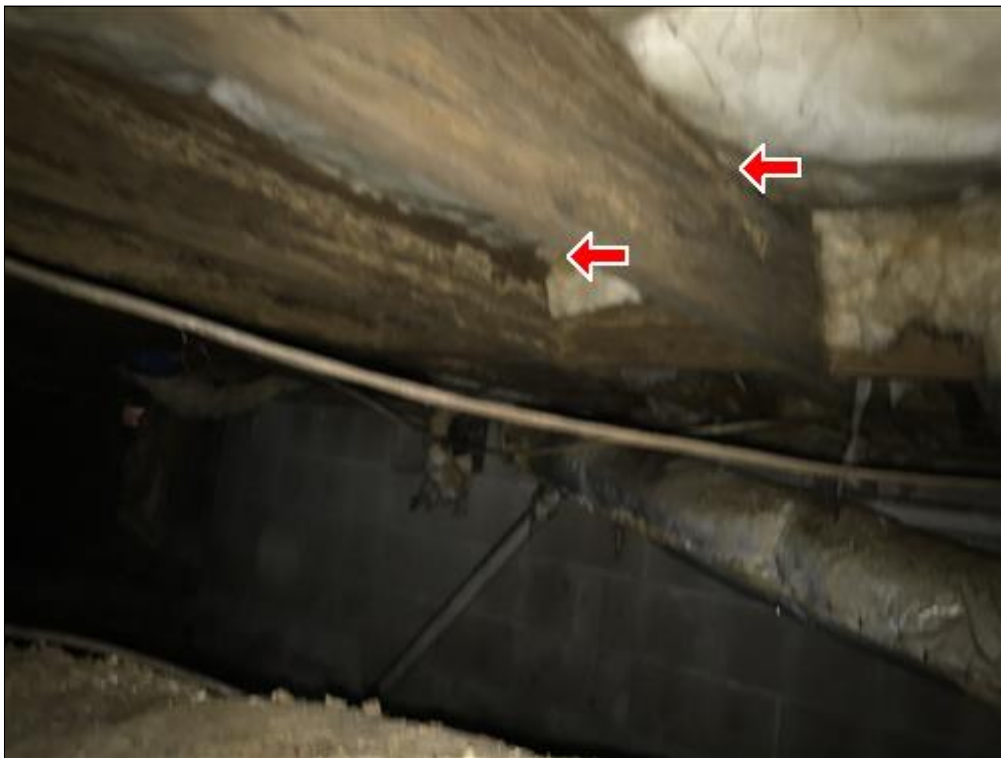
5.3 At least Two floor joist(s) are from moisture absorption or water intrusion under the Kitchen. Repairs are needed. A qualified licensed general contractor should inspect further and repair as needed.

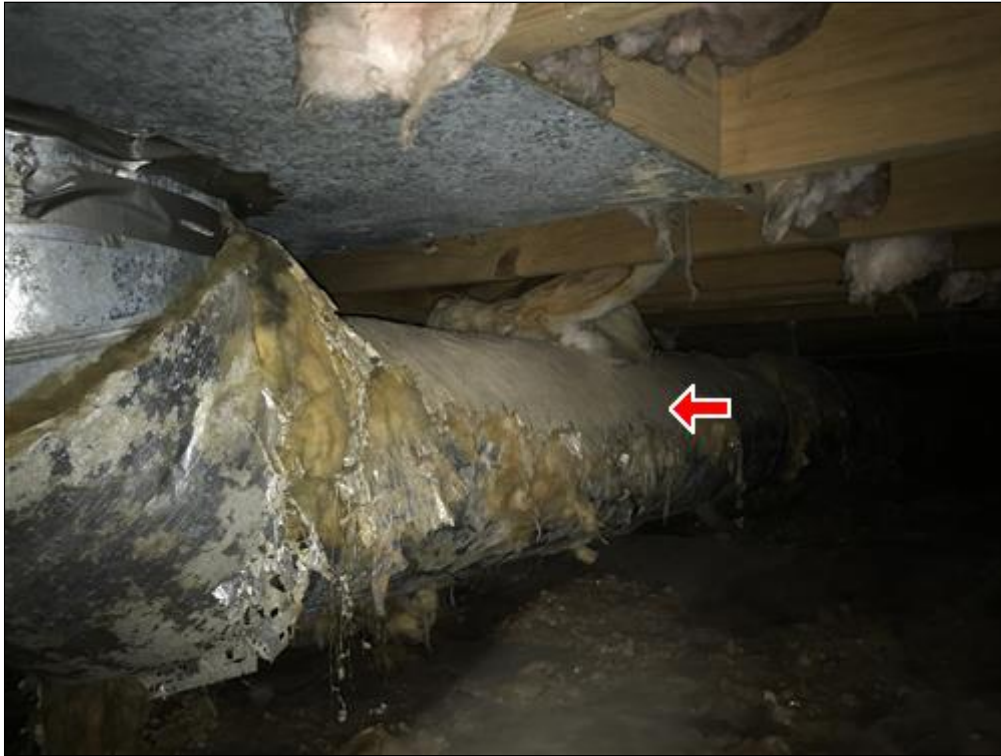
8.3 Picture 1

8.3 The duct pipe has failed in the crawlspace. Energy loss is occurring in crawlspace and immediate correction is needed. .

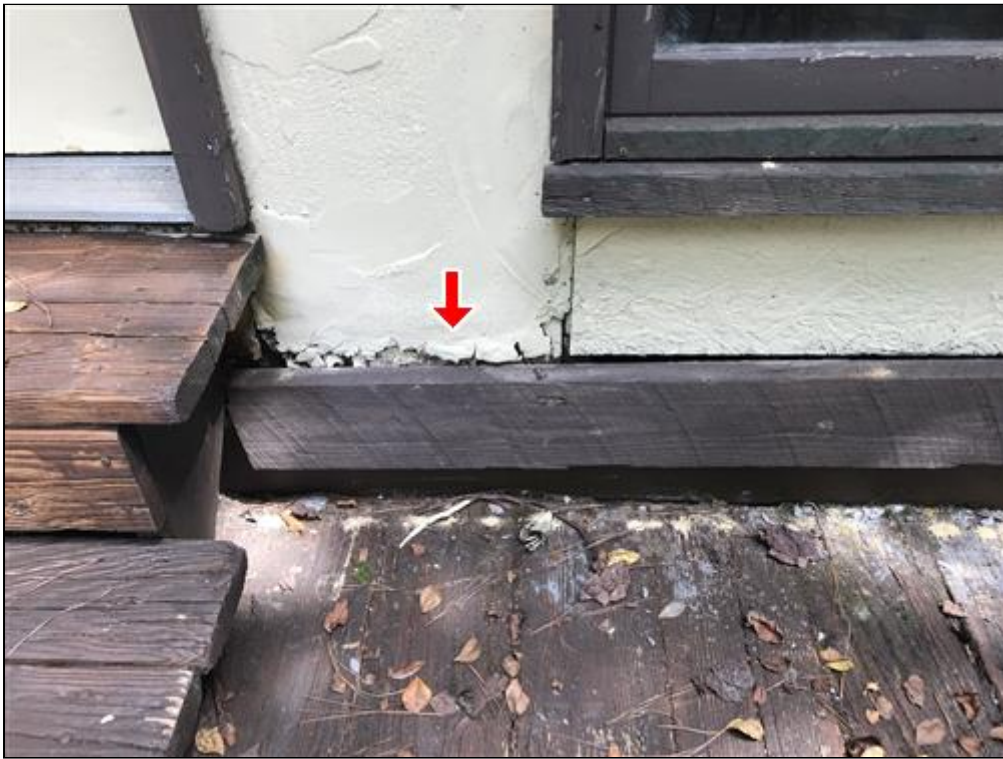
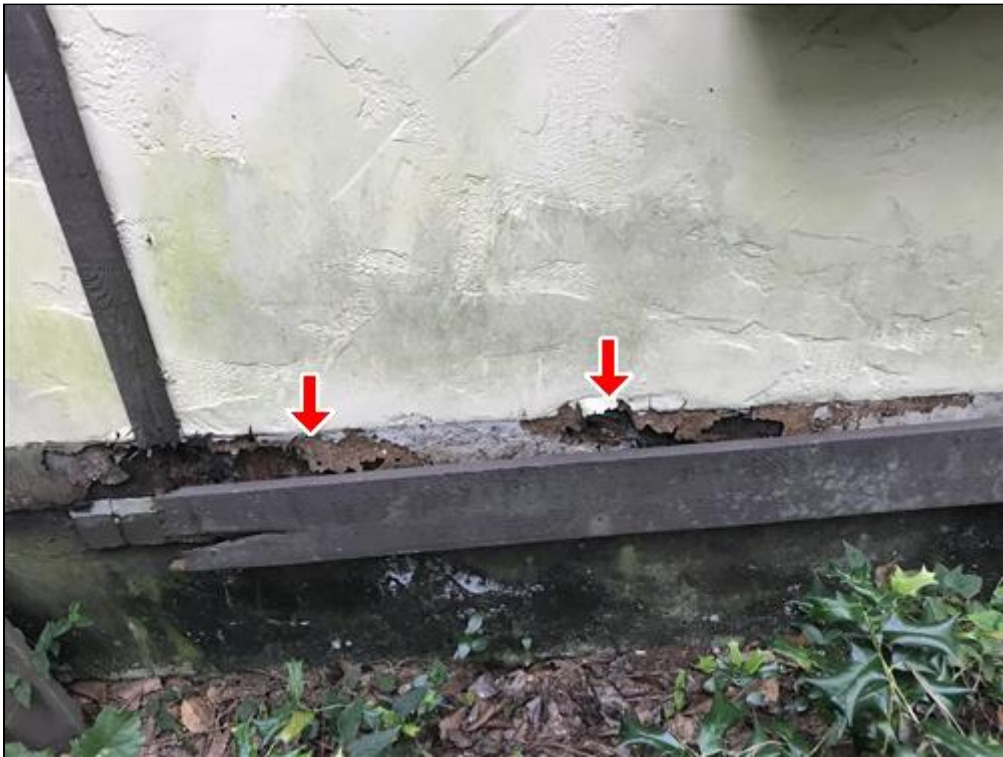
The Composite board siding at the exterior in areas deteriorated. Further deterioration can occur if not corrected. A qualified contractor should inspect and repair as needed.

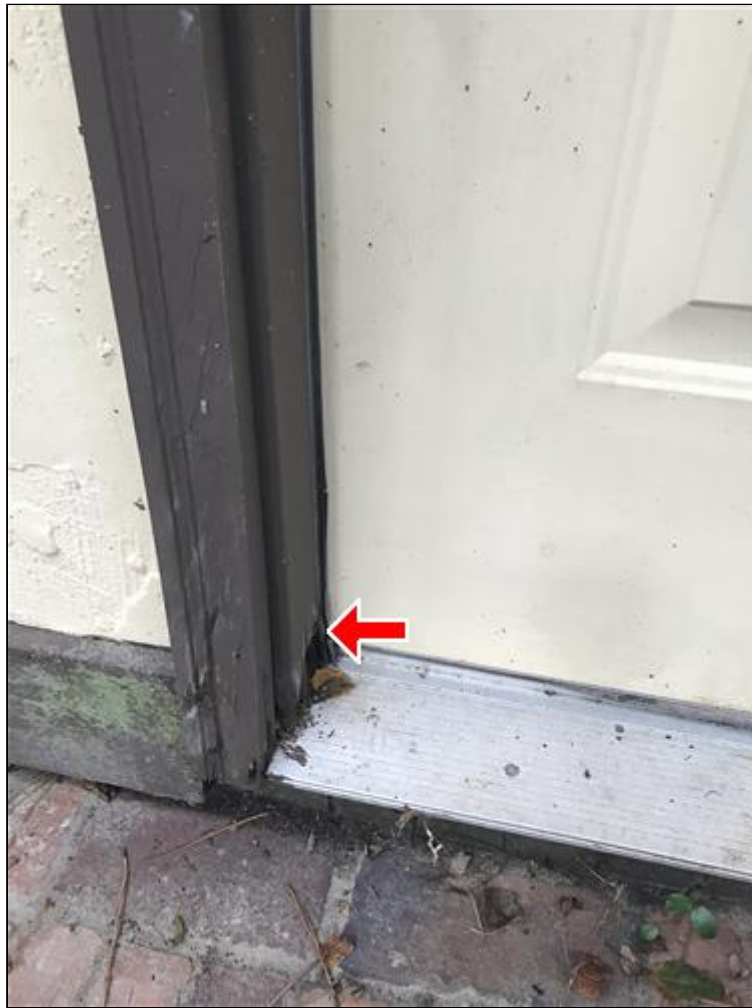
2.1 Picture 1

The entry door at the rear of home has deteriorated at brick-mold or trim (exterior). A repair or replacement is needed. A qualified contractor should inspect and repair as needed.

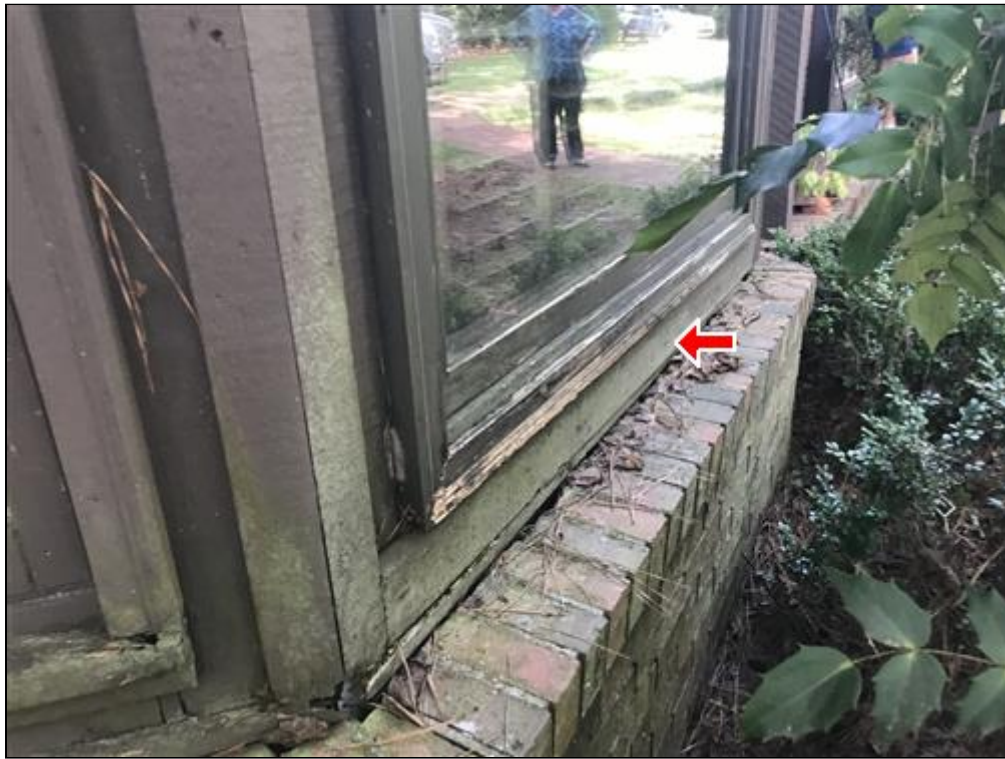
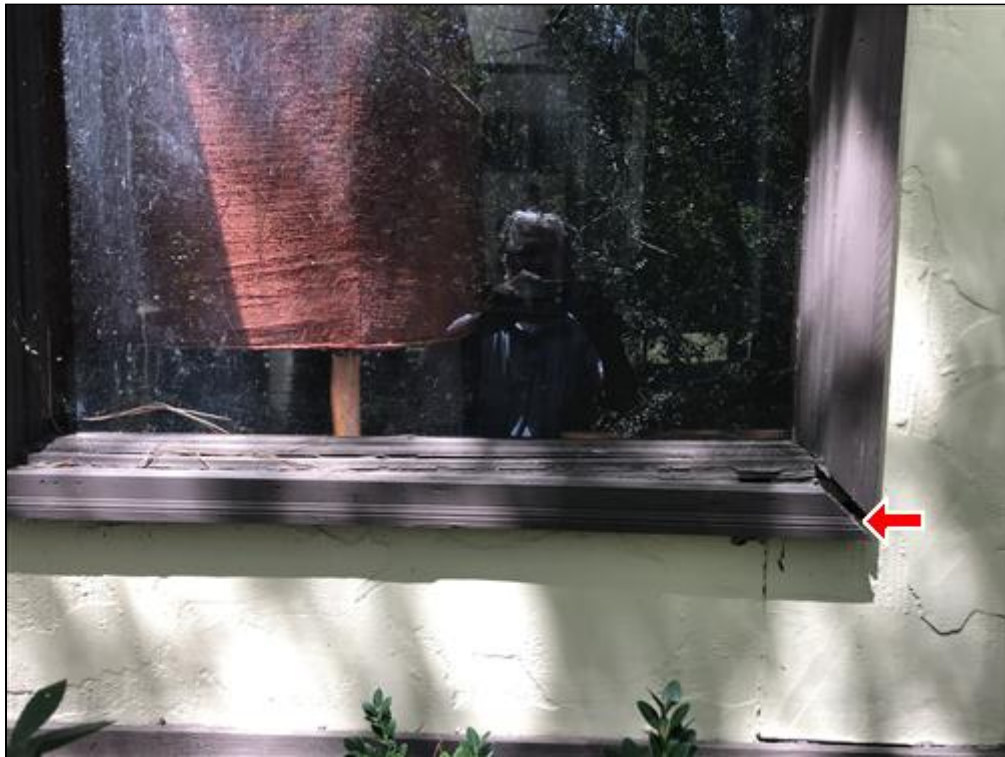
The window frame is deteriorated at front of home. Further deterioration may occur if not repaired. A qualified contractor should inspect and repair as needed.

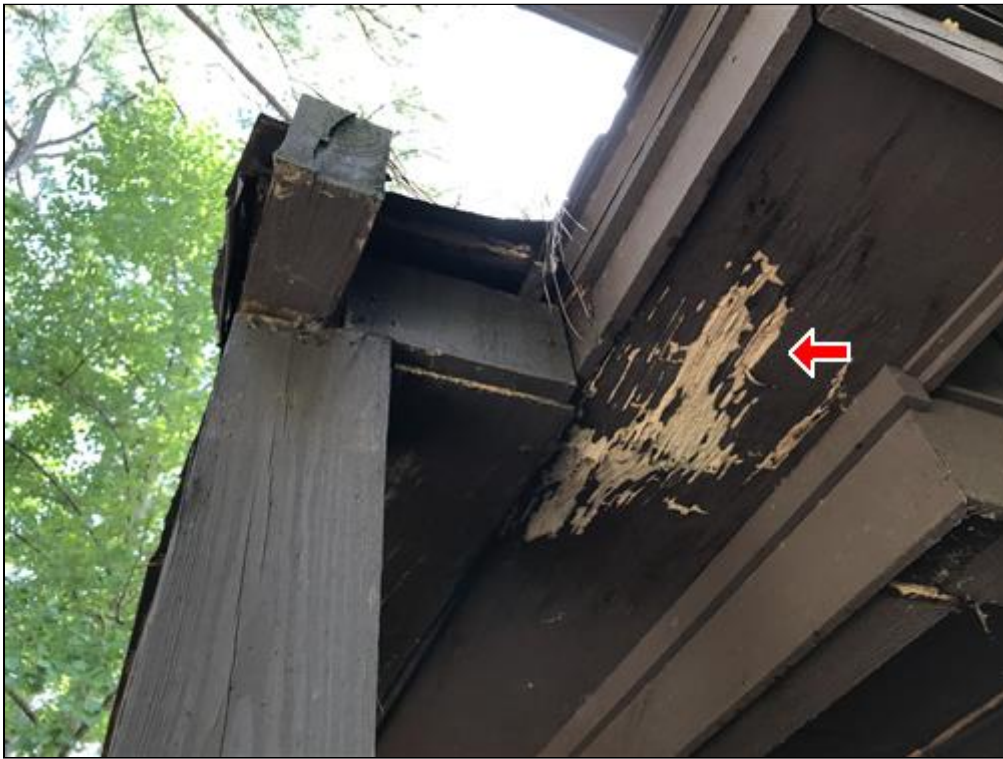
The soffit panel at eave on the front of home beginning to deteriorate. Further deterioration may occur if not repaired. .

2.5 Picture 1 (possible termites)

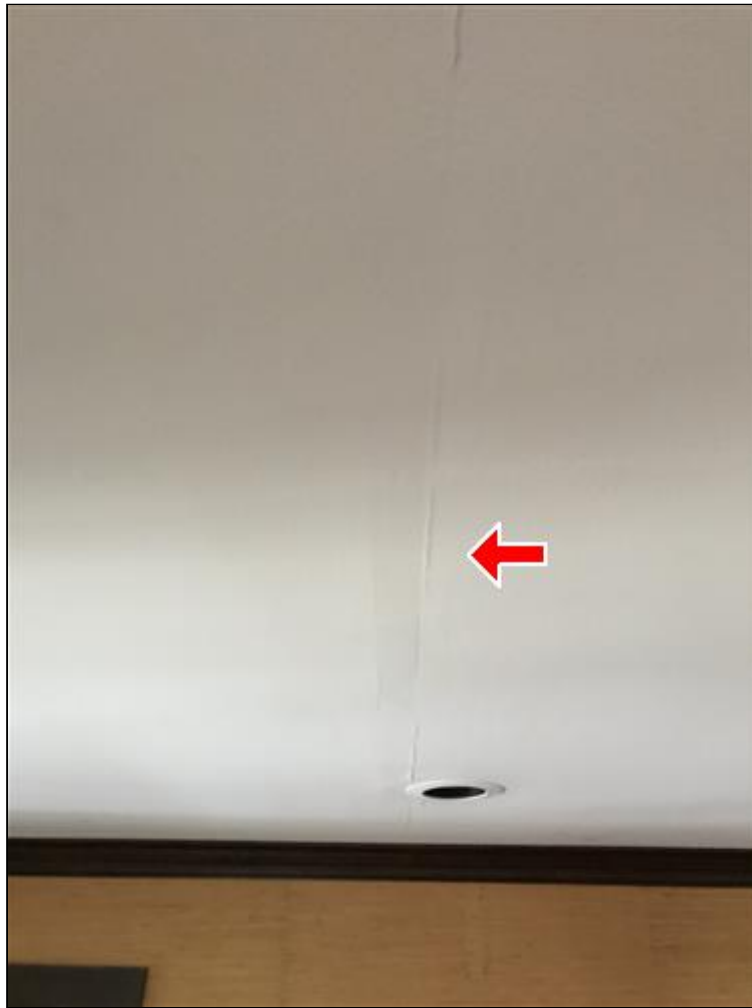
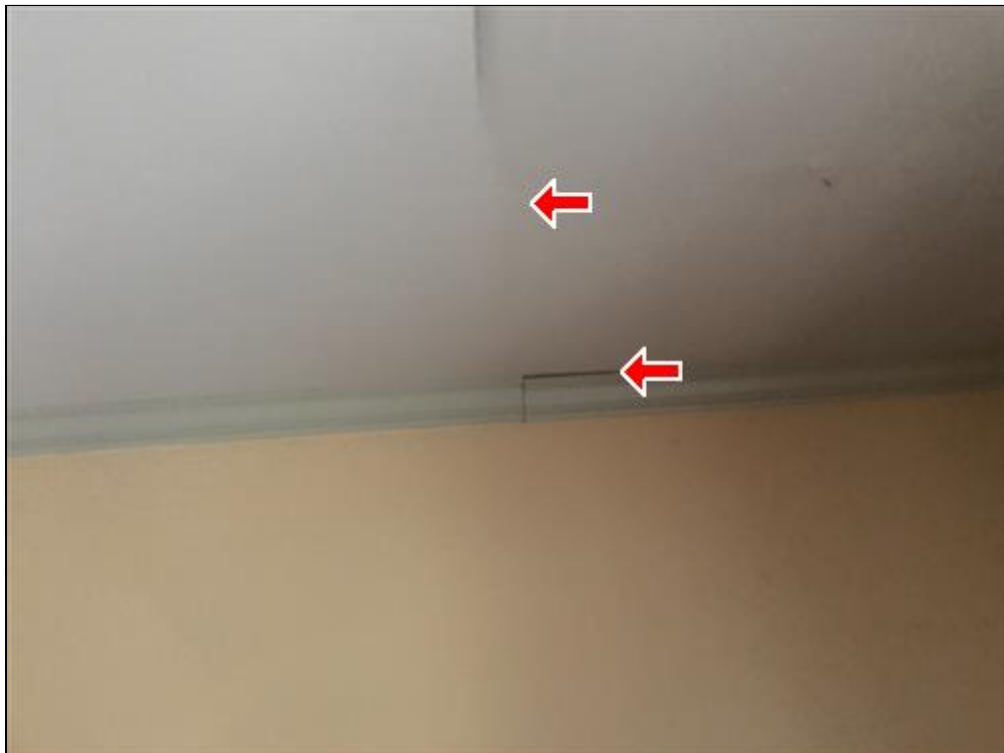
The Sheetrock on the ceiling reveals a water stain indicating a leak did or still exists at the downstairs. While this damage is cosmetic, it needs to be repaired. .

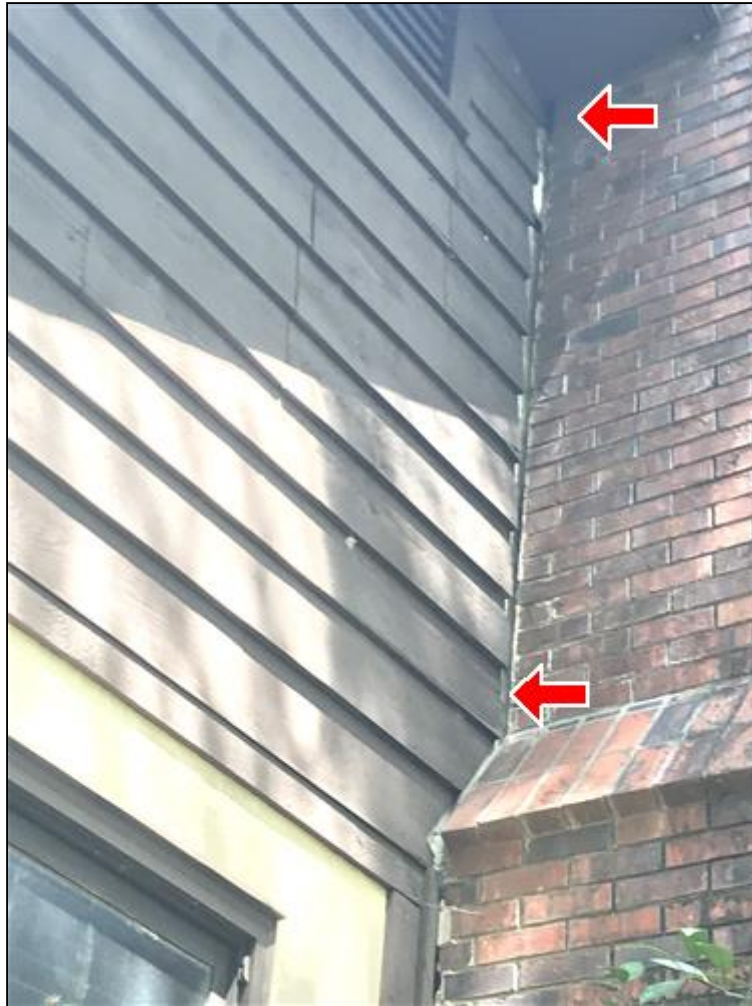
Structural crack in wall at front of home and left side (facing front). The appearance of settlement crack is large enough for concern. Recommend a "Structural Engineer" to inspect.

5.1 Picture 1 The fireplace is separating from the home, due to settlement on the left side of the house.

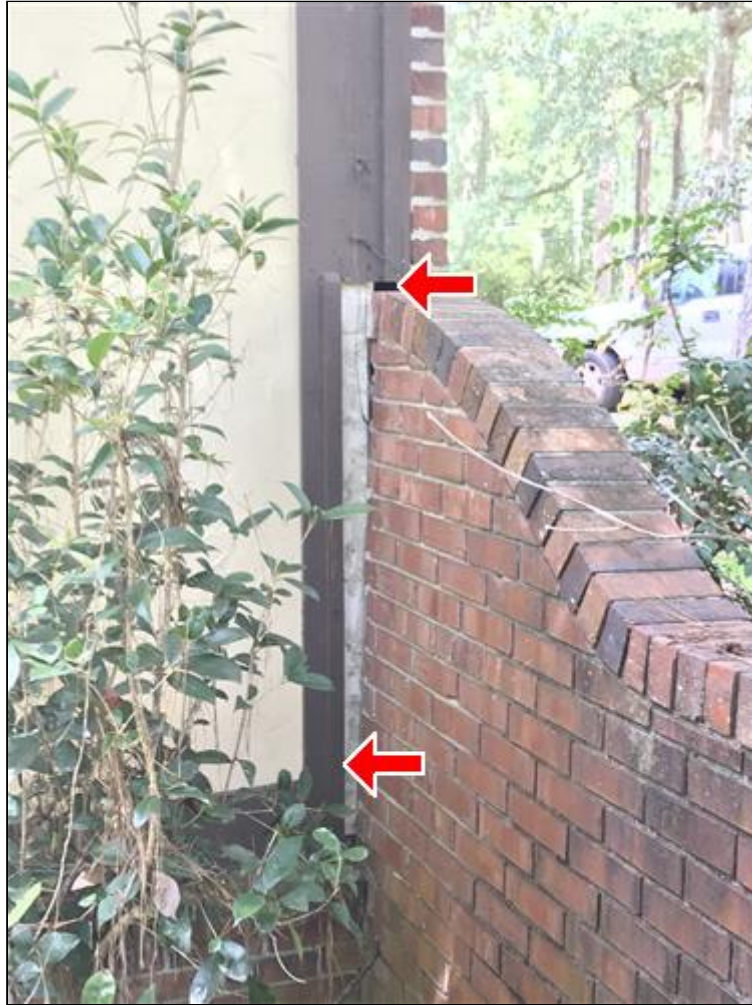
5.1 Picture 2 Brick privacy wall is operating on the left side of the home.

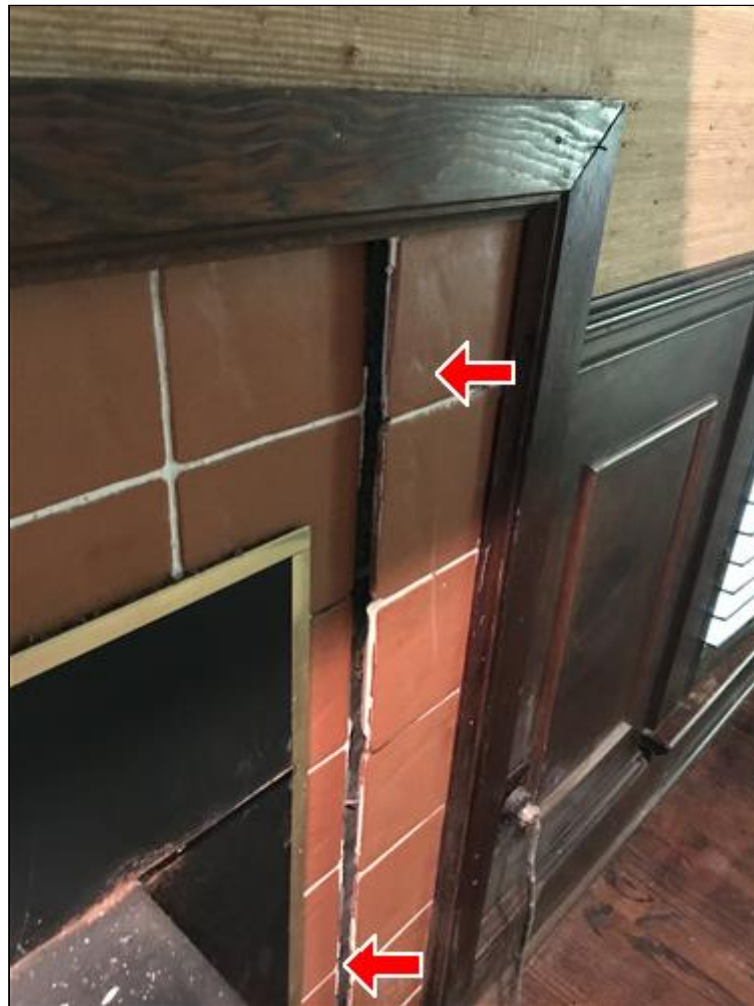
5.1 Picture 4 Signs that the fireplace is seperating from the home.
