Inspection Report

Property Address:
121 Robin Hood Dr
Thomasville Ga 31792

South Georgia Home Inspections

Date: 9/5/2019	Time:	Report ID:
Property: 121 Robin Hood Dr Thomasville Ga 31792	Customer: Weeks Auction Group	Real Estate Professional:

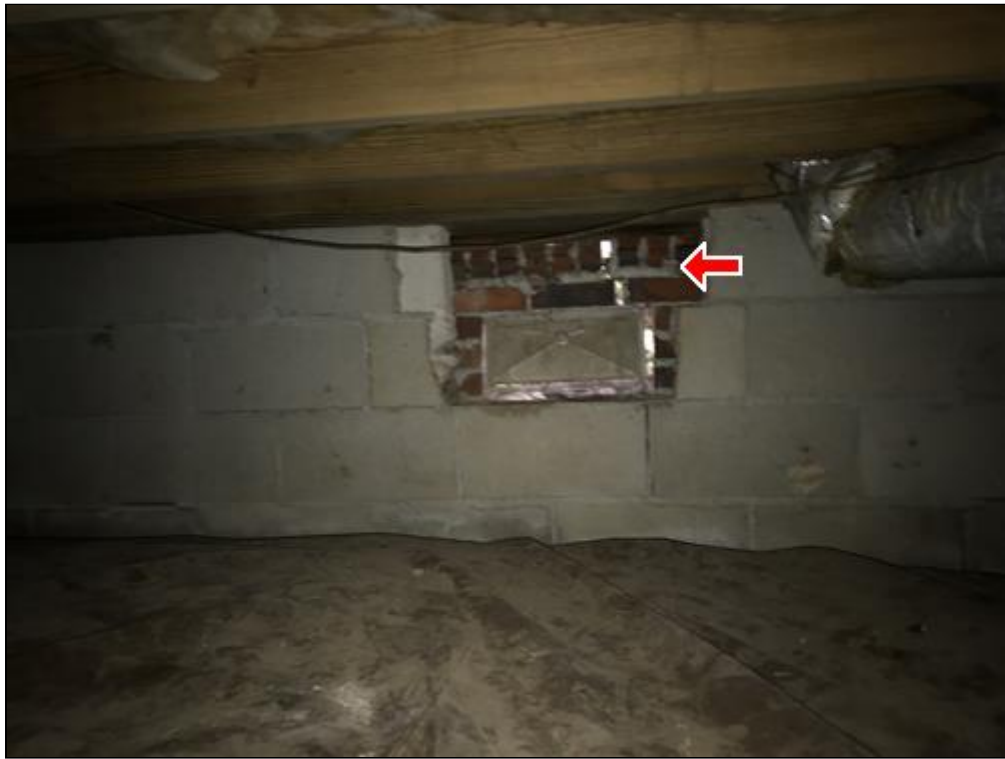
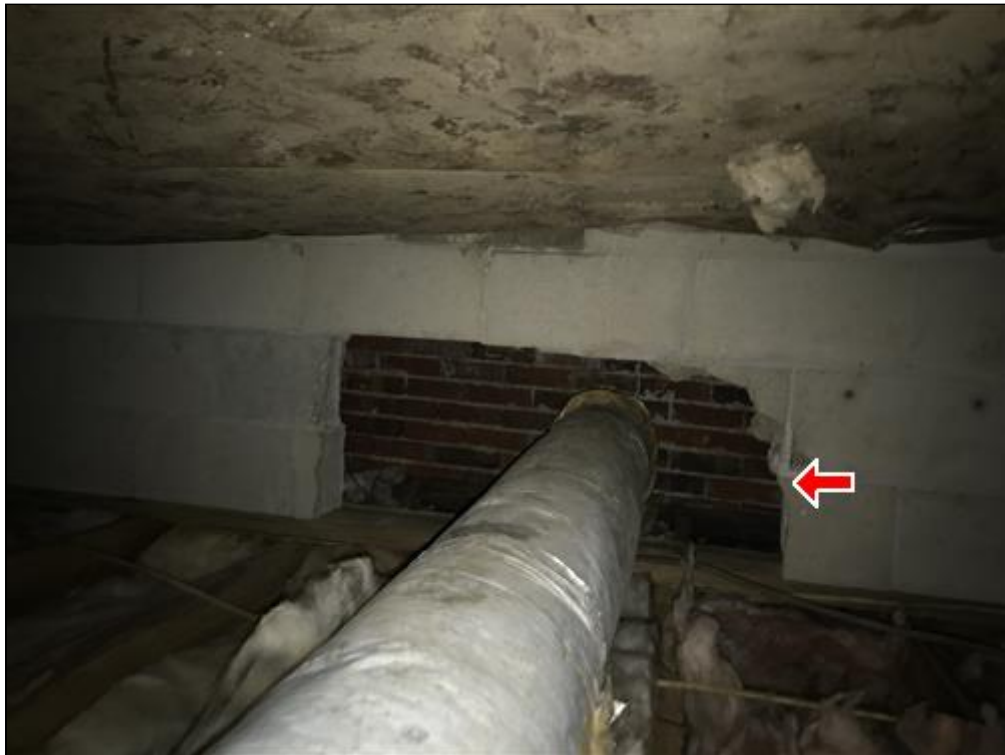
Structural crack in wall at front of home and left side (facing front). The appearance of settlement crack is large enough for concern. Recommend a "Structural Engineer" to inspect.

Structural components were removed in order to get ventilation and Duct work installed, in my opinion this is the cause of the settling of the walls. Pictures 5 and 6

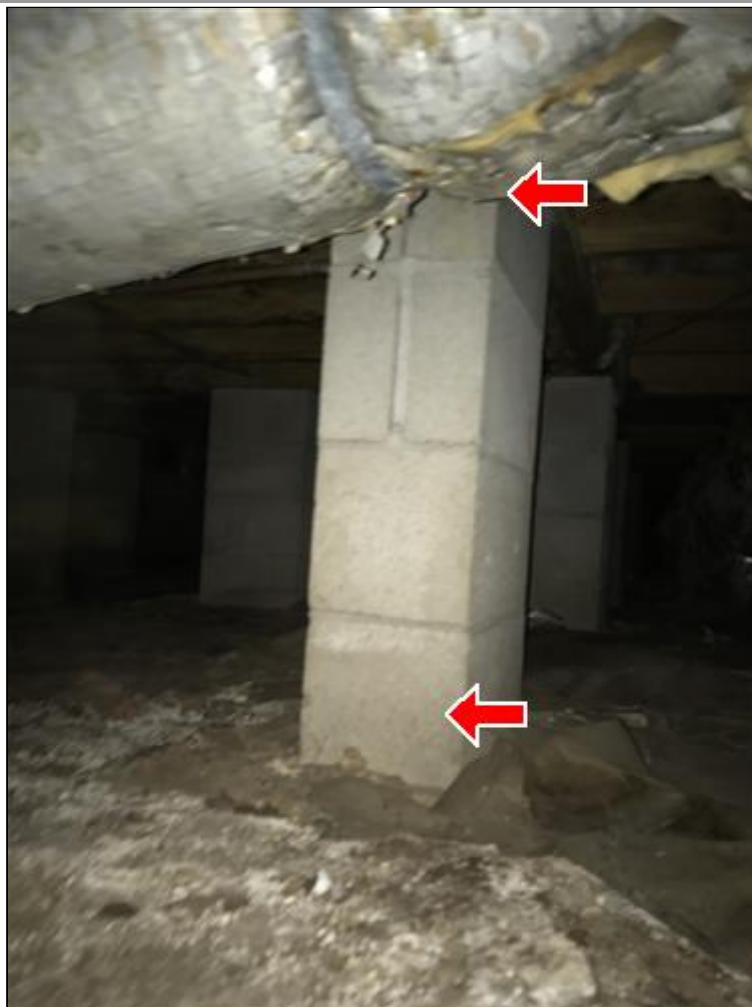
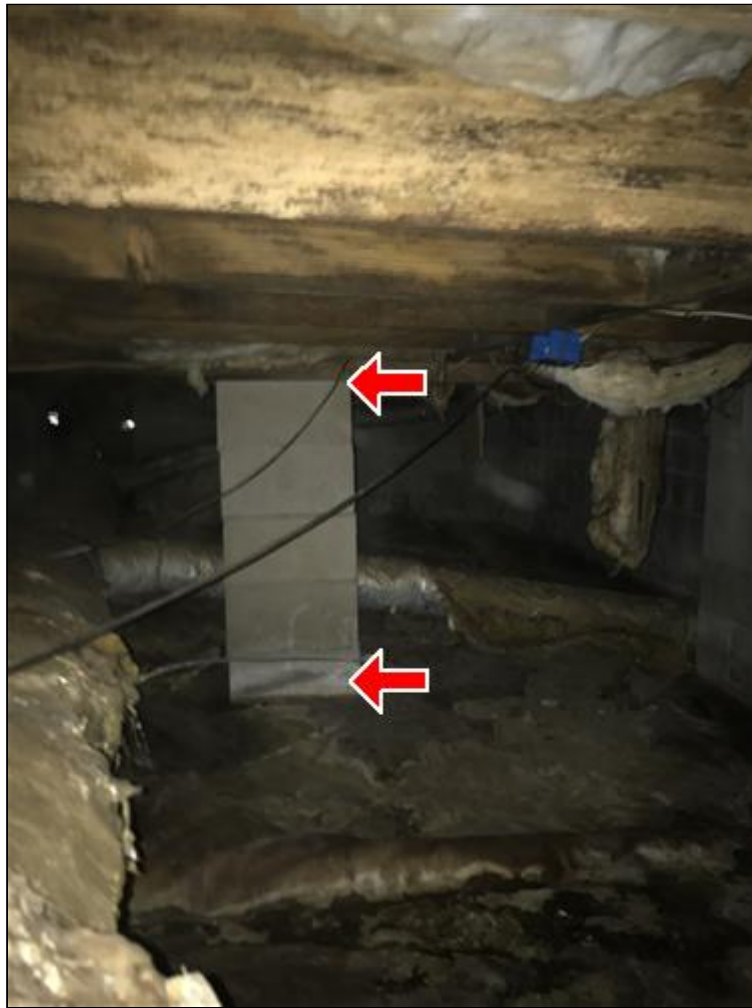
There are a couple of leaning piers underneath the kitchen area, this is causing the floor to have major humps in it, repairs are needed.

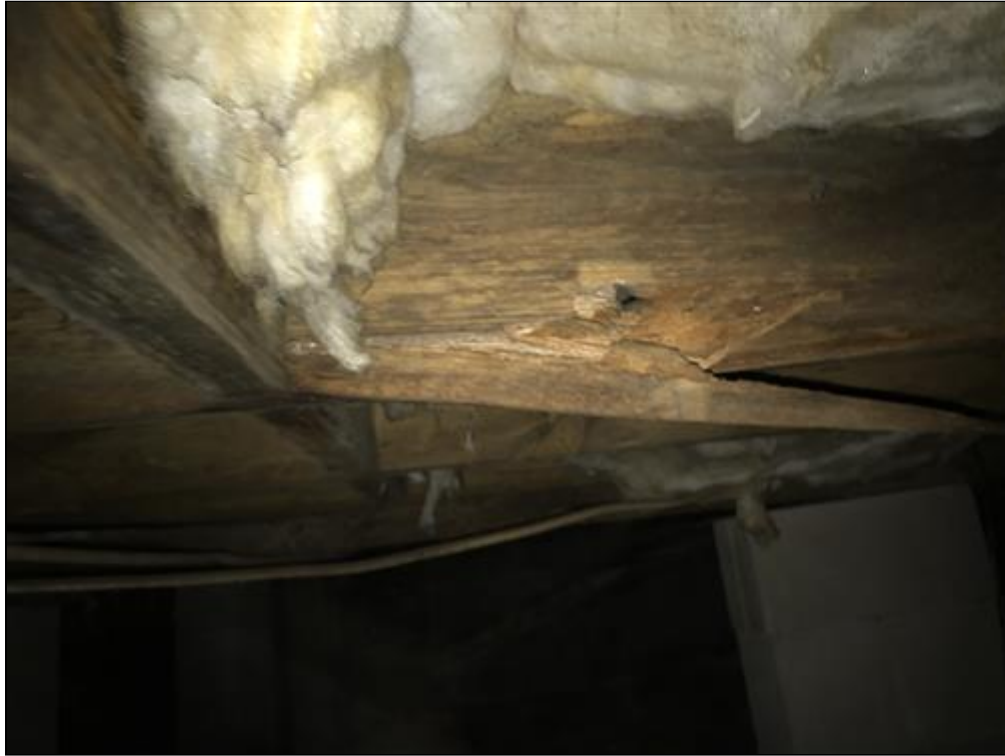
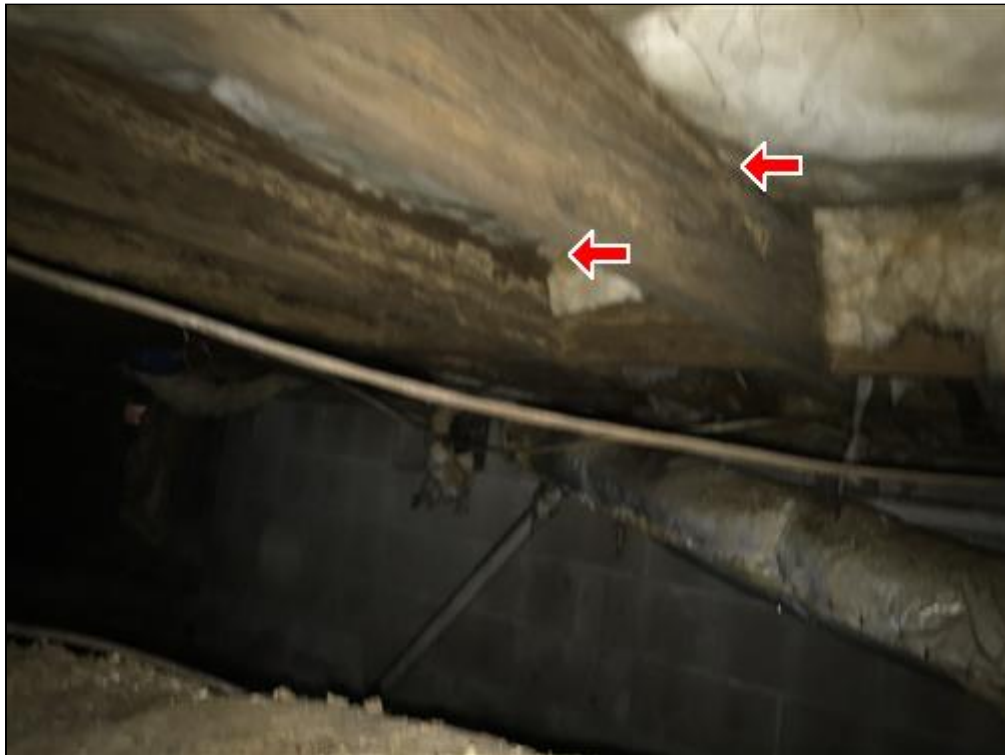
At least Two floor joist(s) are from moisture absorption or water intrusion under the Kitchen. Repairs are needed. A qualified licensed general contractor should inspect further and repair as needed.

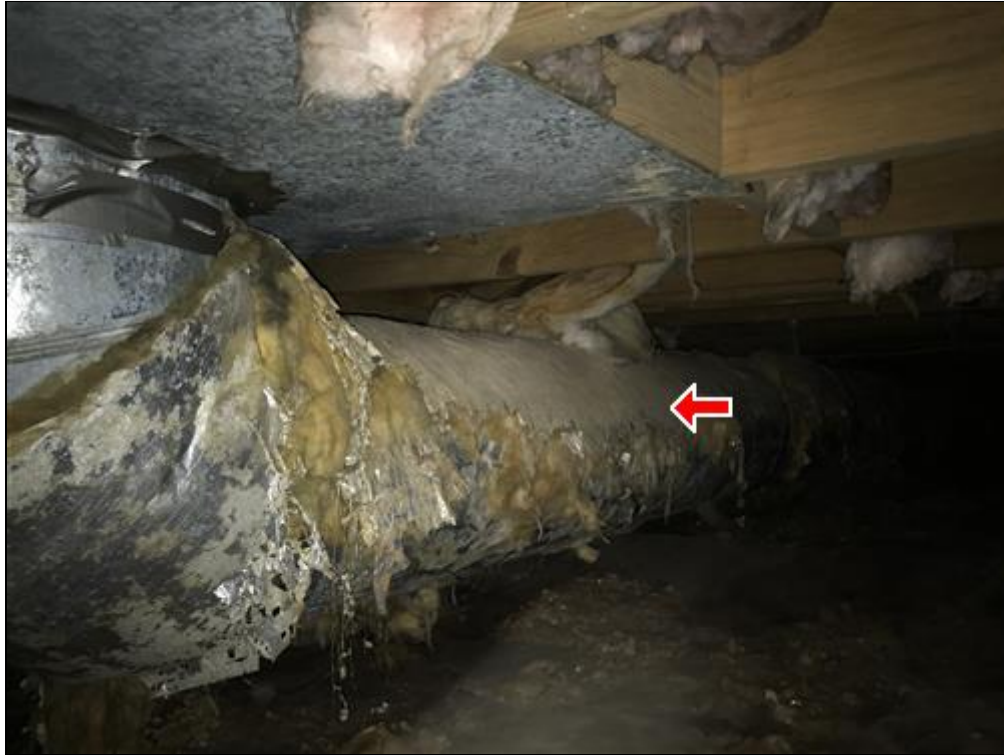
8.3 Picture 1

The duct pipe has failed in the crawlspace. Energy loss is occurring in crawlspace and immediate correction is needed. .
