Inspection Report

Property Address:
602 Earnest St.
Thomasville Ga 31792

South Georgia Home Inspections

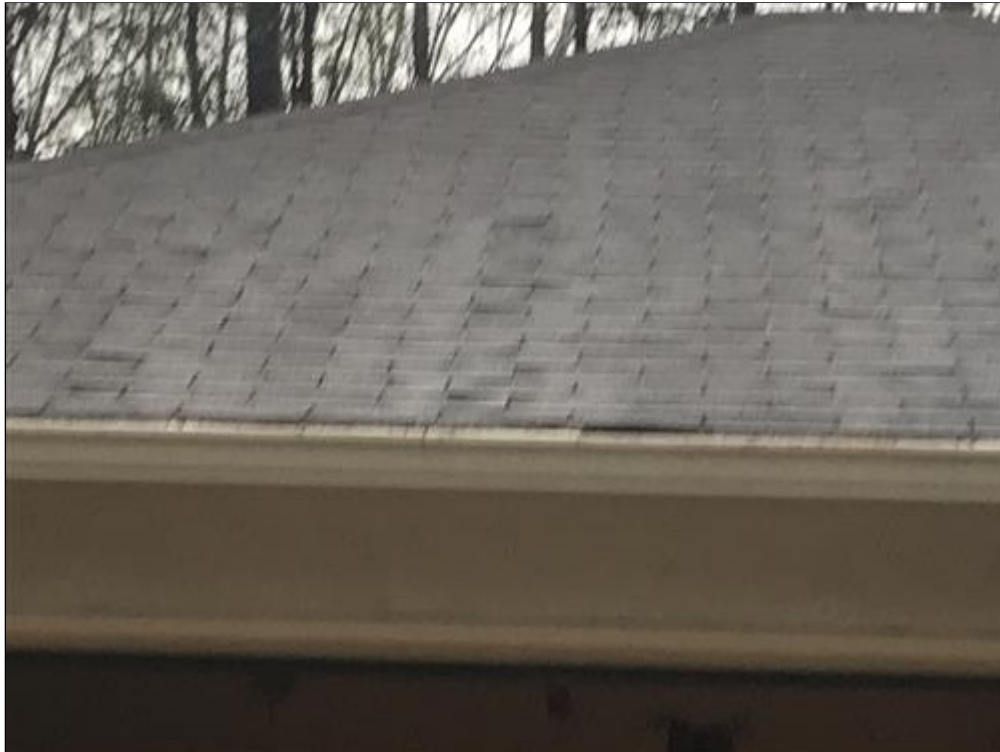
1.0 Picture 1

1.0 The roof covering is old, and the life of covering has expired. While it could last a year or two, some areas may need patching with tar as leaks develop.

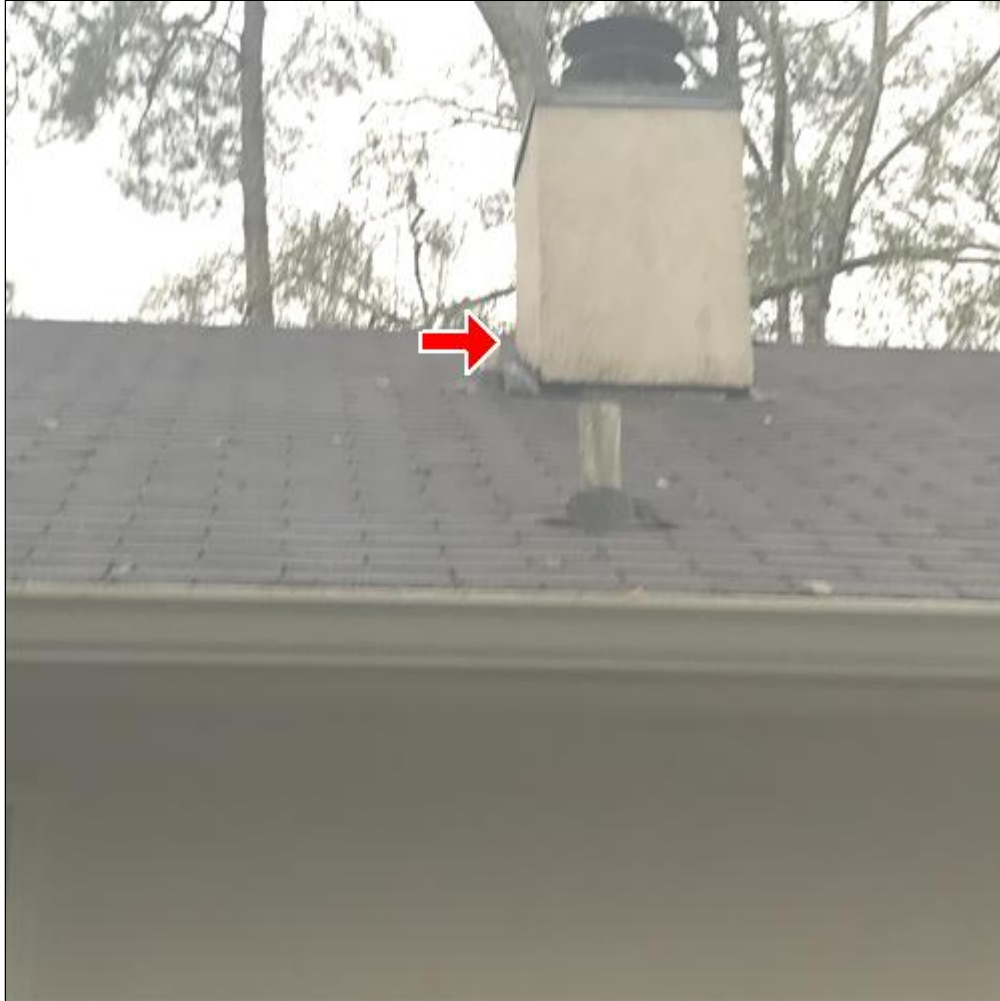
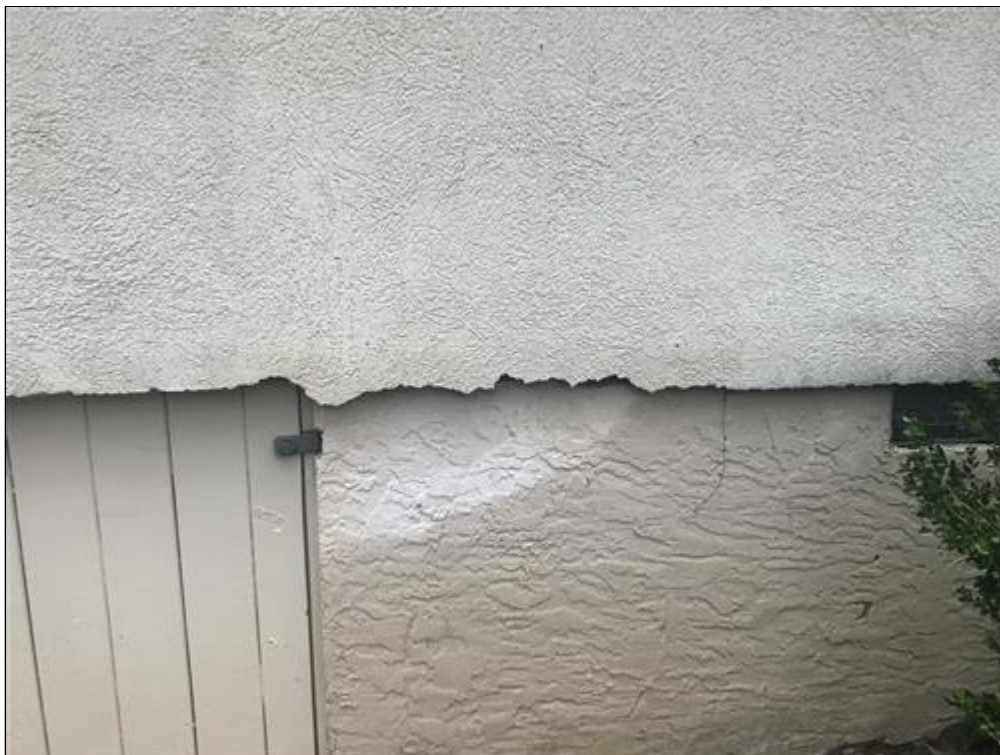
2.0 The Stucco coating at the left side (facing front) left side of chimney deteriorated along bottom edge. A qualified person should repair or replace as needed.

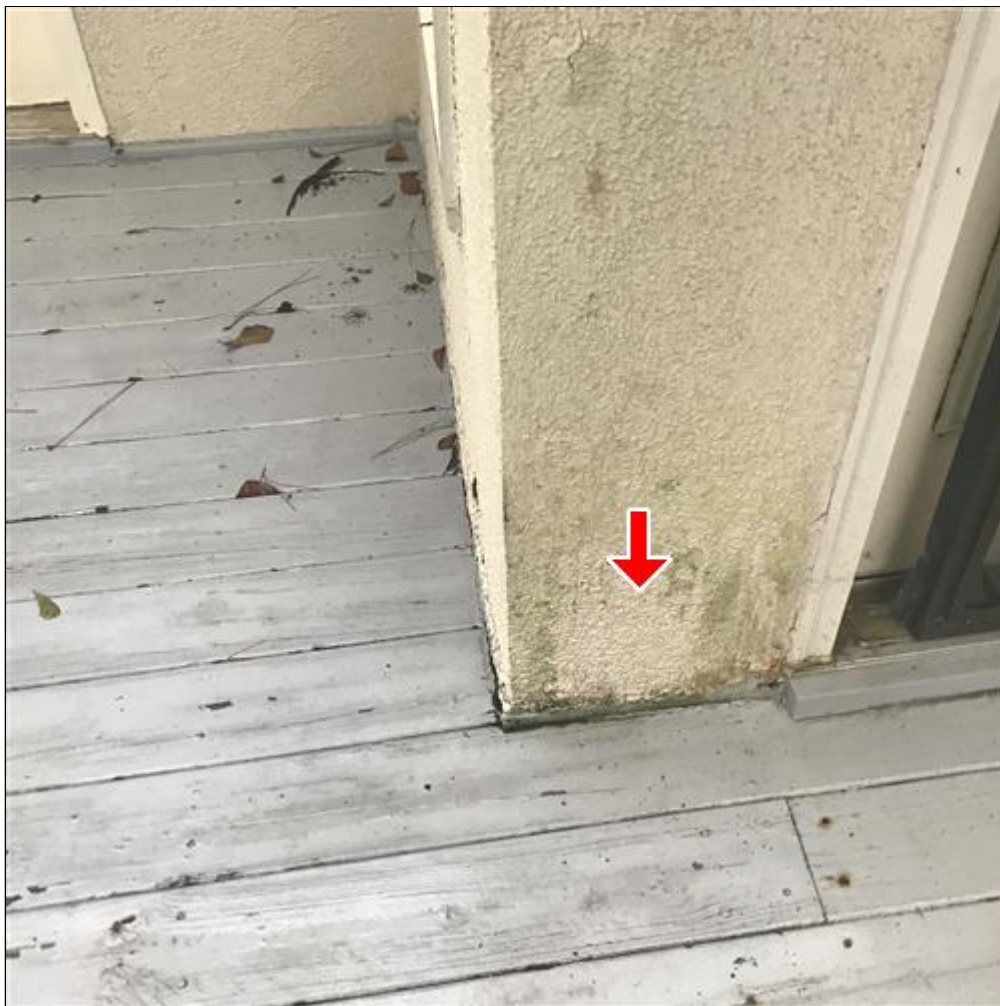
2.0 Picture 3 Back porch area.

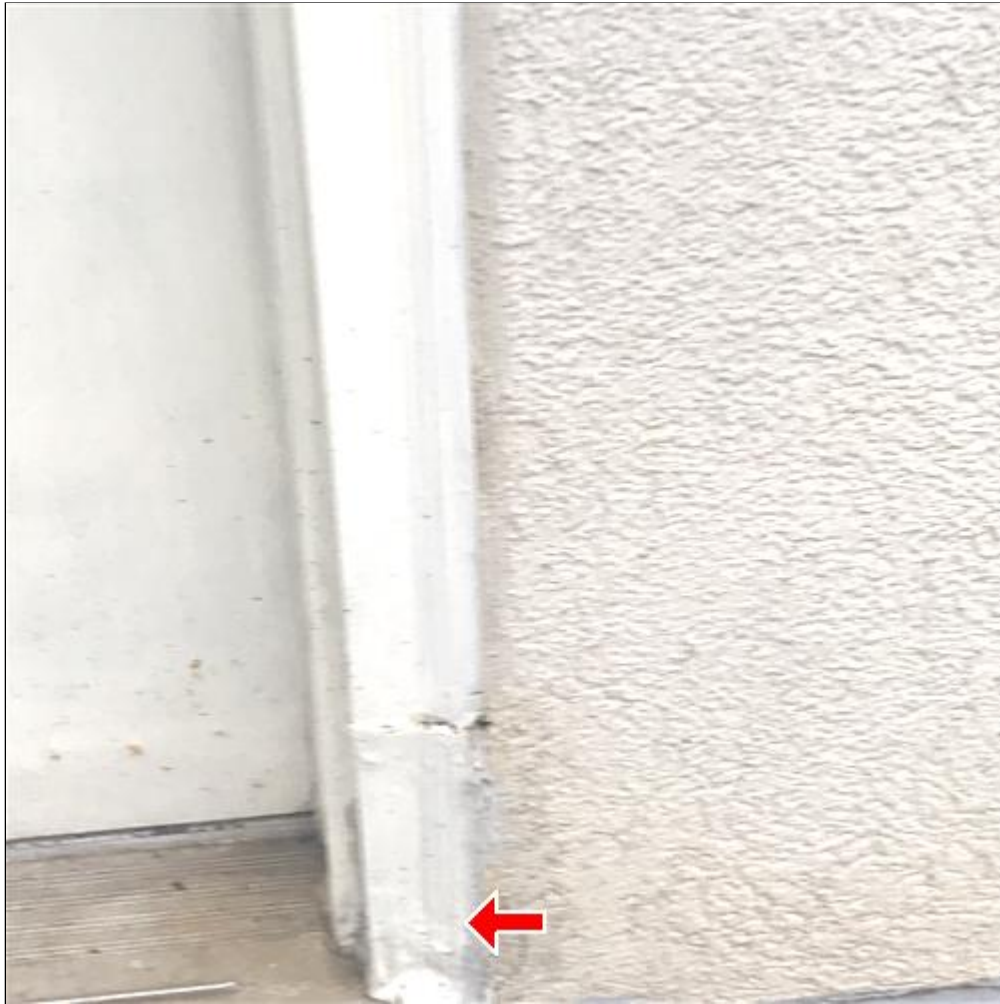
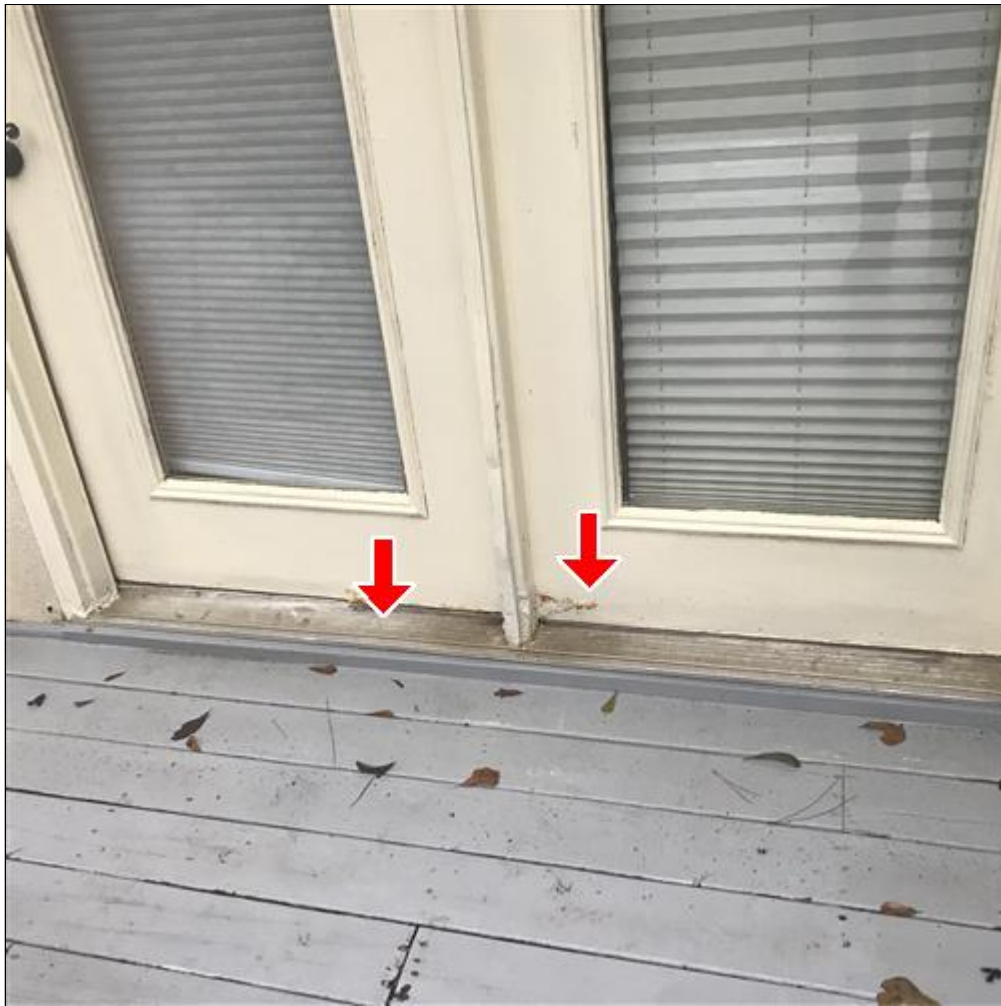
2.1 The entry door at the rear of home . A repair or replacement is needed.

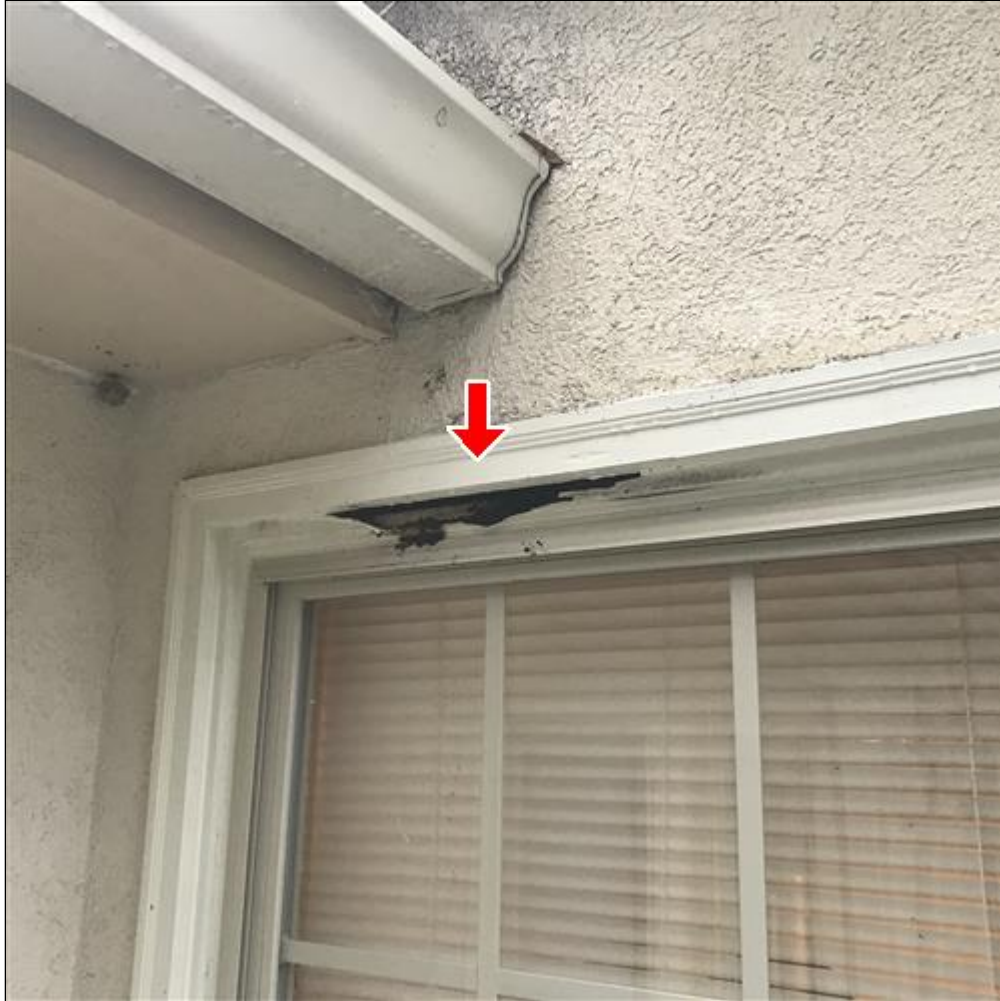
2.2 Picture 1

2.2 The window frame is deteriorated at rear of home. Further deterioration may occur if not repaired. A qualified person should repair or replace as needed.

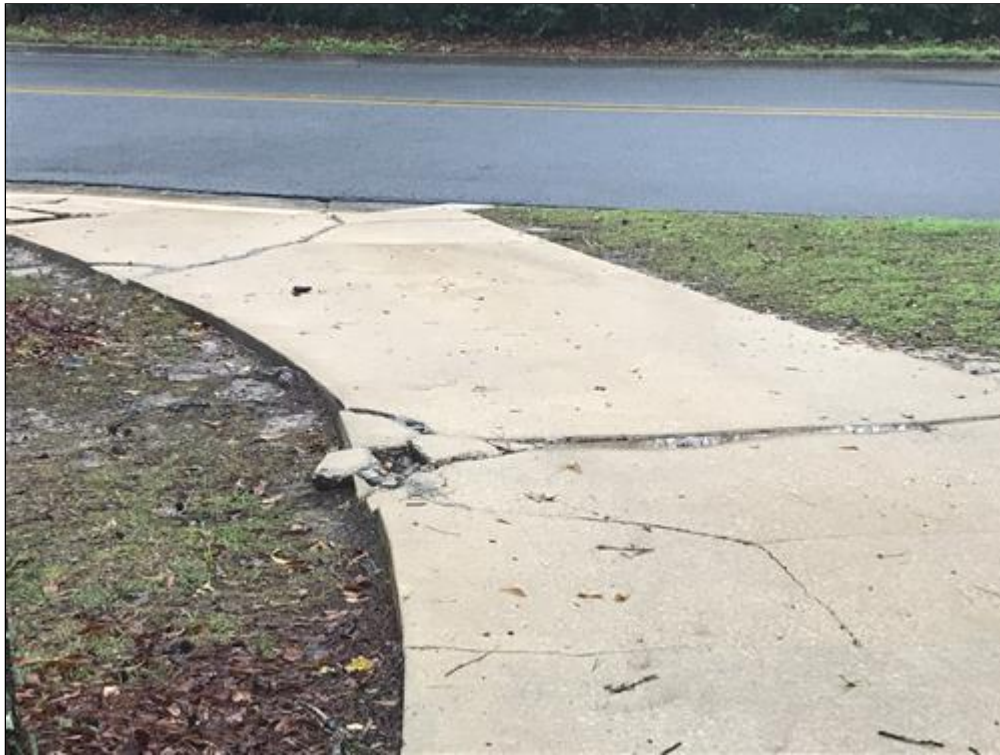
2.4 Picture 1

2.4 The concrete drive at the front of home has settlement cracks shows signs of erosion and problem needs to be addressed. Further erosion or deterioration can occur if not corrected. A qualified person should repair or replace as needed.

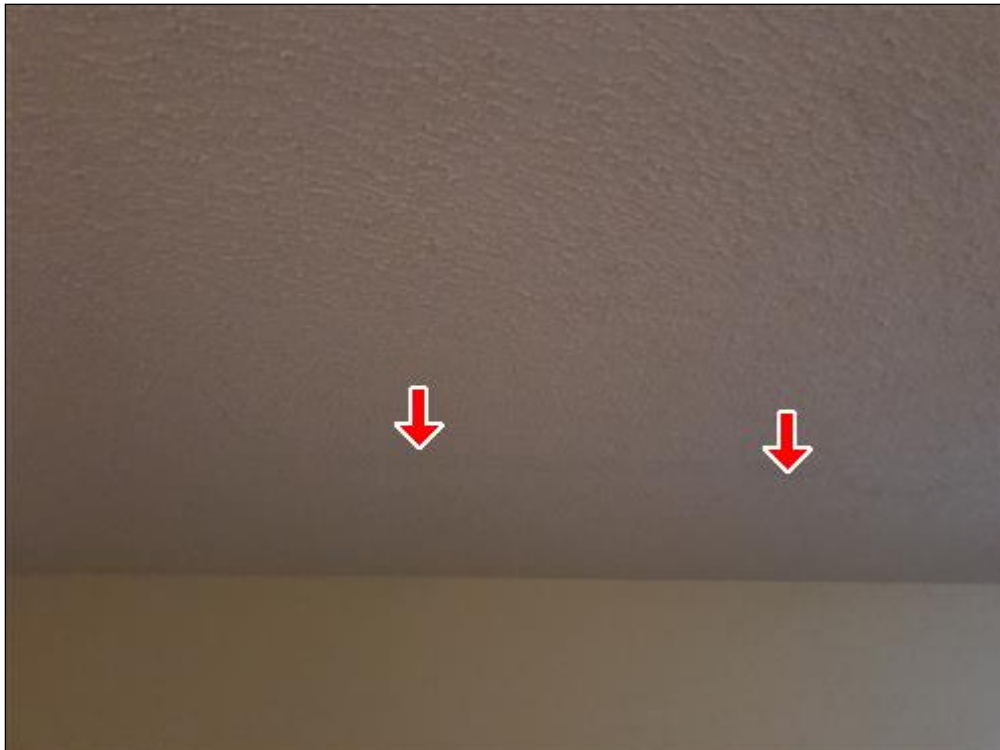
4.0 Picture 1

4.0 The Sheetrock on the ceiling reveals a water stain indicating a leak did or still exists at the Living Room and Master Bedroom. This damage is considered cosmetic. A qualified person should repair or replace as needed.

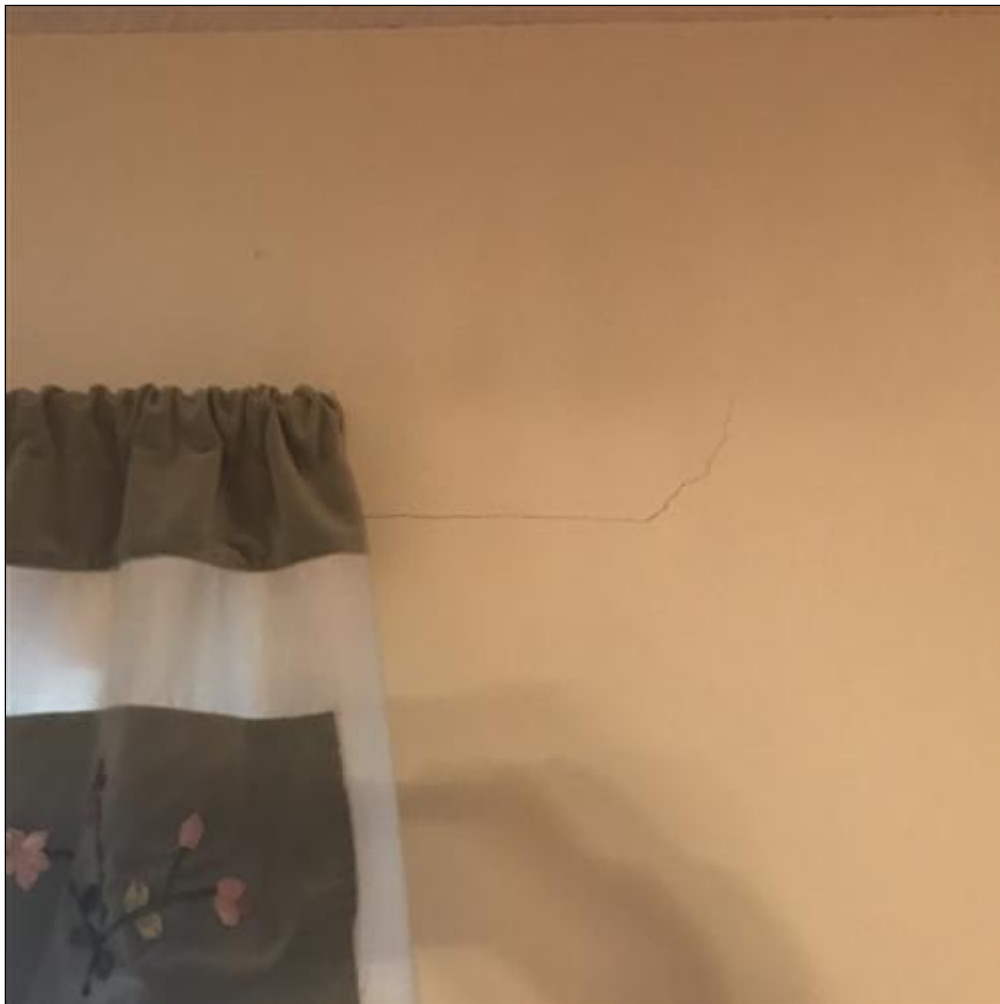
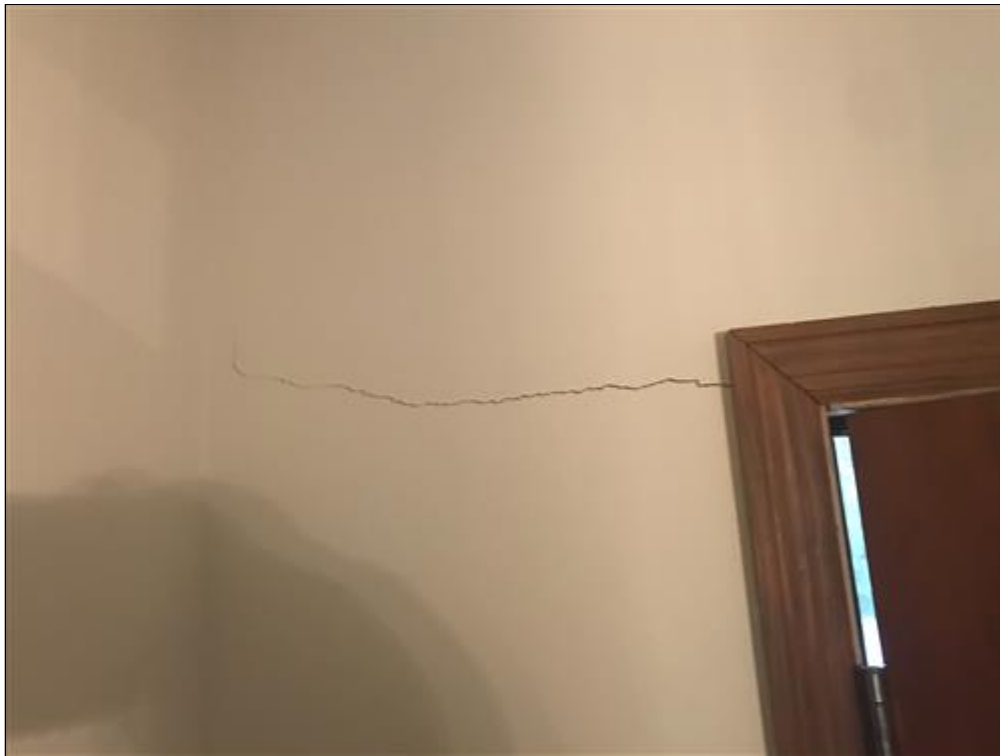
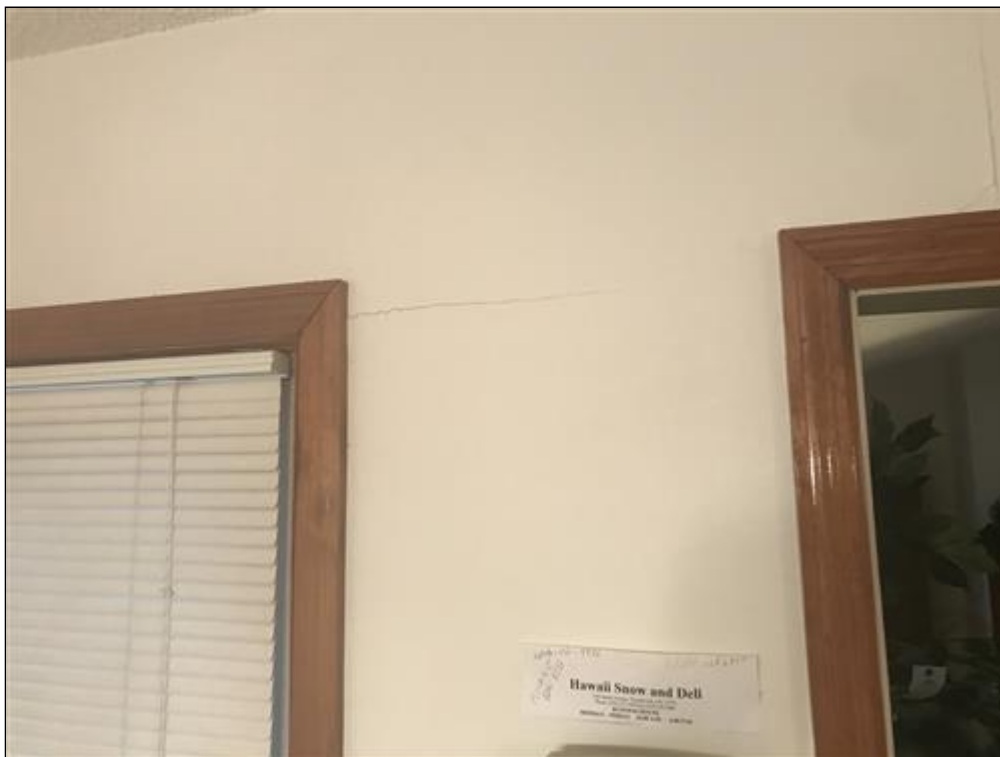
4.1 The sheetrock on the wall has several hairline cracks at the home due to settlement. . A qualified person should repair or replace as needed.

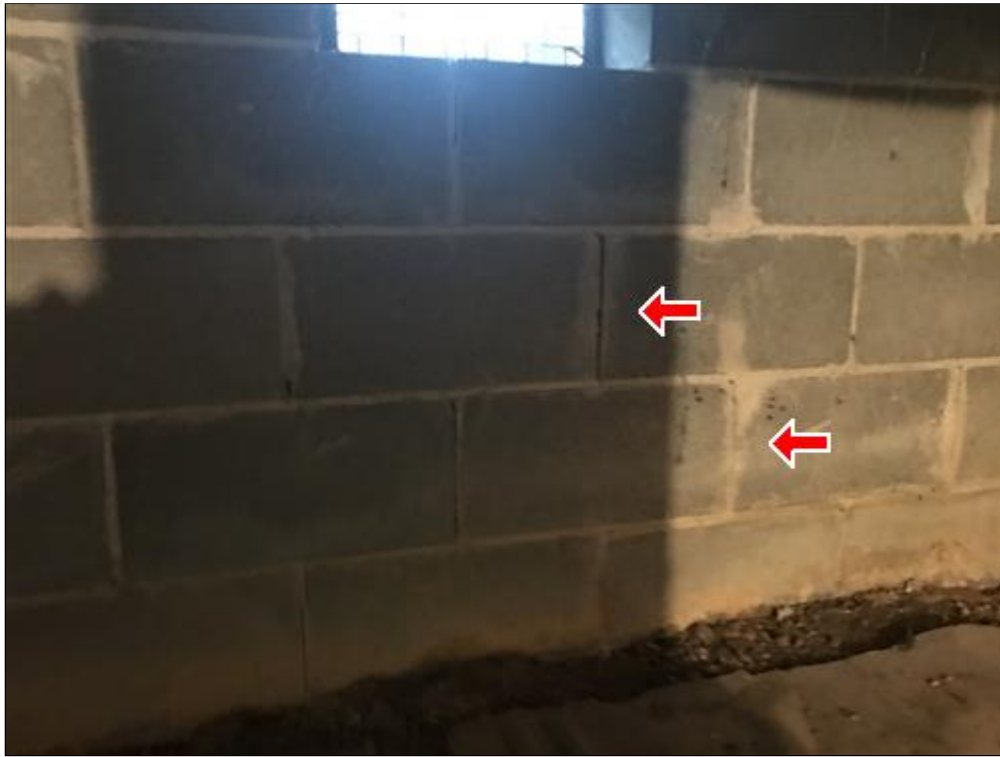
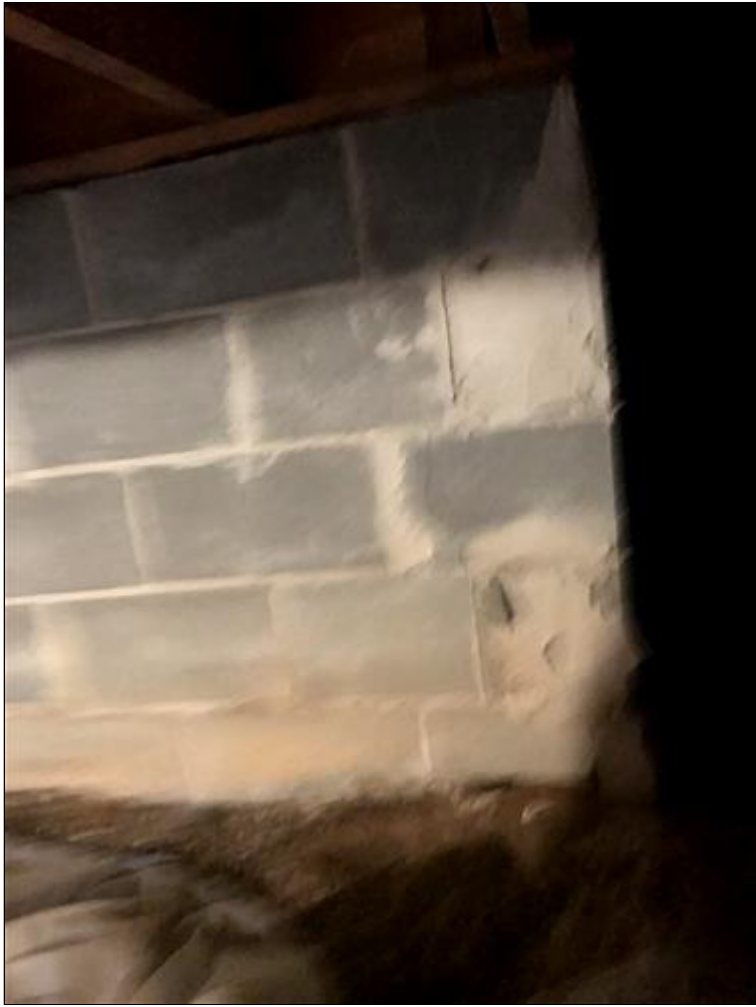
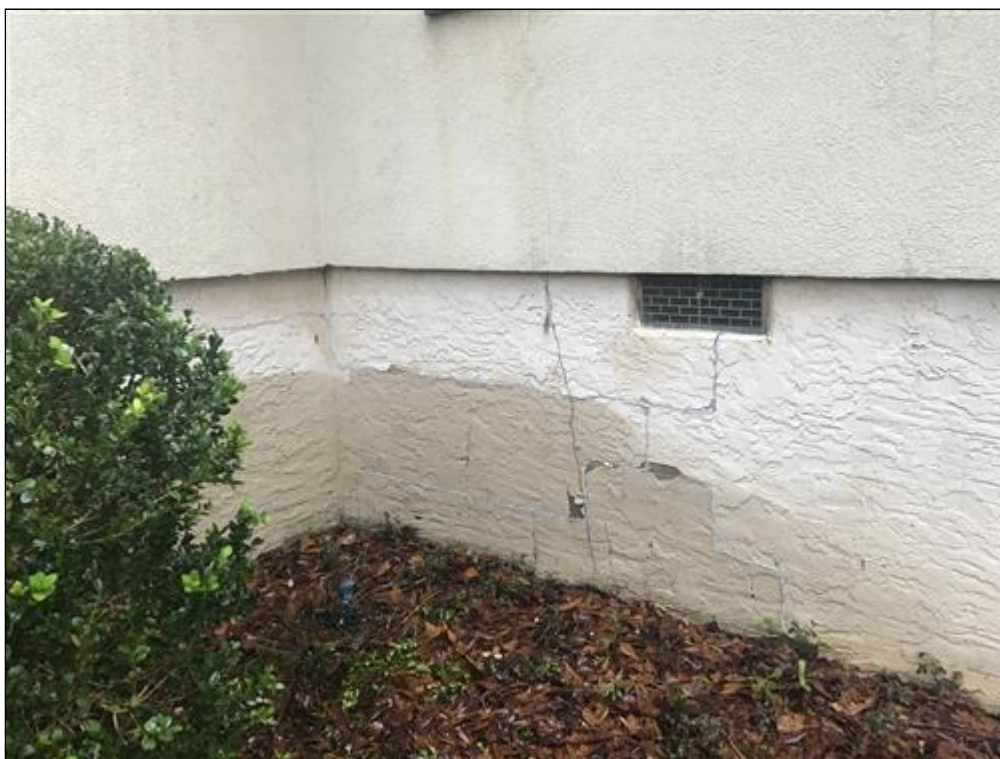
5.0 The structural crack(s) in the foundation wall at the front of home are due to settlement at these areas. The previous repair to wall does not appear adequate. A qualified licensed general contractor should inspect further and repair as needed.

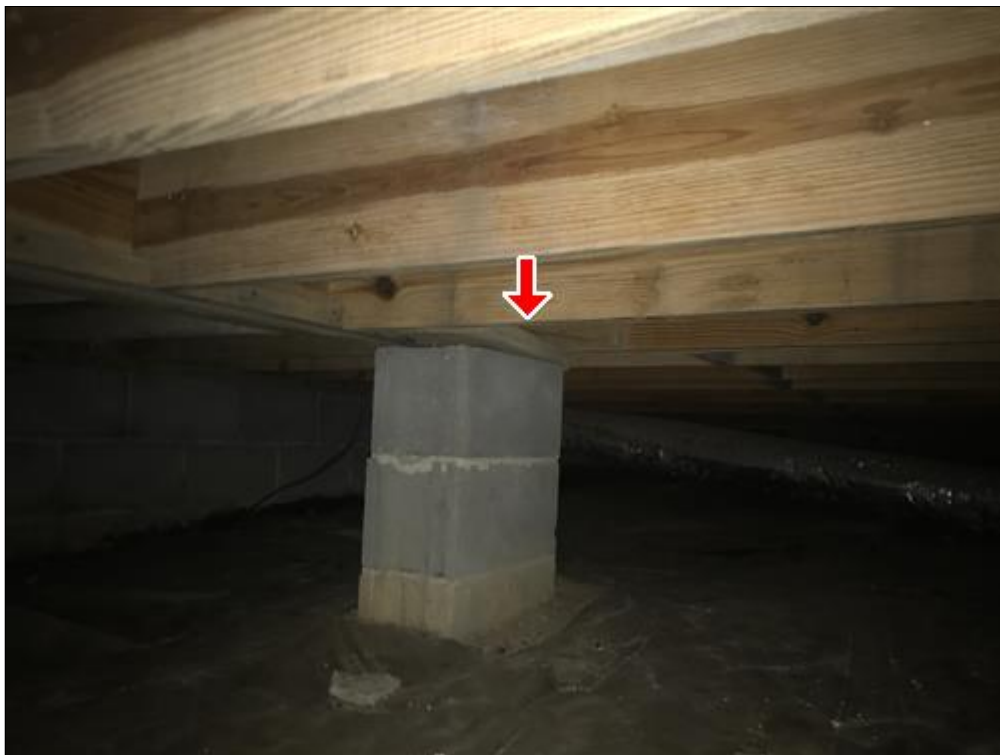
5.0 Picture 3 Wood cap loose

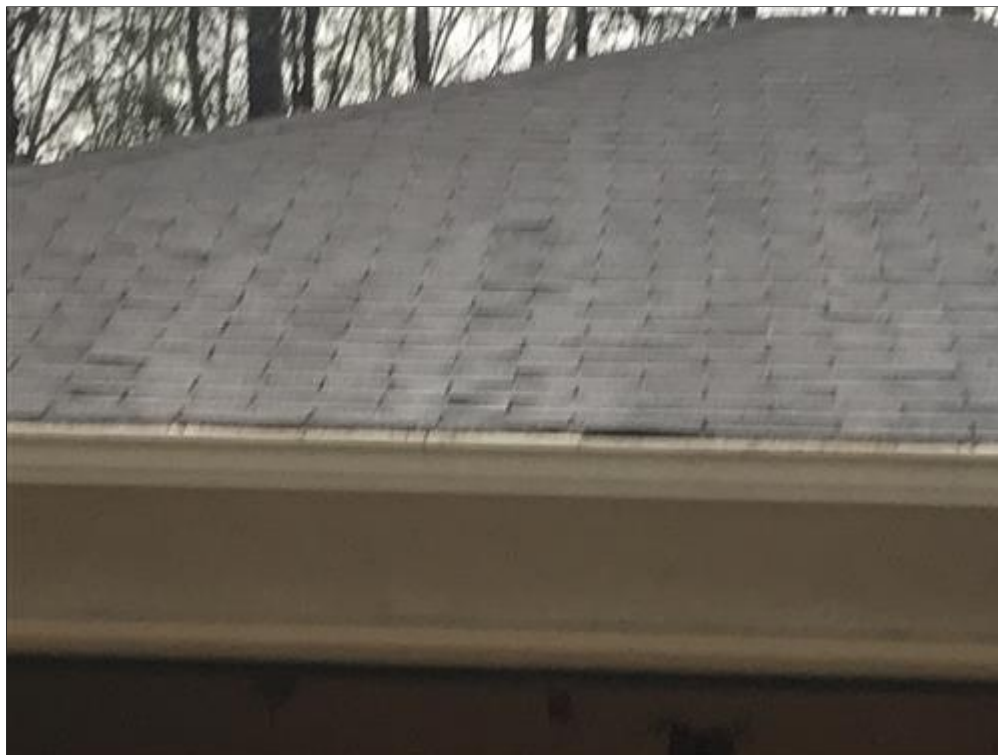
1.0 Picture 1

The roof covering is old, and the life of covering has expired. While it could last a year or two, some areas may need patching with tar as leaks develop.

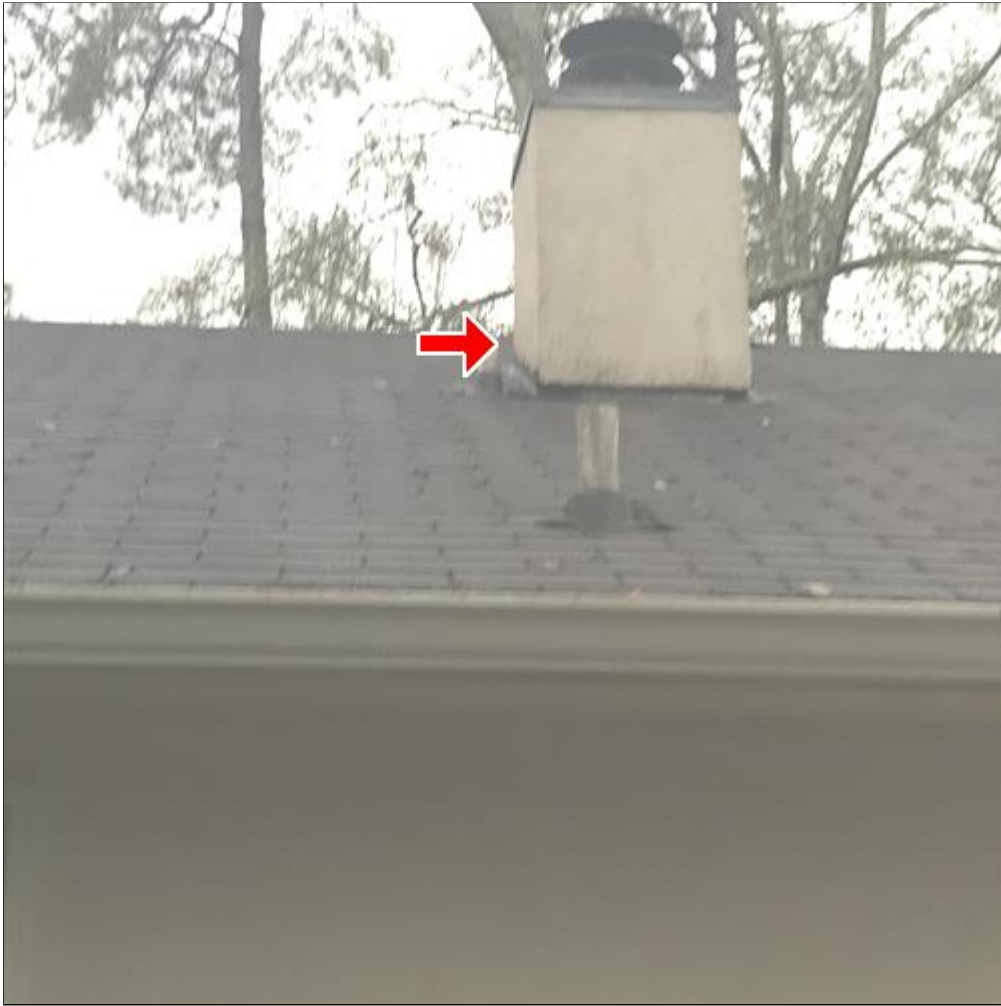
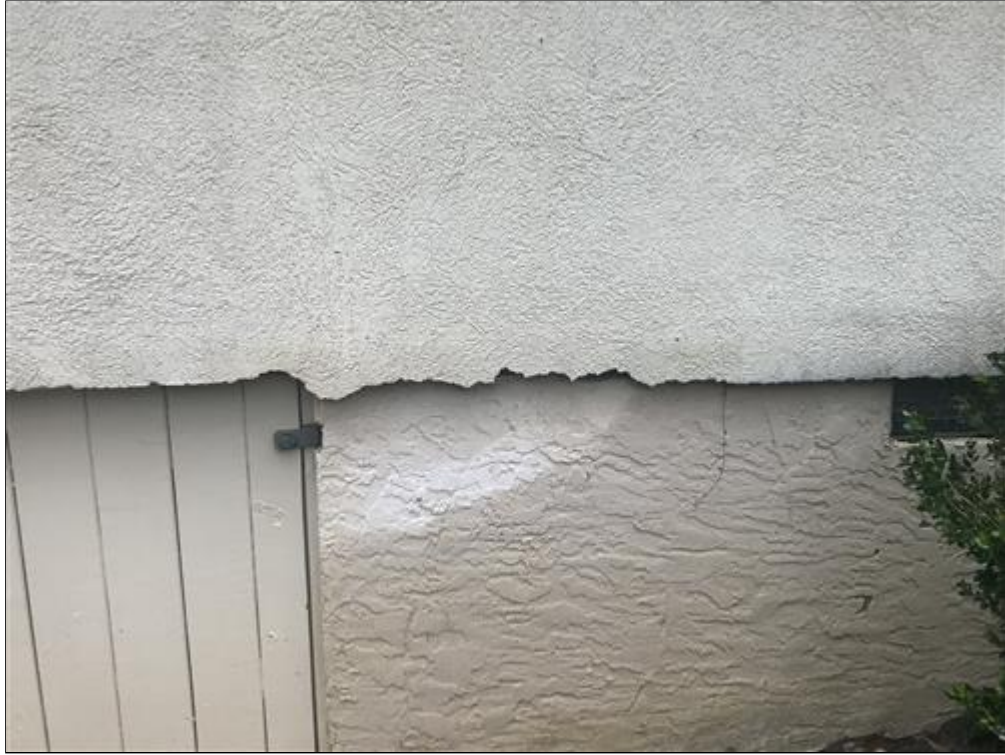
The Stucco coating at the left side (facing front) left side of chimney deteriorated along bottom edge. A qualified person should repair or replace as needed.

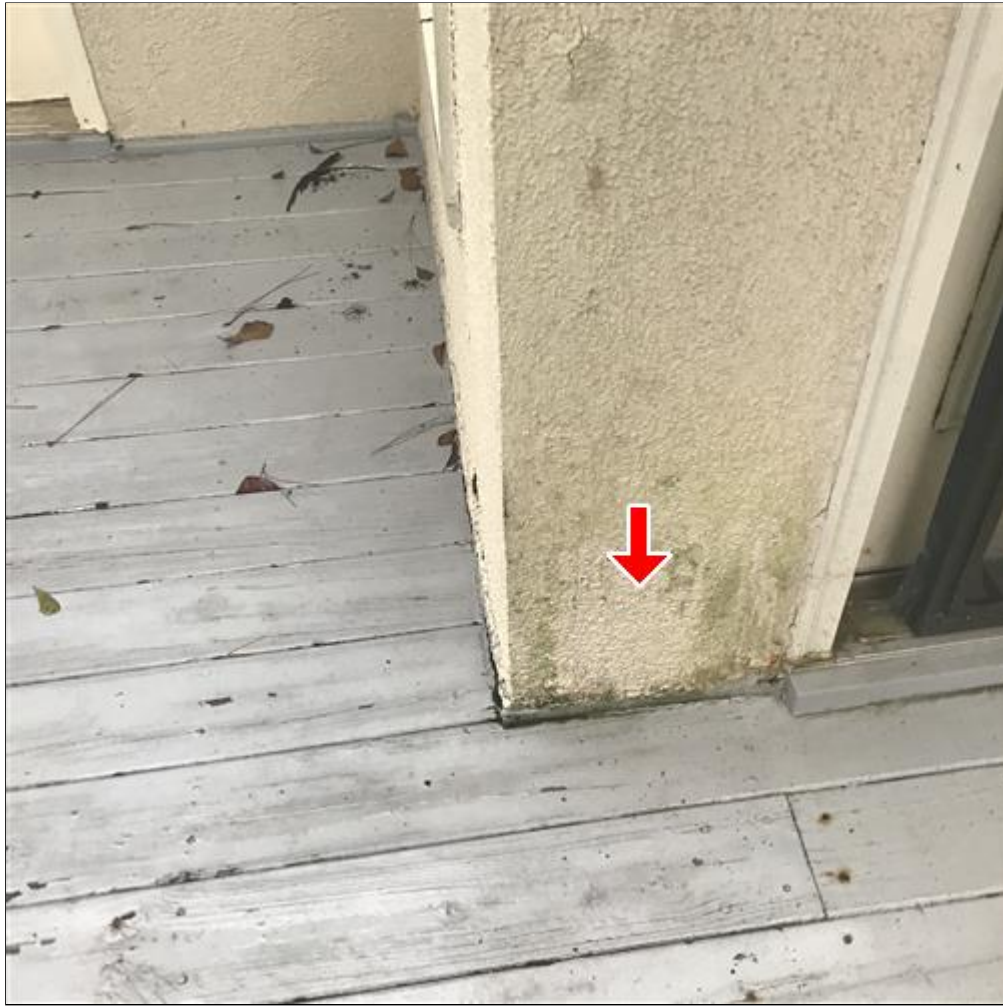
2.0 Picture 3 Back porch area.

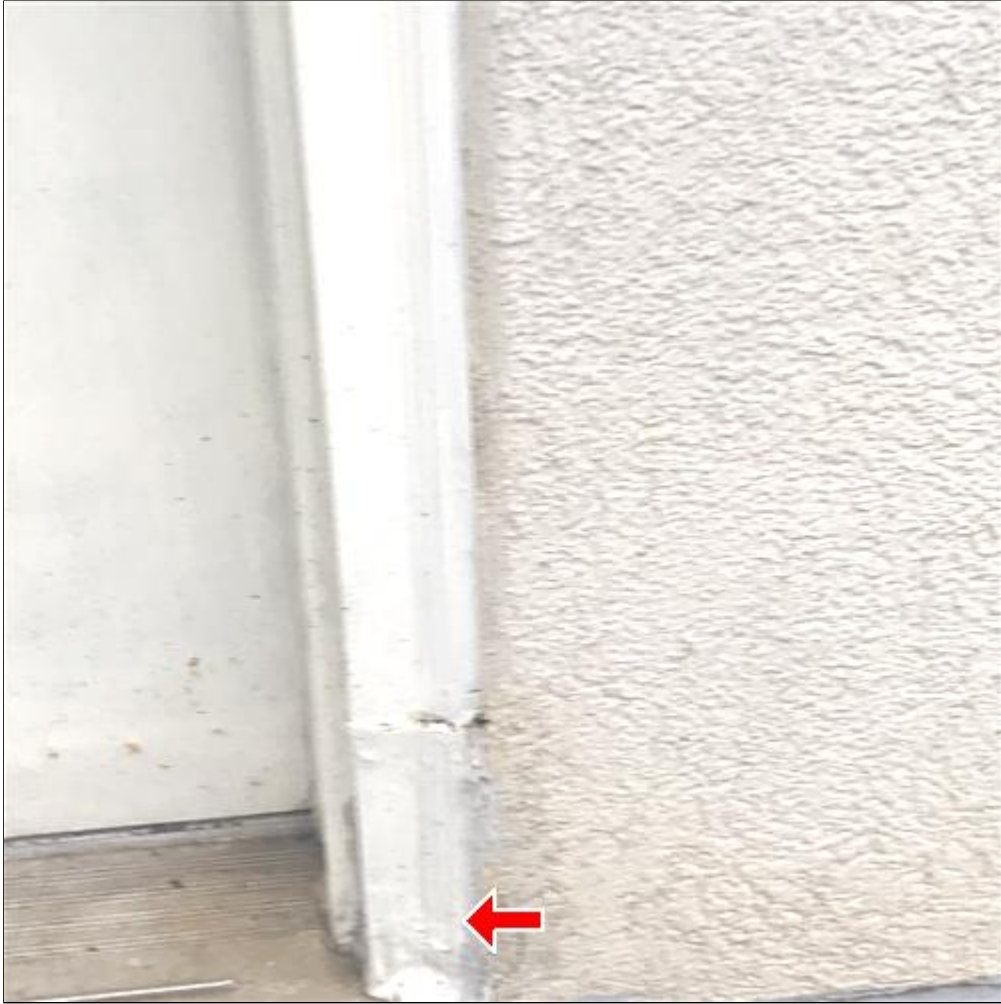
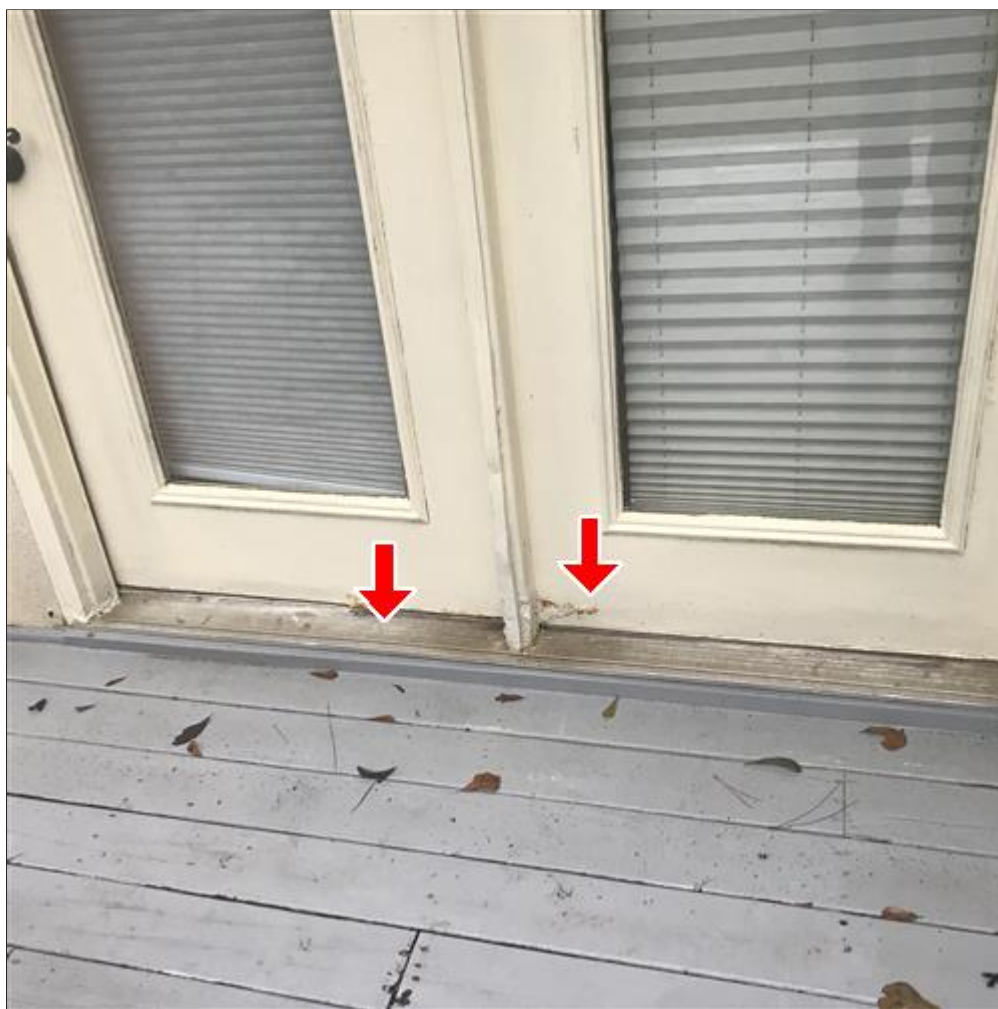
The entry door at the rear of home . A repair or replacement is needed.

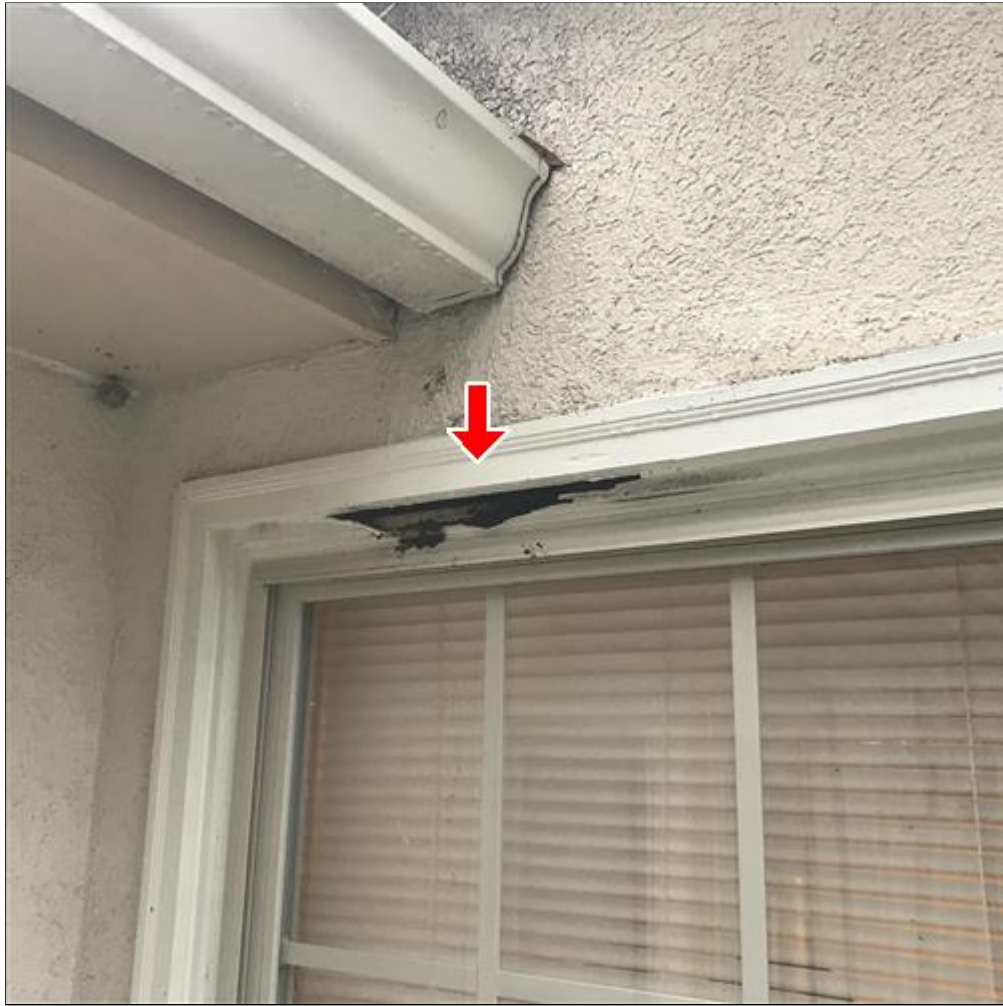
2.2 Picture 1

The window frame is deteriorated at rear of home. Further deterioration may occur if not repaired. A qualified person should repair or replace as needed.

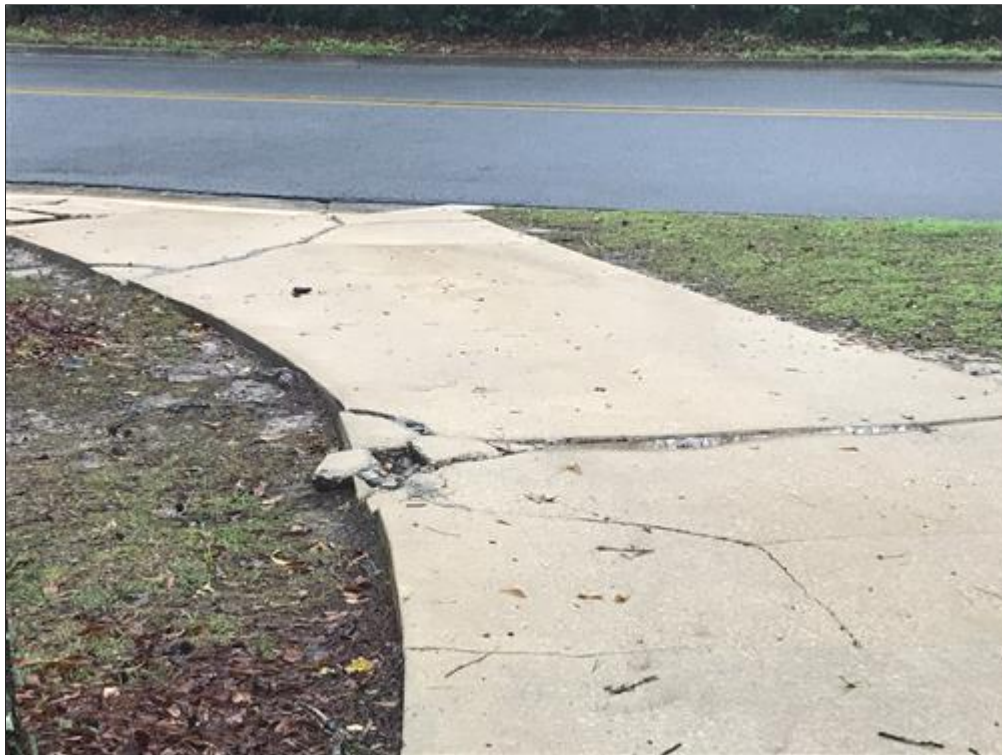
2.4 Picture 1

The concrete drive at the front of home has settlement cracks shows signs of erosion and problem needs to be addressed. Further erosion or deterioration can occur if not corrected. A qualified person should repair or replace as needed.

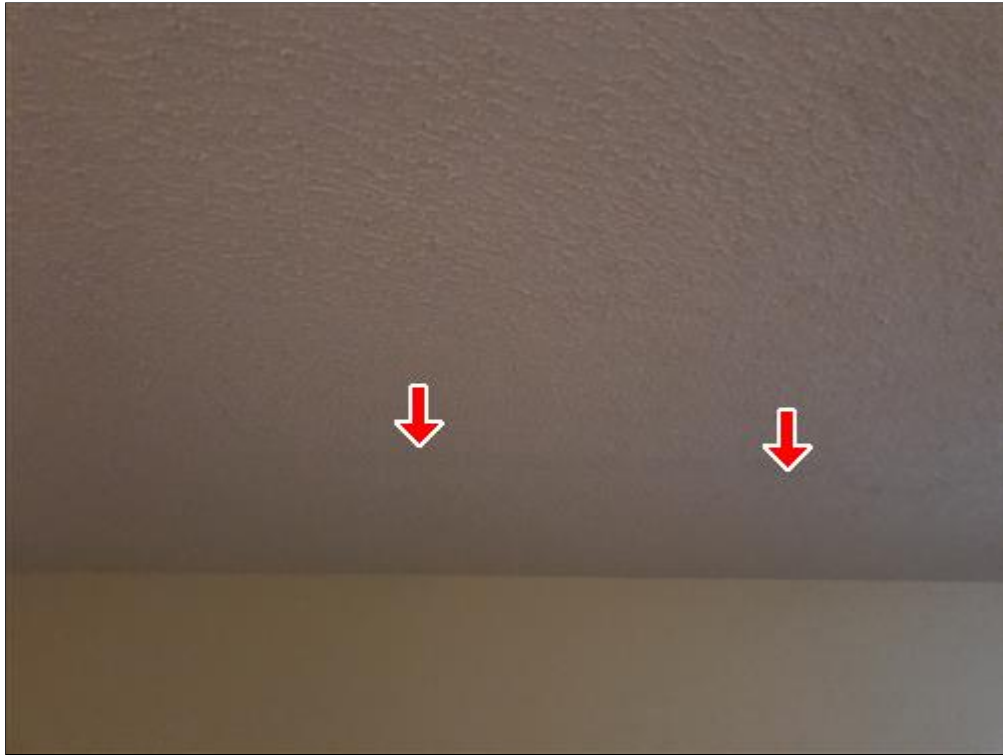
4.0 Picture 1

The Sheetrock on the ceiling reveals a water stain indicating a leak did or still exists at the Living Room and Master Bedroom. This damage is considered cosmetic. A qualified person should repair or replace as needed.
