Inspection Report

Property Address:
602 Earnest St.
Thomasville Ga 31792

South Georgia Home Inspections

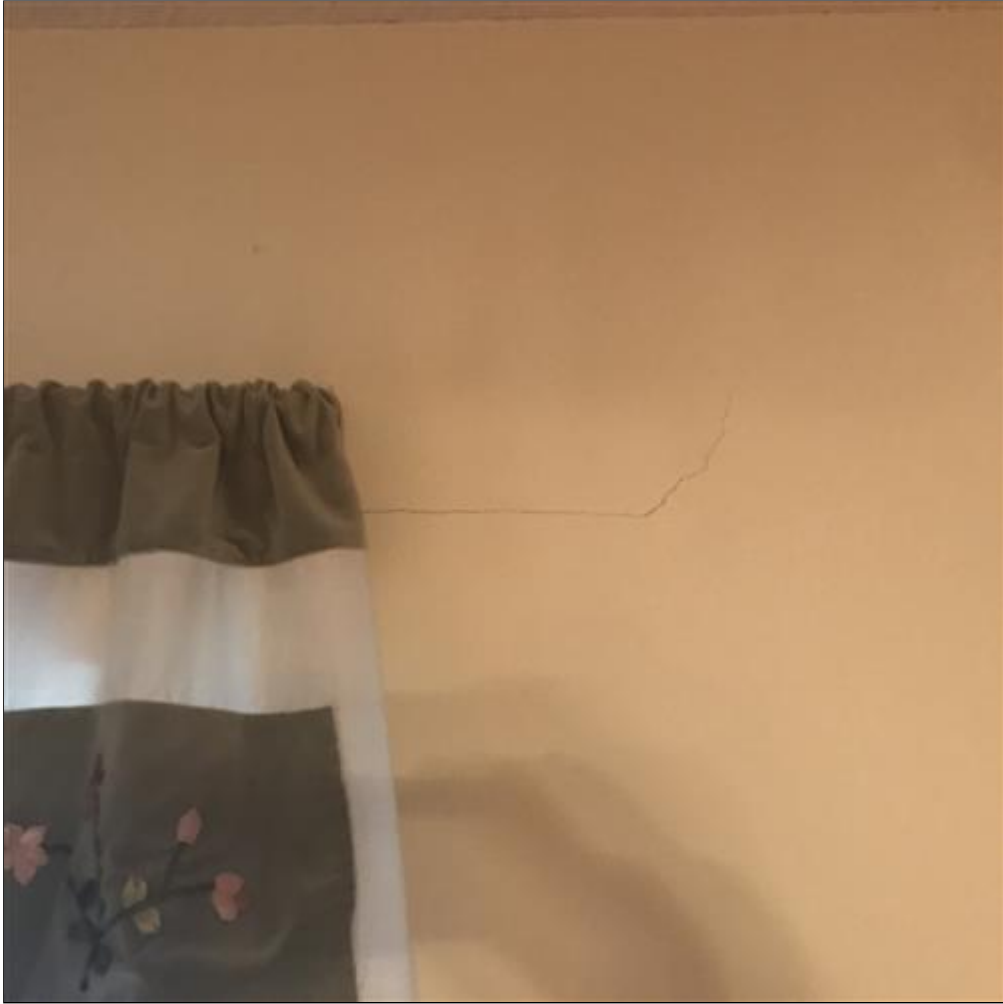
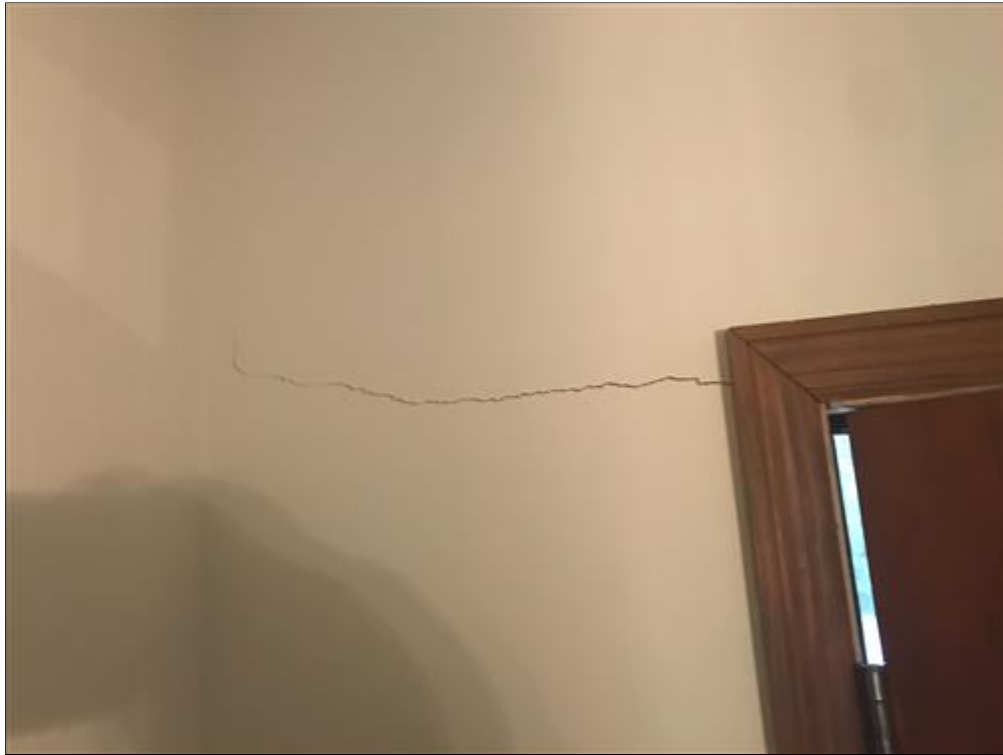
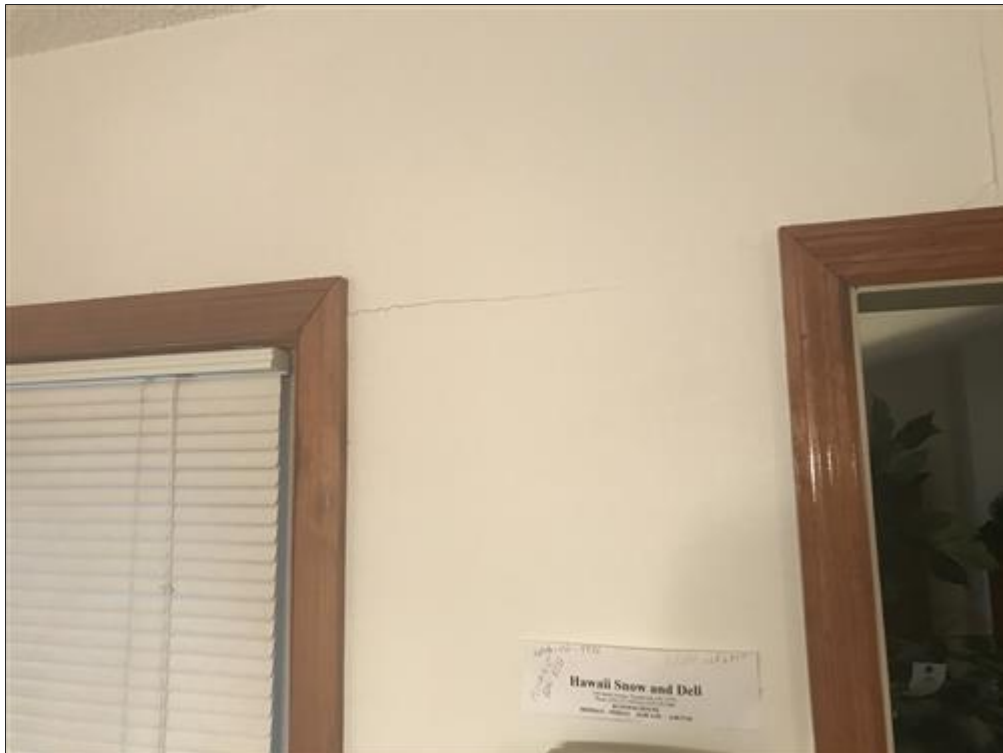
The sheetrock on the wall has several hairline cracks at the home due to settlement. . A qualified person should repair or replace as needed.

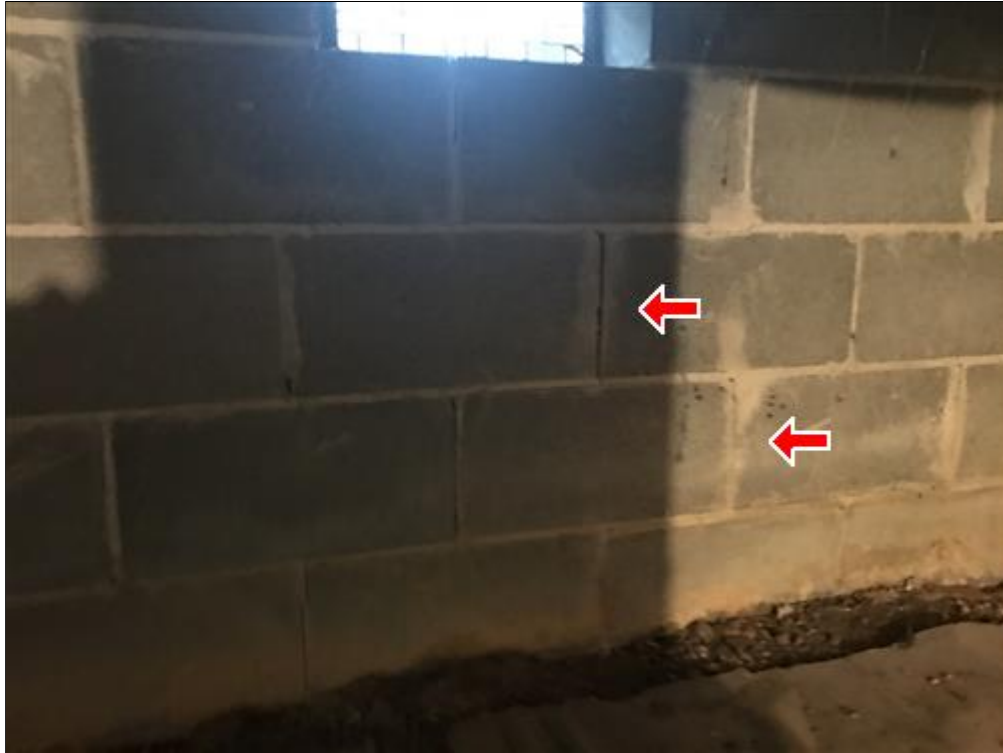
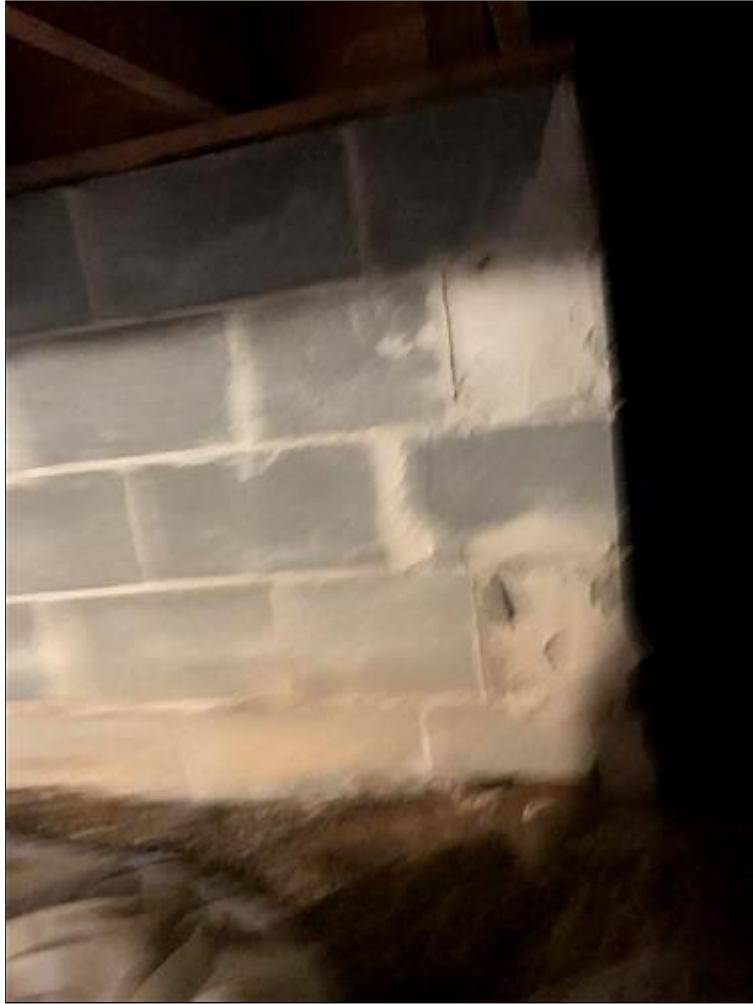
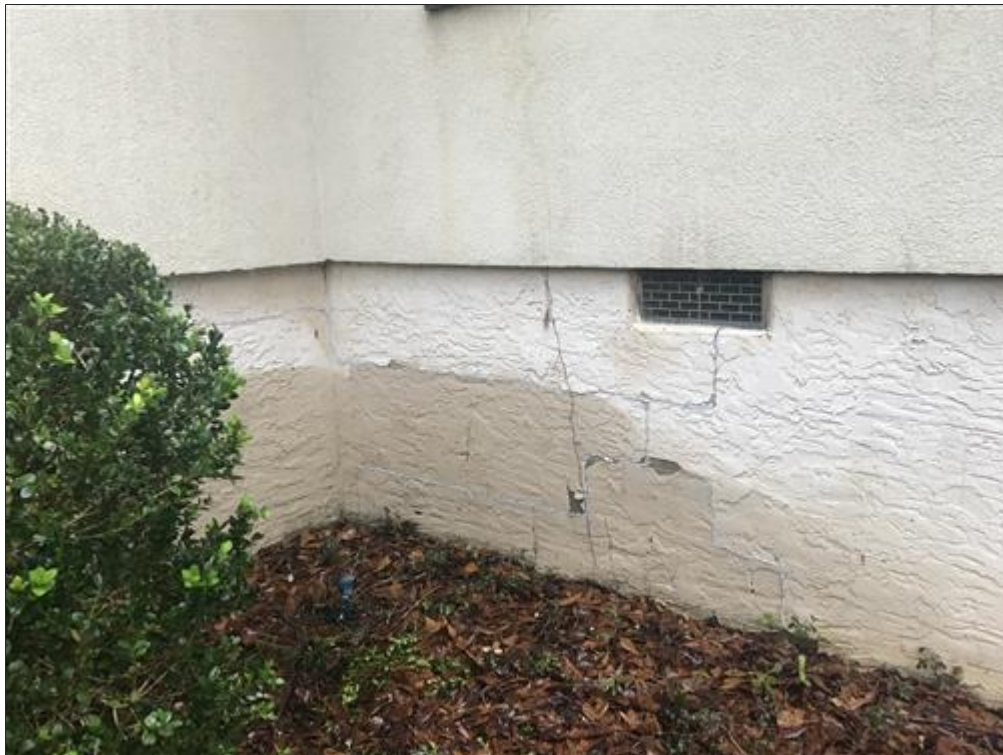
The structural crack(s) in the foundation wall at the front of home are due to settlement at these areas. The previous repair to wall does not appear adequate. A qualified licensed general contractor should inspect further and repair as needed.

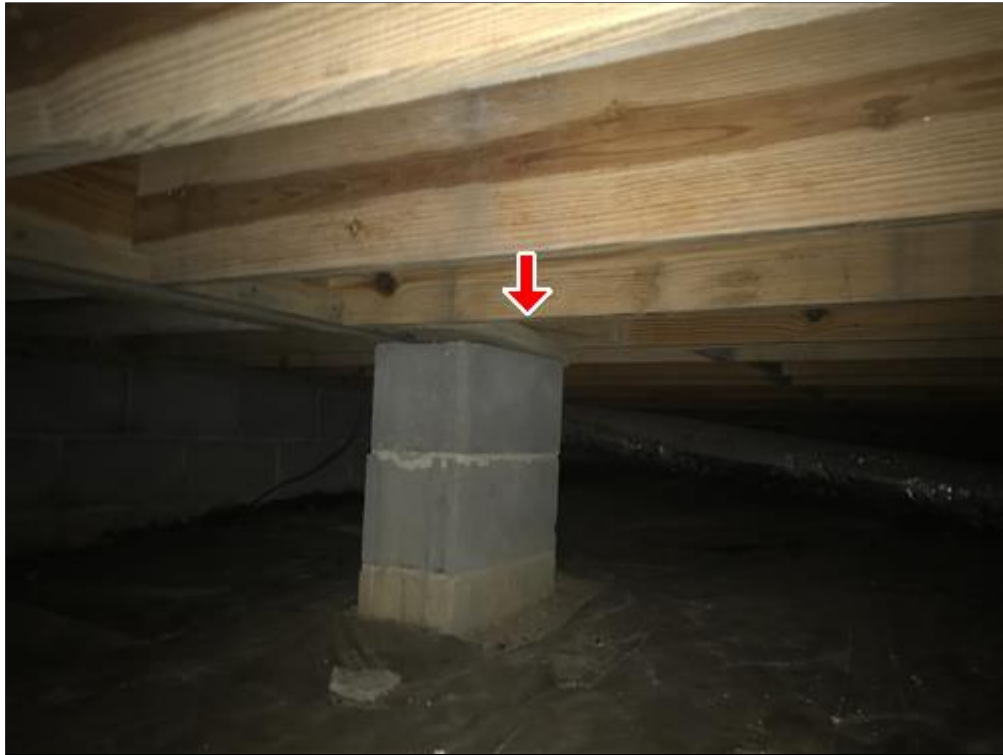
5.0 Picture 3 Wood cap loose
