Inspection Report

Property Address:

24361 GA Hwy 3
Ochlocknee Ga 31773

South Georgia Home Inspections

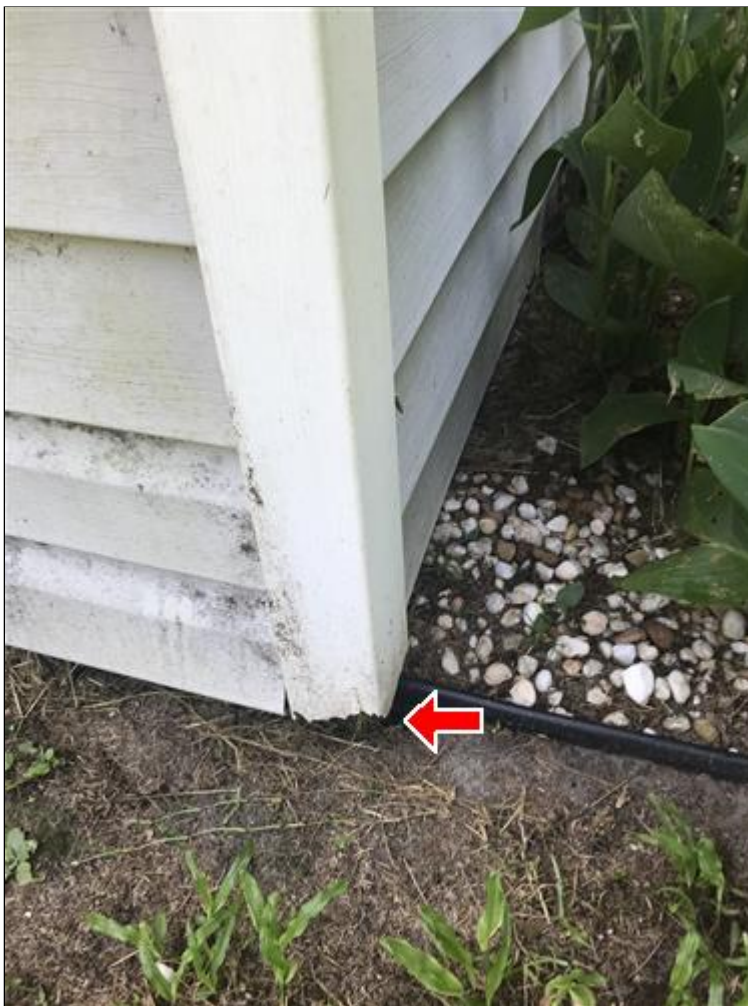
2.0 Picture 1

2.0 The Vinyl siding at the rear of home is damaged. .This is a small repair if desired.

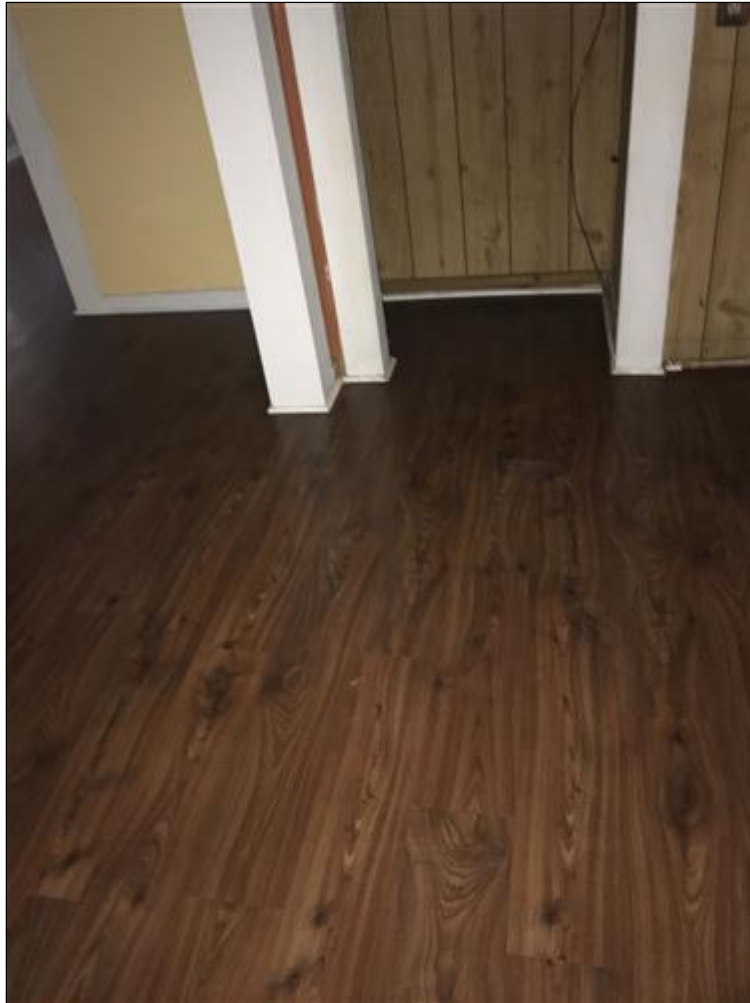
4.2 he laminated flooring is loose in areas, this is a cosmetic issue and for your information. I recommend repair as desired.

4.2 Picture 1 Floating floors.

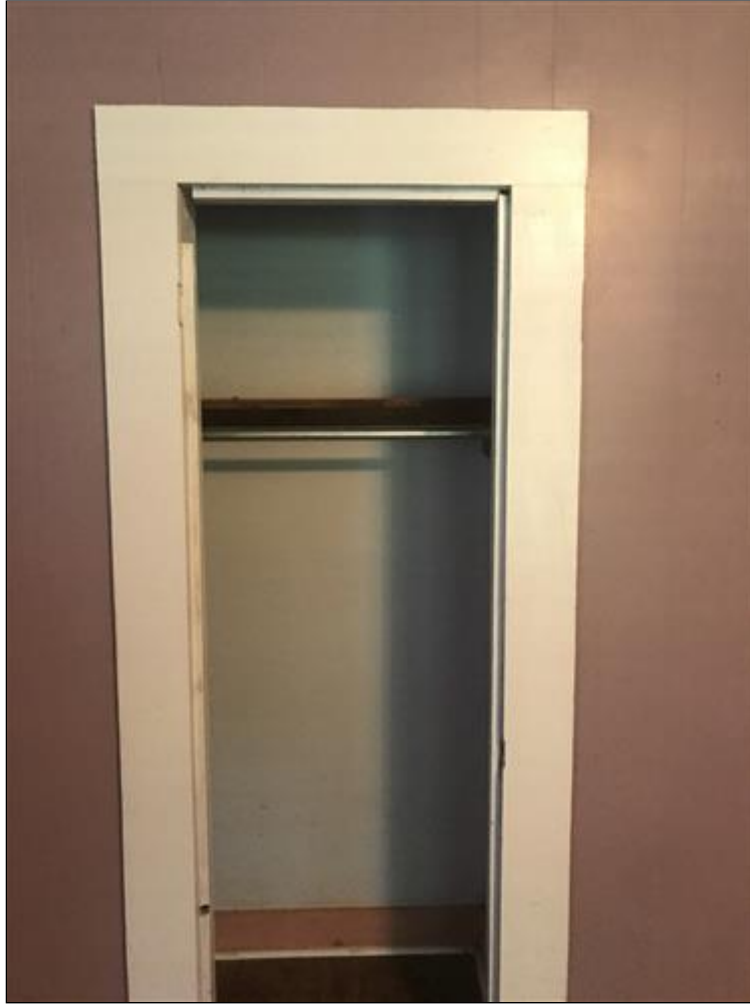
4.5 Picture 1

4.5 The Closet door is missing at the Bedroom. This is a maintenance issue and is for your information. .

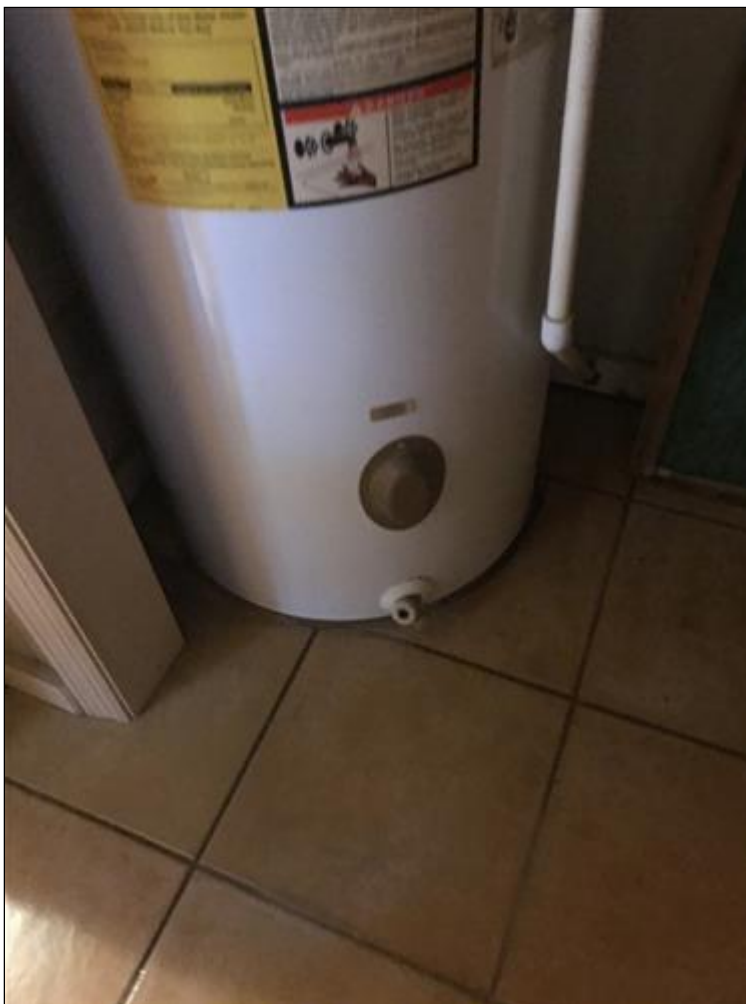
6.2 Picture 1

6.2 The hot water heater leaked at the time of the inspection. I recommend a qualified plumber further inspect and repair or replace as needed.

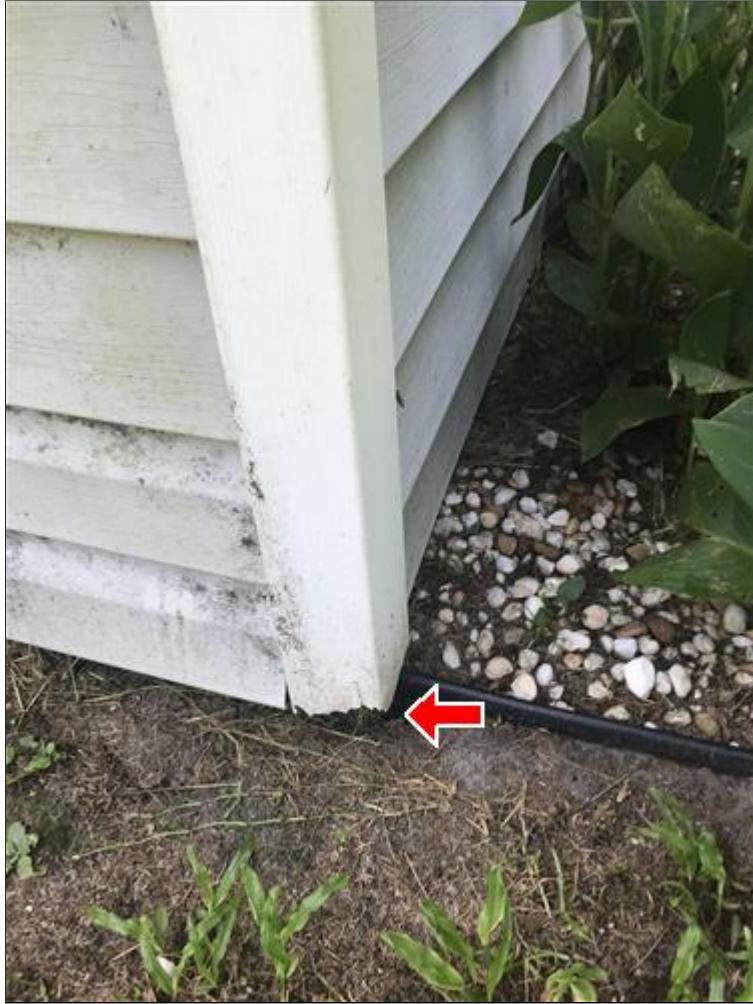
2.0 Picture 1

The Vinyl siding at the rear of home is damaged. .This is a small repair if desired.

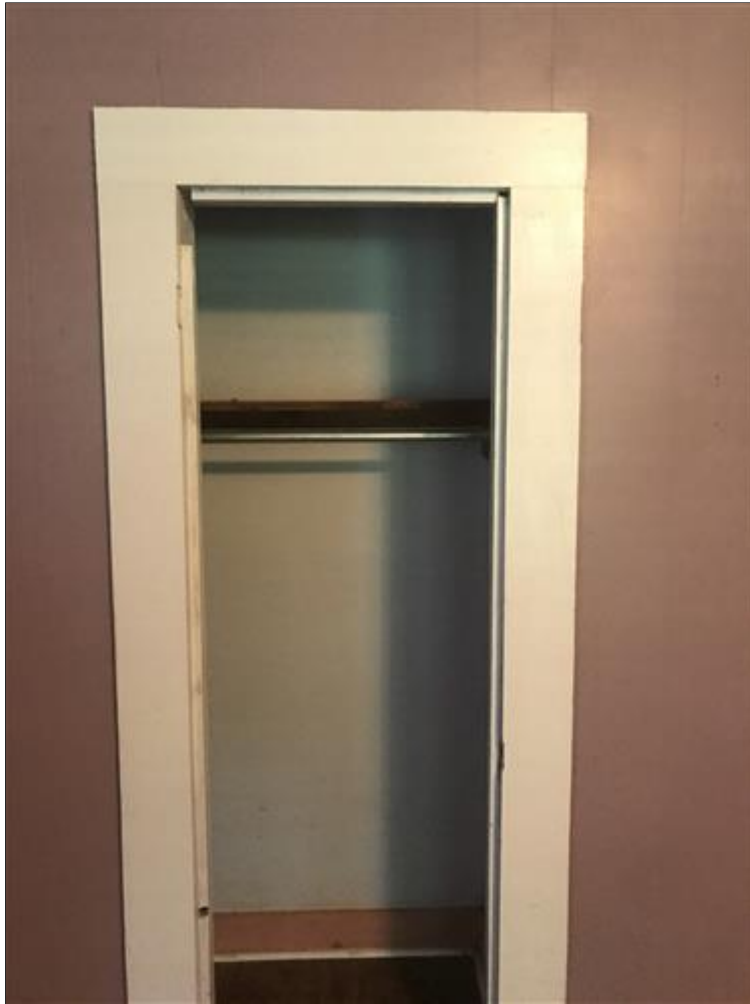
4.5 Picture 1

The Closet door is missing at the Bedroom. This is a maintenance issue and is for your information. .

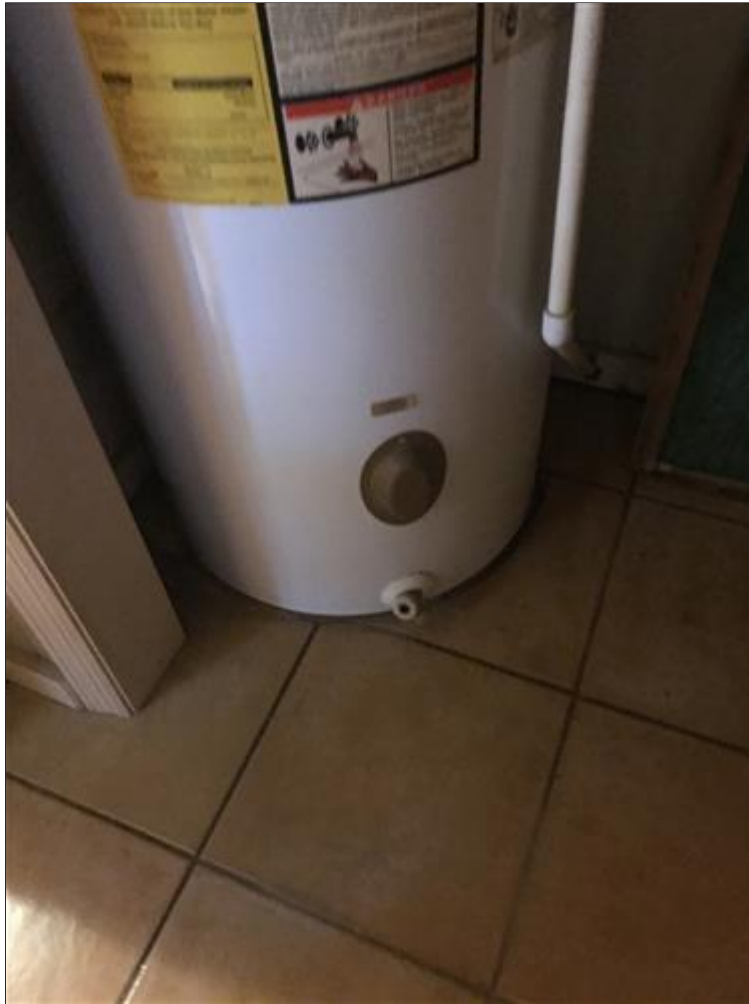
6.2 Picture 1

The hot water heater leaked at the time of the inspection. I recommend a qualified plumber further inspect and repair or replace as needed.
