Inspection Report

Property Address:
220 McRee Dr.
Camilla Ga 31730

South Georgia Home Inspections

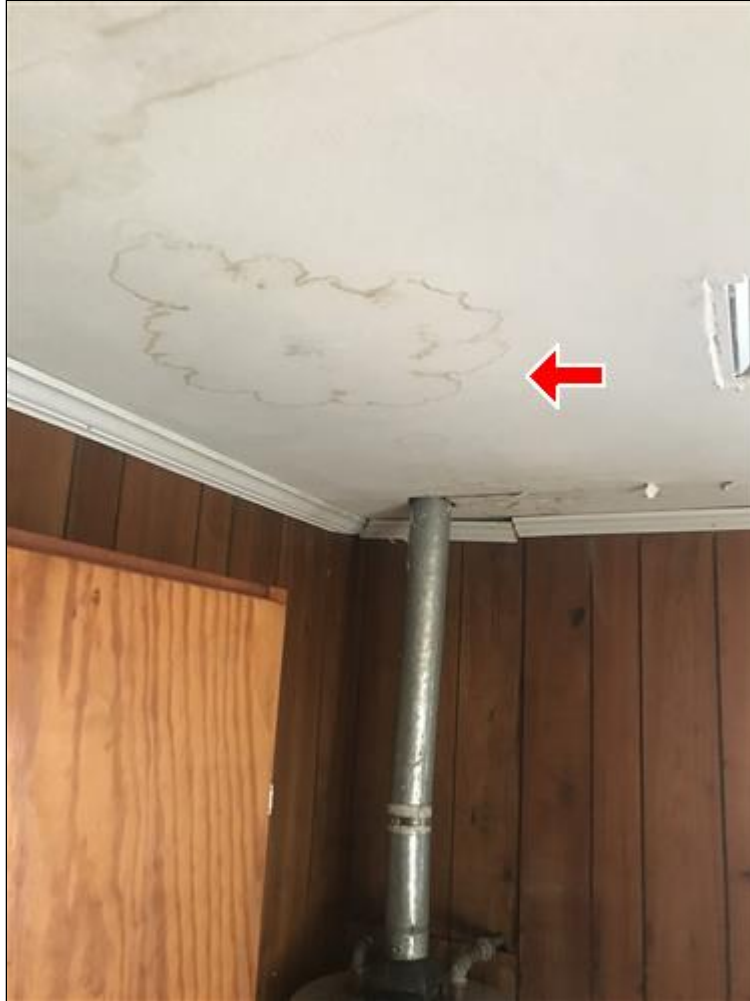
G. Picture 1

G. The Sheetrock on the ceiling reveals a light stain which appears from a water leak. Stain appears old at the Utility Room. This damage is considered cosmetic. A qualified person should repair or replace as needed.

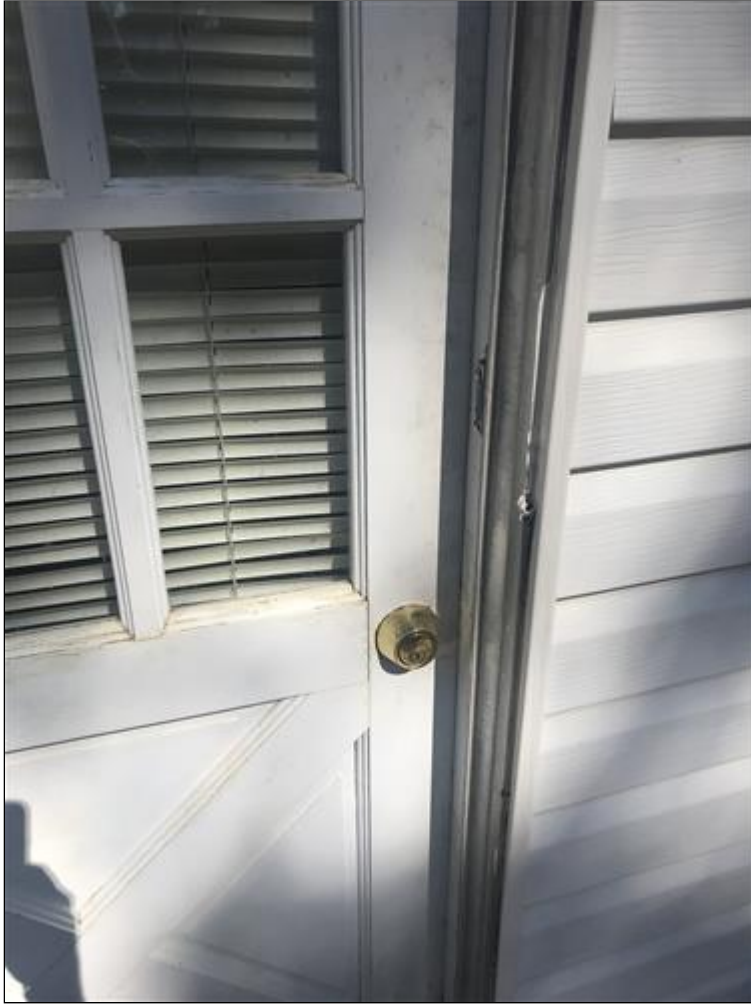
H. Picture 1

H. The Back door of the home does not have a door knob to open and close the door, this is for your information.

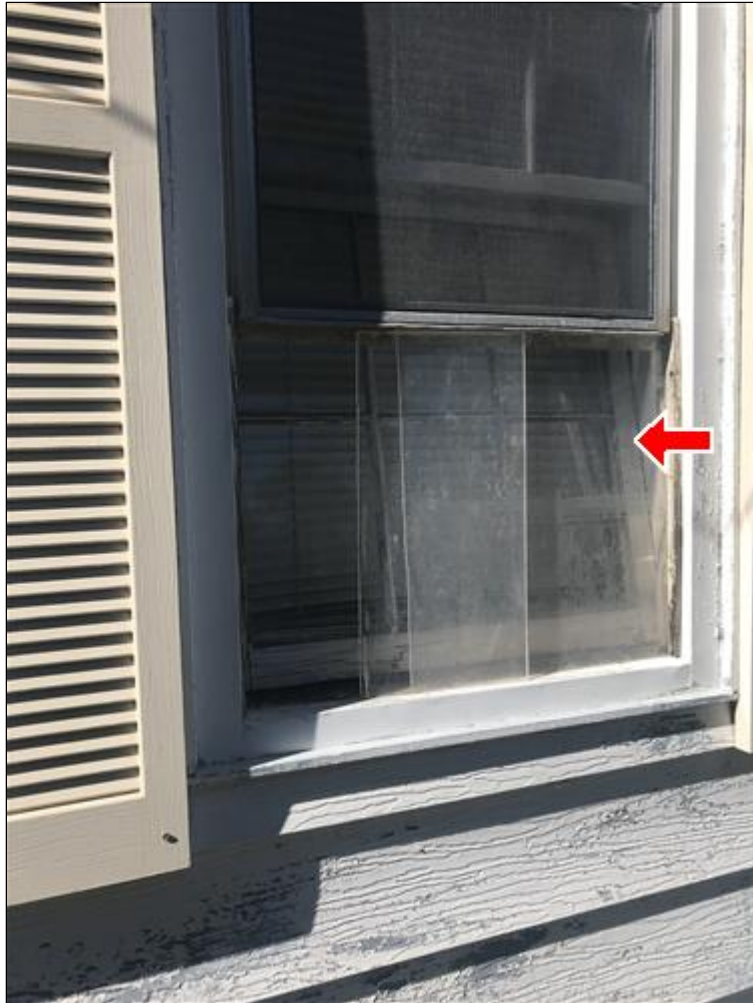
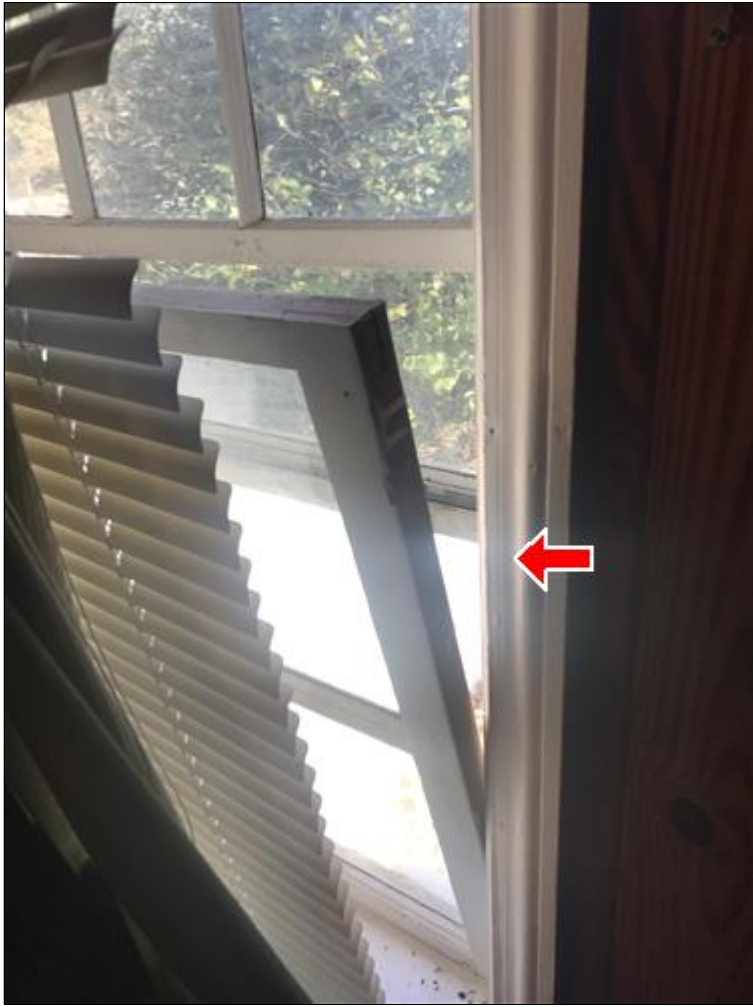
I. Picture 1

I. One window at the Guest Bedroom is damaged and loose from frame.. This is a small repair. I recommend repair as needed.

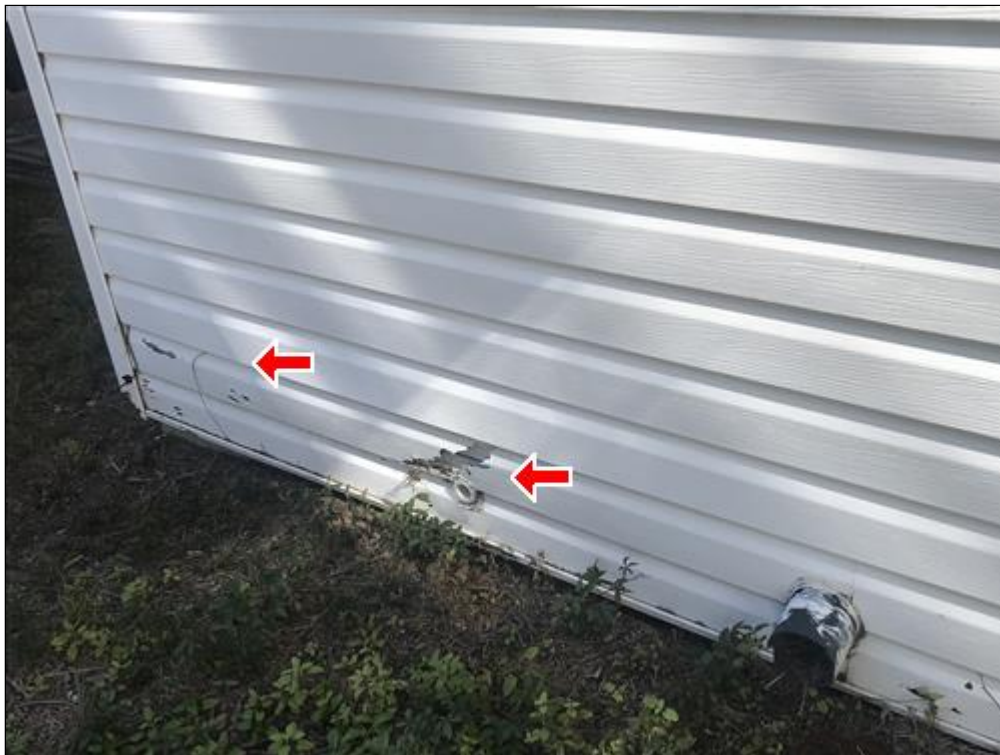
L. Picture 1

L. The vinyl siding is damaged at the right side facing front of the home, this is considered cosmetic damage. I recommend repair as desired.

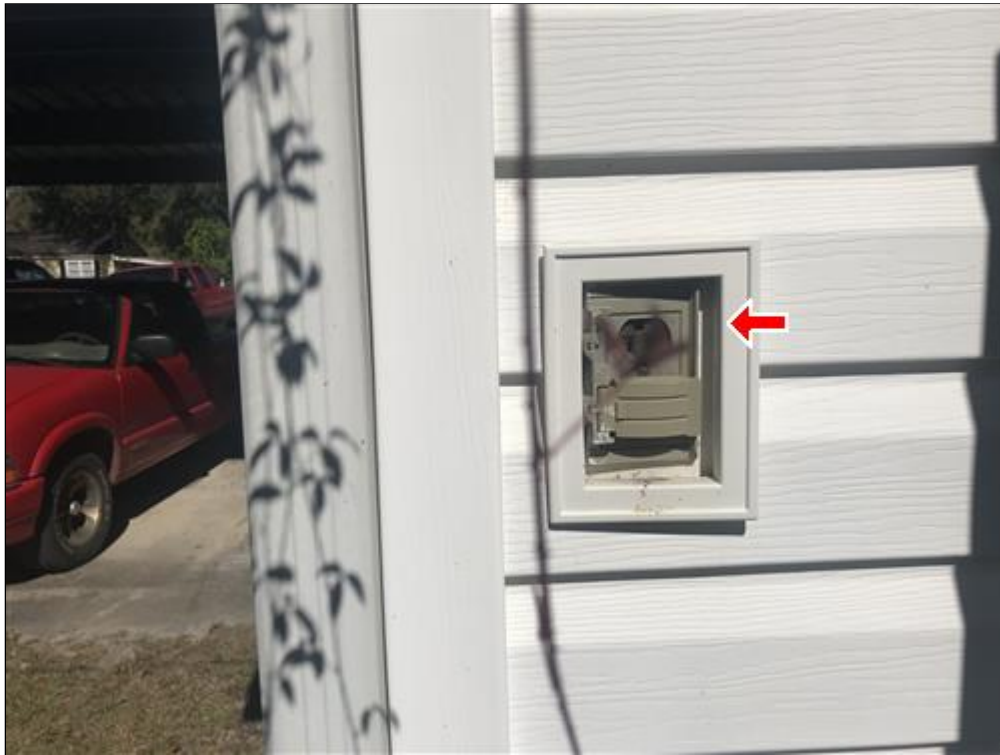
A. Picture 1

A. The exterior outlet at the rear entry is missing a cover. Electrical issues are considered a hazard until repaired. .

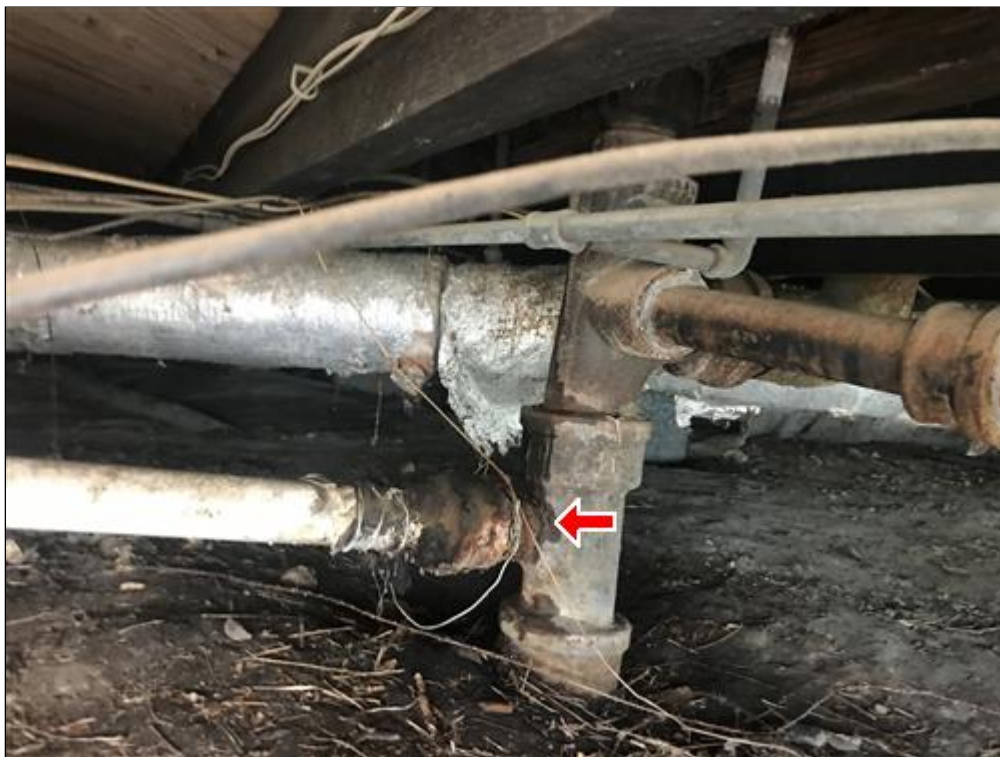
B. Picture 1

B. There is an small active leak at the Hall Bathroom waste line, I recommend a qualified plumber further *investigate*.

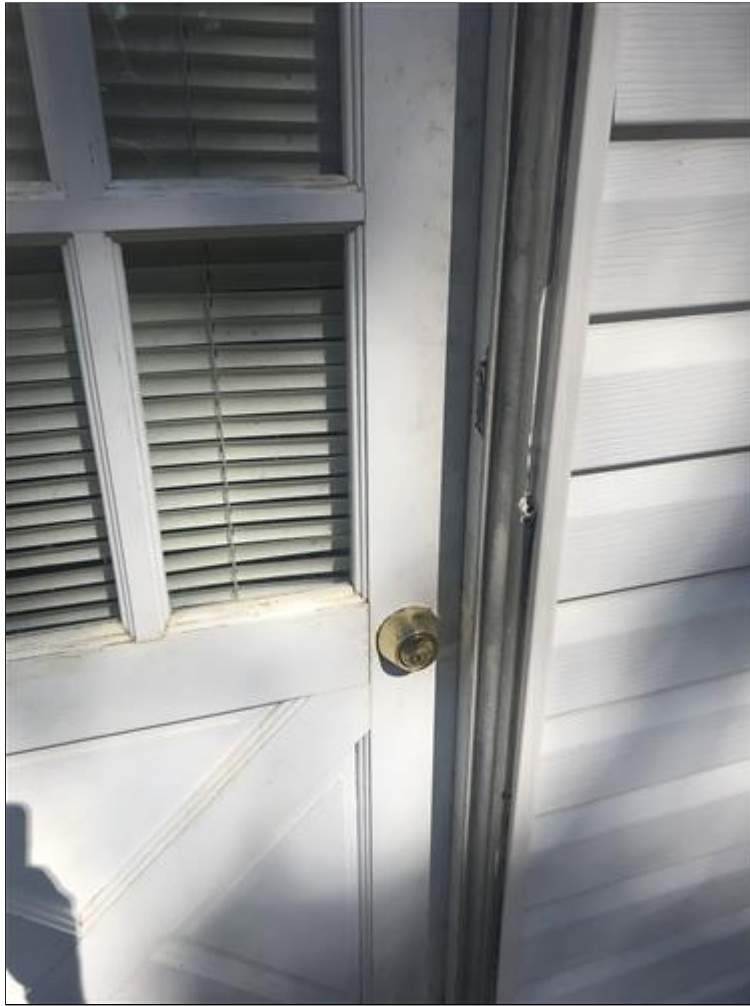
H. Picture 1

The Back door of the home does not have a door knob to open and close the door, this is for your information.

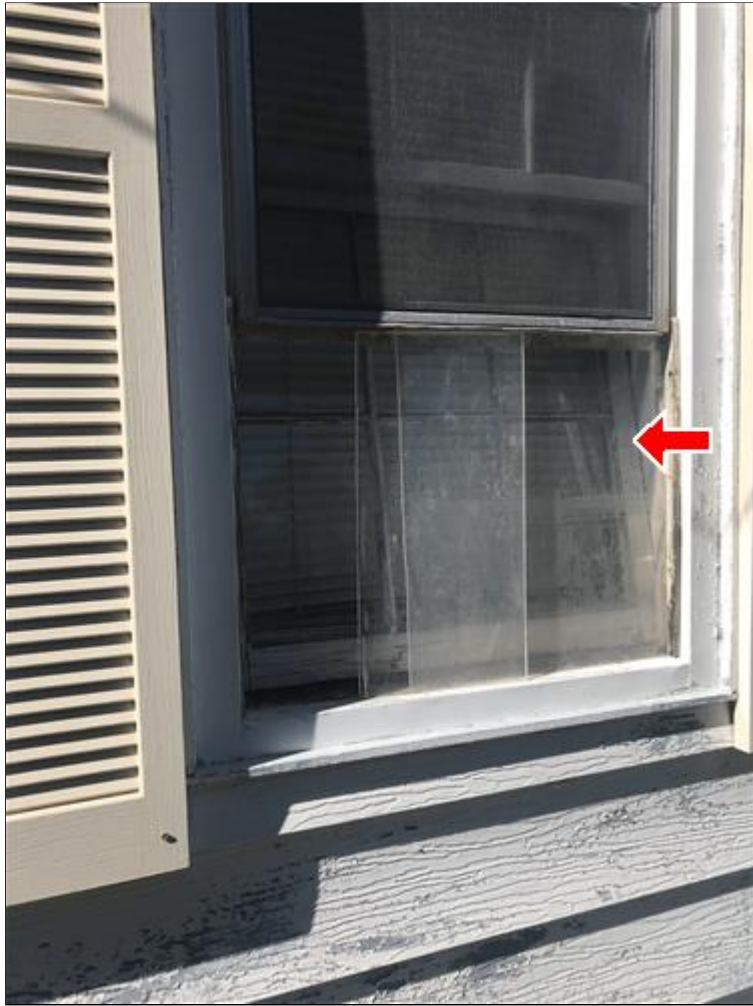
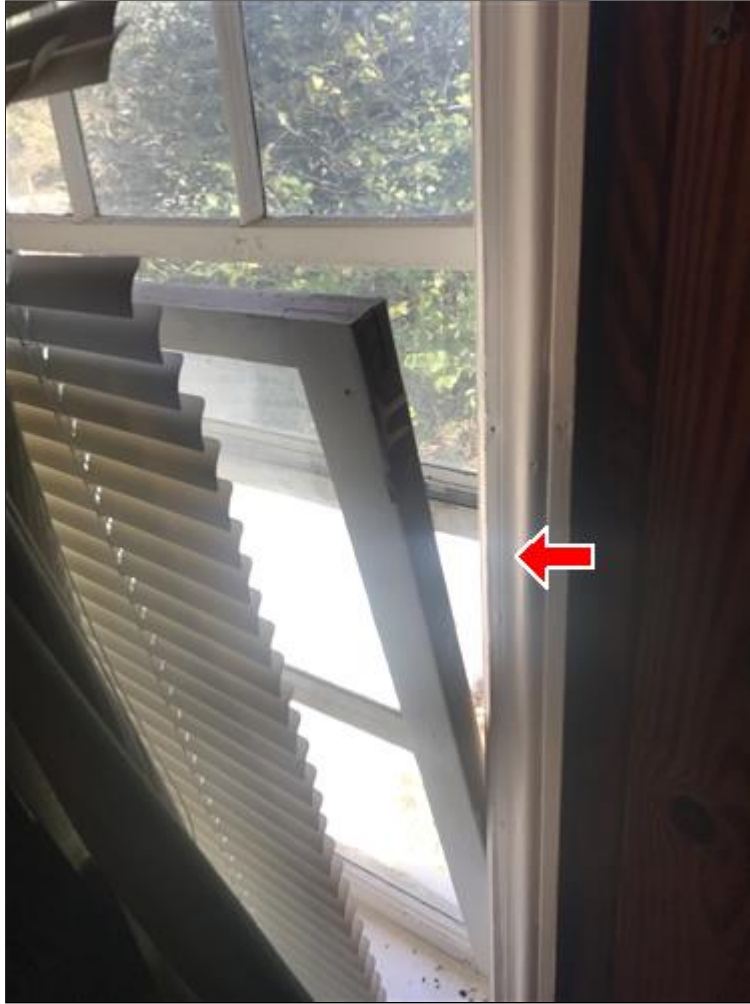
I. Picture 1

One window at the Guest Bedroom is damaged and loose from frame.. This is a small repair. I recommend repair as needed.
