Home Inspection Report

811 Nelchina St

Anchorage, AK 99501

Inspected on Mon, Jul 27 2020 at 12:30 PM

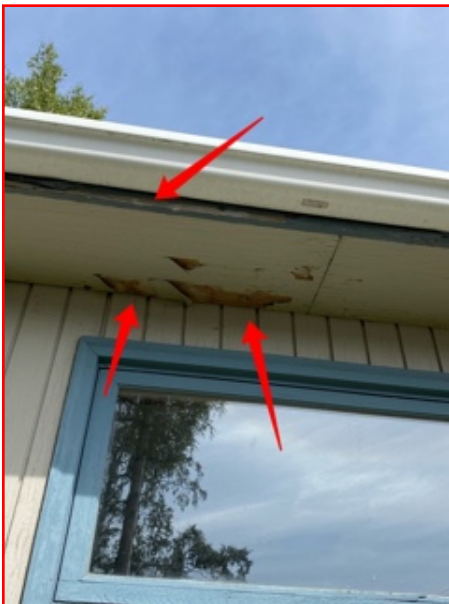
Figure 2-3

Several wood trim pieces rotted and the exterior of the house are weathered and missing paint. Recommend a qualified contractor assess and fix/repaint.

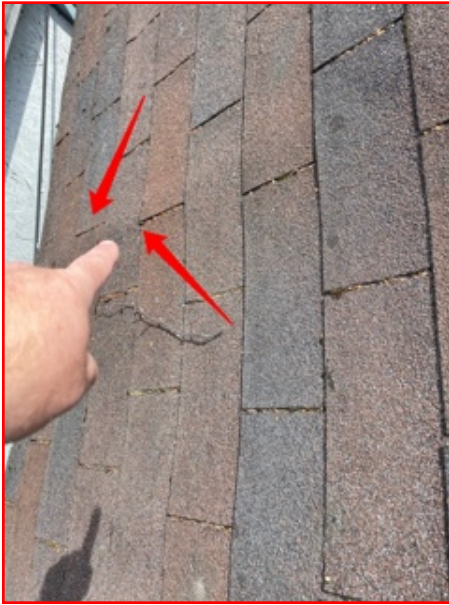
Figure 3-3

Several missing shingles, wind blown shingles, exposed sheathing, and nail heads visible. Several of the vent and flashing boots were cracked. Roof is near the end of its life. Recommend a qualified roofing contractor assess and re roof.

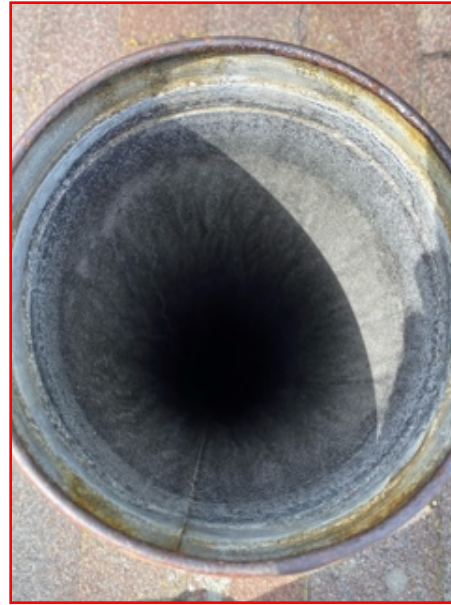
Figure 4-2

House heater furnaces rain cap is missing from the top of the flue. Recommend a qualified contractor install a rain cap at the top of the flue to keep the elements out of the flue and furnace.

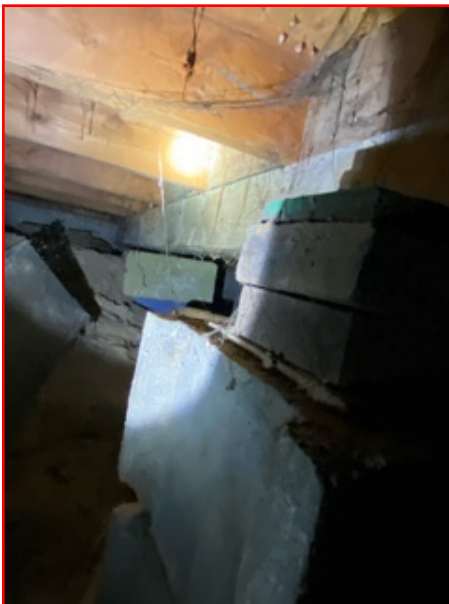
Figure 5-3

The concrete block (piers) aren't mortared together (dry stacked). They were loosely stacked under the girder main support beams under the house. Also, the block should be separated from the wood shim with a thin piece of metal and the girder support beam should be connected (strapped or nailed) to the floor joist. Could not verify that the blocks were built on an actual footer (concrete pad). Recommend a qualified structural contractor assess the concrete block piers, missing metal separation, missing tie points (strapping between girder and joist and footing).

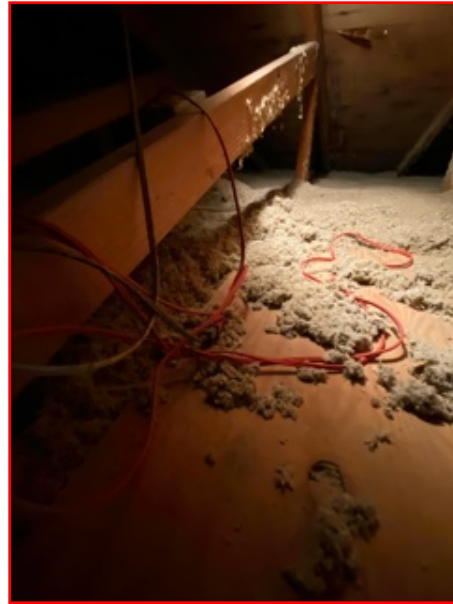
Figure 7-2

Extension cords used for lighting in the attic. This is unsafe and not permitted. Junction boxes with permanent wiring are permitted according to the NEC. Recommend a qualified electrical contractor assess and fix/repair.

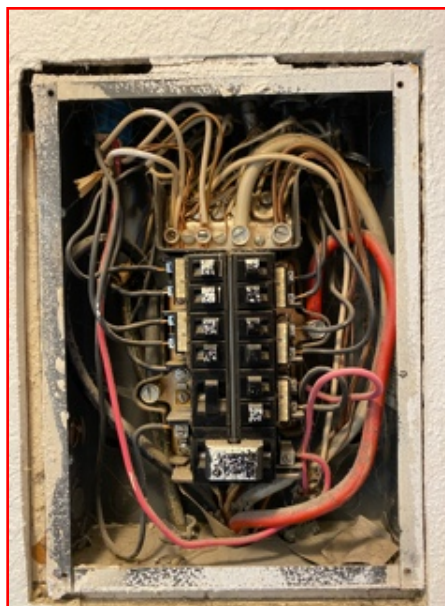
Figure 10-2

Dead front (front cover) was off the main service distribution panel and laying on the ground. This is unsafe and can a shock hazard. Recommend a qualified electrical contractor install the dead front cover back on with the appropriate flat backed screws.

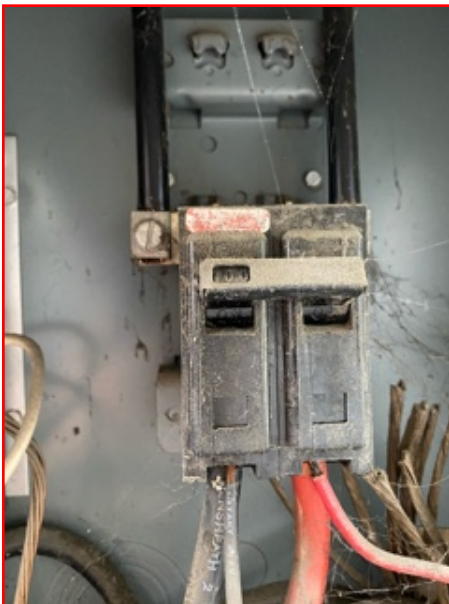
Figure 12-3

The metered service disconnect is missing the dead front (inside cover over the 100 amp breaker) cover. This poses a shock hazard and should be replaced. Recommend a qualified electrical contractor assess and replace the dead front on the metered service disconnect.

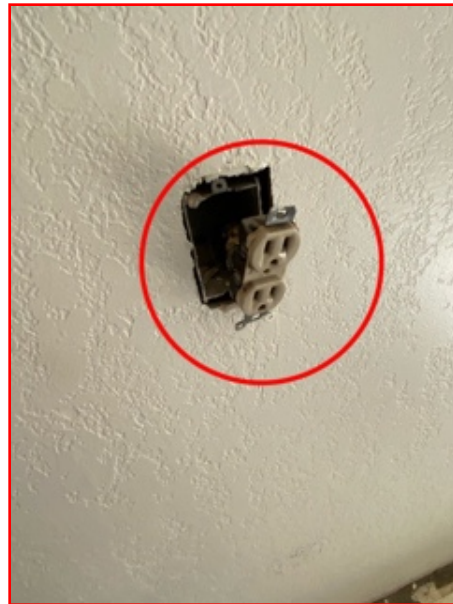
Figure 13-2

Several outlet and switch plates were missing through out the house . Recommend replacing outlet plates to keep from getting electrocuted.

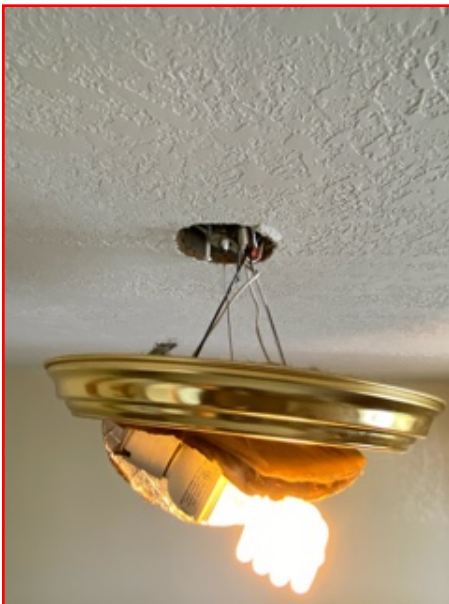
Figure 14-3

Several outlets in the living room/dining room are improperly wired and have open grounds. Also, the light in the front bedroom is hanging by the conductors and not properly supported by a box. Recommend a qualified electrical contractor assess and repair open grounds and install a light box for the front bedroom lights.

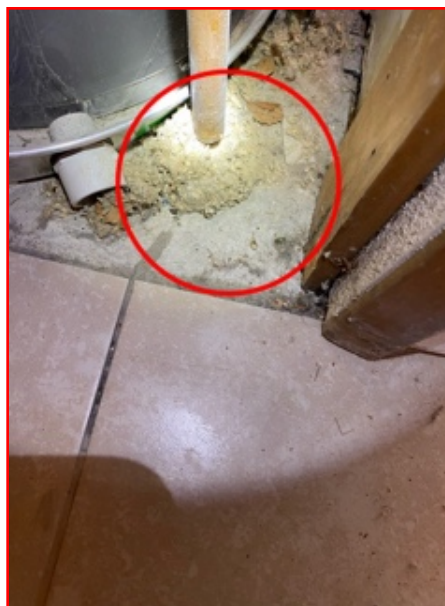
Figure 17-2

T & P valve with blow off Leg present for water heater. Water heater has a drain pan but the T&P valve blow off leg doesn't empty into pan. Also, the pan has no tube to drain into a suitable receptacle. The water heater can over flow onto the subfloor. Recommend a qualified contractor correct blow off leg to empty into drain pan and install drain pipe to a suitable receptacle or drain to the exterior between 6" - 24" above grade.

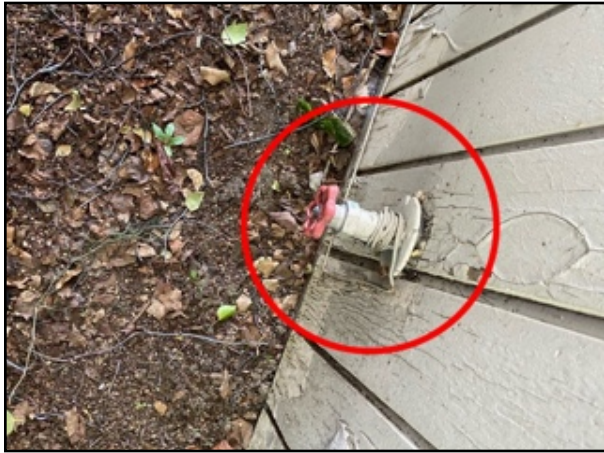
Figure 1-1

The hose bib (faucet) on the Northern side of the house is not anti-siphon hose bib. Also, the copper plumbing to the hose bib is not connected in the crawlspace. Recommend a qualified contractor replace hose bib with an anti-siphon/freeze proof hose bib to be muni code compliant and repair the copper piping to the hose bib in the crawlspace.

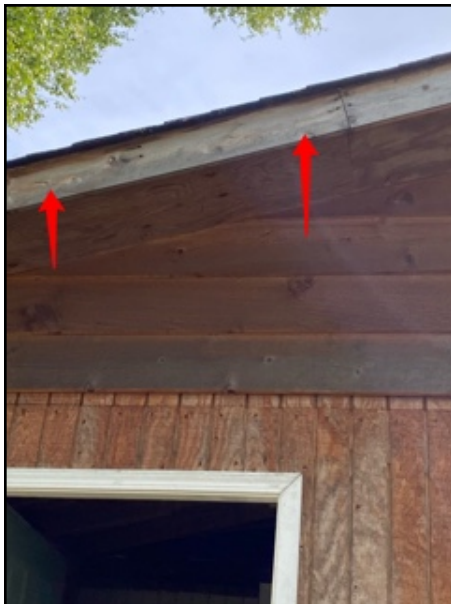
Figure 2-1

Several wood trim pieces rotted and the exterior of the house are weathered and missing paint. Recommend a qualified contractor assess and fix/repaint.

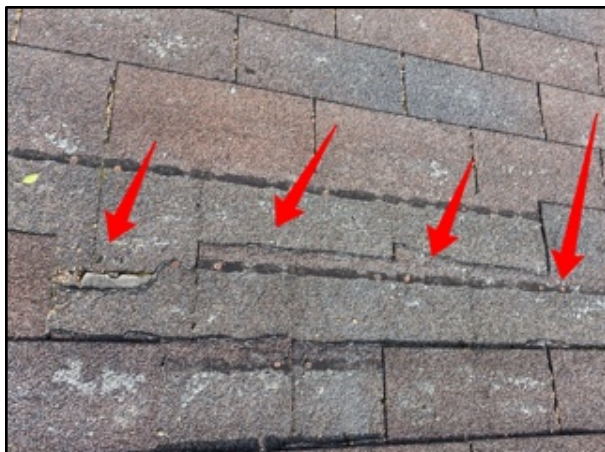
Figure 3-1

Several missing shingles, wind blown shingles, exposed sheathing, and nail heads visible. Several of the vent and flashing boots were cracked. Roof is near the end of its life. Recommend a qualified roofing contractor assess and re roof.

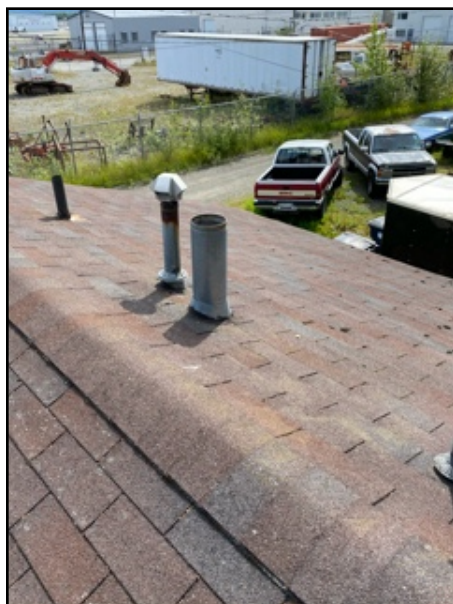
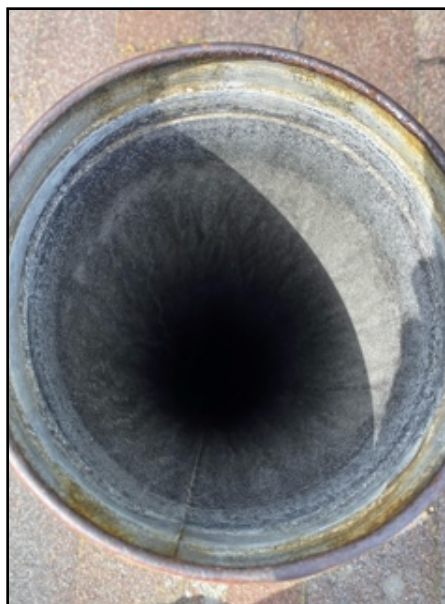
Comment 4:
Repair

House heater furnaces rain cap is missing from the top of the flue. Recommend a qualified contractor install a rain cap at the top of the flue to keep the elements out of the flue and furnace.

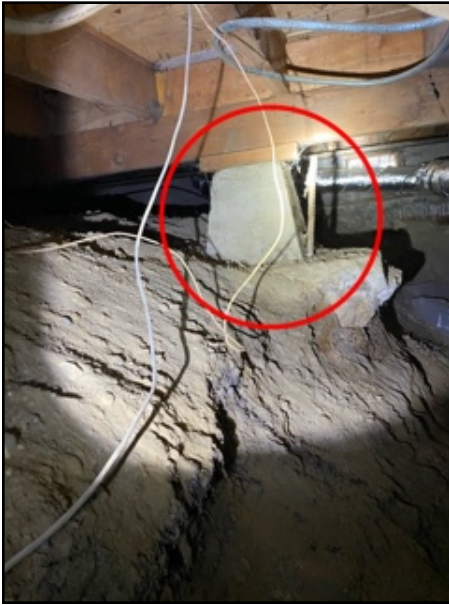
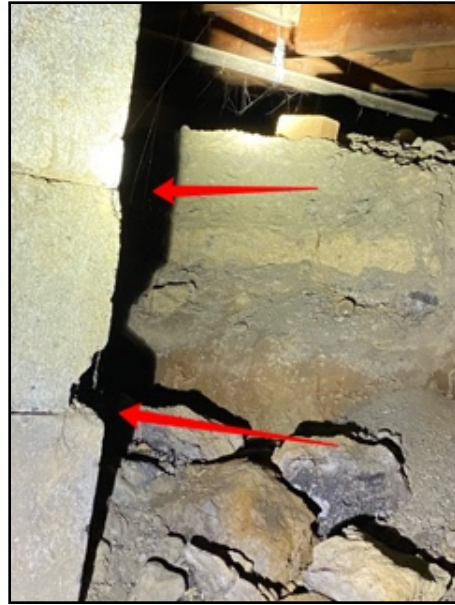
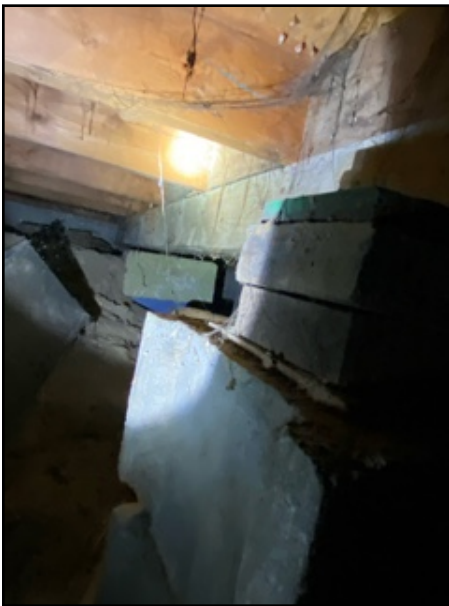
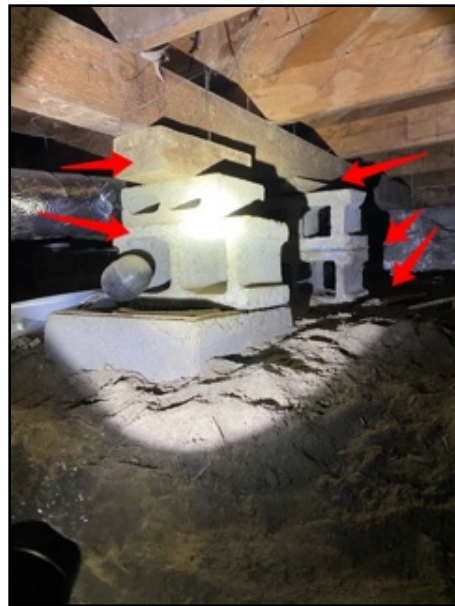
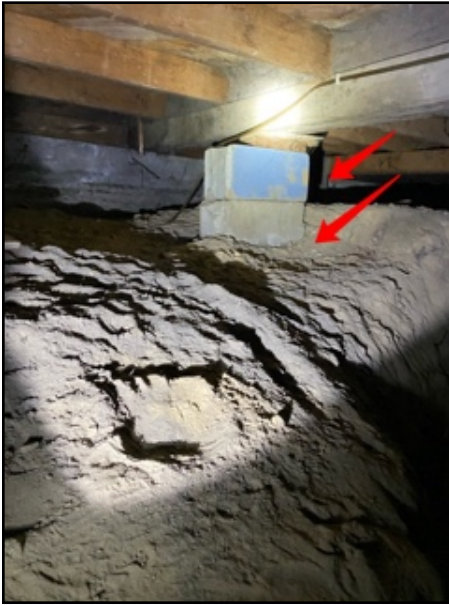
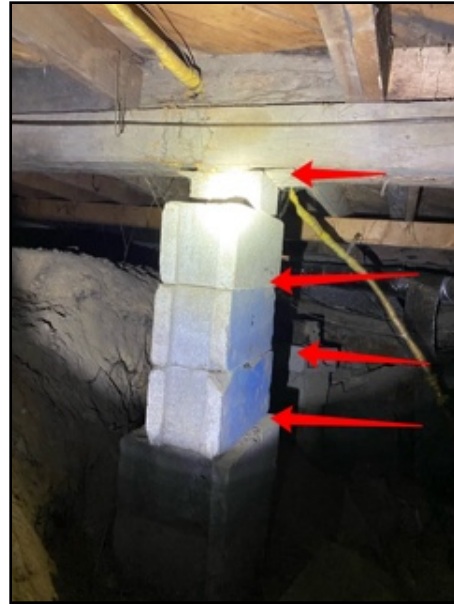
The concrete block (piers) aren't mortared together (dry stacked). They were loosely stacked under the girder main support beams under the house. Also, the block should be separated from the wood shim with a thin piece of metal and the girder support beam should be connected (strapped or nailed) to the floor joist. Could not verify that the blocks were built on an actual footer (concrete pad). Recommend a qualified structural contractor assess the concrete block piers, missing metal separation, missing tie points (strapping between girder and joist and footing).

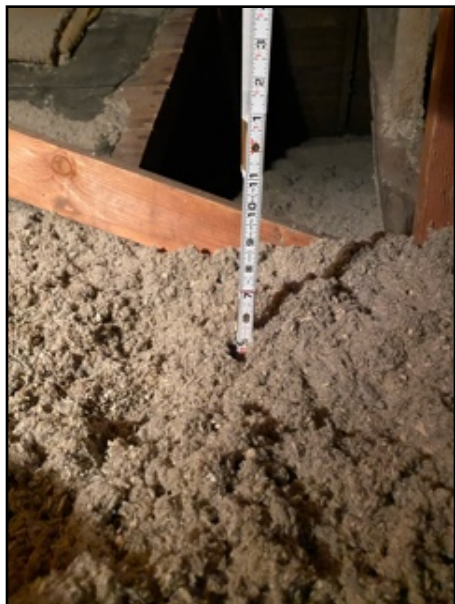
Figure 6-1

Comment 6:
Repair

There were 6"-8" of blown in cellulose in the attic for an R value for around R21-R30. Recommend putting up to 16" in for a rating of R 50-R60 for this region.

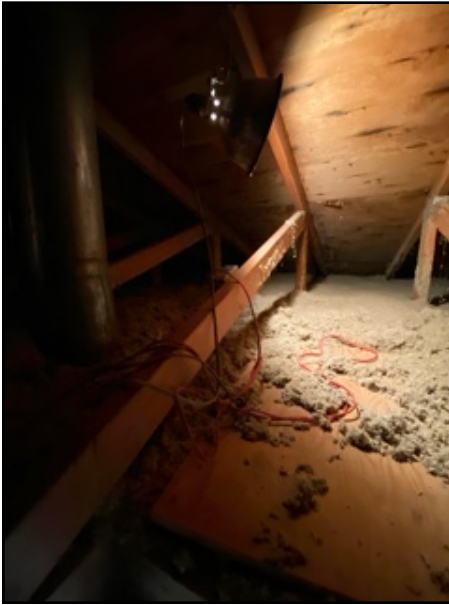
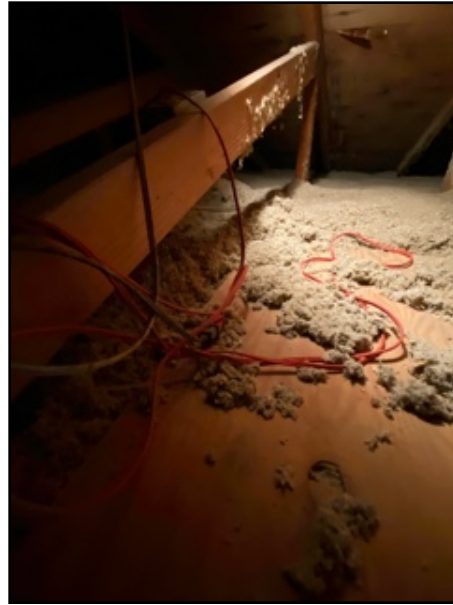
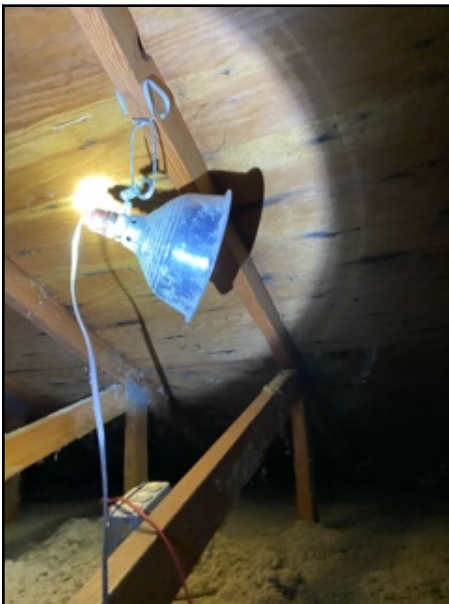
Extension cords used for lighting in the attic. This is unsafe and not permitted. Junction boxes with permanent wiring are permitted according to the NEC. Recommend a qualified electrical contractor assess and fix/repair.

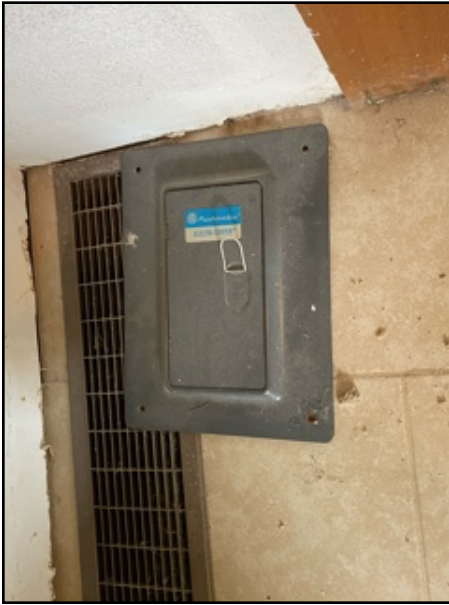
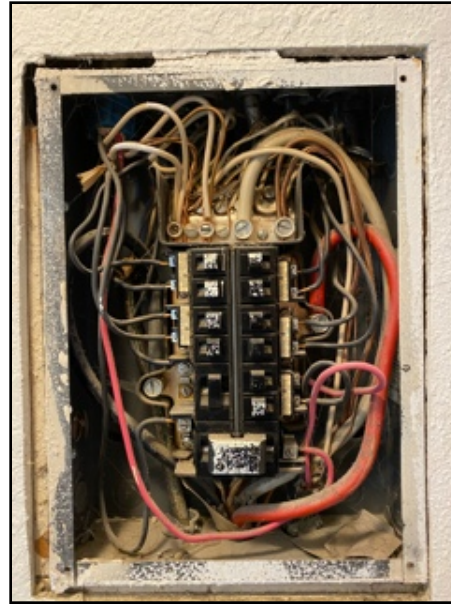
Dead front (front cover) was off the main service distribution panel and laying on the ground. This is unsafe and can a shock hazard. Recommend a qualified electrical contractor install the dead front cover back on with the appropriate flat backed screws.

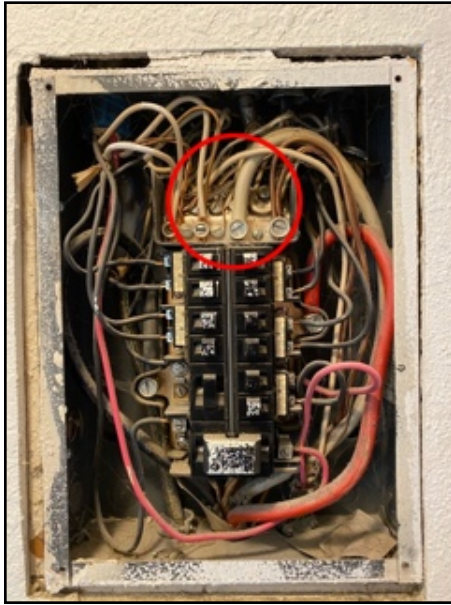
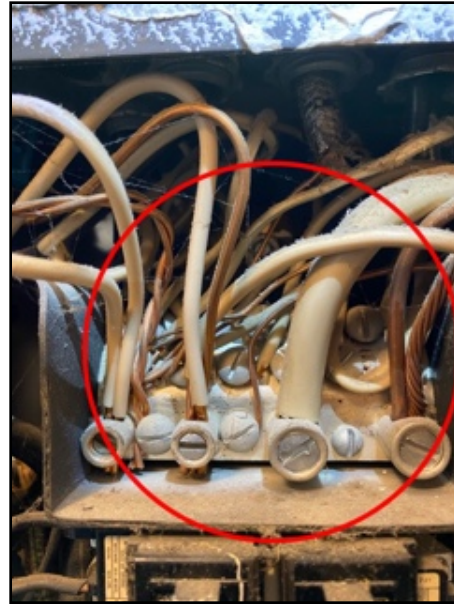
The service panel is a pushmatic and is very old. They have neutrals and grounds together and need to be separated on their own bus bars. Recommend a qualified electrical contractor assess and repair or replace service panel with updated version.

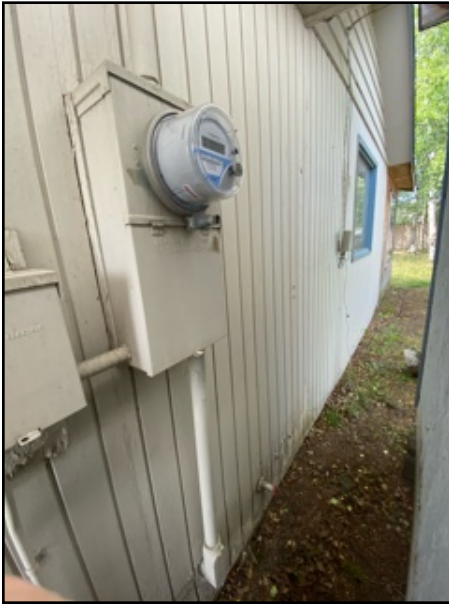
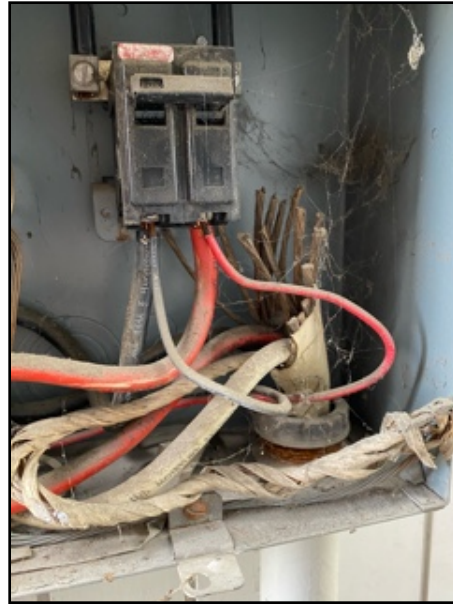
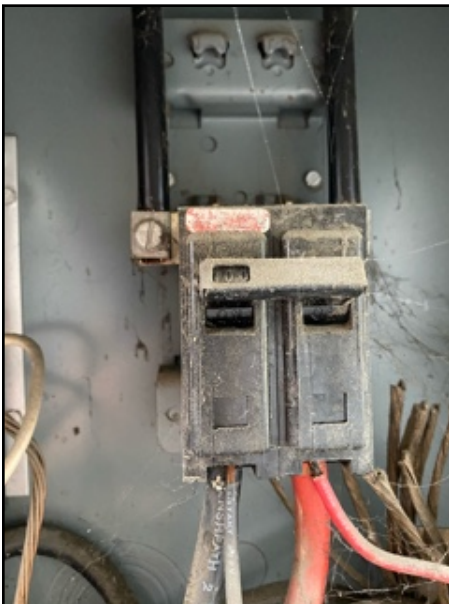
The metered service disconnect is missing the dead front (inside cover over the 100 amp breaker) cover. This poses a shock hazard and should be replaced. Recommend a qualified electrical contractor asses and replace the dead front on the metered service disconnect.

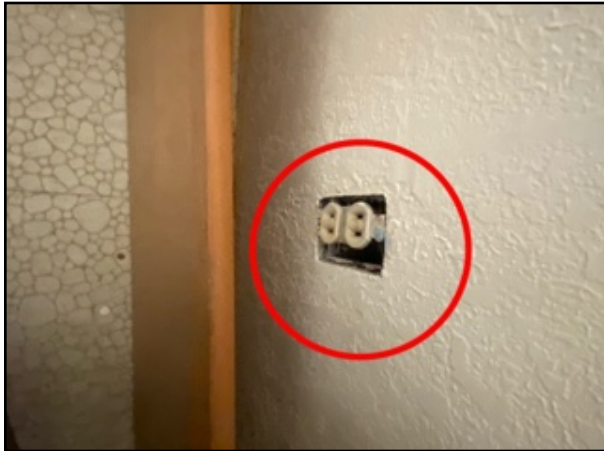
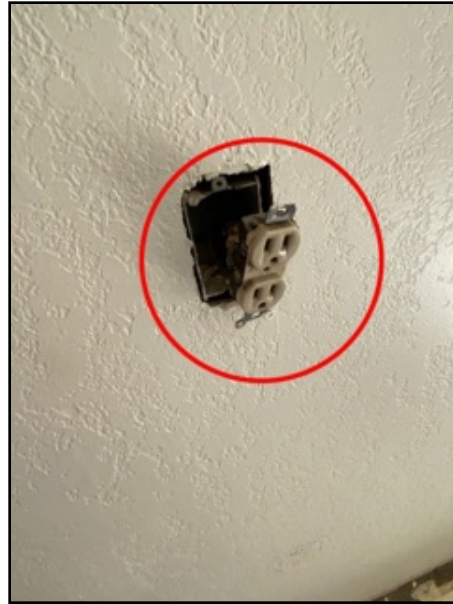
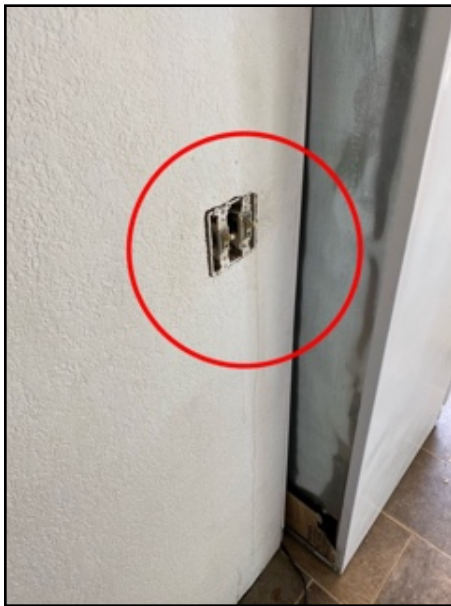
**Comment 13:
Health and Safety**

Several outlet and switch plates were missing through out the house . Recommend replacing outlet plates to keep from getting electrocuted.

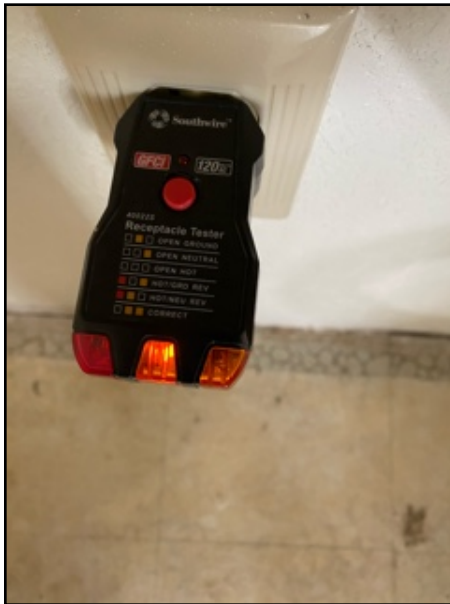
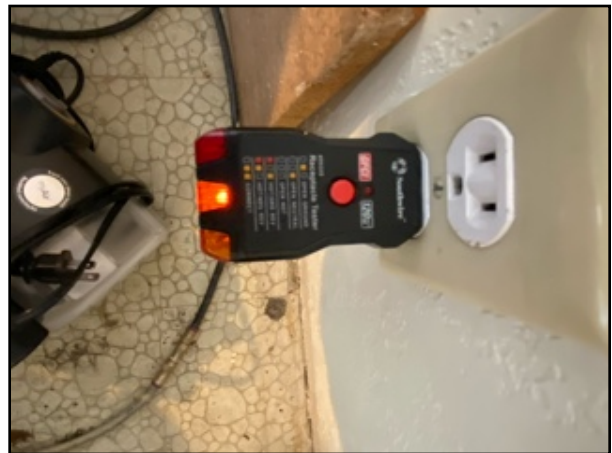
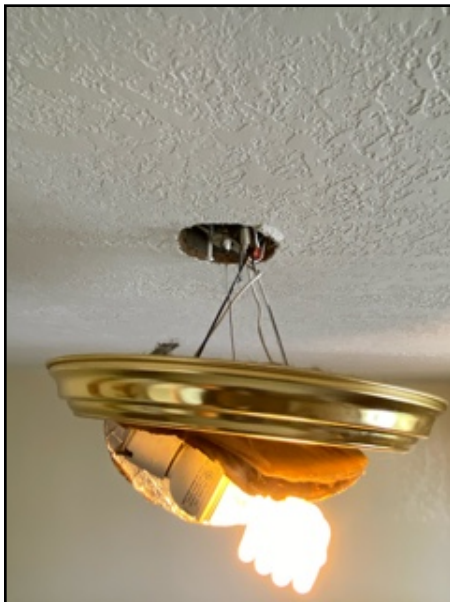
**Comment 14:
Health and Safety**

Several outlets in the living room/dining room are improperly wired and have open grounds. Also, the light in the front bedroom is hanging by the conductors and not properly se ured by a box. Recommend a qualified electrical contractor asses and repair open grounds and install a light box for the front bedroom lights.

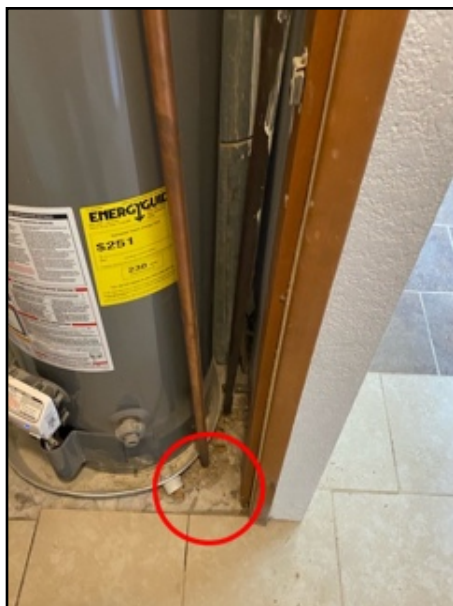
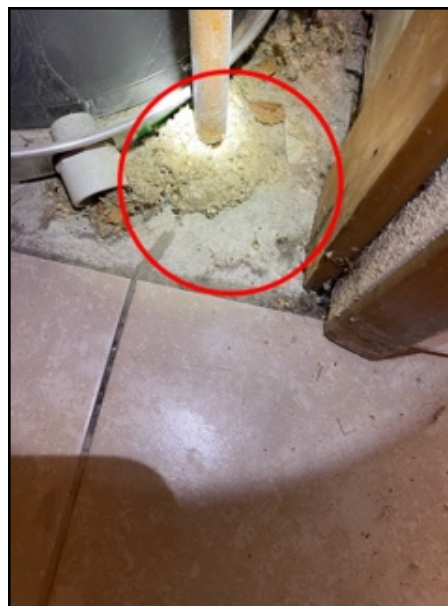
T & P valve with blow off Leg present for water heater. Water heater has a drain pan but the T&P valve blow off leg doesn't empty into pan. Also, the pan has no tube to drain into a suitable receptacle. The water heater can over flow onto the subfloor. Recommend a qualified contractor correct blow off leg to empty into drain pan and install drain pipe to a suitable receptacle or drain to the exterior between 6" - 24" above grade.

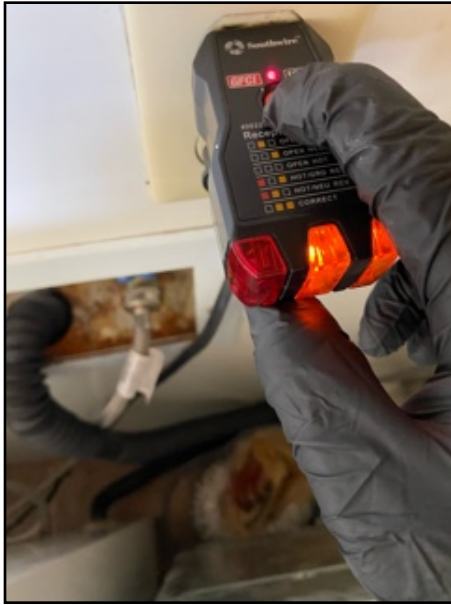
Figure 18-1

Regular outlet in laundry room for washer. Recommend replacing regular outlet with a GFCI outlet or install a GFCI breaker on that circuit to be GFCI protected.

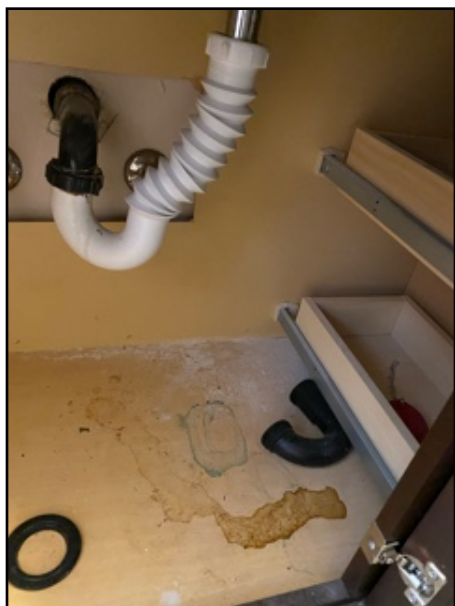
Figure 19-1

Bathroom sink has an unapproved corrugated waste pipe that can cause clogs. Suggest replacing with a smooth approved waste pipe.

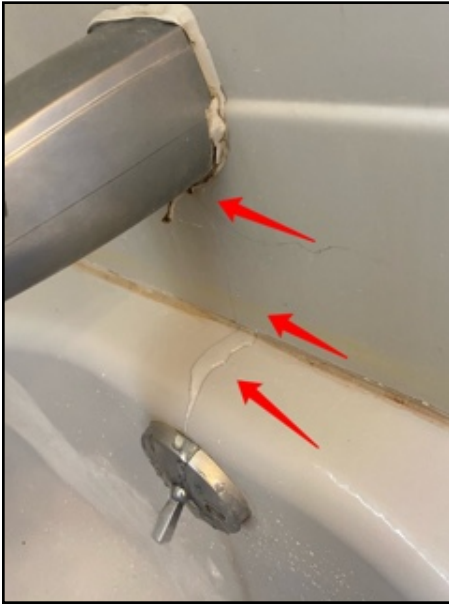
Figure 21-1

Tub faucet is leaking at the connection point. Possible water intrusion behind the vinyl tub surround. Recommend a qualified contractor assess and repair/replace.

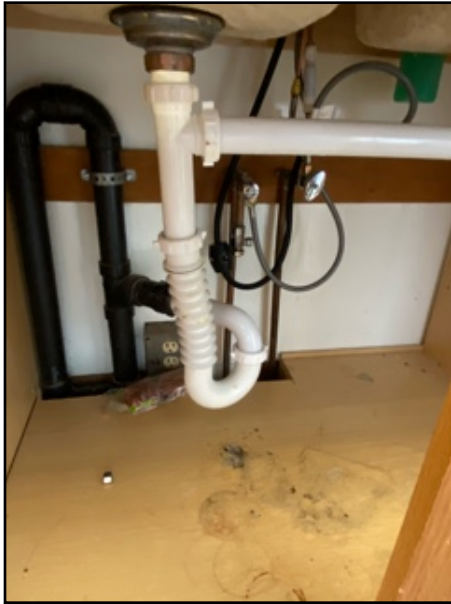
Figure 22-1

Kitchen sink has an unapproved corrugated waste pipe that can cause clogs. Recommend replacing with a smooth approved waste pipe.

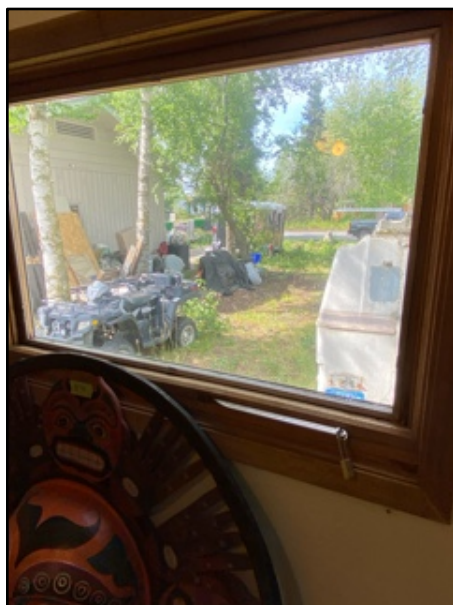
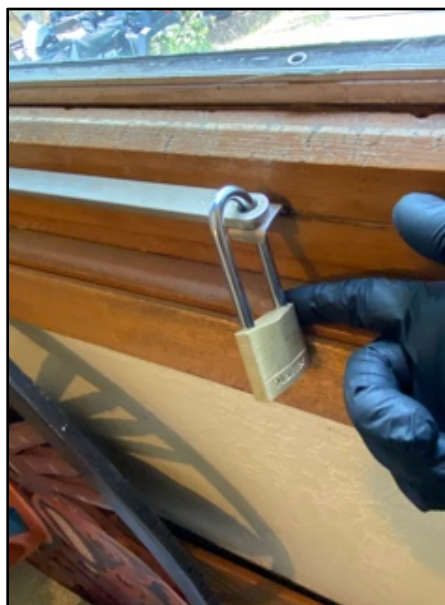
Front bedroom casement window is locked with a pad lock. This is a safety hazard due to it being able to quickly unlock and exit in case of fire or emergency. Recommend removing pad lock and placing a window locking mechanism or replacing window with a newer style with built in lock.

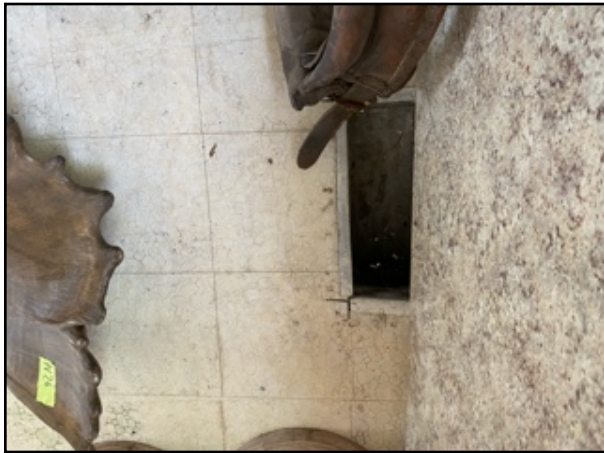
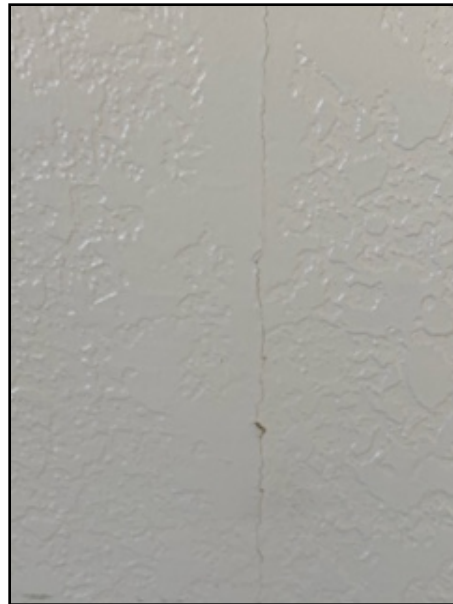
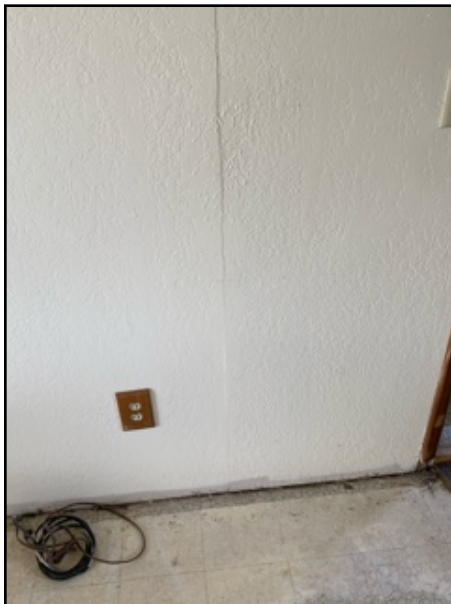
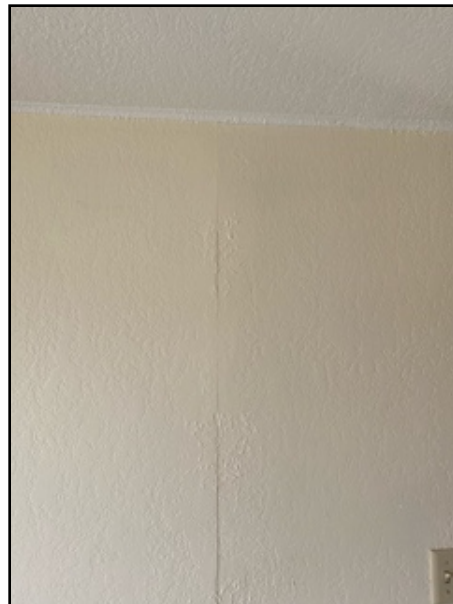
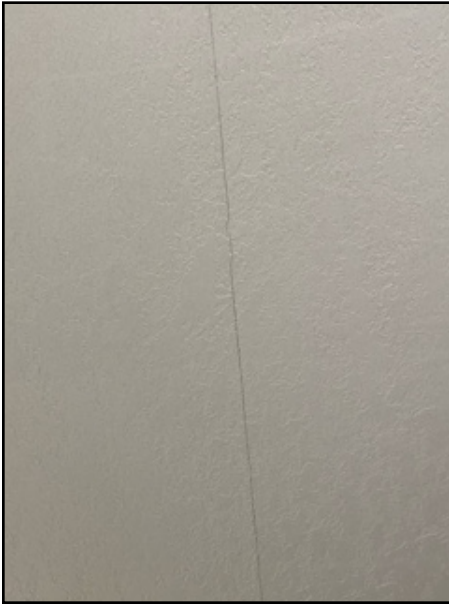
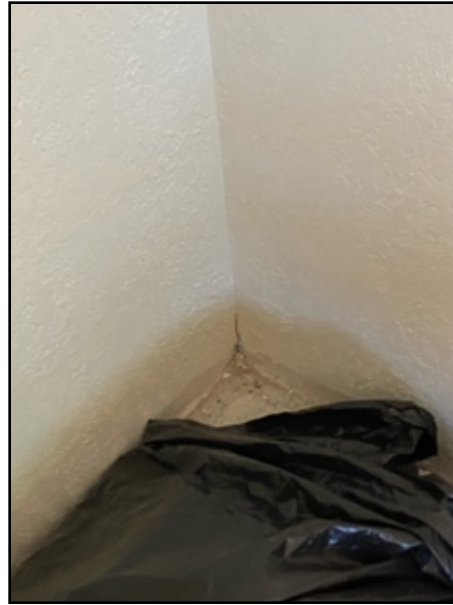
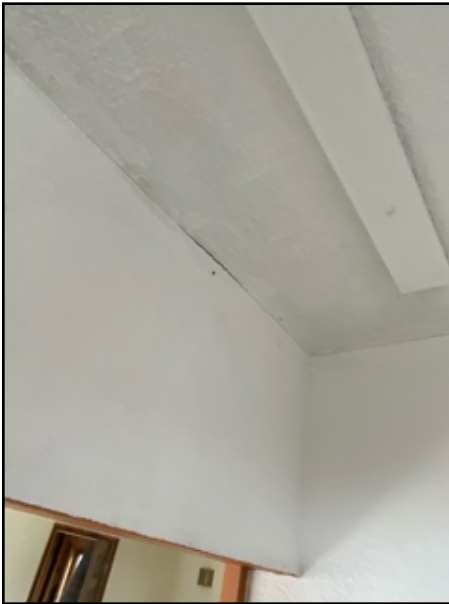
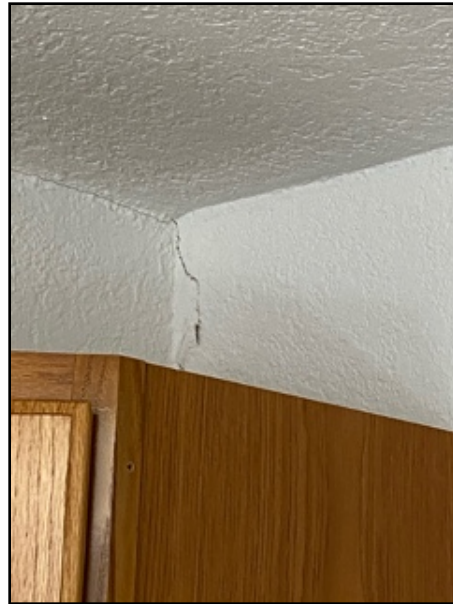
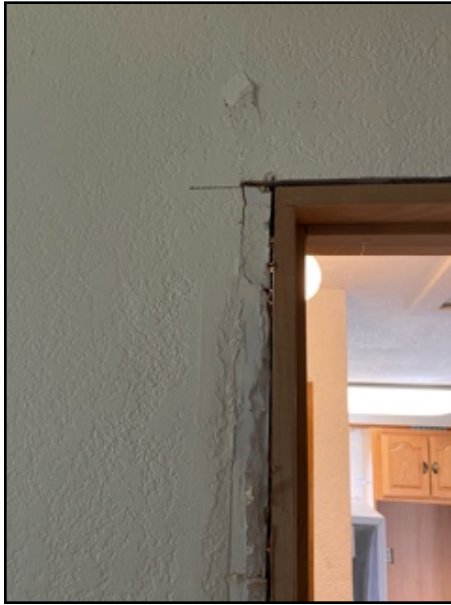
Some cosmetic damage possibly from earthquake and foundational movement with Sheetrock cracking at tape seems in various locations and also, holes in walls and some patching that was not done to standards. Also cracked tile and missing trim boards. Recommend a qualified contractor asses and repair Sheetrock areas.

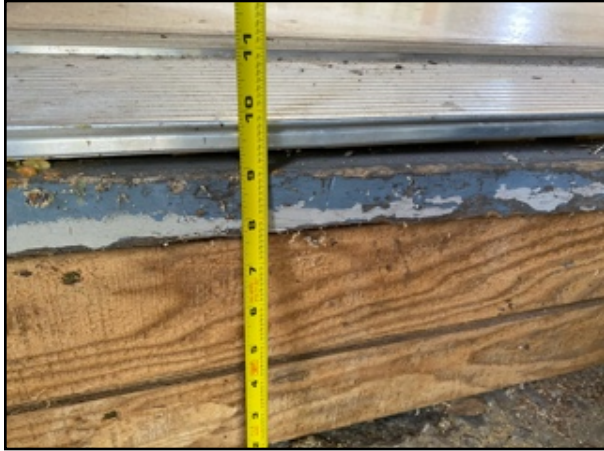
Figure 25-1

The step up/down from the arctic entry to the home is 11" to the threshold. The max rise on a step is 7 3/4". For safety purposes a single step should be put in place and secured to the wall. Recommend a qualified contractor add a single step that has a minimum rise of 4" and maximum rise of 7" and a tread depth of 11".

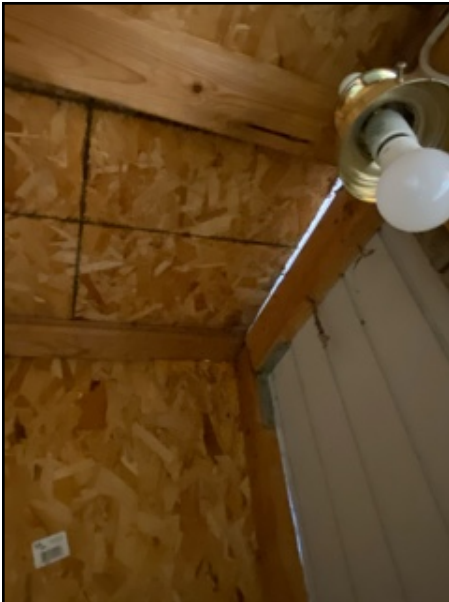
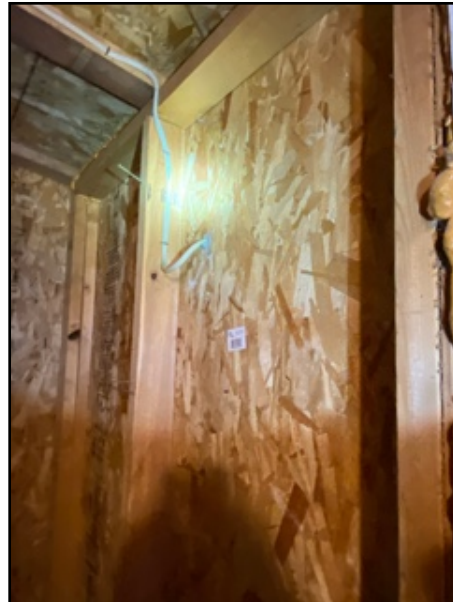
Rear arctic entry has gaps in between the house siding and the plywood. Recommend a qualified contractor seal with foam sealant to fill the gaps and keep out water.
