SPY Inspection Services, Inc.

Home Inspection Report

229 Lower Valley Rd
North Wales, PA 19454

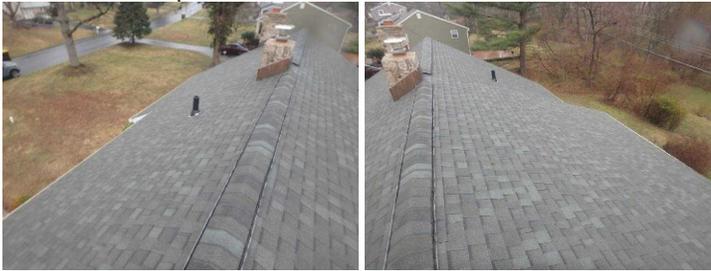
1. Method of Inspection: On roof
2. Unable to Inspect: 10%

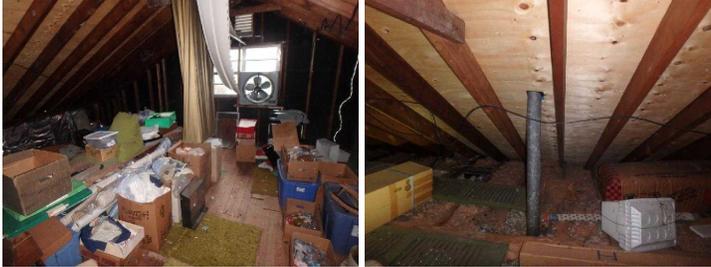
1. Method of Inspection: In the attic
2. Unable to Inspect: 20% - Roof line

3. Roof Framing: Rafter
4. Sheathing: Plywood
5. Ventilation: Gable, Ridge and soffit vents
6. Insulation: Blown in - **Insulation compressed, recommend adding insulation to help conserve energy.**

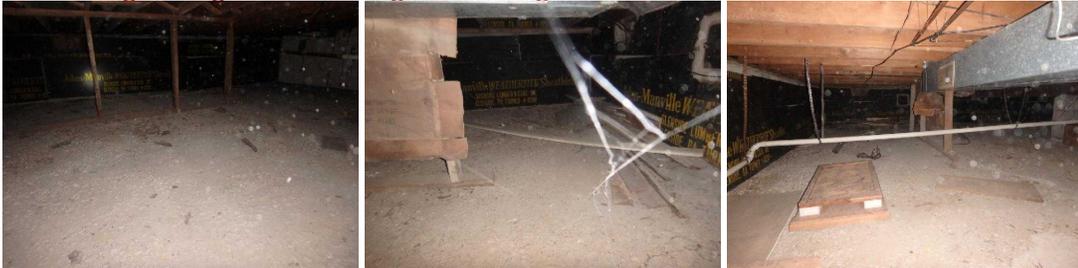
1. Method of Inspection: In the crawl space
2. Unable to Inspect: 20%
3. Access: Wood door
4. Moisture Penetration: None - **Crawlspace was dry at inspection, recommend maintaining exterior grading and drainage, running a dehumidifier.**
