Prepared by: Nicholas Frey  
ASHI#: 262051 EDI#: PA-158

# **Home Inspection Report**

113 Mica Cir  
Bethlehem, PA 18017

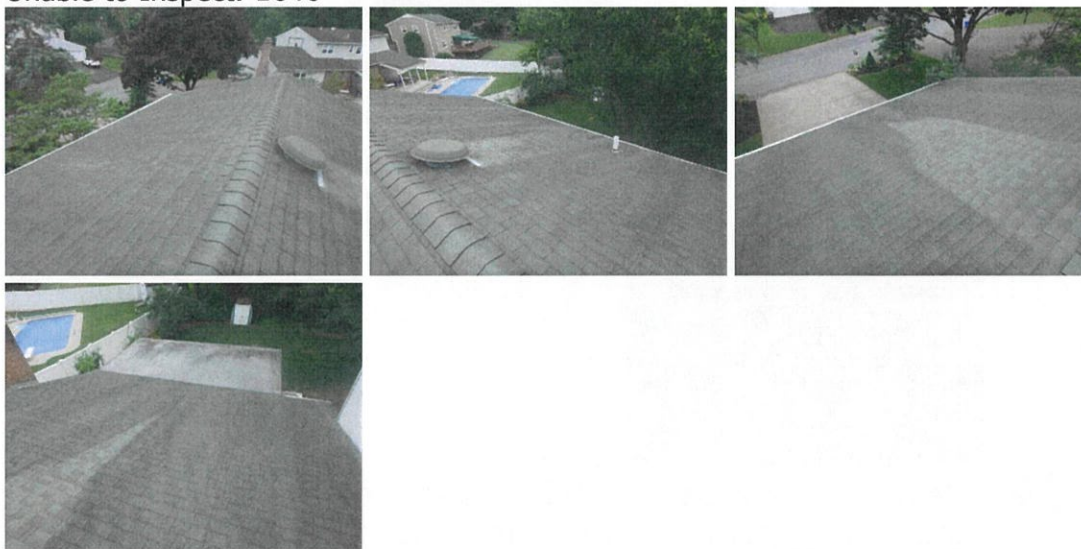
3.      Material: Asphalt shingle - **Damaged shingle noted on gable end of roof, recommend repair by roofer to reduce the risk of water infiltration.**

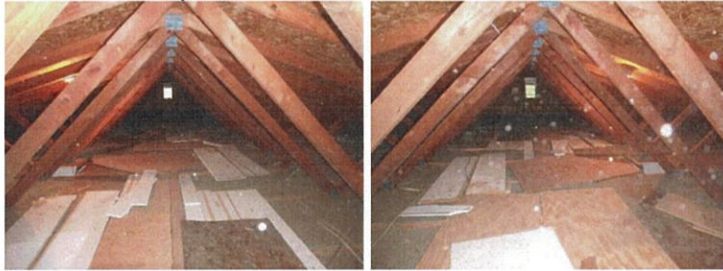
3.      Roof Framing: Truss
4.      Sheathing: Plywood
5.      Ventilation: Gable and soffit vents
6.      Insulation: Blown in
7.      Insulation Depth: 8
8.      Attic Fan: Thermostat controlled
9.      Wiring/Lighting: 110 VAC lighting circuit - **Open junction box noted, recommend covering to reduce the risk of shock.**

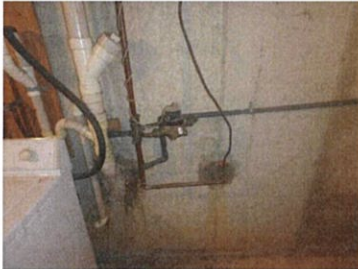
3.  Water Lines: Copper  
4.  Drain Pipes: PVC - **Missing backflow preventer on where humidifier drain connects to drain line, recommend installation to reduce the risk of sewage entering the house.**
