SPY Inspection Services, Inc.

Home Inspection Report

651 New Galena Rd.
Chalfont , PA 18914

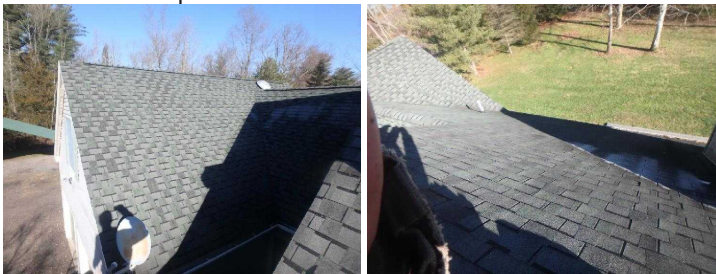
1. Method of Inspection: On roof
2. Unable to Inspect: 10%

3. Material: Asphalt shingle - **Shingles are showing signs of deterioration, Signs of cracking noted on shingles, evidence of patching/repairs, water stains and active moisture detected on roof sheathing in attic (see photos in attic section), recommend evaluation and replacement of shingles by roofer to prevent further water infiltration.**

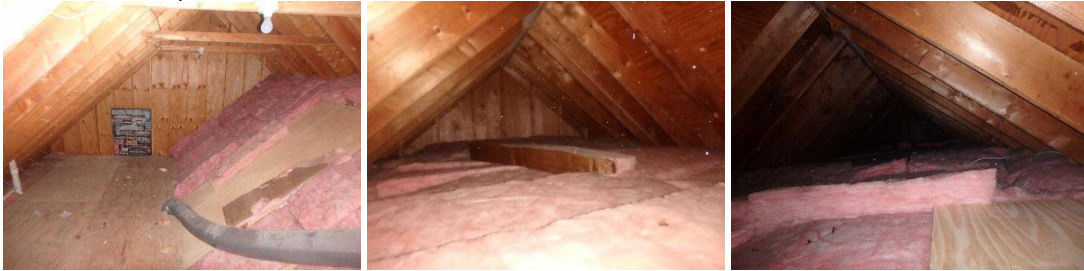
1. Method of Inspection: In the attic, From the attic access
2. Unable to Inspect: 20% - Roof line, Insulation

3. Roof Framing: Rafter
4. Sheathing: Plywood - Water stains present, active moisture detected on sheathing at rear attic, recommend further evaluation and repair as needed by roofer to prevent further water damage.
