SPY Inspection Services, Inc.

Home Inspection Report

6254 Greenhill Rd
New Hope, PA 18938

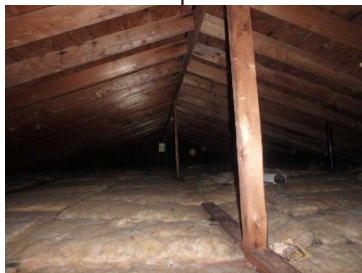
Main Attic

3. Roof Framing: Rafter - Some 2x6 roof rafters appear to be sagging, recommend adding support by roofing contractor to prevent further damage.
4. Sheathing: Plywood - Water damage present on roof sheathing in attic, recommend further evaluation and repair/replace as needed by roofing contractor.
5. Ventilation: Ridge and Gable vents
