May 16th, 2024

1032 Park Ave, Wycombe, PA, 18980

Right Way Home Inspection Plus

Alderfer Auction

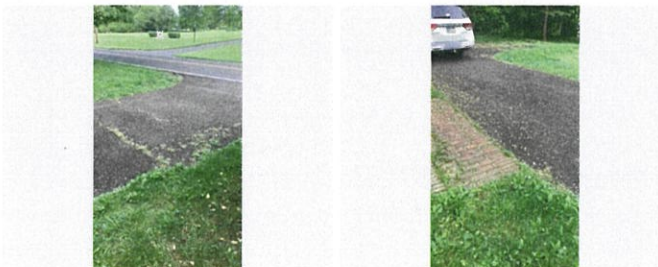
Recommend Sealing Asphalt to Preserve Surface

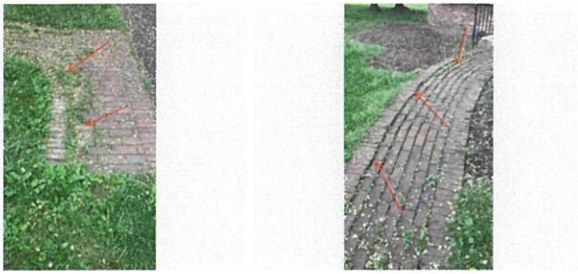
1.2 WALKS

Defective

Uneven surface, possible trip hazard, recommend resettig, recommend further evaluation from a qualified landscape contractor

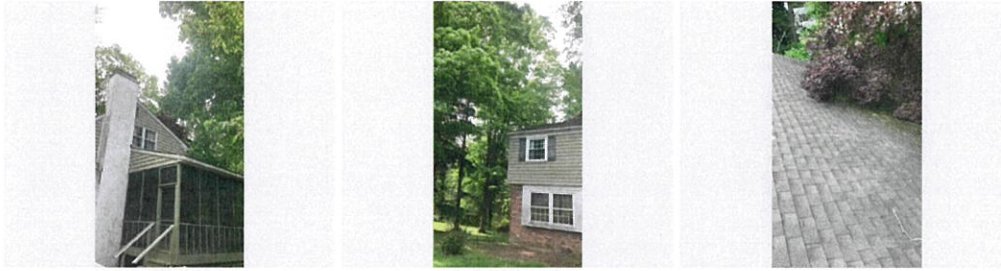
Defective

Recommend Tree limbs that over hang the roof be cut back to prevent roof damage, recommend further evaluation from a qualified Arborist

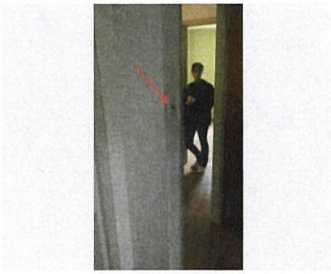
Location - Left Rear Bedroom

It is recommended when entering a room a switch should operate a light or a Receptacle, recommend further evaluation from a qualified Electrician

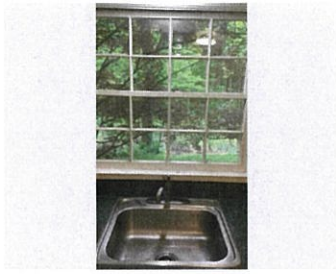
Defective

Will not open-recommend correction, A qualified glazier is recommended to evaluate and estimate repairs

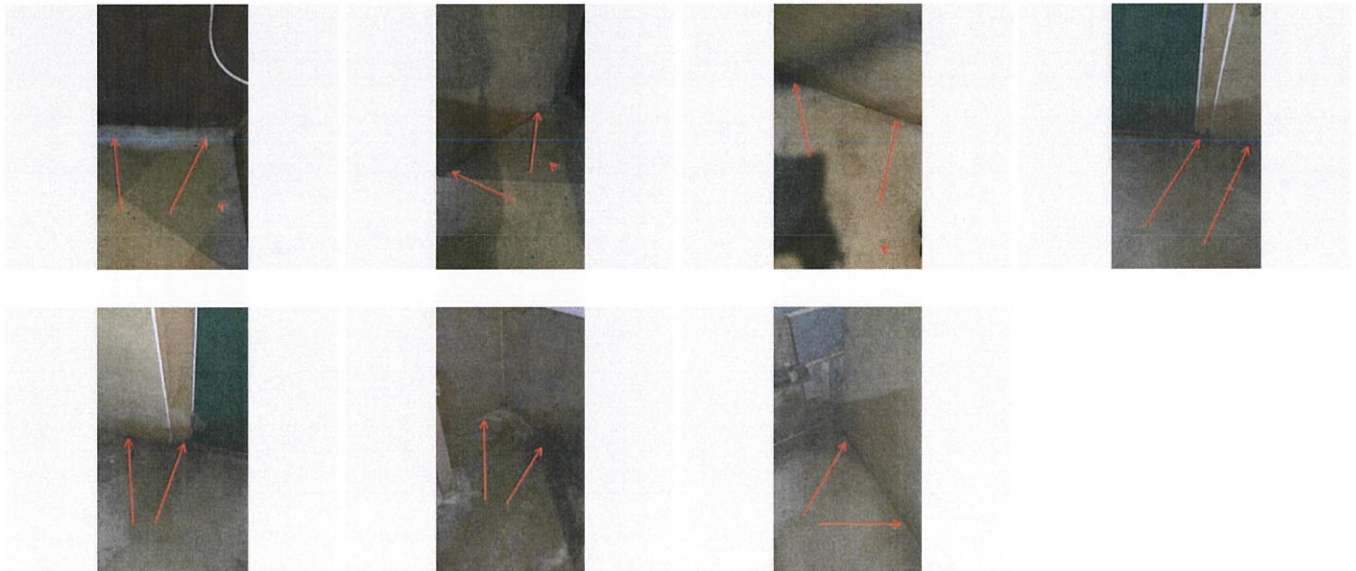
11.4 WALLS

Defective

Evidence of possible wood rot, moisture present at bottom of paneling, Recommend further evaluation from a qualified contractor

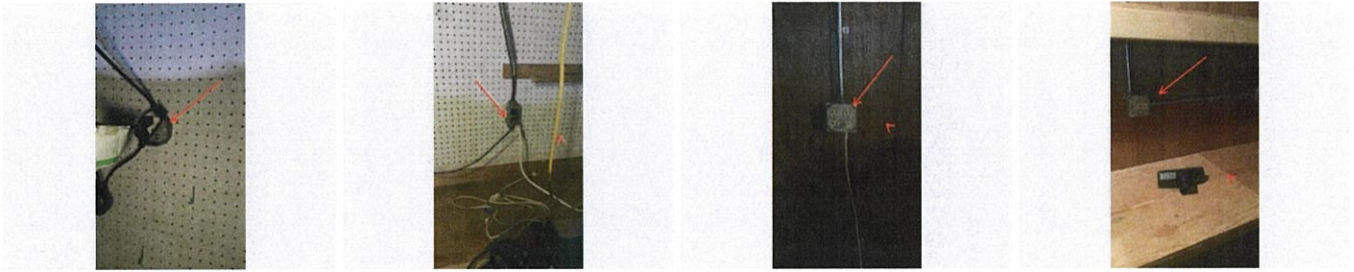
Defective

Receptacle is not installed correctly, It is recommended that all Receptacles in an unfinished basement be GFCI Protected, recommend further evaluation from a qualified Electrician

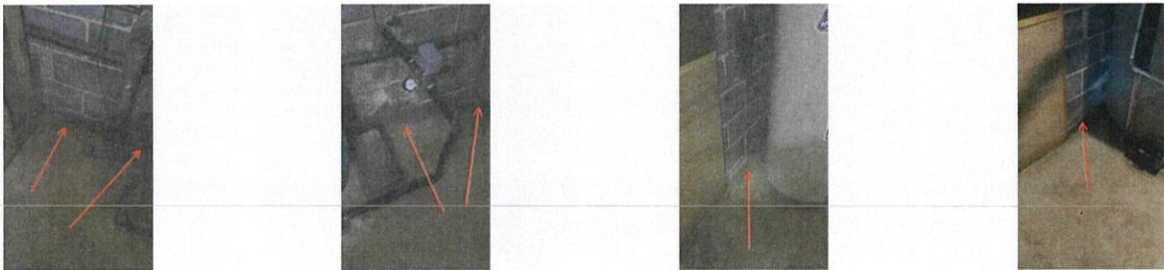
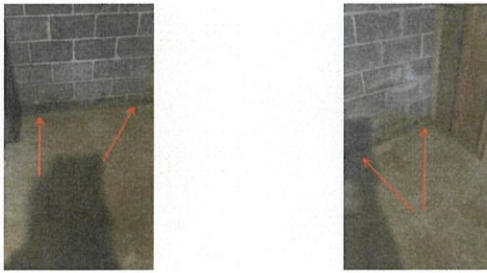
Moisture present around perimeter, Efflorescence is also present, A qualified basement water proofing contractor is recommended to evaluate and estimate repairs

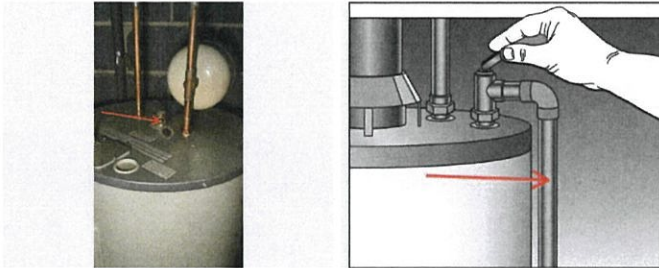
Defective

Missing drain tube, It is recommended that the Drain Tube extend to 6" above the floor, Recommend further evaluation from a qualified plumbing contractor

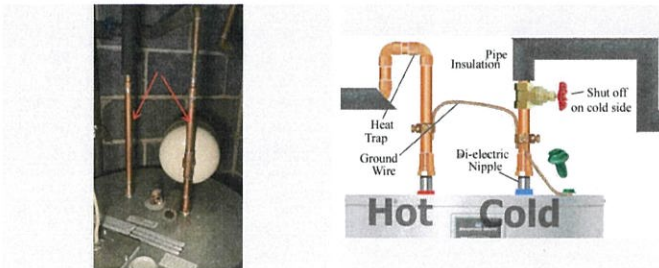
16.12 HOT AND COLD LINE BONDED

Defective

It is recommended that a bonding wire be attached across the hot and cold pipe, recommend further evaluation from a qualified Electrician
