May 30th, 2024

157 Upper Church Road, Chalfont, PA, 18914

Right Way Home Inspection Plus

RIGHT WAY HOME INSPECTION PLUS

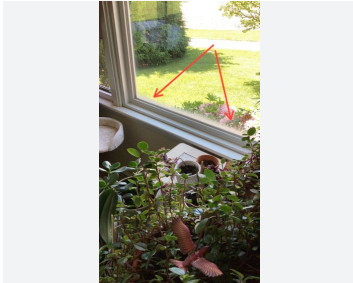
Location - Living room

Defective

Window has fogging between the layers of glass

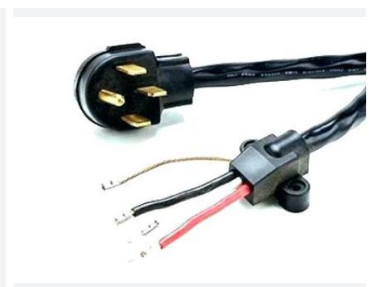
Wire and Plug

Defective

Dryer is direct wired, it is required that a Receptacle be installed for Dryer, recommend further evaluation from a qualified Electrician

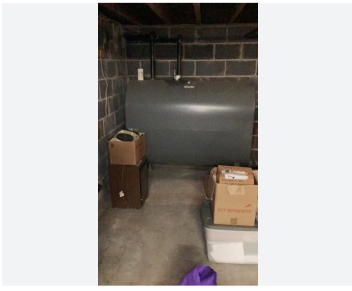
No leaks noted at time of inspection

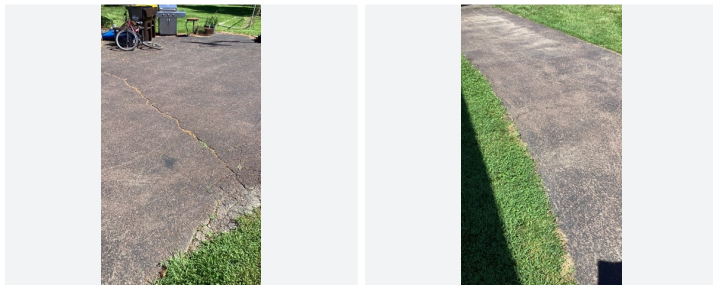
Recommend Sealing Asphalt to Preserve Surface

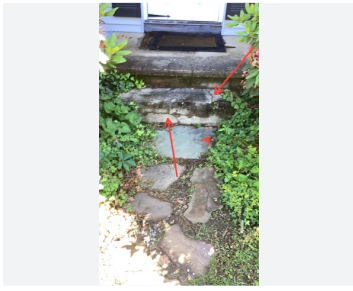
Damaged or deteriorated, recommend estimate for repair or replacement by a concrete contractor

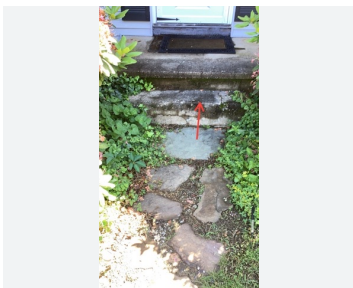
Defective

Not the correct step height, average step height is 7.5 "; recommend estimate for repair or replacement by a concrete contractor

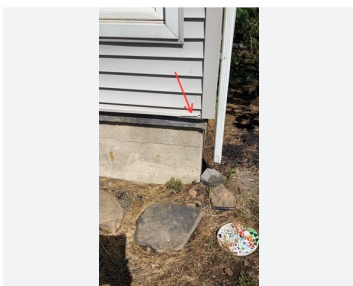
Location - 3 Season Room

Damaged Siding

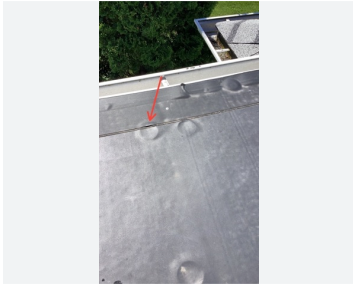
Defective

Recommend re sealing to prevent possible water intrusion, Recommend further evaluation from a qualified roofing contractor

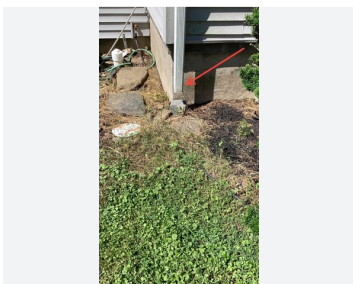
Marginal

Leaders do not extend 6 feet beyond the foundation perimeter

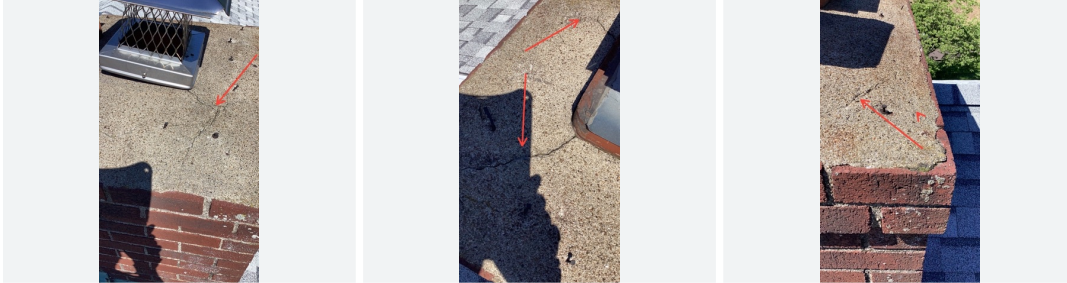
Defective

Crown cracked, recommend Repairing chimney mortar crown to prevent water penetration, recommend further evaluation from a qualified chimney sweep

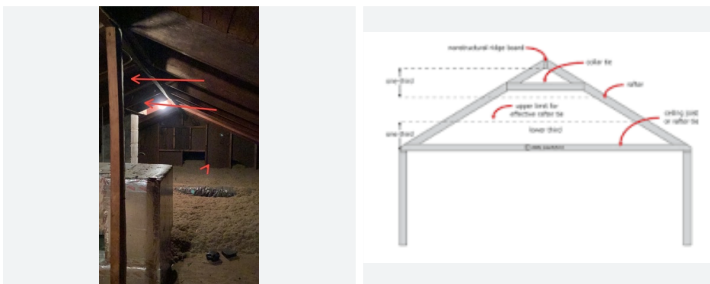
Defective

Missing Collar Ties, recommend further evaluation from a qualified contractor

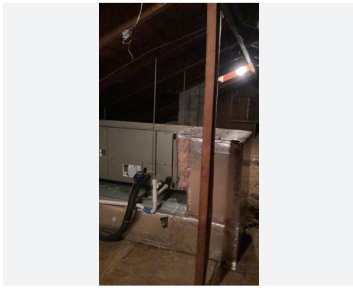
Defective

110 volt Receptacle is required in the attic no further than 8ft away from the HVAC system for repair, recommend further evaluation from a qualified Electrician

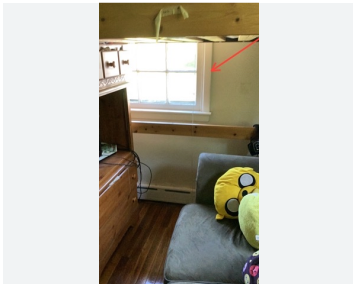
Location - Bedroom Rear

Defective

Hard operation-needs improvements for ease of operation, A qualified glazier is recommended to evaluate and estimate repairs

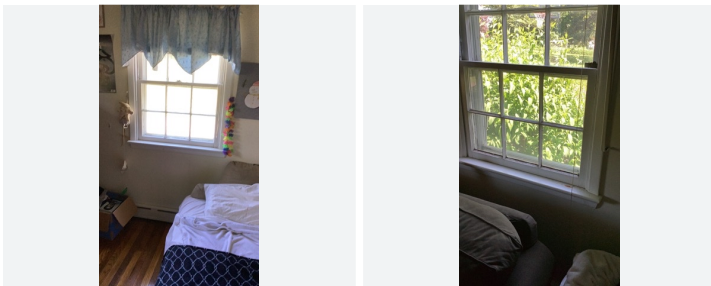
Location - Bedroom Both

Defective

Window does not stay up, A qualified glazier is recommended to evaluate and estimate repairs

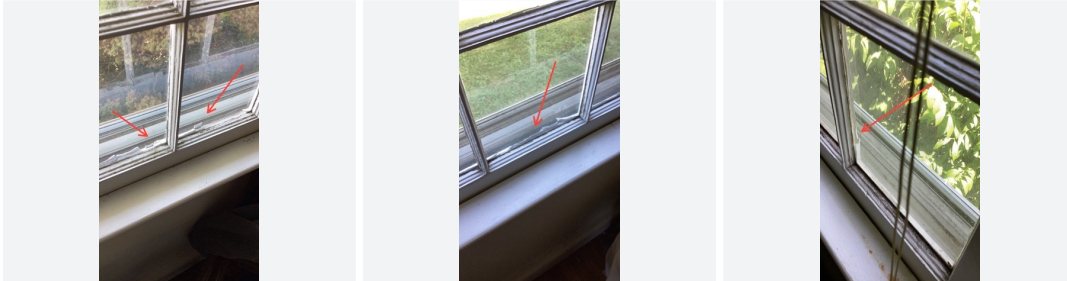
Location - Bedroom Both

Defective

Glazing is peeling off, A qualified glazier is recommended to evaluate and estimate repairs

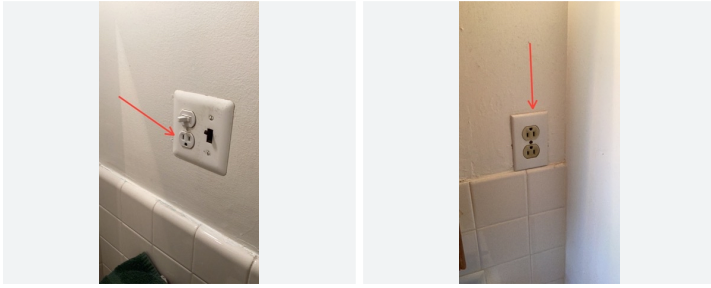
Location - Bathrooms Both

Defective

It is recommended that all bathrooms have a GFCI Receptacle, recommend further evaluation from a qualified Electrician

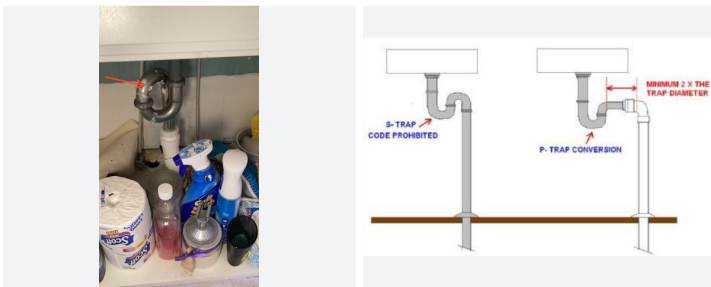
Location - Hall Bath

An 'S' trap has been used. S traps should be replaced during any new plumbing work as they are subject to siphoning problems. Replacement is sometimes difficult and thus the S traps are usually tolerated. Care should be taken to keep the trap 'primed.' Fixtures should be monitored for sewer odor.

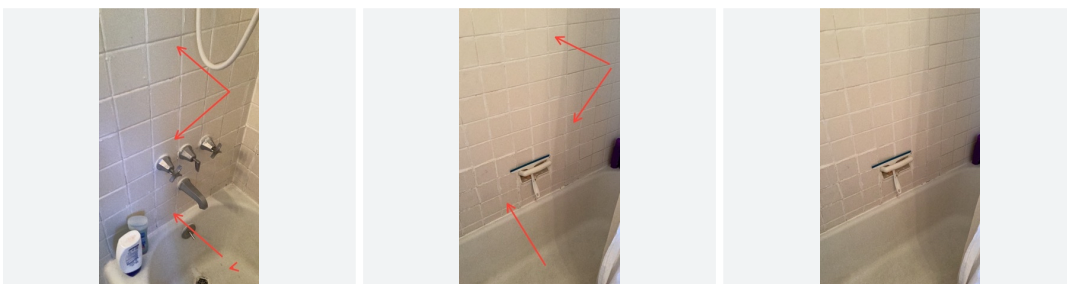
Location - Main Bathroom

Tile grout has been repaired with caulk, possible wall Damage, Recommend further evaluation from a qualified contractor

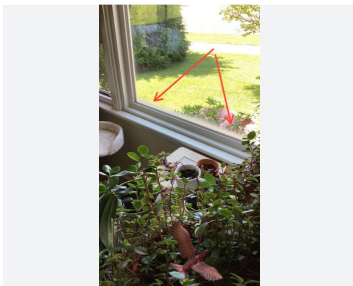
Location - Living room

Window has fogging between the layers of glass

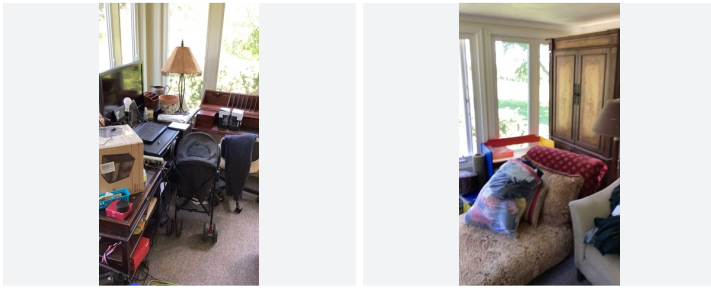
Marginal

Could not Test all windows

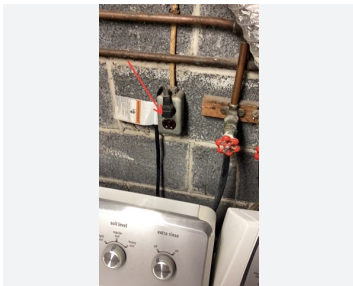
Non-GFCI circuit, It is recommended that all Receptacles in a Laundry Room be GFCI Protected

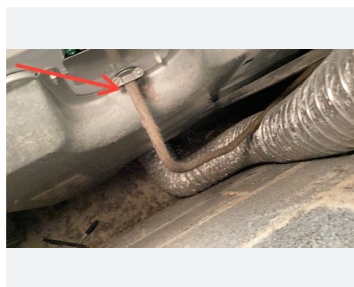
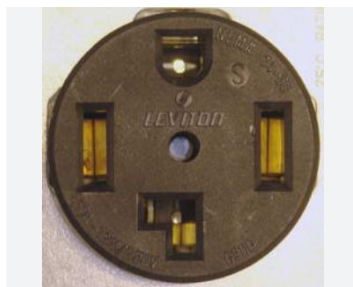
Dryer is direct wired, it is required that a Receptacle be installed for Dryer, recommend further evaluation from a qualified Electrician

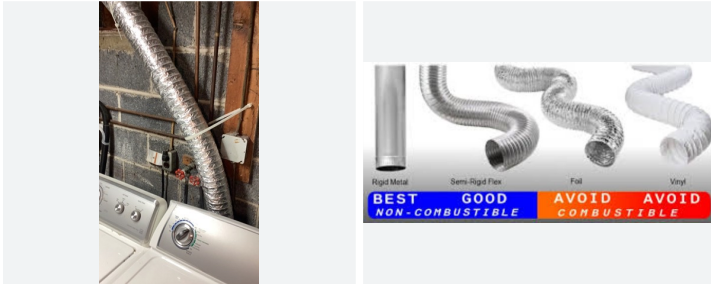
Aluminum Foil Flex has been known as a Fire Hazard, Recommend a Ridged Flex Hose be Installed

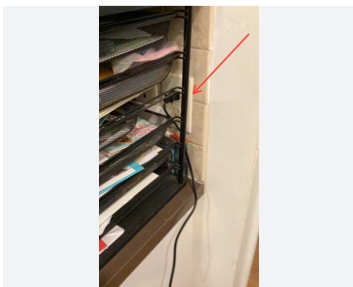
Non GFCI Receptacles present, it is recommended that all Receptacles on a kitchen counter be GFCI Protected, recommend further evaluation from a qualified Electrician

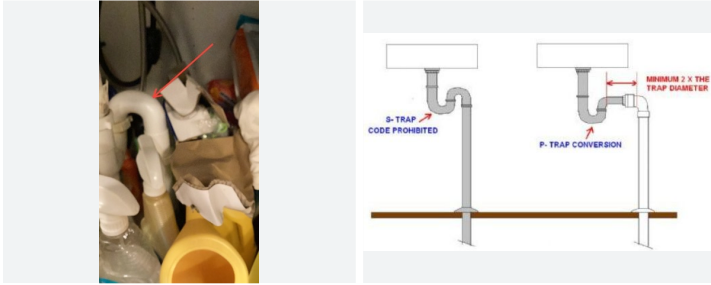
An 'S' trap has been used. S traps should be replaced during any new plumbing work as they are subject to siphoning problems. Replacement is sometimes difficult and thus the S traps are usually tolerated. Care should be taken to keep the trap 'primed.' Fixtures should be monitored for sewer odor.

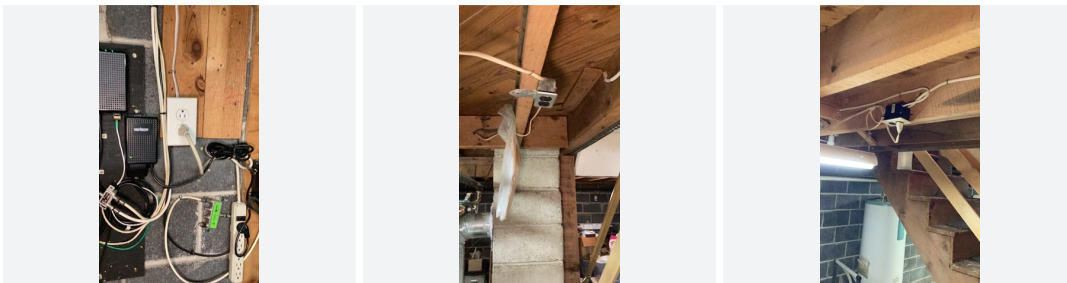
It is recommended that all Receptacles in an unfinished basement be GFCI Protected, recommend further evaluation from a qualified Electrician

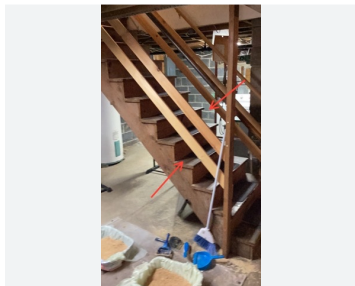
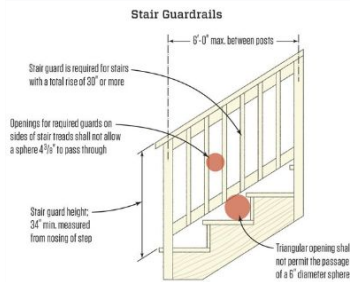
Improper baluster spacing, A qualified contractor is recommended to evaluate and estimate repairs

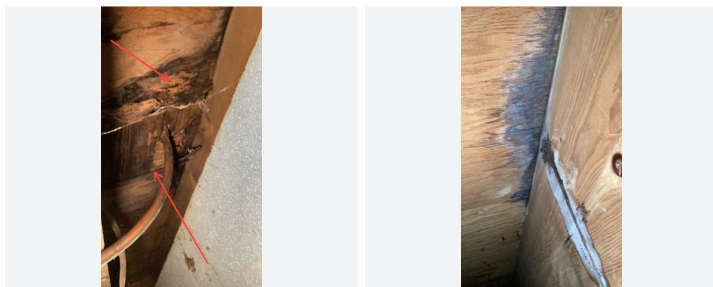
evidence of previous water stains, evidence of rotted wood, possible mold present

Evidence of previous water stains, evidence of rotted wood, possible mold present, Recommend further evaluation from a qualified contractor/and a qualified mold remediation specialist

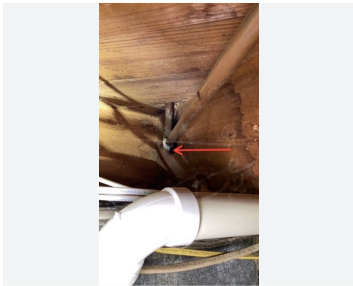
Leaking Fitting, Recommend further evaluation from a qualified plumber

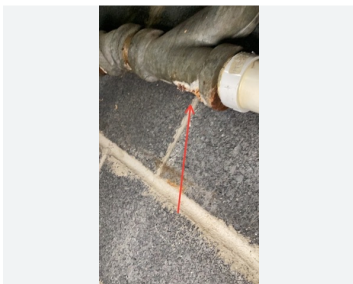
Galvanized drain pipe showing signs of corrosion, no leak observed at time of inspection

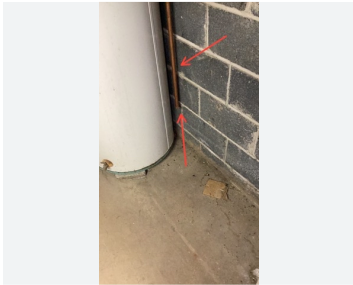
Drain tube opening is not within six inches of the floor, Recommend further evaluation from a qualified plumber

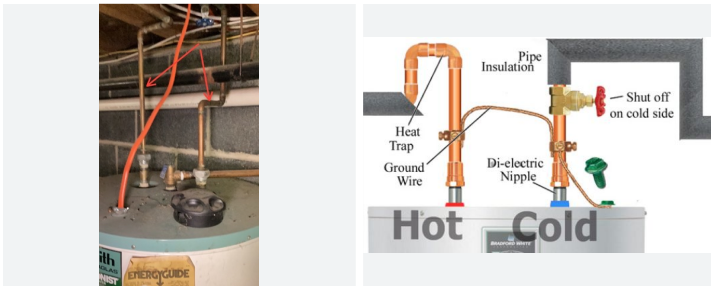
It is recommended that a bonding wire be attached across the hot and cold pipe, recommend further evaluation from a qualified Electrician

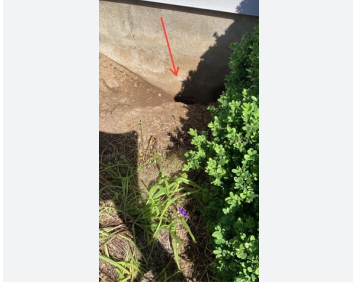
Location - Right Side of House

Evidence of Possible Rodent Activity, Recommend further evaluation from a qualified pest control Technician
