Home Inspection Report

Prepared for: Sherry Russell Alderfer Auction

244 Larkspur Lane
Hatfield, Pa. 19440

Inspected by:
Mike Bilyk
Cornerstone Home Inspection Services Inc

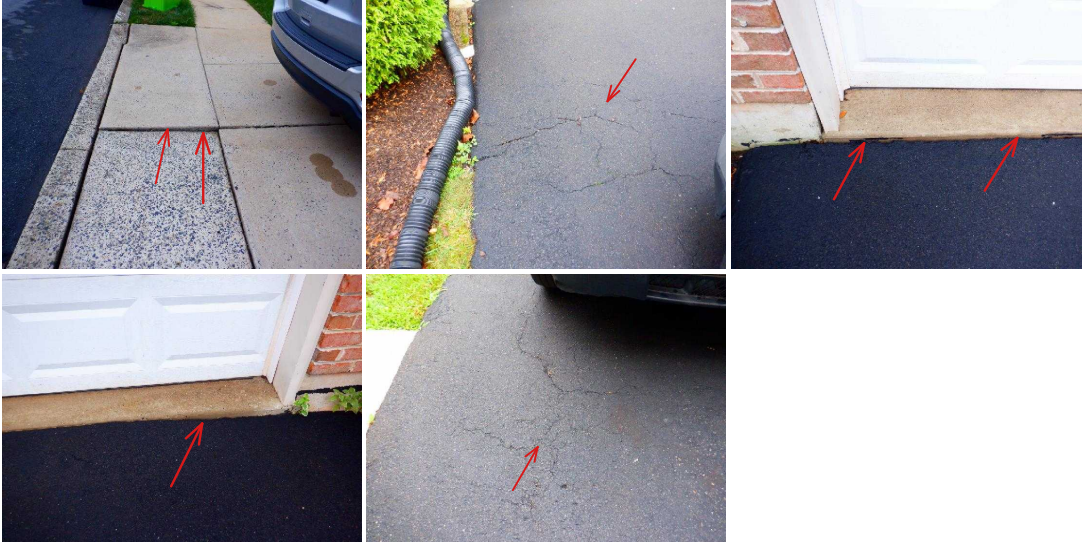
1. Driveway: Asphalt and Concrete Seal cracks and top surface as needed to prevent water damage, Repair uneven areas to prevent a trip hazard. Fill low area where the driveway meets the garage.

1. Driveway: Asphalt and Concrete Seal cracks and top surface as needed to prevent water damage, Repair uneven areas to prevent a trip hazard. Fill low area where the driveway meets the garage.

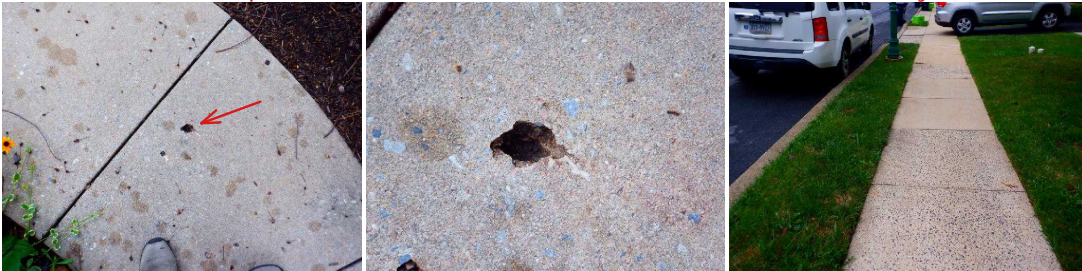
2. Walks: Concrete Repair hole and uneven areas to maintain safe walk ways.

2. Walks: Concrete Repair hole and uneven areas to maintain safe walk ways.

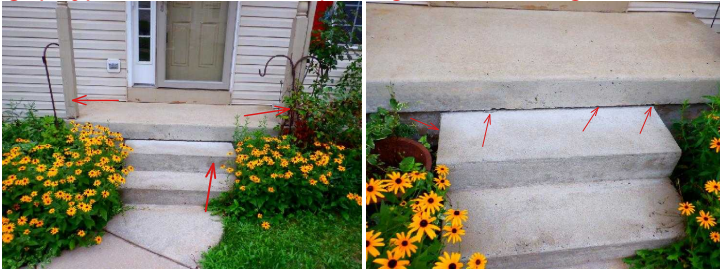
3. Steps/Stoops: Concrete Seal the open gap where the steps meet the structure to prevent water damage. Install a grip type hand rail with openings in the railings no more than 4 inches to prevent a fall.

3. Steps/Stoops: Concrete Seal the open gap where the steps meet the structure to prevent water damage. Install a grip type hand rail with openings in the railings no more than 4 inches to prevent a fall.

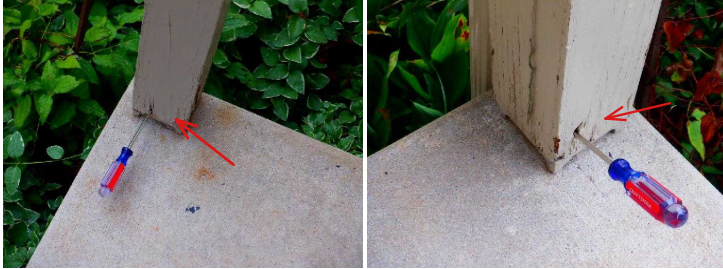
4. Porch: Concrete Water damage noted to the front porch roof support post, repair to maintain support.

4. Porch: Concrete **Water damage noted to the front porch roof support post, repair to maintain support.**

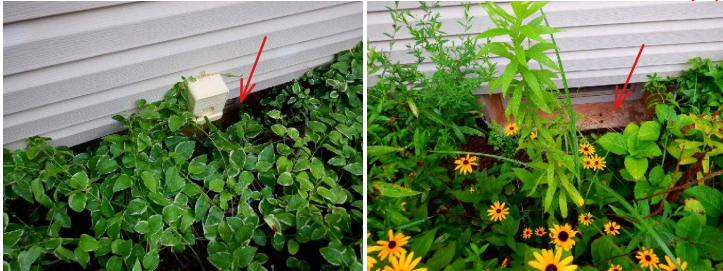
5. Vegetation: Shrubs and trees **Cut back trees and bushes to 12 inches of the structure to prevent water or insect damage.**
6. Window Wells: Metal **Install a window well cover to help prevent basement moisture.**

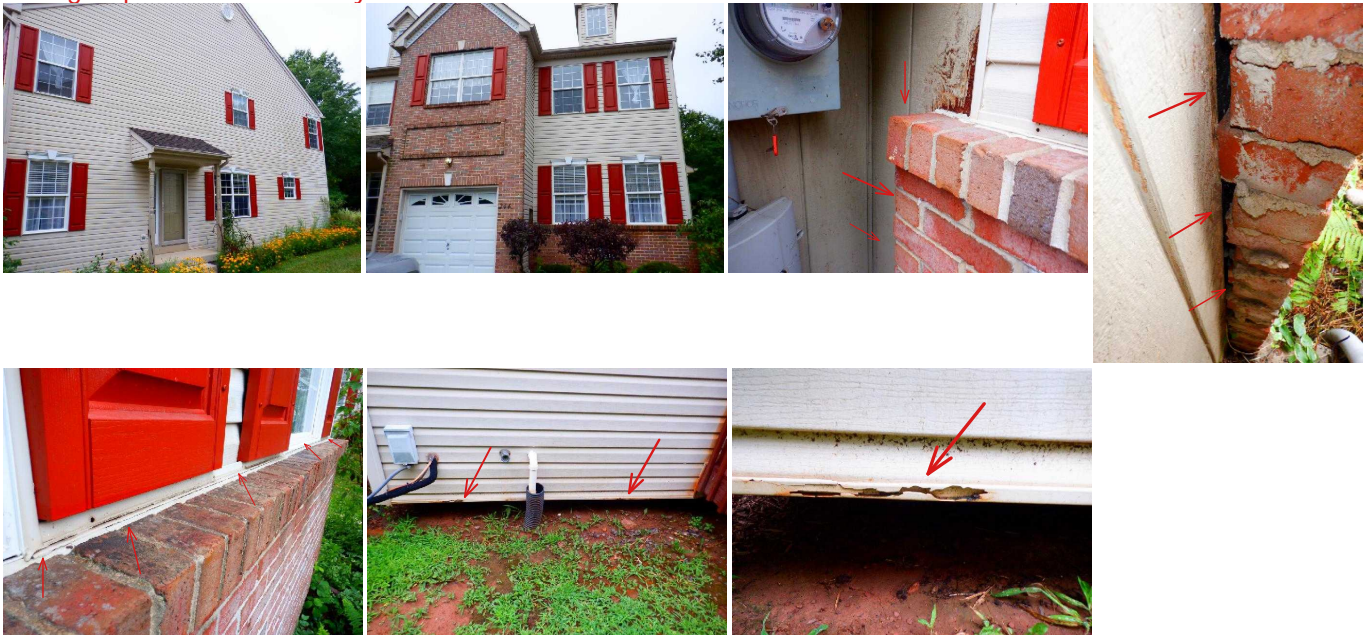
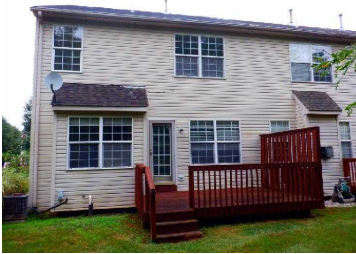
7. All Exterior Surface Type: Brick and vinyl siding **Gaps not properly sealed at front left side , repair to prevent water damage. Caulk where the brick wall meets the siding to prevent water related damage. Repair the holes in the siding to prevent water entry.**

1. Type: Brick and vinyl siding **Gaps not properly sealed at front left side , repair to prevent water damage. Caulk where the brick wall meets the siding to prevent water related damage. Repair the holes in the siding to prevent water entry.**

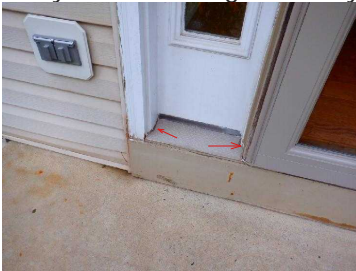
8. Entry Doors: Fiberglass entry door **Caulk the open gaps at the lower frame to prevent water related damage.**

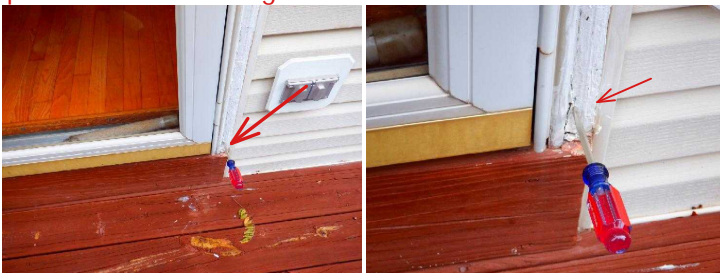
9. Patio Door: Metal entry door **Water damage noted to the exterior wood trim of the deck sliding glass door. Repair to prevent water damage.**

- 6. Patio Door: Metal entry door **Water damage noted to the exterior wood trim of the deck sliding glass door. Repair to prevent water damage.**

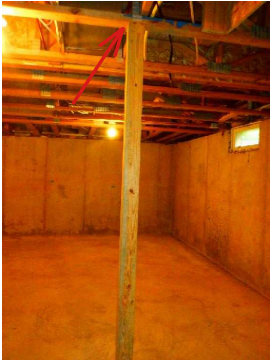
13. Piers/Posts: Wood **Attach the supporting post to prevent movement.**

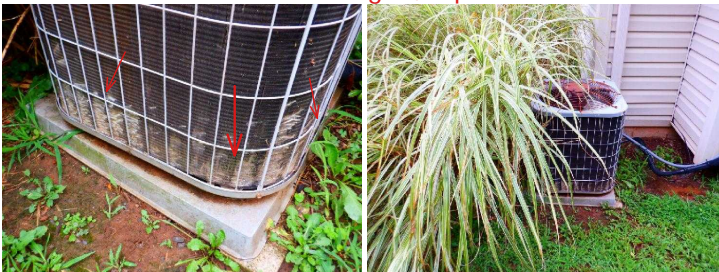
15. Rear Yard AC System A/C System Operation: Functional **Clean and service yearly to maintain efficiency , The unit is currently in service beyond the manufactures stated design life,budget for replacement , No recent service tags noted,Recommend servicing by a qualified contractor.**
16. Rear Yard AC System Visible Coil: Copper core with aluminum fins **Cut back bushes to maintain air flow 1 foot at sides 6 feet above. Fins damaged, repair to maintain efficiency.**

- 1. A/C System Operation: Functional **Clean and service yearly to maintain efficiency , The unit is currently in service beyond the manufactures stated design life,budget for replacement , No recent service tags noted,Recommend servicing by a qualified contractor.**
- 2. Condensate Removal: Electric pump
- 3. Exterior Unit: Pad mounted
- 4. Manufacturer: Carrier
- 5. Area Served: Whole building,unless stated on the sellers discloser Approximate Age: 24
- 6. Fuel Type: 120-240 VAC Temperature Differential: 18 Degrees
- 7. Type: Central A/C Capacity: 3 Ton
- 8. Visible Coil: Copper core with aluminum fins **Cut back bushes to maintain air flow 1 foot at sides 6 feet above. Fins damaged, repair to maintain efficiency.**

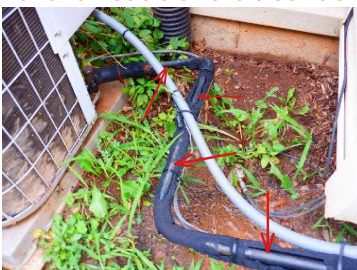
17. Rear Yard AC System Refrigerant Lines: Suction line and liquid line **Replace missing or damaged insulation to prevent heat transfer/condensation/water damage.**

- 9. Refrigerant Lines: Suction line and liquid line **Replace missing or damaged insulation to prevent heat transfer/condensation/water damage.**

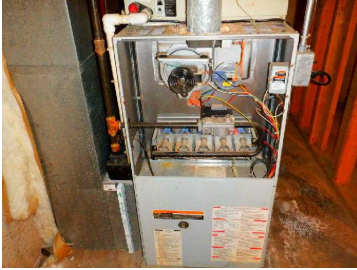
18. Basement Heating System Heating System Operation: Functional Furnace existing beyond design life,budget for replacement. No recent service tag noted,recommend cleaning and servicing needed

1. Heating System Operation: Functional Furnace existing beyond design life, budget for replacement.
No recent service tag noted, recommend cleaning and servicing needed

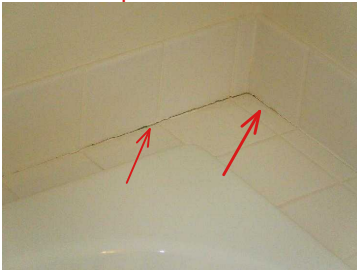
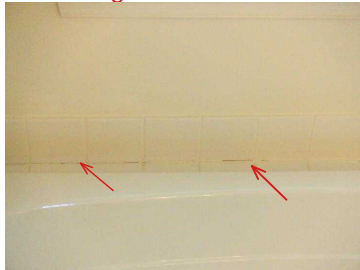
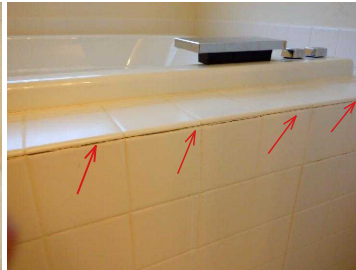
20. 2nd Floor Master Bathroom Doors: PVC Lockset(s) not latching-requires adjustment
21. 2nd Floor Master Bathroom Tub/Surround: Fiberglass tub with ceramic surround Caulk where the wall tiles meet the tub to prevent water related damage

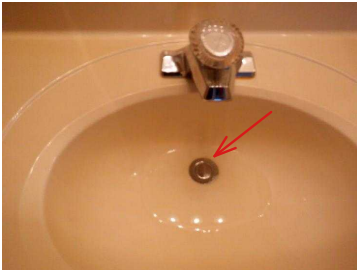
22. 2nd floor main Bathroom Faucets/Traps: Moen fixtures with a PVC trap Sink stopper not operating, repair

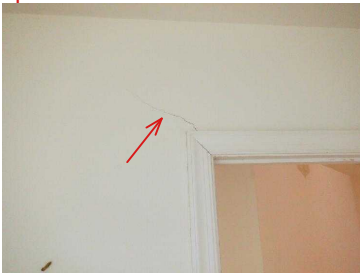
25. 2nd floor rear right side Bedroom Walls: Painted Drywall Cracks present below the rear window , further evaluate , repair and monitor

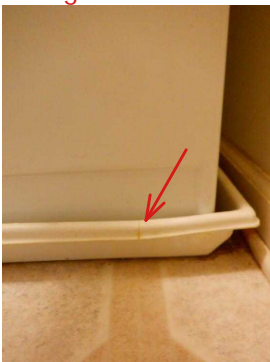
27. 2nd Floor Laundry Room/Area Washer Hose Bib: Ball valves Install metal braided hoses to prevent rubber failure.
28. 2nd Floor Laundry Room/Area Washer and Dryer Electrical: 110-240 VAC Washer and dryer are as is condition. Not tested.
29. 2nd Floor Laundry Room/Area Dryer Vent: Metal flex The clothes dryer vent and piping needs cleaning now and yearly for fire safety.
30. 2nd Floor Laundry Room/Area Floor Drain: Pan under washer Pan is cracked,replace to prevent water related damage.

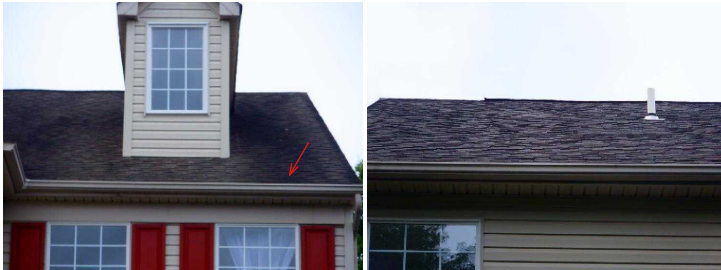
1. Main Roof Surface Material: Dimensional Shingles, Average life cycle 30-35 Years **A qualified roofing contractor is recommended to evaluate and estimate repairs , water stains noted above window at the master bedroom. Recommend a roof certification.**

- 1. Method of Inspection: Compact Zoom
- 2. Material: Dimensional Shingles, Average life cycle 30-35 Years **A qualified roofing contractor is recommended to evaluate and estimate repairs, water stains noted above window at the master bedroom. Recommend a roof certification.**

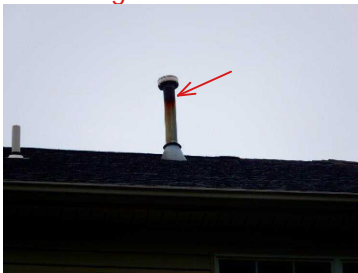
2. Heater Chimney Chimney: Metal pipe **Rust noted, repair or replace to prevent deterioration/water damage. Consult a heating contractor.**

11. Chimney: Metal pipe **Rust noted,repair or replace to prevent deterioration/water damage. Consult a heating contractor.**

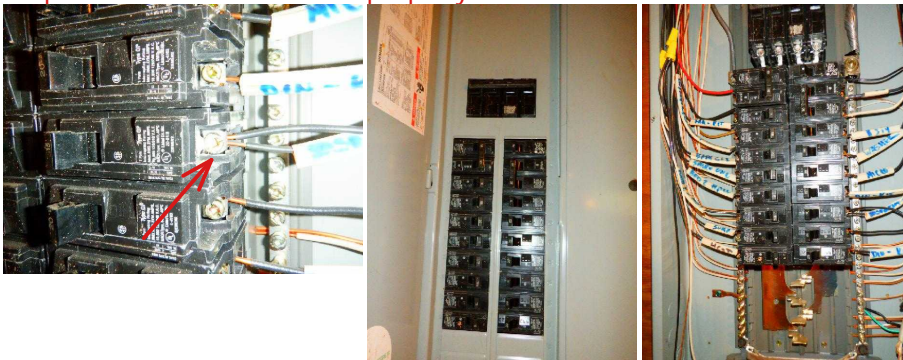
3. Basement Electric Panel Manufacturer: Seimens **Double taps are present at breakers. These circuits need to be moved to their own circuit breaker and cannot share a breaker. It is recommended that a qualified electrician inspect the new circuits and properly connect the new circuits to an individual breaker for each circuit.**

8. Manufacturer: Seimens **Double taps are present at breakers. These circuits need to be moved to their own circuit breaker and cannot share a breaker. It is recommended that a qualified electrician inspect the new circuits and properly connect the new circuits to an individual breaker for each circuit.**

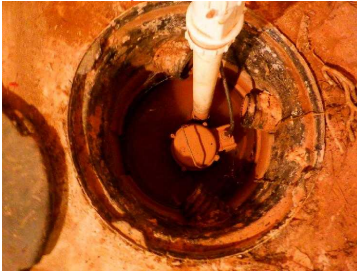
4. Main Basement Sump Pump: Submerged Recommend install the sump pump on a dedicated GFCI protected outlet. Recommend installation of water-powered back-up sump pump to protect basement finishes if the electrical power was were off. Diaphragm type pump switch,no water in the crock,fill crock and verify operation.

1. Doors: PVC
2. Windows: Awning
3. Electrical: 110 VAC GFCI outlets and lighting circuit
4. Smoke Detector: Present
5. Ventilation: Windows
6. Sump Pump: Submerged **Recommend install the sump pump on a dedicated GFCI protected outlet. Recommend installation of water-powered back-up sump pump to protect basement finishes if the electrical power was were off. Diaphragm type pump switch,no water in the crock,fill crock and verify operation.**

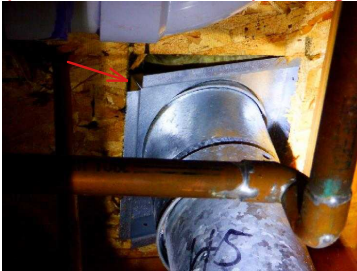
5. Basement Heating System Flue Pipe: Double wall Repair loose fire space blocker to close off the open chase to prevent a fire from passing into the attic.

9. Flue Pipe: Double wall Repair loose fire space blocker to close off the open chase to prevent a fire from passing into the attic.

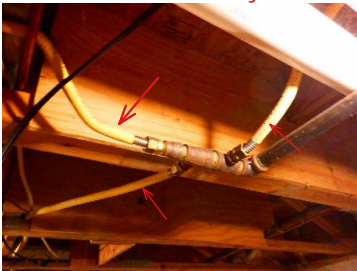
6. Gas Service Lines: Steel and flex Ground gas lines as per local codes , consult a Electrical contractor for safety, Csst yellow flex gas lines have been experienced pin holes if a lightning strikes the property , consult a qualified contractor for safety.

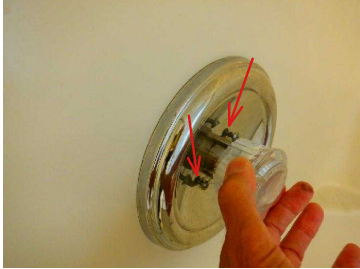
7. 2nd Floor Master Bathroom Shower/Surround: Fiberglass pan and fiberglass surround Repair loose faucets to prevent water related damage.

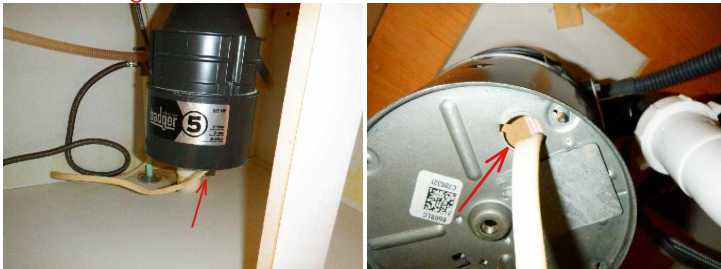
9. Main Level Kitchen Disposal: In-Sinkerator **Install a wire connector to protect the wire from damage or be pulled out ,or causing electrical shock.**

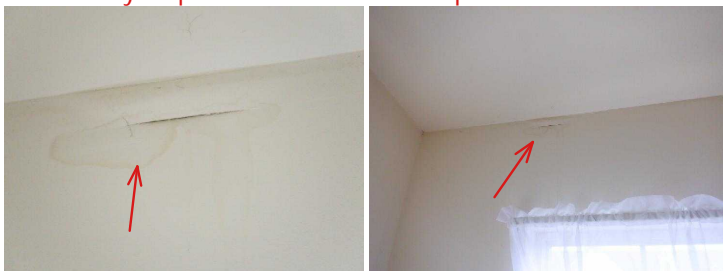
12. 2nd floor rear left side Bedroom Doors: PVC **Doors stick,need trimming/adjustment,fire safety**
13. 2nd floor front left side Bedroom Windows: Vinyl single hung **Locks do not align/lock-need correction , 1 window.**
14. 2nd Floor Master Bedroom Ceiling: Painted Drywall **Water stains present , Checked with a moisture meter,no high level of moisture noted , Consult the home owner for details of the staining,if no explanation is given further evaluate by a qualified contractor to prevent water related damage.**

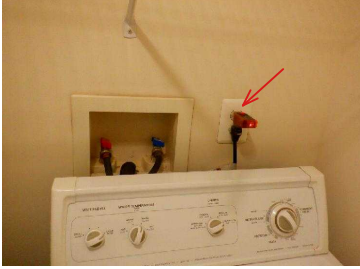
15. 2nd Floor Laundry Room/Area Electrical: 110 VAC outlets and lighting circuits **Non-GFCI circuit ,install within 6 feet of a water source for safety**
