Home Inspection Report

323 Applebrook Drive
Malvern, Pa. 19355

Inspected by:
Mike Bilyk
Cornerstone Home Inspection Services Inc

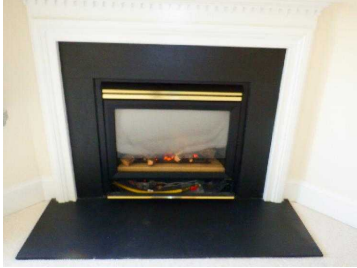
Master Bedroom Fireplace

2. Type: Decorative gas appliance
3. Flue: Not inspected ,clean and re inspect prior to use
4. Hearth: Flush mounted

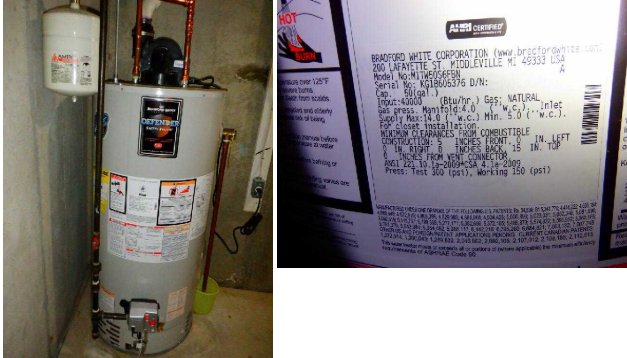
Basement Water Heater

8. Water Heater Operation: Functional at time of inspection **Average life 8-12 years**
