Job #39006485

Level 2 Chimney Inspection

890 Eichele Road, Perkiomenville, PA 18074 USA

2024-08-07

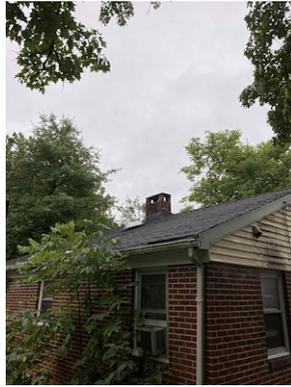
Picture of Chimney from the ground

Pillars are missing mortar
Chimney is not to height required by code
Crown is lifting off of brick and cracked

Based on our findings at this appointment, we have determined that this chimney
should have repairs made as soon as possible
