HOME INSPECTION

12/29/25

3795 Route 202
Doylestown, PA 18902

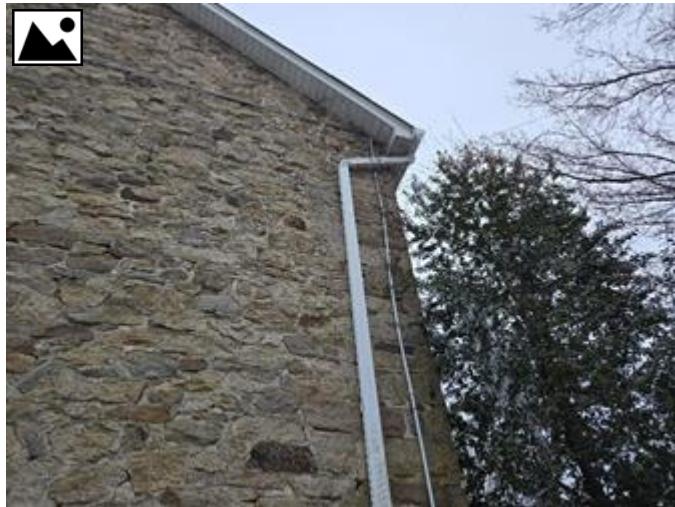
Water Control - Gutter/Downspout

Downspout(s) discharge into an underground drainage system. The condition of underground portions of the drainage system cannot be inspected.

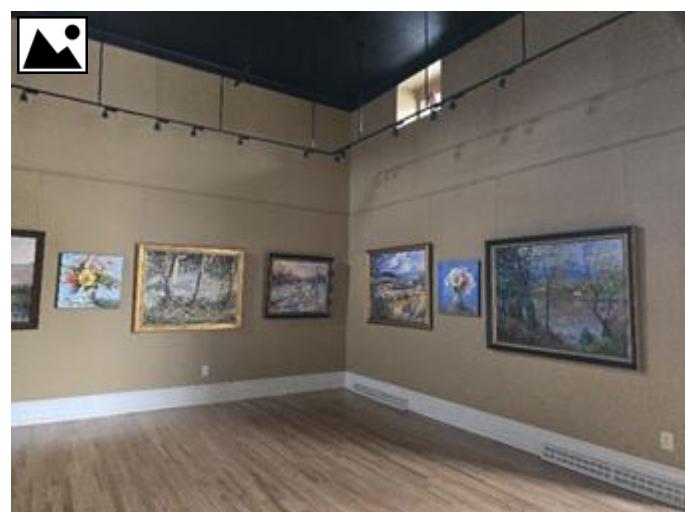
Interior - Walls

The cracks in the wall surfaces are typical. These are generally due to the shrinkage of lumber and/or normal settlement. Make cosmetic repairs before painting.

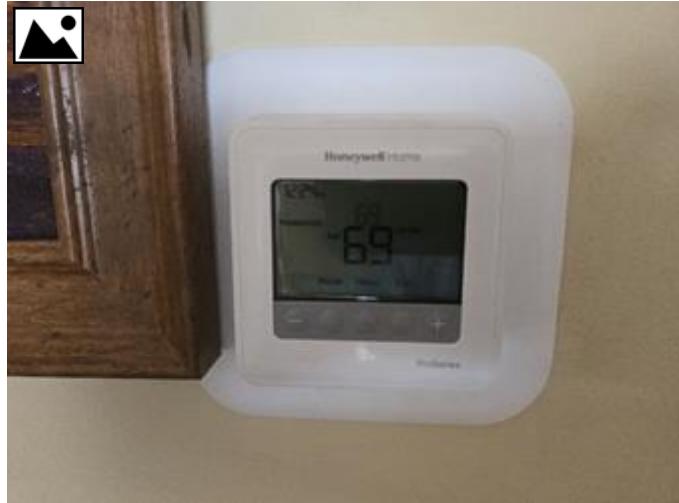
HVAC - Thermostat

ℳ Issue The outside temperature is too cold to operate the cooling system. Most manufacturers caution that running the AC when it is below 60F can damage the system. Therefore, the cooling system is only inspected visually.
Location
Action *Hire an HVAC technician to evaluate the system prior to closing.*

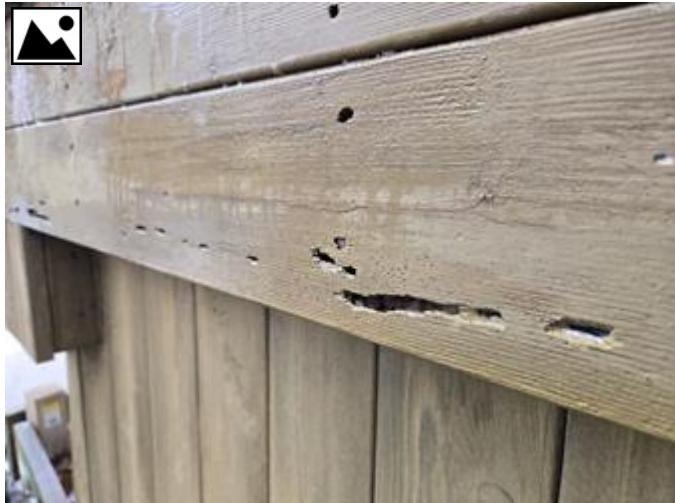
Issue There is evidence of possible wood-destroying insect activity and damage. We do not determine the extent of the activity or any damage during a home inspection.

Action *Hire a pest specialist for further evaluation and required action.*
