379 Sweetbriar Road
Perkasie, PA 18944
Bedminster Township
Bucks County

Report # TP083018001

BACKGROUND:

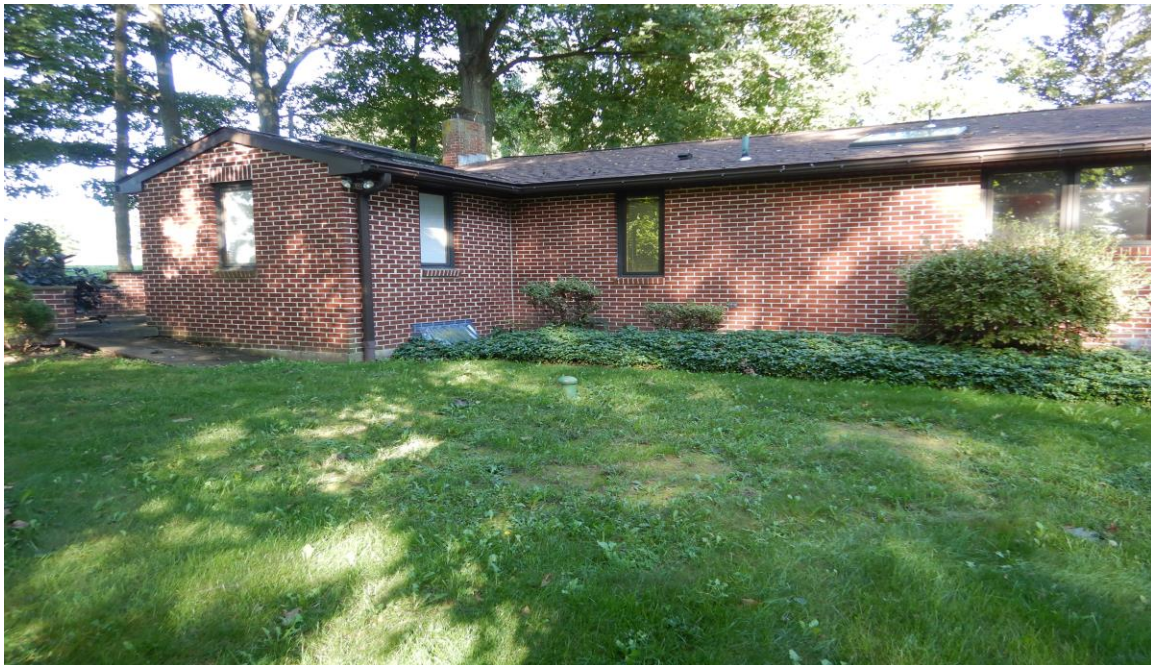
The septic tank was located to the rear of the home, 13' off the back wall. The main access was found to be 10", below grade and consisted of a concrete lid. The tank is a 1,000-gallon, concrete tank. The opening was found to be in the center of the tank. The concrete lid was opened to investigate the interior of the tank. The water level of the tank was viewed through this main access. The water level was found to be equal to the bottom of the outlet pipe, indicating a normal operating level. There were no signs of overfull conditions or back-ups from the past. The area of the tank above the water level, was found to be clean, and structurally sound. The inlet and outlet

baffles were present, and structurally sound, above the water level. The outlet baffle appears to be disforming, and may require a repair in the future. That being stated, the outlet baffle is presently performing its required duties of preventing solids from escaping the tank. Baffles assist in the proper breakdown of solids in the tank. Without baffles, floating solids can be “churned” by incoming water, causing solids to pass through the tank, out into the absorption area, leading to premature failure of the absorption field. The solids level of the tank was found to be minimal and consistent with a tank that is maintained. No information was available, as to the date of the last pumping.

1. It is recommended to repair the outlet baffle prior to it needing to be repaired. The baffle could be repaired once the tank is empty. If the outlet baffle is not repaired, it should be monitored closely, and repaired at the time it is an issue.
2. It is recommended that this septic system be pumped out every two to three years, through the main access, as suggested by PA State Code, Act 537.
