Inspection Report

Property Address:
2035 Clover Mill Rd
Quakertown Pa 18951

A1 House Prep LLC and Inspections

Date: 06/05/20	Time: 10:30 AM	Report ID: 6844 Ed & Joann Leber
Property: 2035 Clover Mill Rd Quakertown Pa 18951	Customer: Ed Leber	Real Estate Professional: Michelle Hunsberger Sanford Alderfer Real Estate

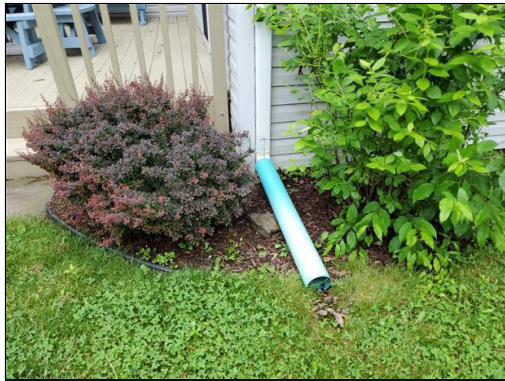
1.3 Item 2(Picture)

Downspouts are not moving water effectively away from the foundation. Suggest to extend downspouts as discussed for better drainage away from the foundation. Saturating foundation walls for extended periods of time can cause potential unseen structural damage from water and insects. Could not determine how long water was flowing towards the foundation.

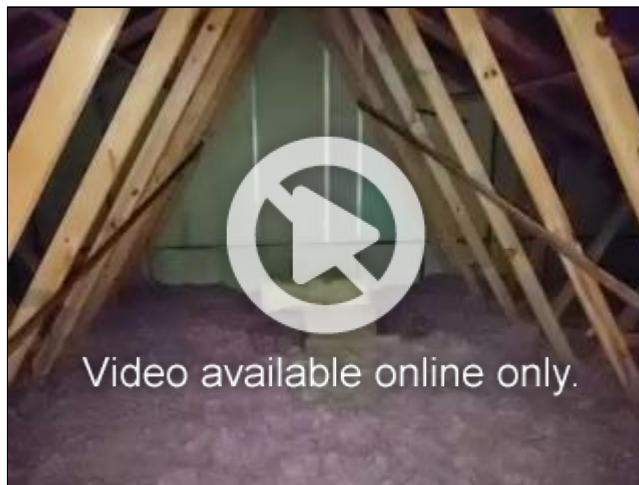
1.4 Item 1(Video) *** ATTIC VIDEO ***

Suggest to view attic video for more information.

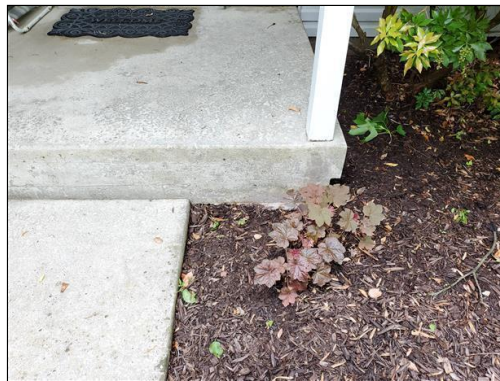
2.3 Item 2(Picture)

(1) Negative grading at the front of home. Highly recommend to correct grading as needed by a qualified person. Negative grading can cause unseen structural issues and water penetration if not corrected.

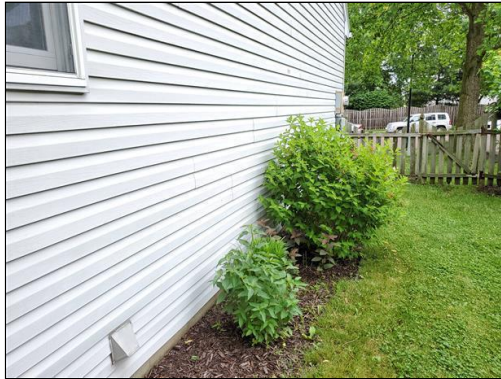
2.3 Item 5(Picture)

(2) Shrubbery is growing too close to the siding for proper ventilation. Recommend to trim shrubbery a minimum of 12 to 16 inches away from the siding to restore proper ventilation. This would be considered normal maintenance.

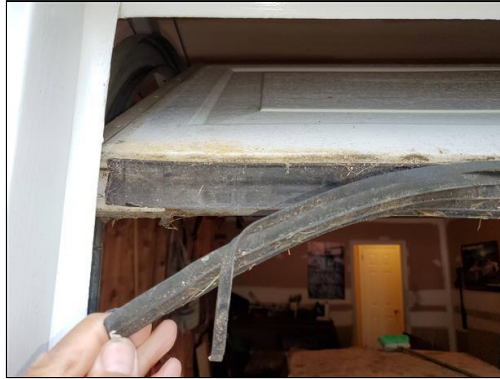
3.4 Item 2(Picture)

(1) Damaged weatherstripping around the garage door and under door. Recommend to replace weatherstripping as needed by a qualified person.

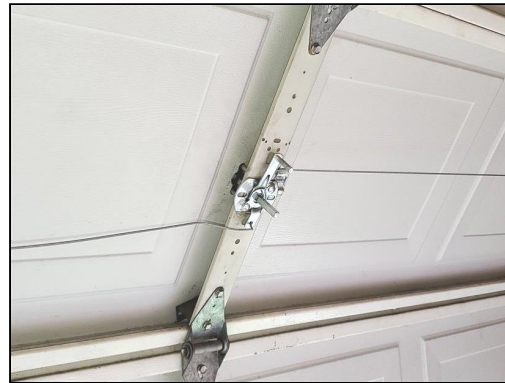
3.4 Item 3(Picture)

(2) Suggest to install a handle on the garage door.

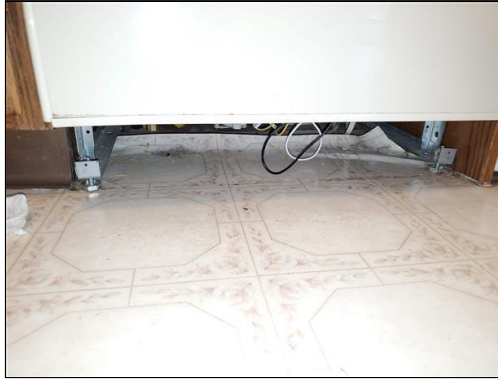
4.11 Item 2(Picture)

Dishwasher is not secured to the cabinet and missing a coverplate at the bottom. Recommend to secure and replace coverplate as needed by a qualified person.

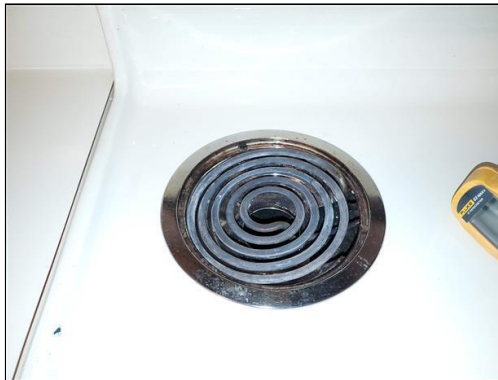
4.13 Item 2(Picture)

- Left front burner was nonfunctional. Recommend to repair left front burner as needed by a qualified person.
- Left rear burner is not fitting properly. Recommend to replace as needed by a qualified person.

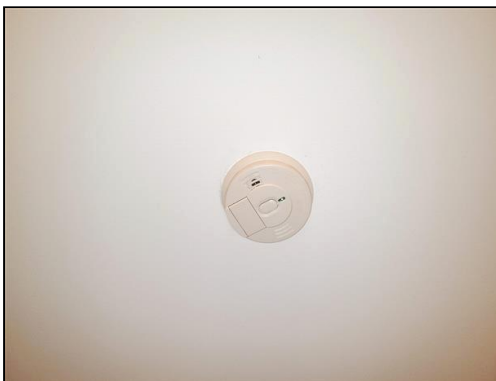
8.7 Item 1(Picture)

Recommend to install and replace all older smoke detectors as suggested by the Fire Protection Association.

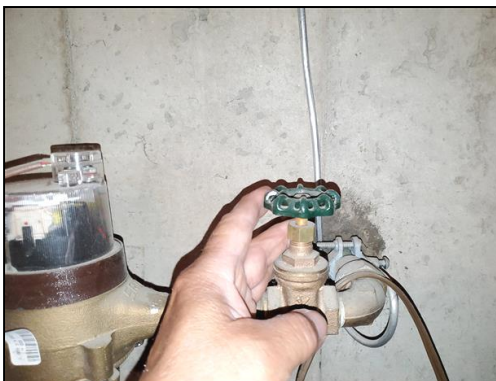
9.3 Item 1(Picture)

The main shut off is the green knob located in the basement. This is for your information.

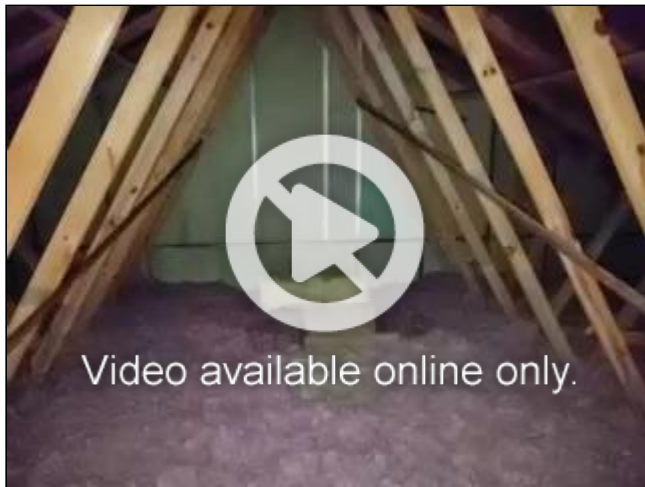
1.4 Item 1(Video) *** ATTIC VIDEO ***

Suggest to view attic video for more information.

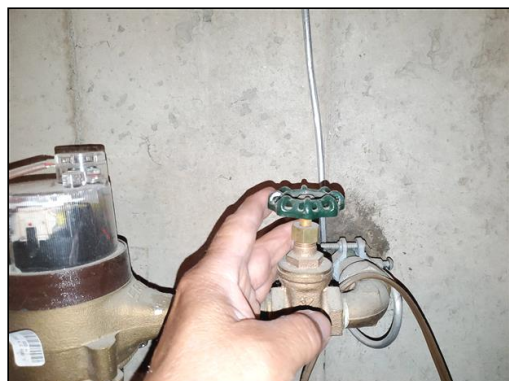
9.3 Item 1(Picture)

The main shut off is the green knob located in the basement. This is for your information.
