Asbestos Abatement Close-out Report

**Mayfield Downtown
Cost Center No. RFC023517
117 North 7th Street
Mayfield, Kentucky**

August 3, 2018
Terracon Project No. 18187225

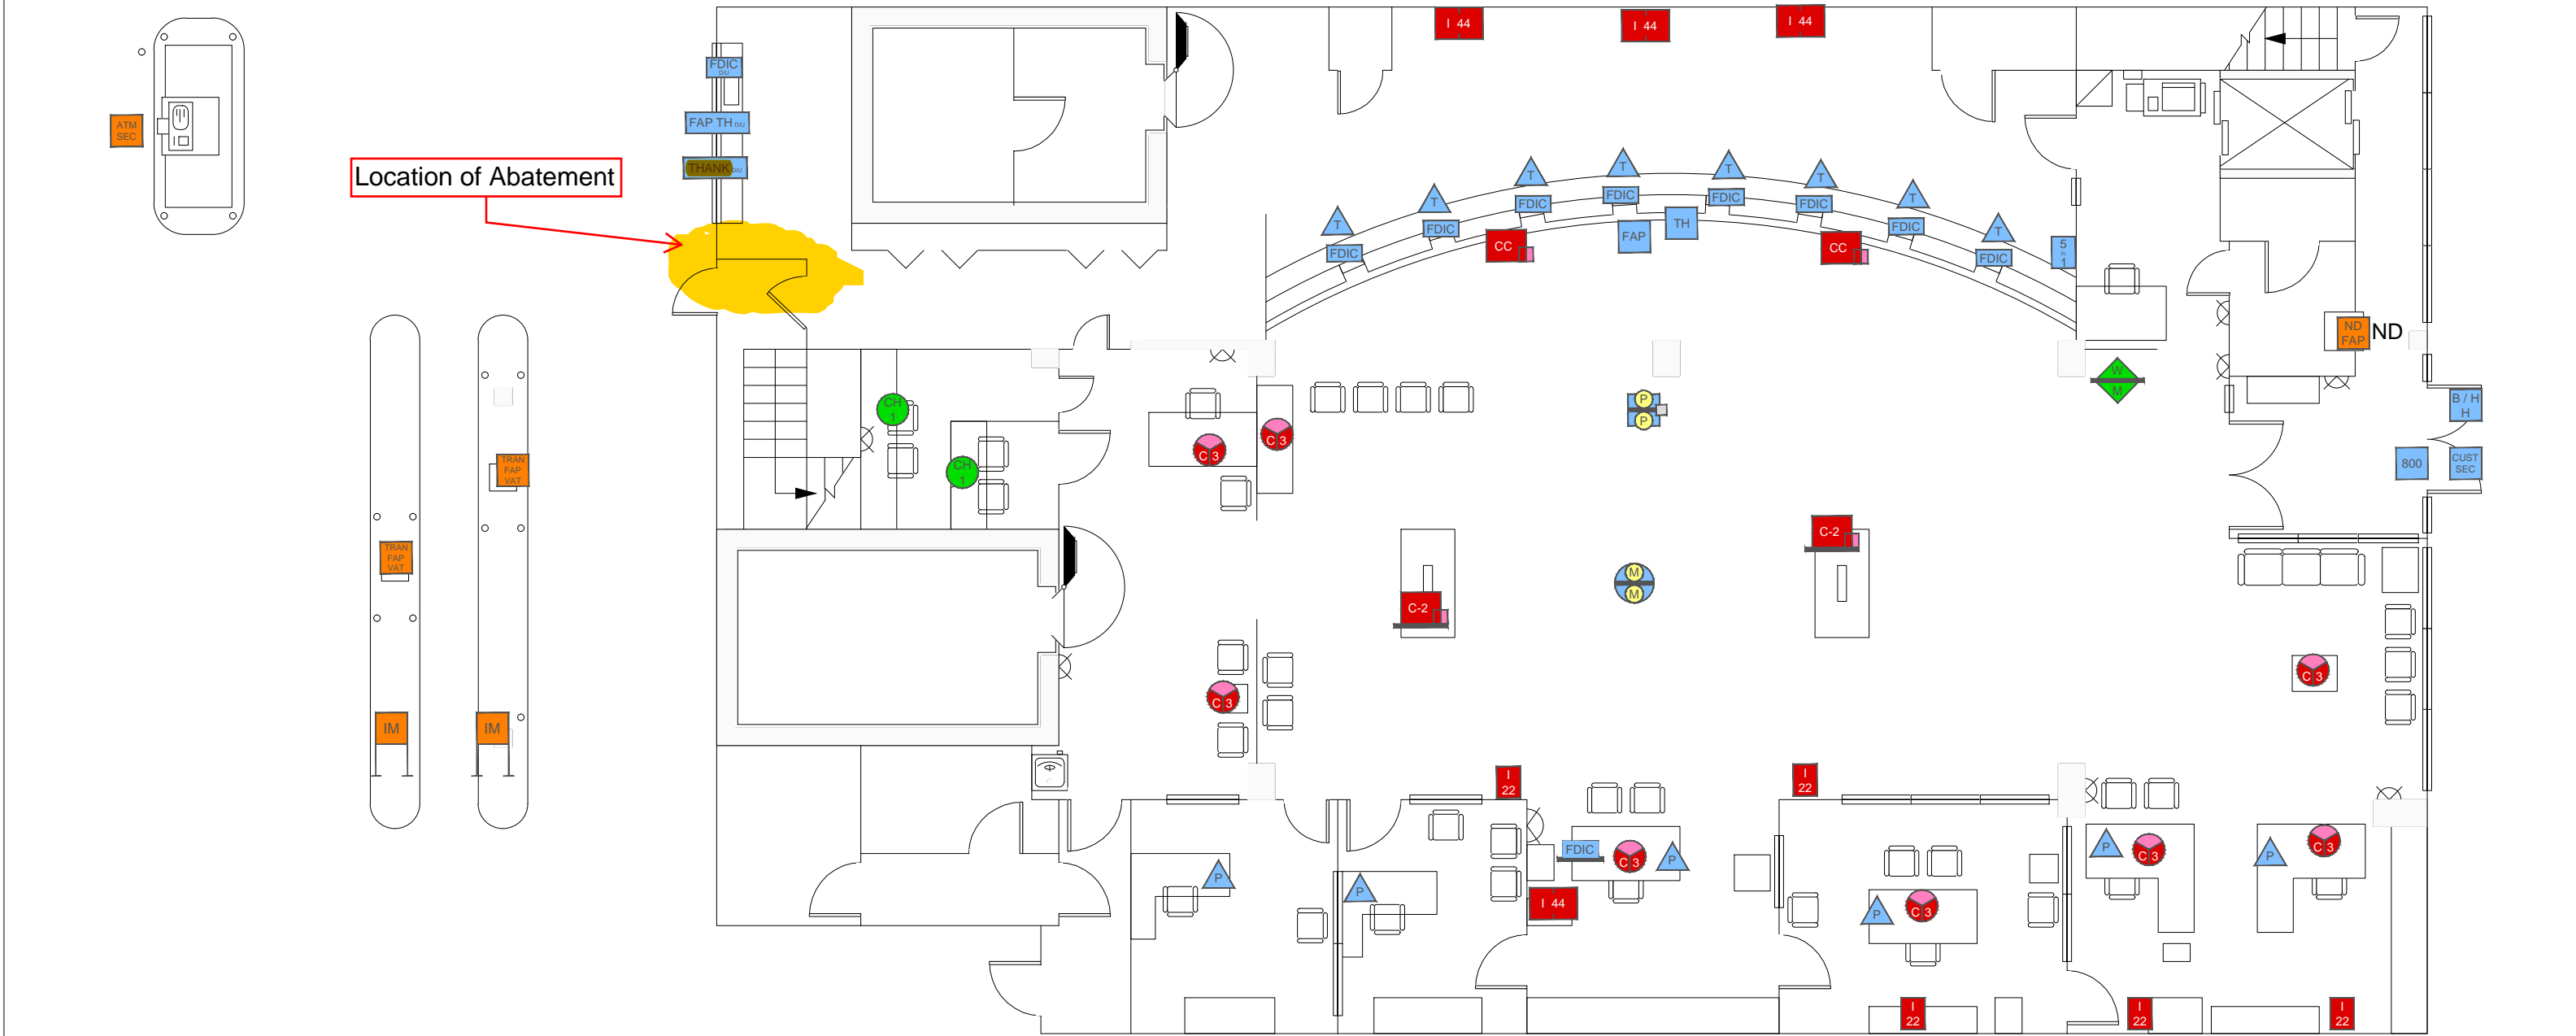
Activity	ACM	Location (Area)	Estimated Quantity
Removal of vinyl floor tile and associated ACM mastic from locations specified on the attached photo and drawing. Work shall be performed inside negative pressure containment, utilizing HEPA vacuums, hand tools and wet methods. Workers to wear appropriate personal protective equipment (PPE). Clearance via visual & PCM air sampling by Terracon.	Vinyl Floor Tile – ND Mastic – 2%C	Rear Stairwell	15 SF
