Asbestos Survey Report

Remington
Cost Center No. RFC023341
15 South Ohio Street
Remington, Indiana

November 9, 2010
Terracon Project No. N1107185 / Task 1
P.O. No. CA398907IN

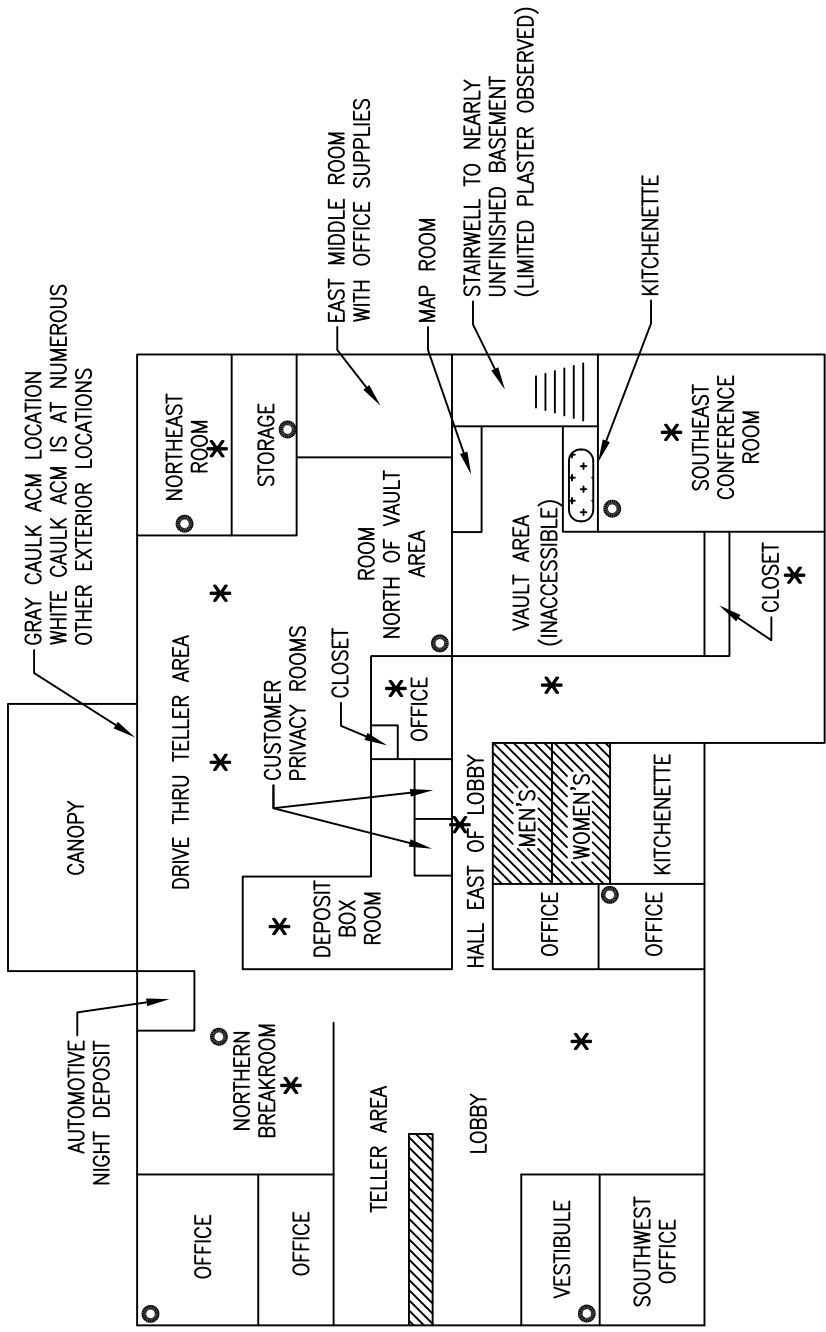
APPENDIX F
SITE DIAGRAM

Tan pebble pattern sheet vinyl ('linoleum') flooring was observed on the floors of the men's room, women's room, and the customer standing area in front of the lobby counter. This material is considered Category I non-friable ACM in good condition. However, the material also has a fibrous backing that could be rendered friable if disturbed. Terracon further recommends that if this material is to be disturbed, then it should be abated as a regulated asbestos containing material (RACM).

White caulk was observed on the exterior doors and the windows for the structure. This material is considered a Category II non-friable ACM in good condition.

Terracon recommends that the identified ACM be removed and disposed of by an Indiana Department of Environmental Management (IDEM) licensed asbestos abatement contractor prior to the renovation activity that will disturb the asbestos-containing materials identified.
