ASBESTOS SURVEY REPORT

NETTLETON
COST CENTER NO. RFC004904
4902 EAST NETTLETON AVENUE
JONESBORO, ARKANSAS 72401

Terracon Project No. 94107574.004
PO No. CA398907AR

October 14, 2010

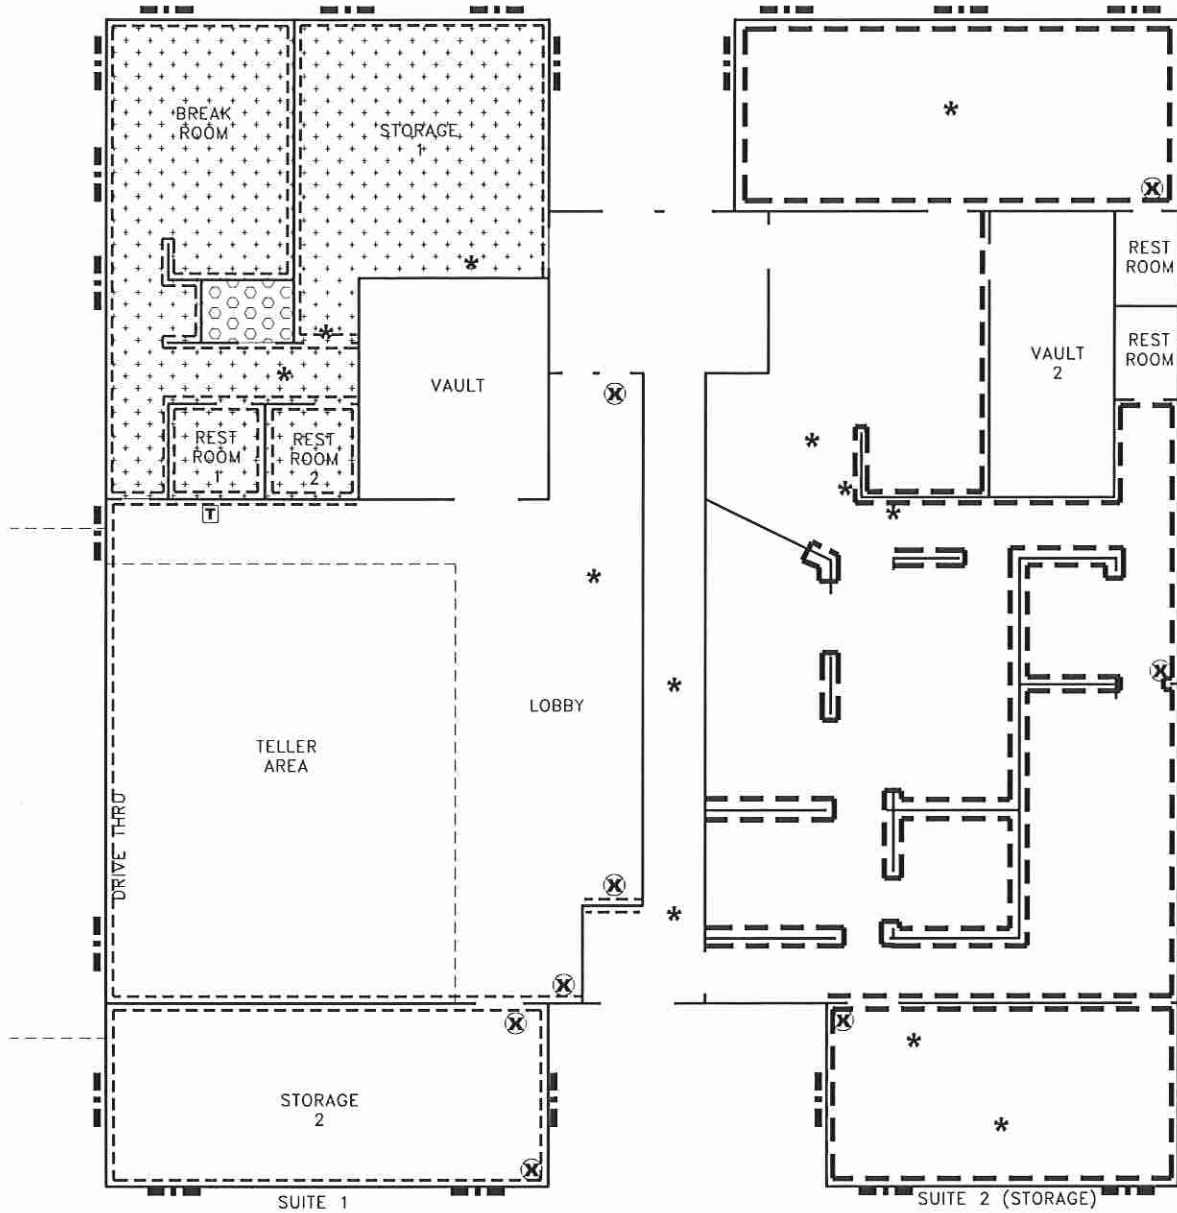
APPENDIX F
SITE DIAGRAM

The wall texture/drywall/joint compound (tan, semi-smooth) is located throughout Suite 1 and is assessed as a non-friable ACM in good condition.
