5021 Martins Point Rd
Kitty Hawk NC 27949

6/13/2018

Burke Inspection Service dba HouseMaster - VA #3380001054
109-G Gainsboro Sq. - #165
Chesapeake, VA 23320
(757) 549-3433

Table of Contents

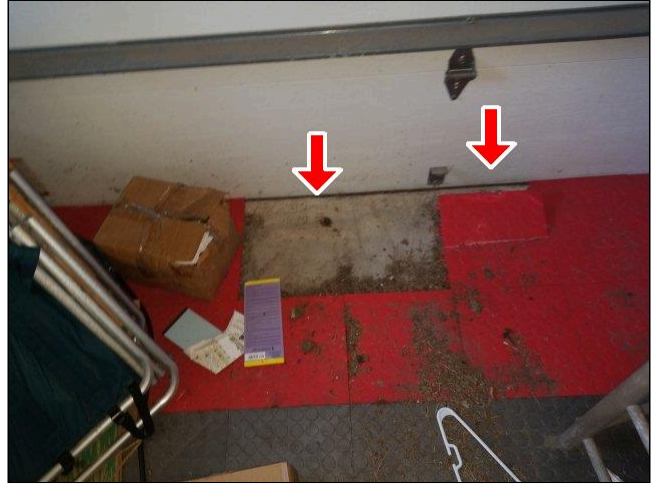
4.0.A ROOFING Photo 1

●					4.0.A ROOFING The roof cover is in generally good condition, but minor damage was noted at the eave at the rear of the structure, monitor and maintain as needed.
●					4.1.A EXPOSED FRAMING
●					4.2.A FOUNDATION / WALLS
●					4.3.A FLOOR SLAB A few of the plastic floor tiles are damaged or missing, replace as needed / desired.
●					4.4.A SIDING / TRIM
●					4.5.A WINDOWS The interior hardware and trim is missing from the casement windows, replace as needed. (crank handles and caps for latch levers)
	●				4.6.A ENTRY DOOR(S) Both exterior entry doors rub the jambs, and there are no holes in either for the deadbolts, correct and maintain as needed.
		●			4.7.A WALLS / CEILINGS Walls have been insulated (except for below the windows) but not finished with drywall, upgrade as desired.
●					4.8.A OVERHEAD/VEHICLE DOOR(S) The bottom seal is deteriorating at the west front door, replace as desired.

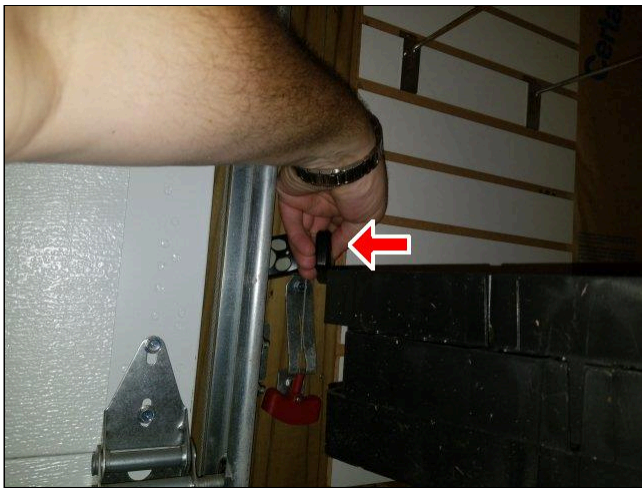
4.9.A DOOR OPERATOR(S) Photo 2

●				4.9.A DOOR OPERATOR(S) The west front door was disconnected from the opener at time of inspection, (hardware was missing) and neither of the rear doors would respond to the wall mounted wired remotes, and the west rear door did not respond to the handheld remotes as well. A defective reversing sensor was also found at the east front door. Have all checked and corrected as needed by a qualified overhead door specialist. Please be advised that there is currently no latch for the west front door, correct as needed for security.
●					4.10.A ELECTRIC / GFCI The GFCI unit on the front of the Detached Garage is redundant to one on the interior, consider replacing with a standard duplex receptacle to eliminate confusion when a fault occurs and a reset is needed.
●					4.11.A HEATING & COOLING The heat pump seemed to function properly at time of inspection, but no register covers were installed, and the equipment is approaching the end of it's design life. Add registers as needed to ensure balanced air flow and anticipate repair or replacement needs. Please be advised that system may not heat or cool adequately until finish work is complete. Inspection of the outdoor condensing unit was limited by overgrowth, keep area around unit clear to allow for servicing and proper airflow.
