INSPECTION REPORT  
210 81st St  
Virginia Beach VA 23451

INSPECTED BY  
John Burke  
Beacon  
Inspections -  
OBX, LLC

INSPECTION DATE  
📅 9/28/2023  
🕒 09:00 AM

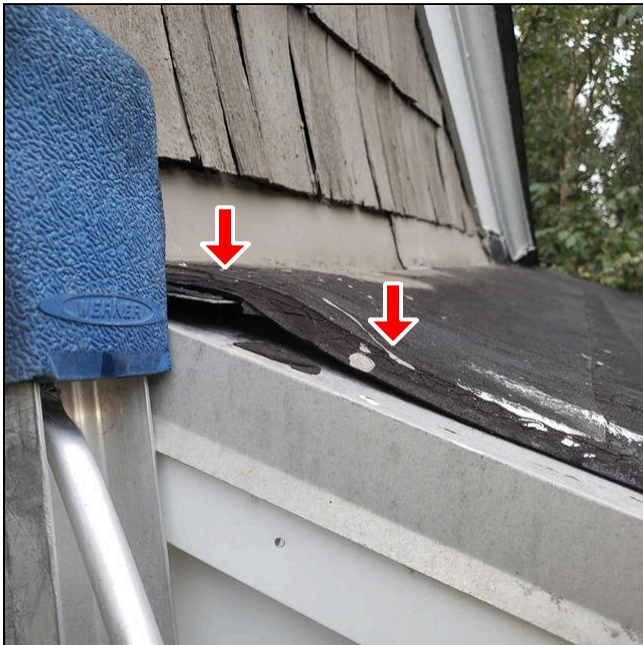
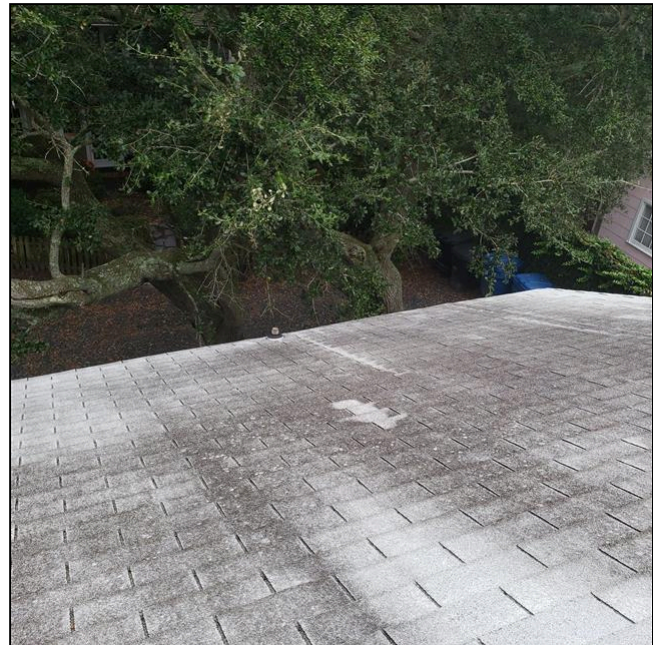
**1.0 (2)** The roof covers on the Guest House / Apartments appear to be approaching the end of their service lives. Lifting was observed at the edge of the flat roofing membrane on the northern portion above the stairs. Buyer should have evaluated further and obtain estimates for future replacement.

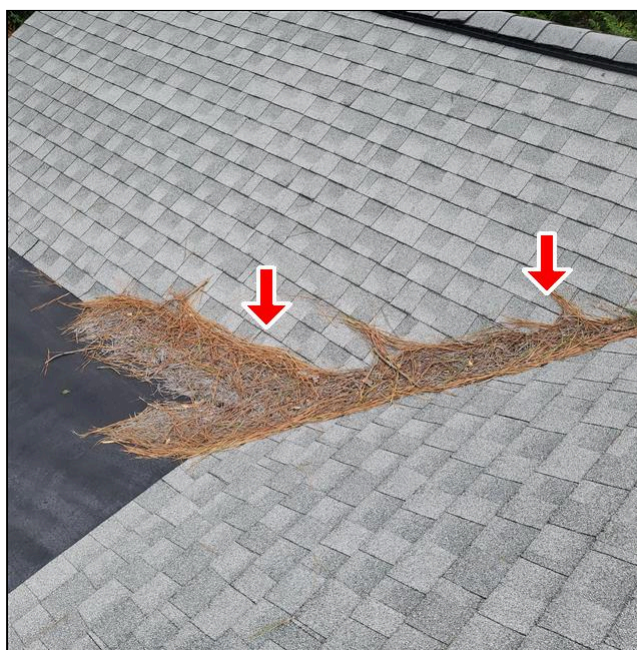
1.0 Item 5 (Picture)

**1.0 (3)** Pine needles and other debris is collecting in the valleys of the roof over the main house, clear and maintain as needed to reduce the potential for leakage resulting from damming.

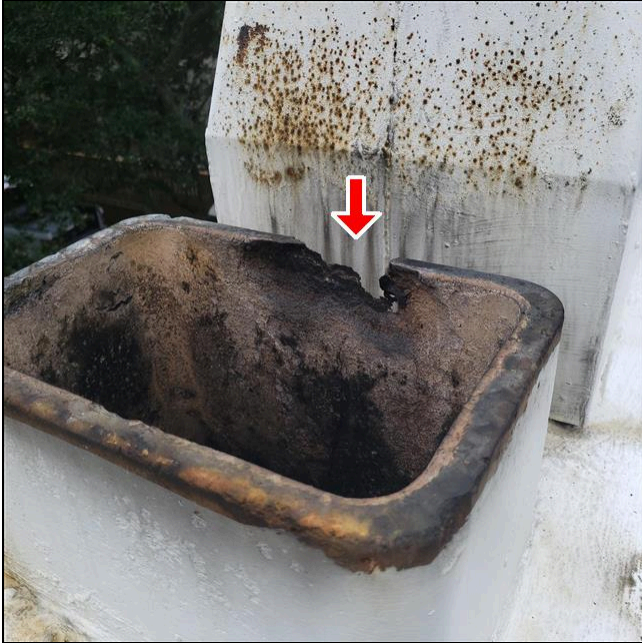
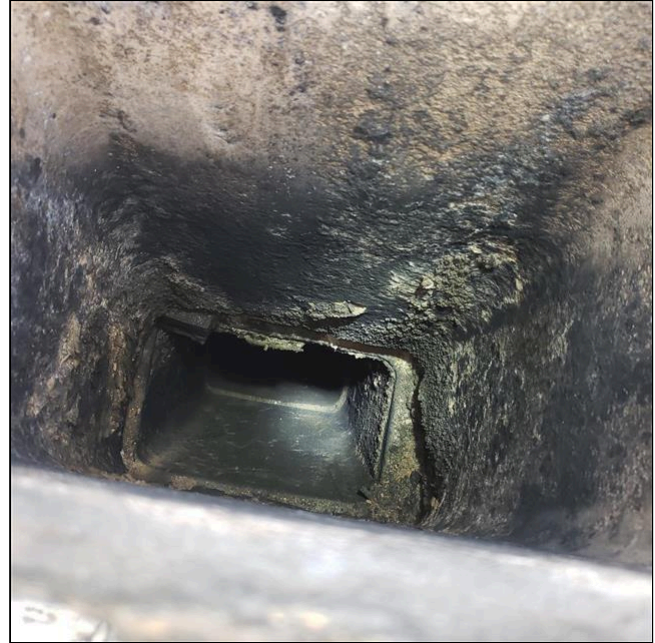
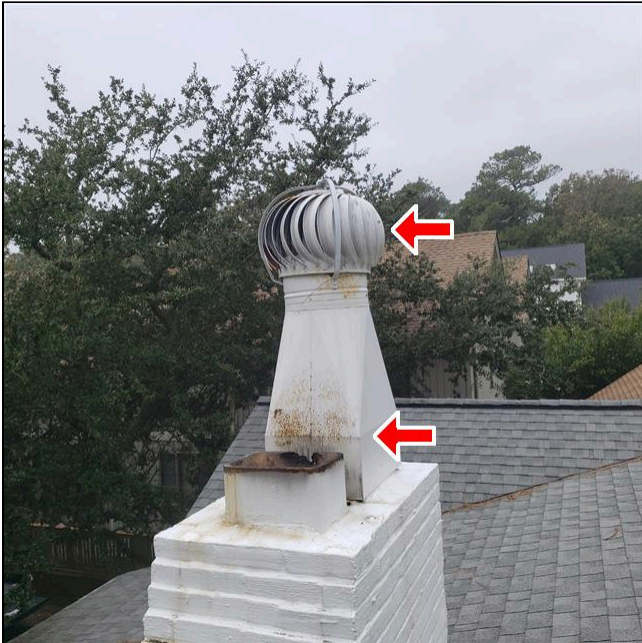
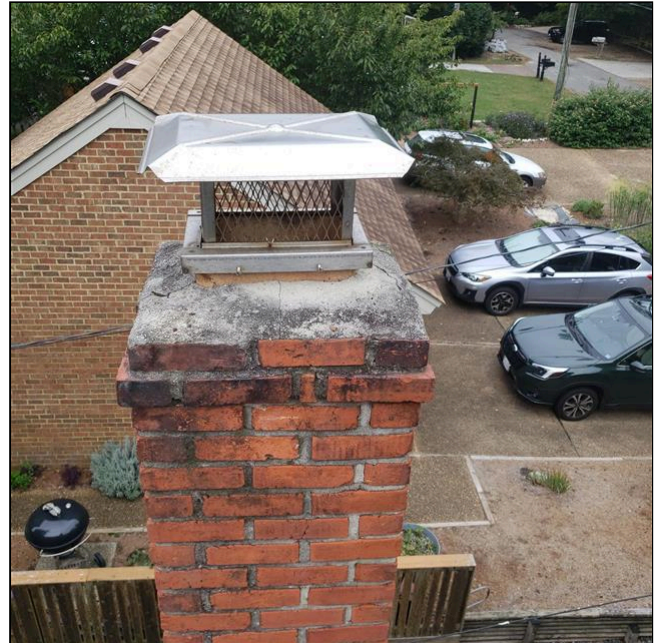
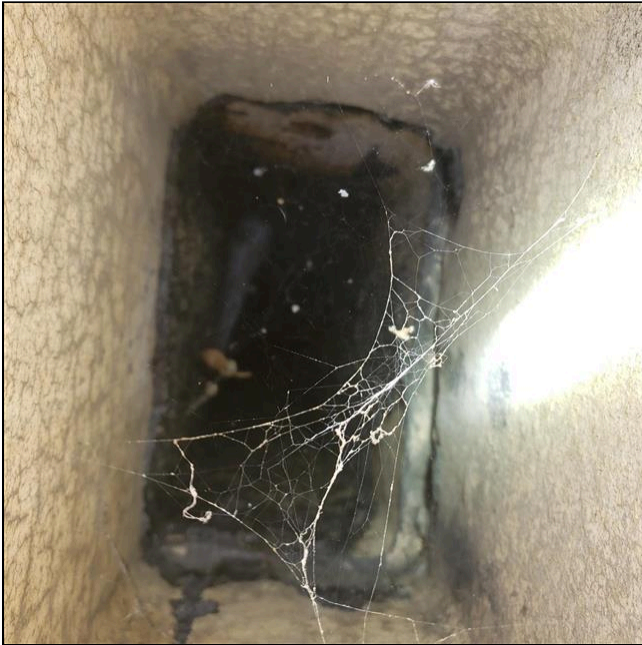
**1.1 (1)** The flue that is in use for the oil-fired furnace at the chimney at the center of the main house is badly deteriorated, and the fireplace flue at that chimney has been improperly covered with a (chefs hat style) spinning turbine roof vent. The vent extension that the roof vent is mounted to could also contribute to down-drafting of the exhaust from the furnace. Minor cracking and deterioration was observed in the flue of the chimney for the 1st Fl Family Rm fireplace as well, and in its crown. Have checked and corrected as needed by a Certified Chimney Sweep. Of particular concern is the potential for leakage of flue gasses from the oil furnace into the living space.

*Inspection of the chimney(s) was limited to readily accessible and visible components. Having a "Level*

2" inspection performed by a (CSIA) Certified Chimney Sweep is generally recommended prior to the sale of any property with a wood burning fireplace, or one that has been converted for use with gas logs.

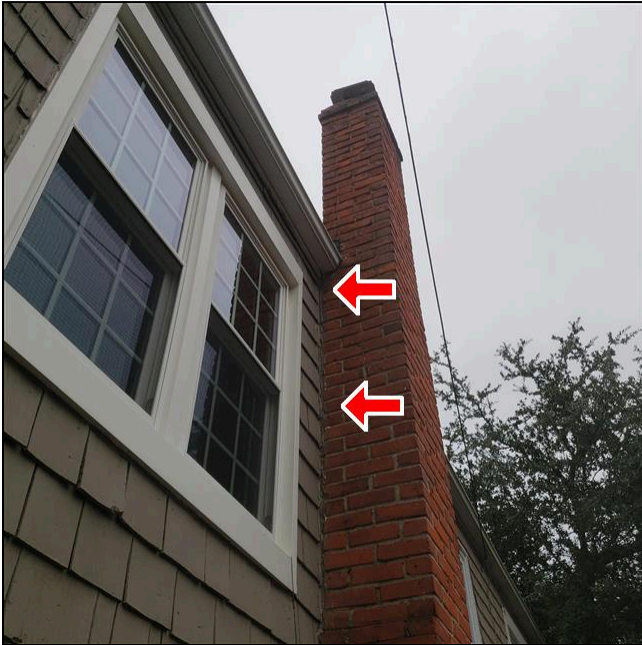
1.1 Item 7 (Picture)

**1.1** (3) The chimney for the 1st Fl Family Rm fireplace of the Main House has settled and pulled away from the house slightly. Conditions should be closely monitored and the gap re-sealed periodically or as needed to prevent water intrusion.

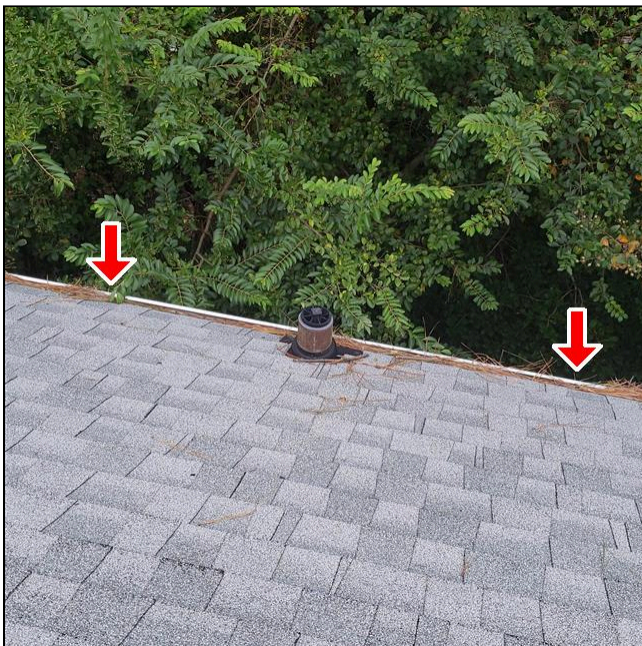
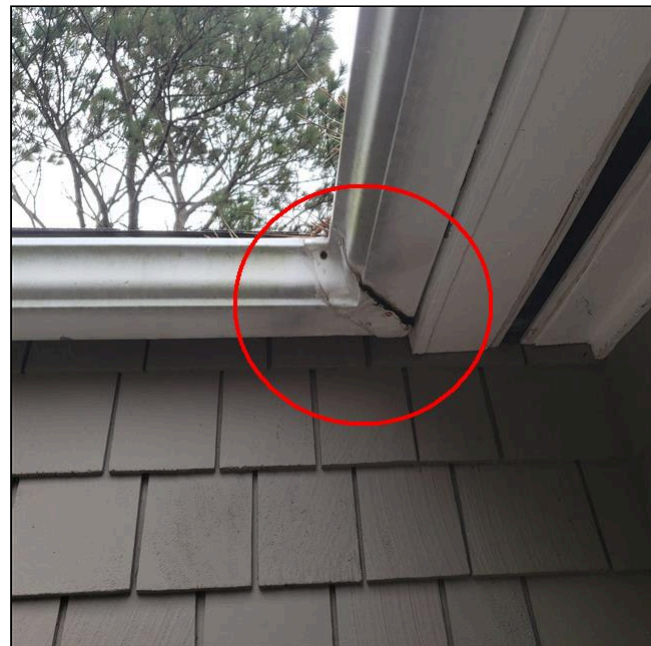
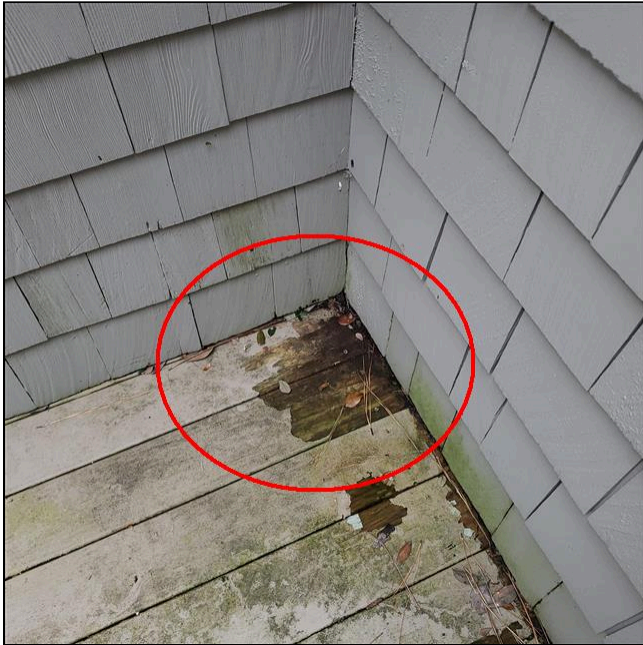
**1.6** (1) The gutters were full of pine needles and debris at the time of inspection, and signs of leakage were observed at the seams, clear, re-seal, and maintain as needed.

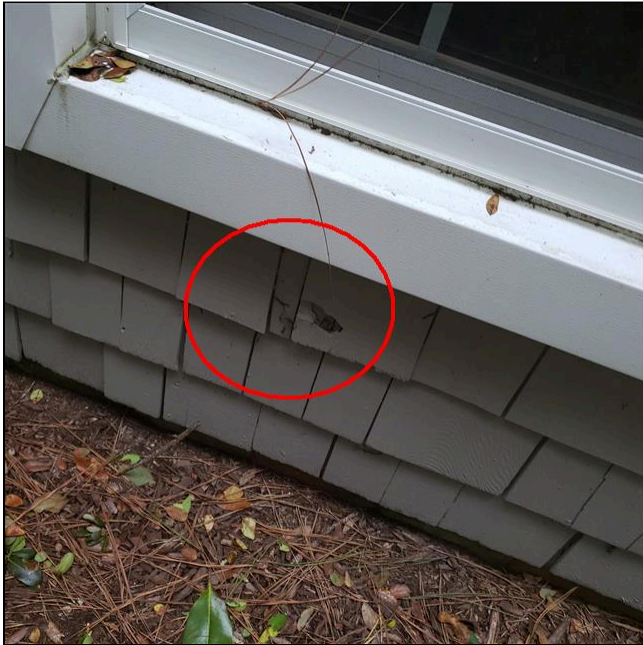
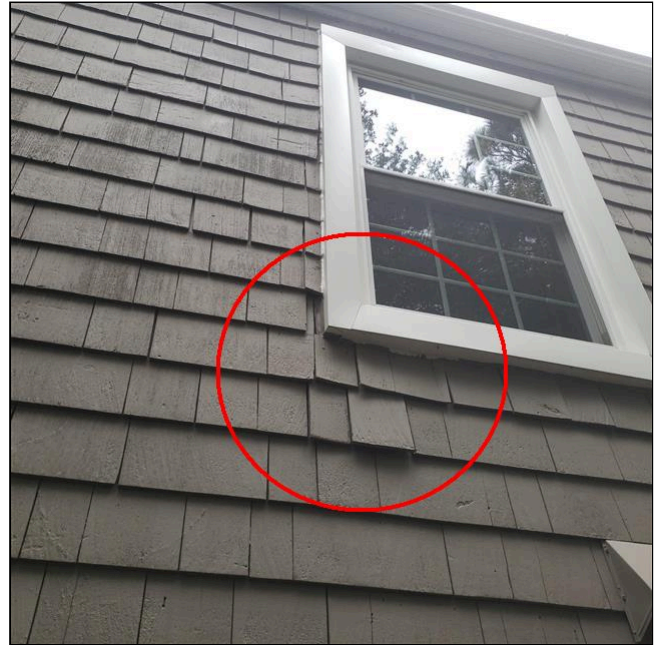
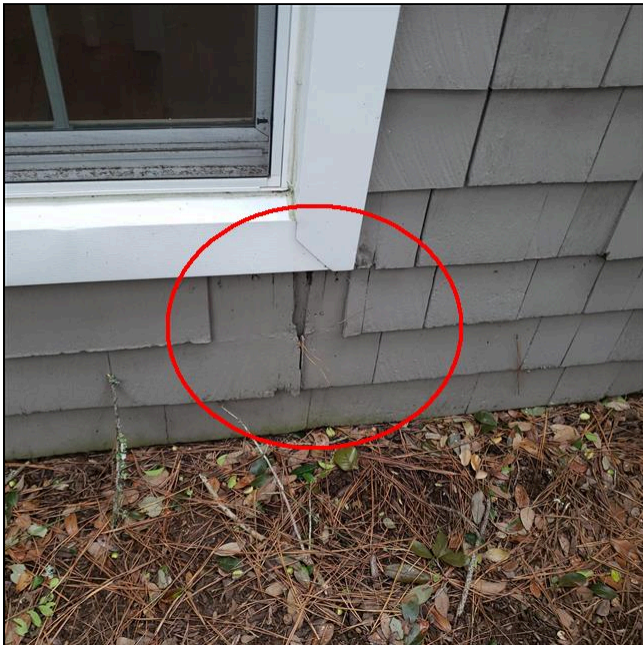
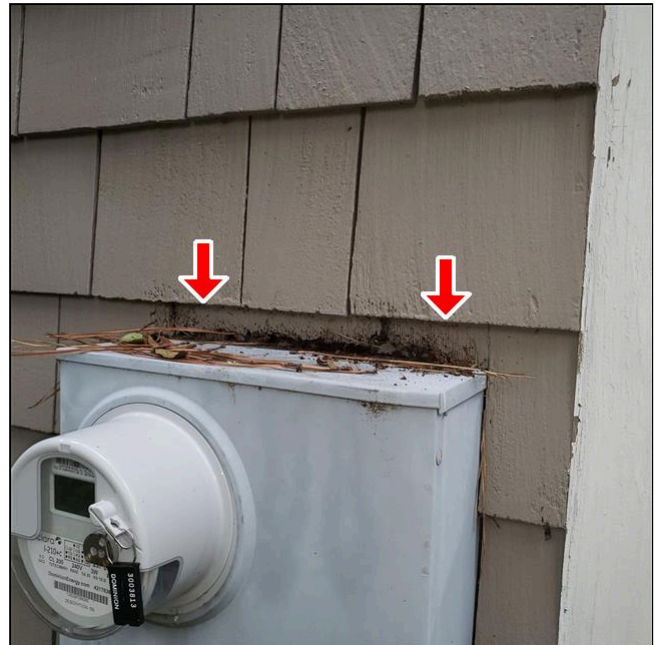
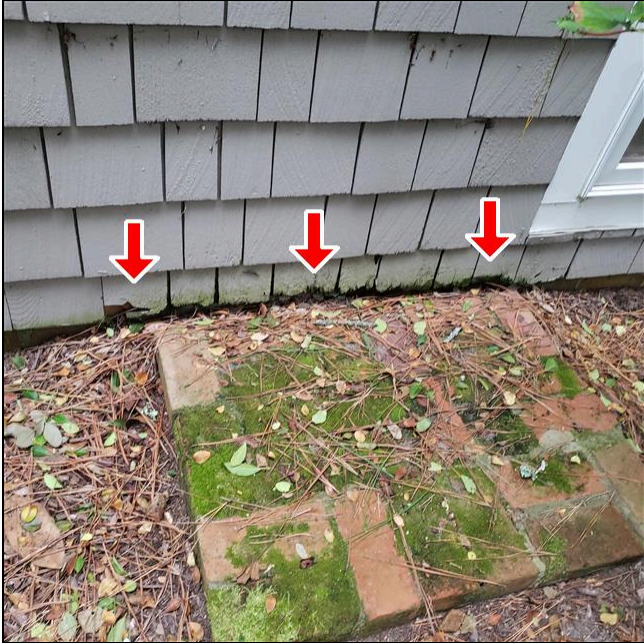
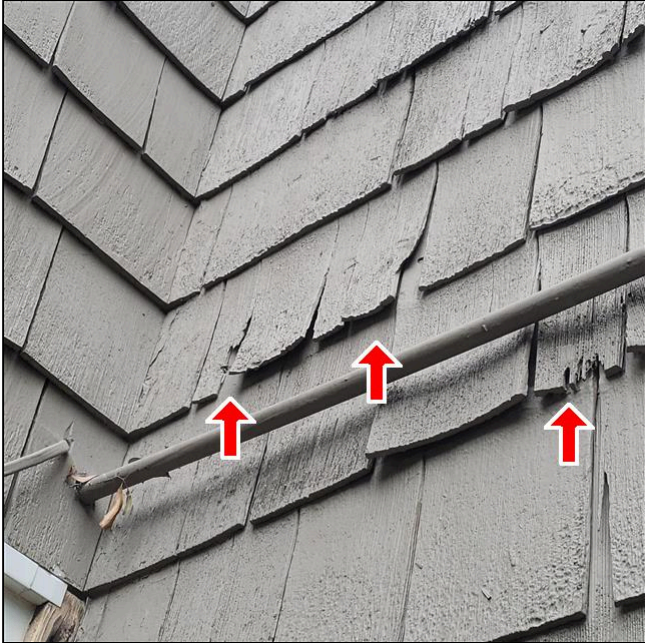
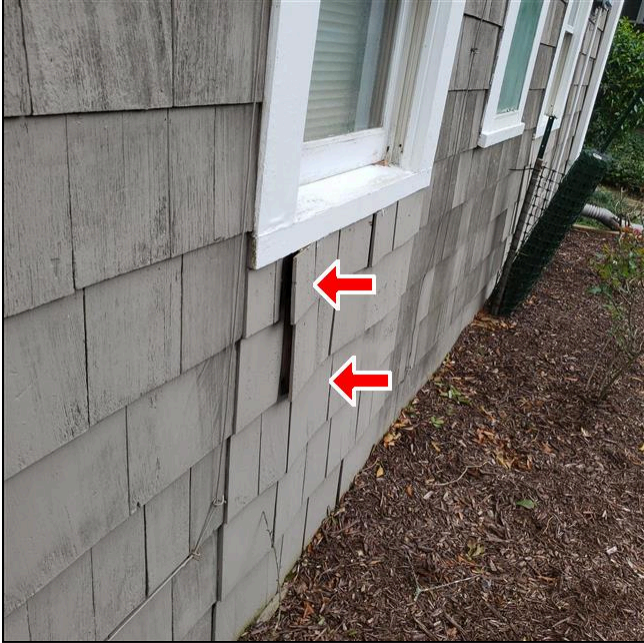
2.0 The wood shingles on both buildings are warping, decayed, thinning, and/or missing in multiple locations, have checked and corrected as needed by a licensed Contractor to reduce the potential for water intrusion and subsequent decay and/or mold concerns.

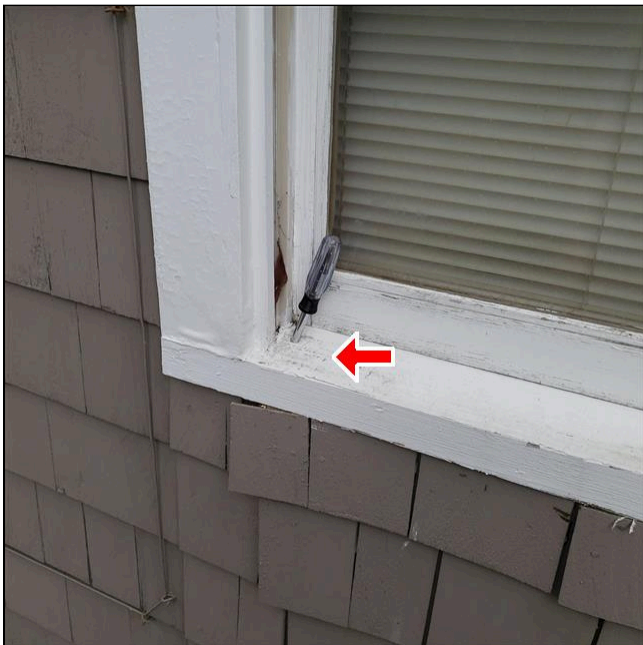
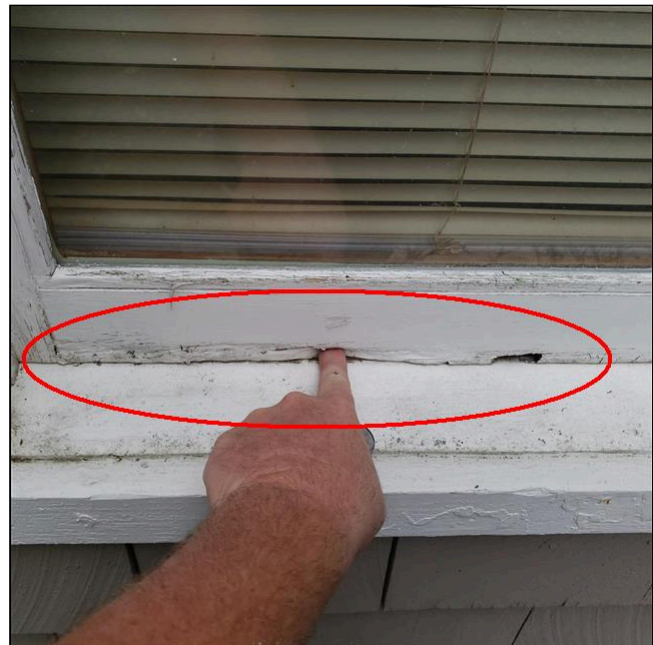
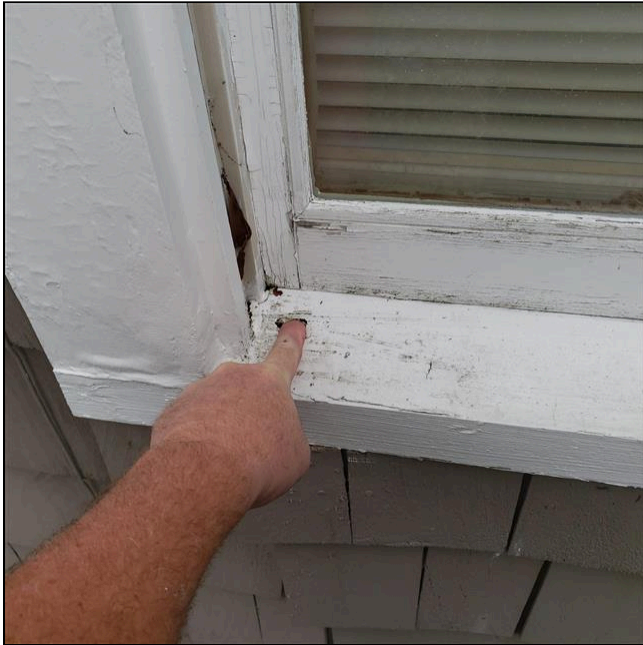
**2.2 (2)** Significant decay was observed in a window sash and in the sills of the windows on the east side of the Guest House, correct as required to reduce the potential for water intrusion and additional damage, decay, and/or mold concerns.

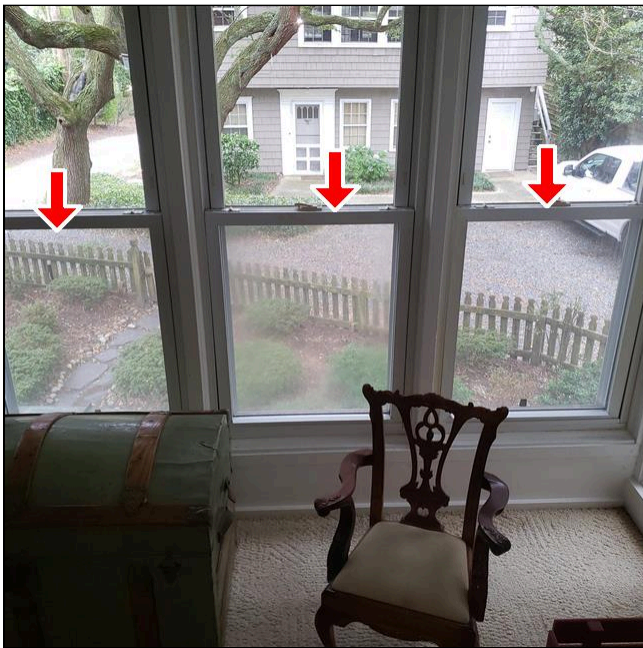
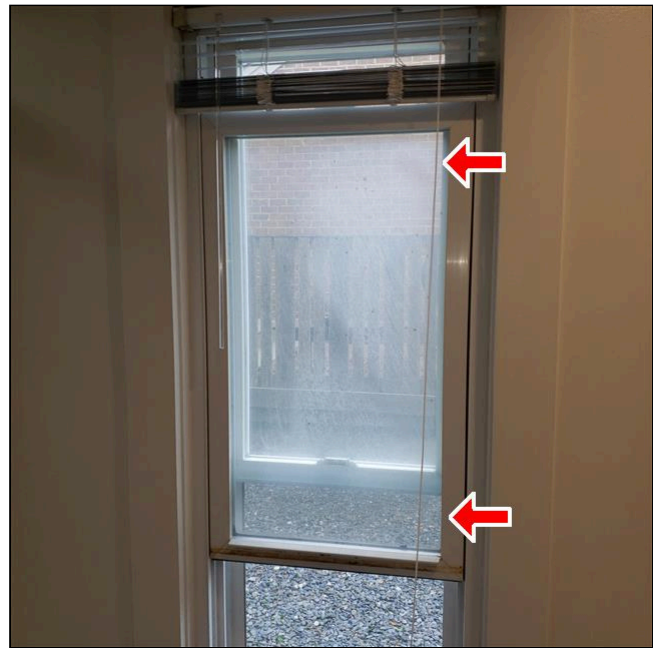
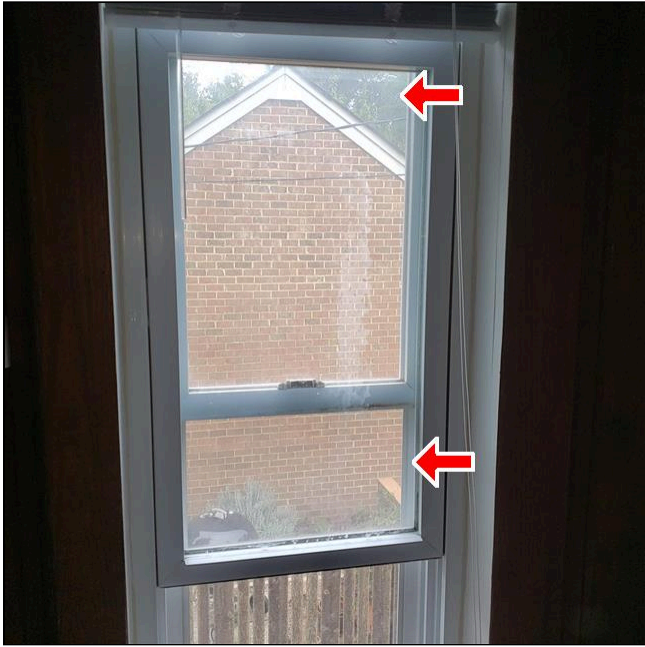
**2.2 (3)** The seals for the insulated glass have failed at several of the windows, such as at the Main House Sunroom, and both of its Hall Baths; and at the 1st Fl windows on the east side of the Guest House. While not readily apparent at the time of inspection, other insulated-glass units may have also failed. Recommend a check of all units to determine extent of repair/replacement work required. Replacement of insulated glass windows or doors is usually required to correct failed or defective vacuum seals. Fortunately, the insulation value is usually not significantly reduced. Replacement time frame may be discretionary; however, conditions will gradually worsen with time.

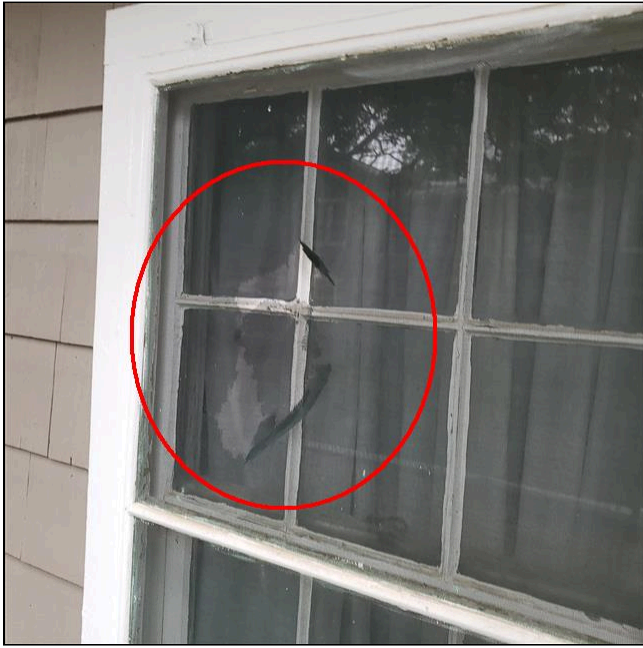
2.2 Item 11 (Picture)

2.2 (5) Missing and damaged screens noted, repair or replace as desired.

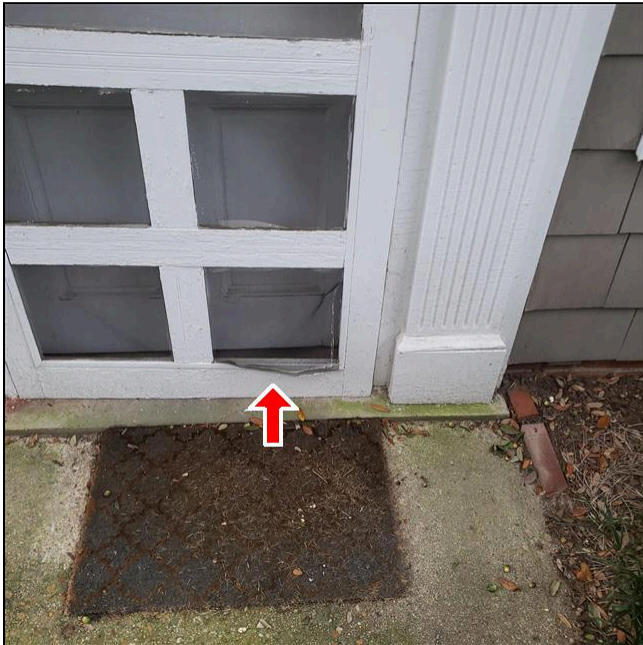
2.3 Item 3 (Picture)

2.3 (3) Damaged screens were noted at the screen doors of the Guest House, correct as desired.

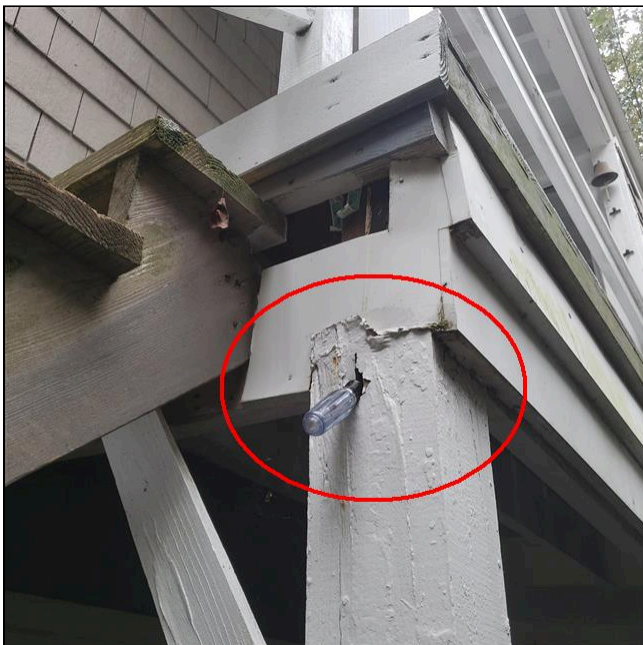
2.5 Item 1 (Picture)

**2.5 (1)** Significant decay was observed in the outer girder for the rear porch / balcony of the Guest House, and at the top of a post for it by its stairs, obtain repair estimates from a licensed Contractor and have corrected immediately.

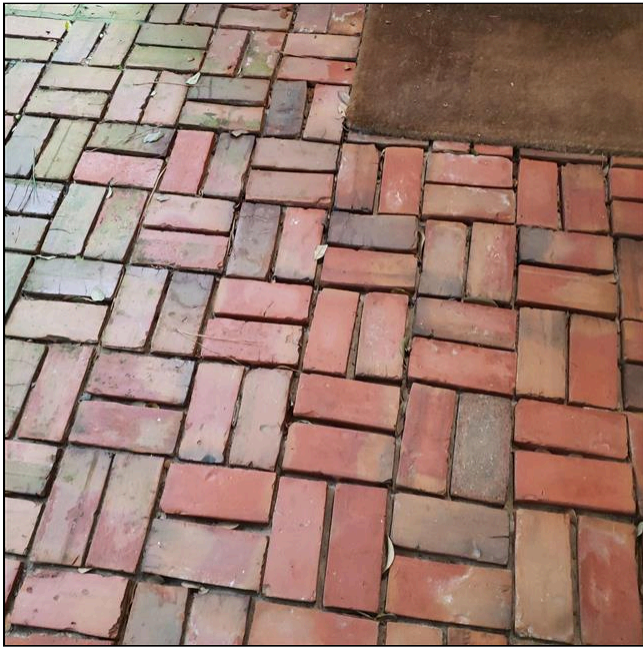
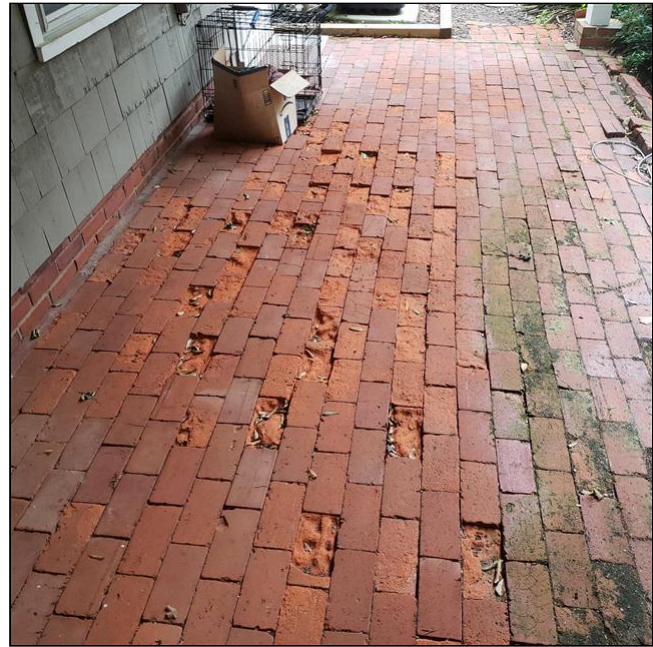
**2.5 (3)** The brick mortar has deteriorated at the front porch of the Main House, and spalling / deteriorated and loosening bricks were noted at the patio area below the porch of the Guest House, correct and maintain as needed to eliminate potential tripping hazards.

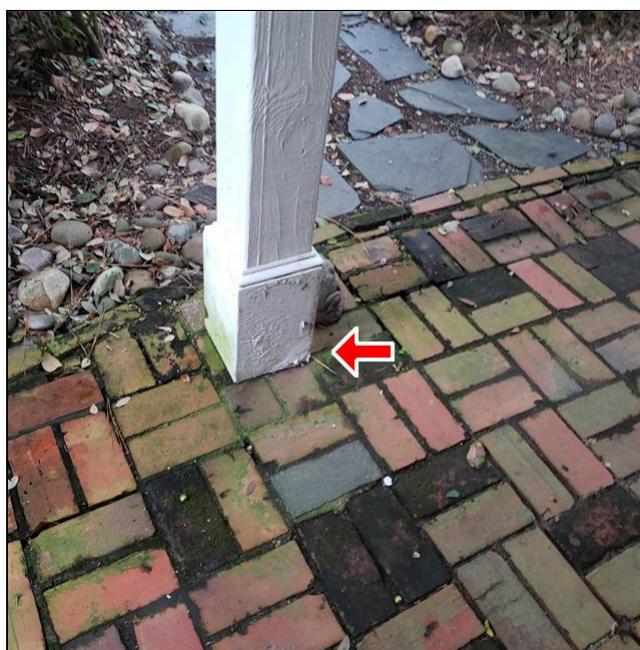
2.5 Item 7 (Picture)

**2.5 (4)** Deteriorated paint was noted at the base of the columns at the front porch of the main house, re-paint and maintain as needed.

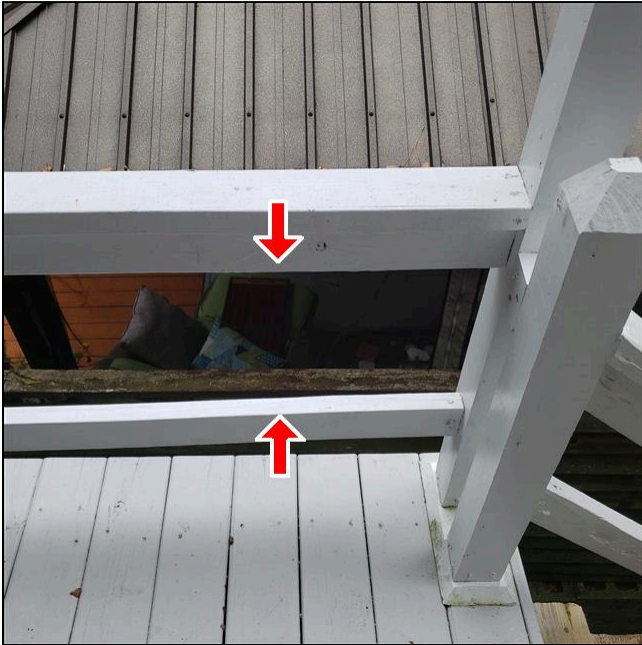
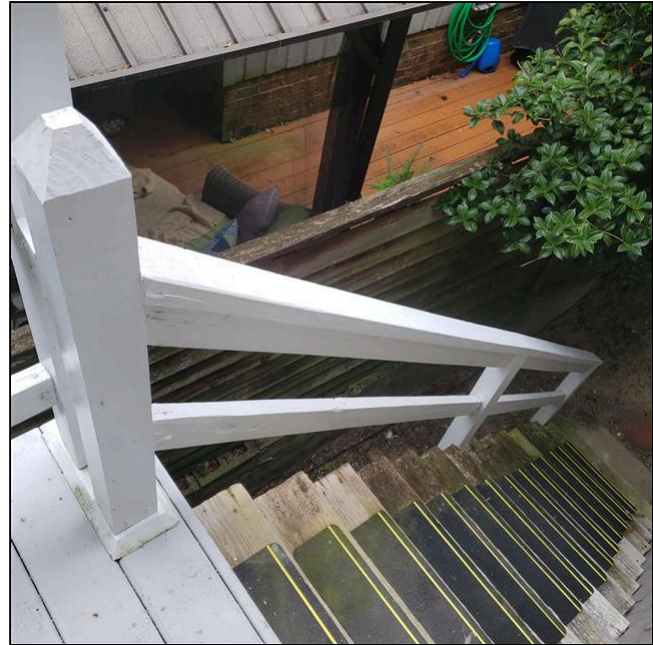
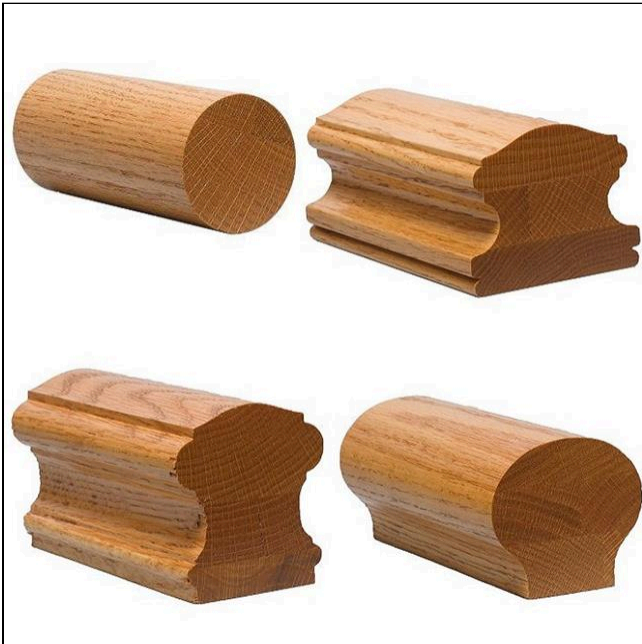
**2.6** The open rails at the stairs of the Guest House are no longer permitted due to child safety concerns, and the top rail is not graspable as required by current standards as well, consider upgrading for improved safety.

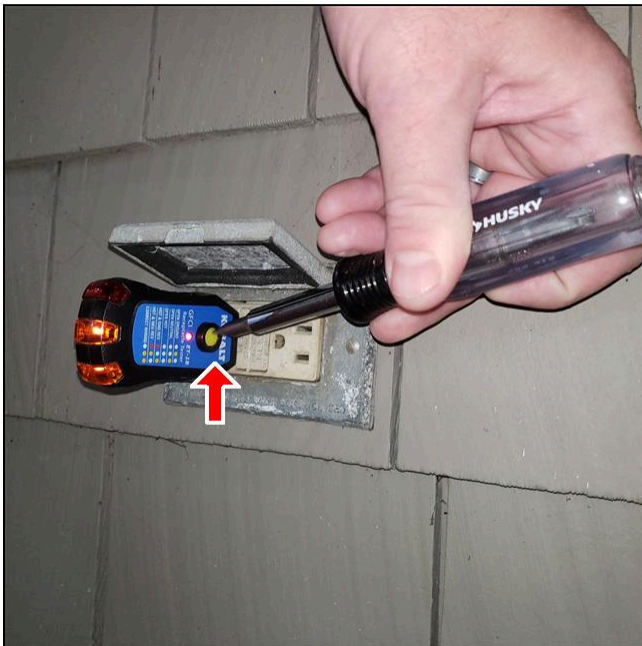
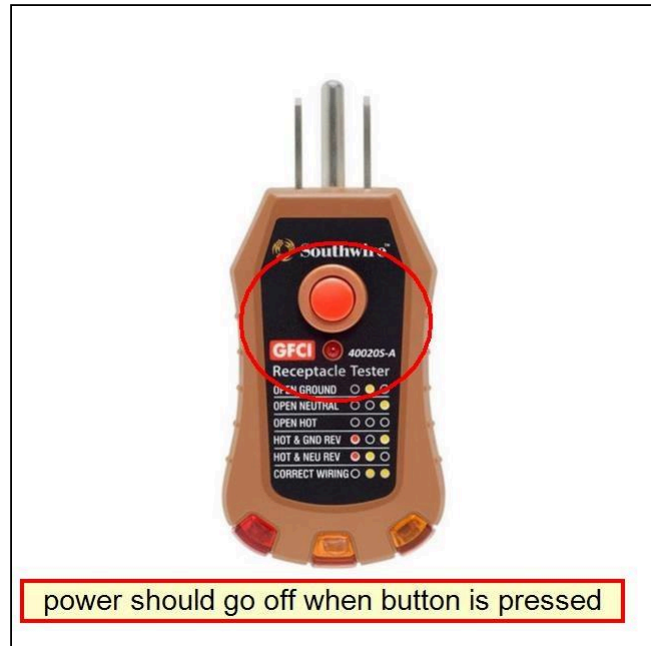
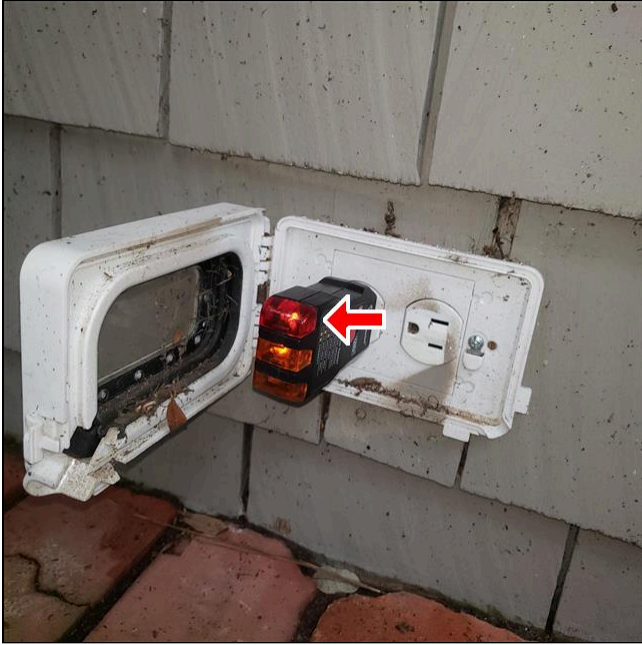
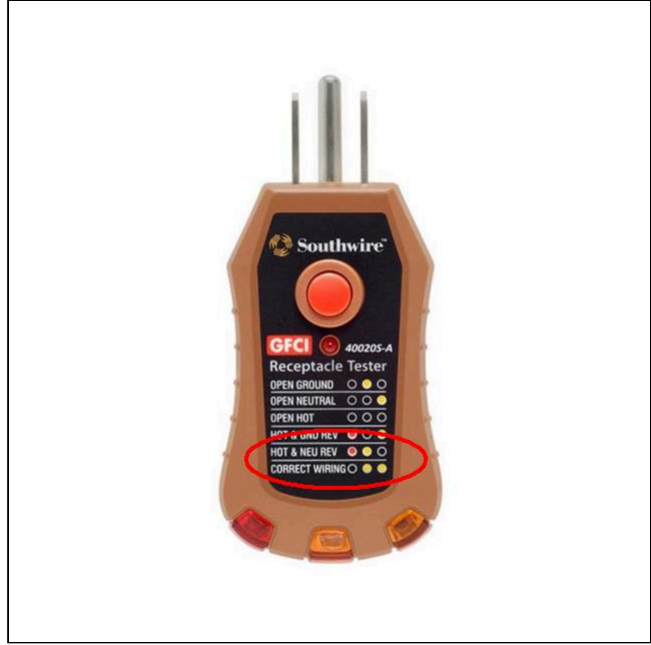
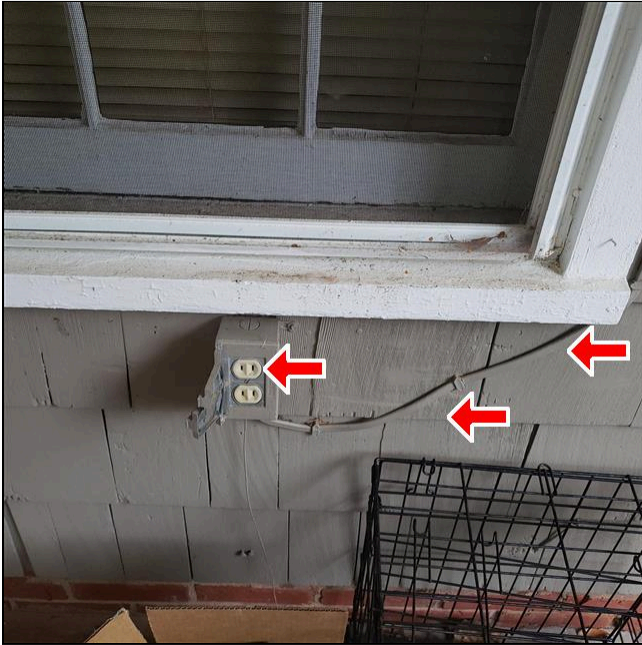
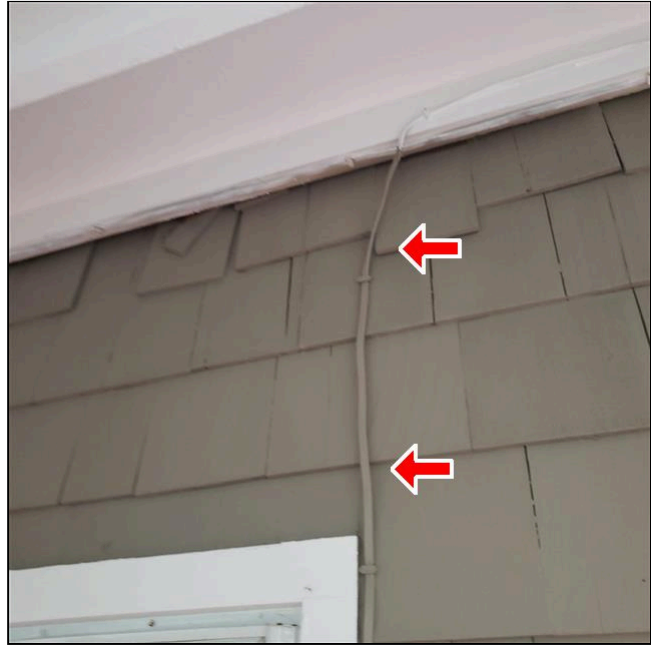
**2.12 (1)** The GFCI outlet at the front porch of the main house is defective / will not test, and the other outdoor receptacles lack GFCI protection as well; the outlet on the rear of the main house is wired with reversed polarity, presenting an additional shock hazard; and the outlet on the rear of the Guest House is also ungrounded, and the wiring for it is improperly exposed / unprotected. Have checked and corrected as needed by a licensed Electrical Contractor to ensure safety.

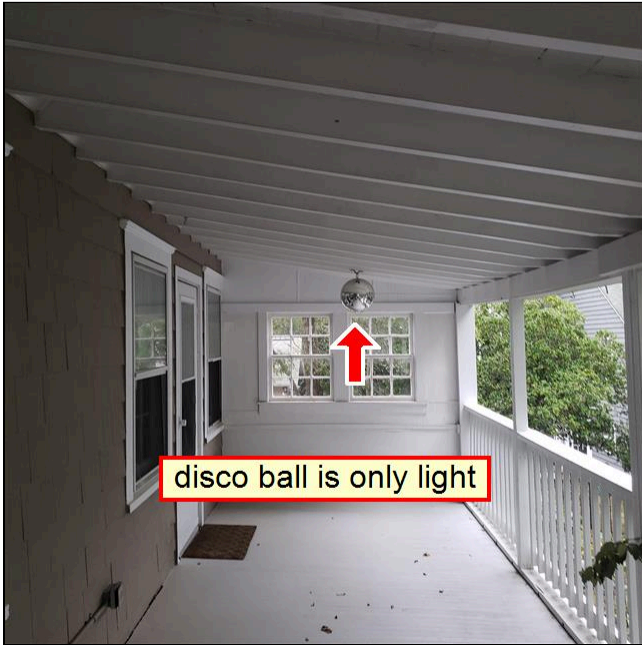
2.12 Item 7 (Picture)

2.12 (2) There are no exterior light fixtures by the Guest House doors on at its porch, add as needed for improved safety.

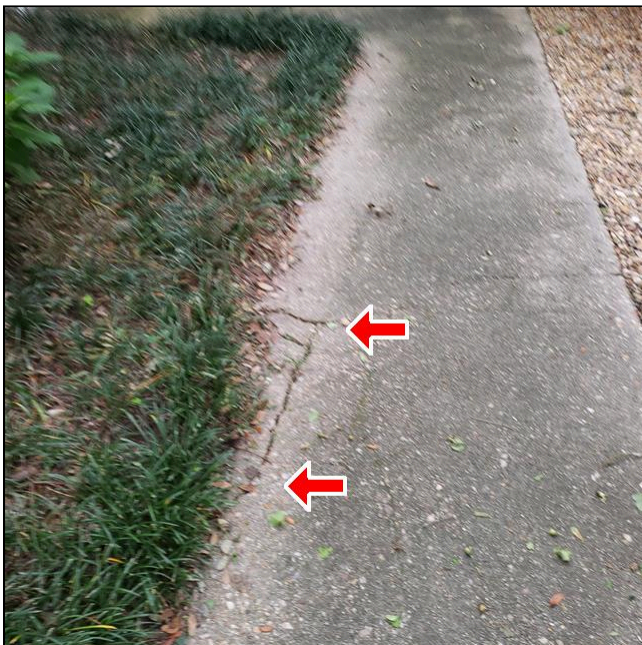
2.16 Item 1 (Picture)

**2.16** (1) Cracking and minor damage was observed in the concrete walkway at the front of the Guest House, correct and maintain as needed / desired.

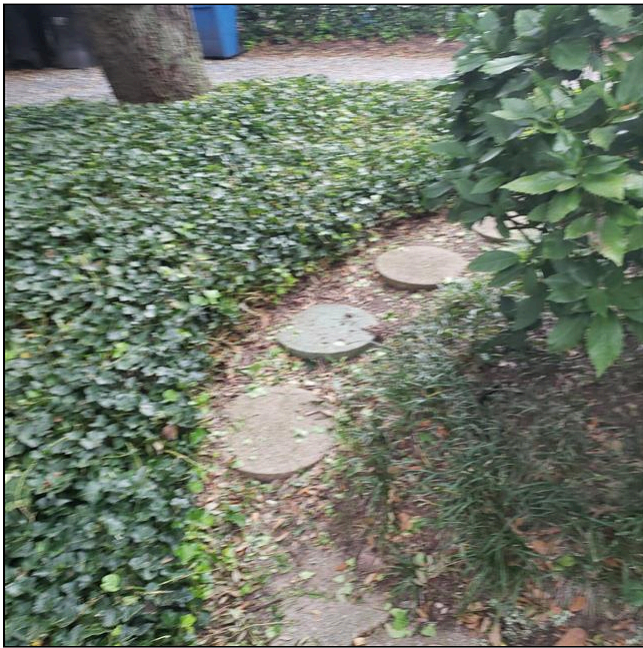
2.16 Item 3 (Picture)

**2.16** (2) The stepping stone and slate walkways will require periodic maintenance / leveling, monitor

and maintain as needed.

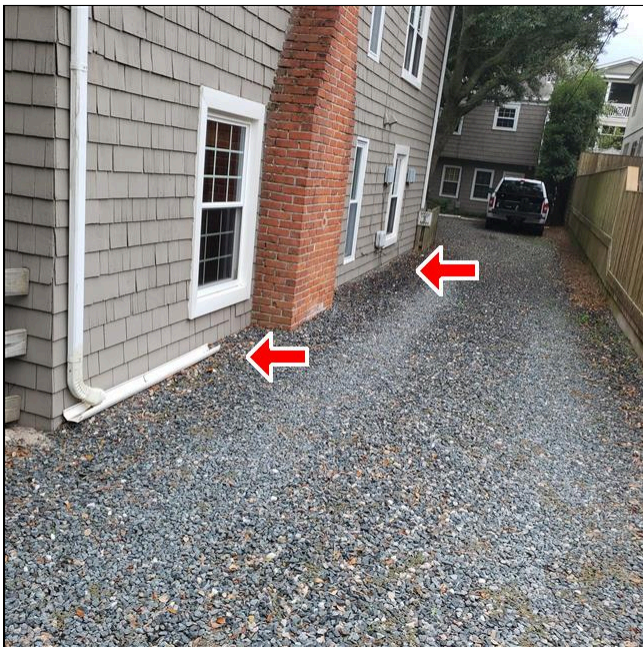
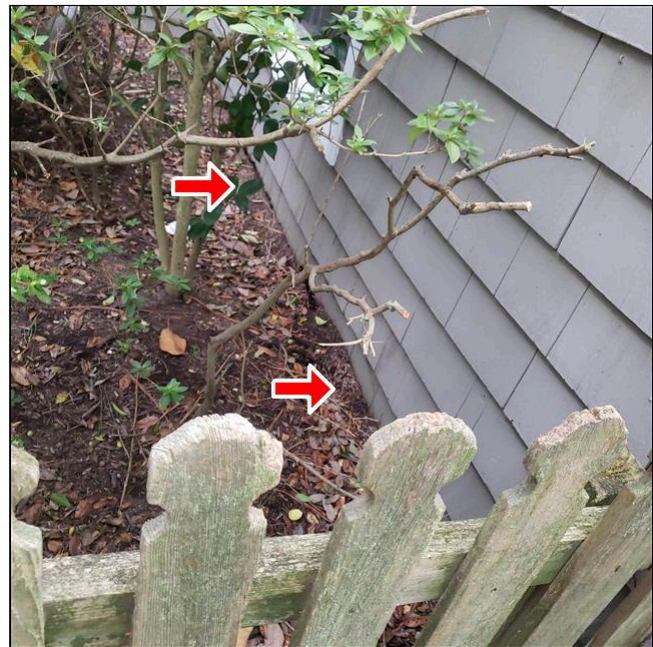
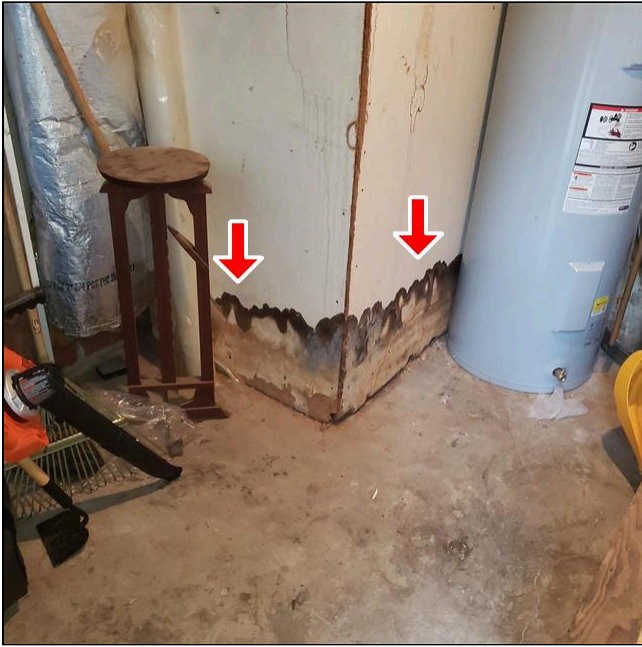
**2.18** The lot slopes toward the structures and soil-siding contact was observed in multiple locations. Signs of prior flooding were observed in the Guest House Utility Rm. Adjust the grade levels and drainage as needed to reduce the potential for water intrusion and decay.

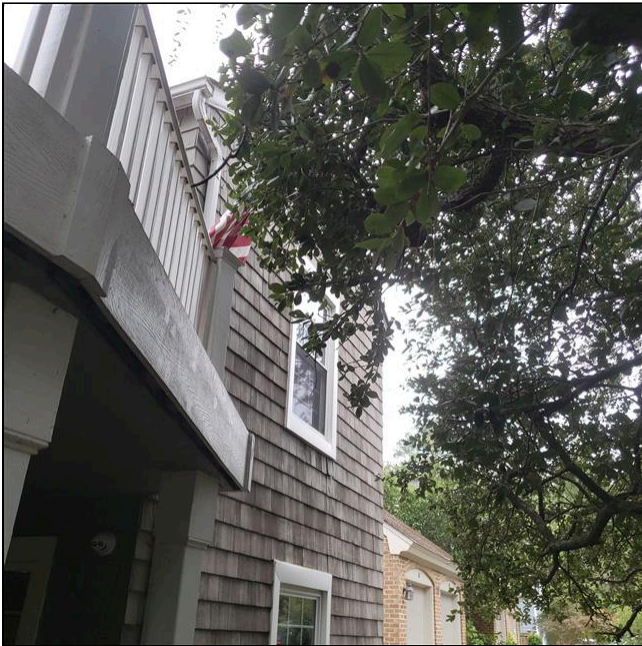
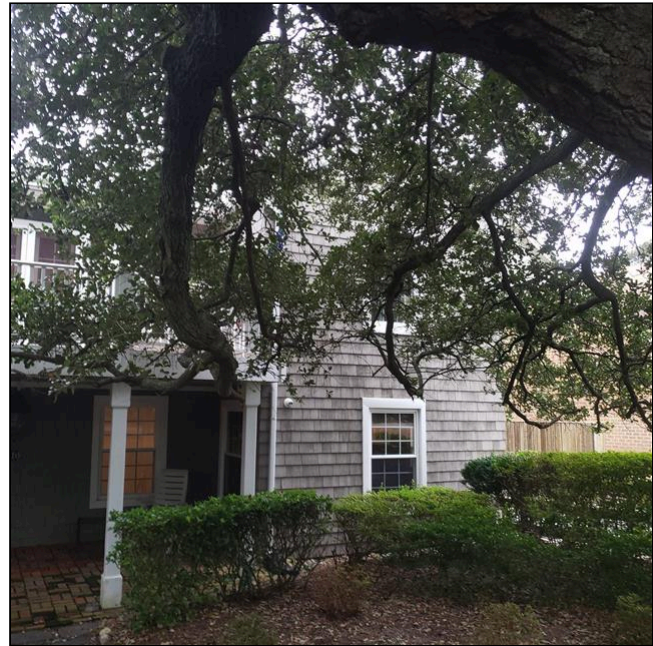
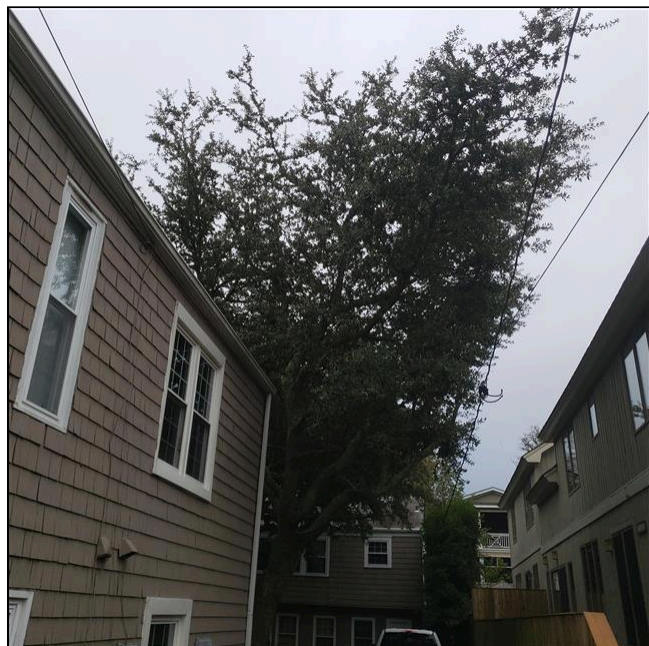
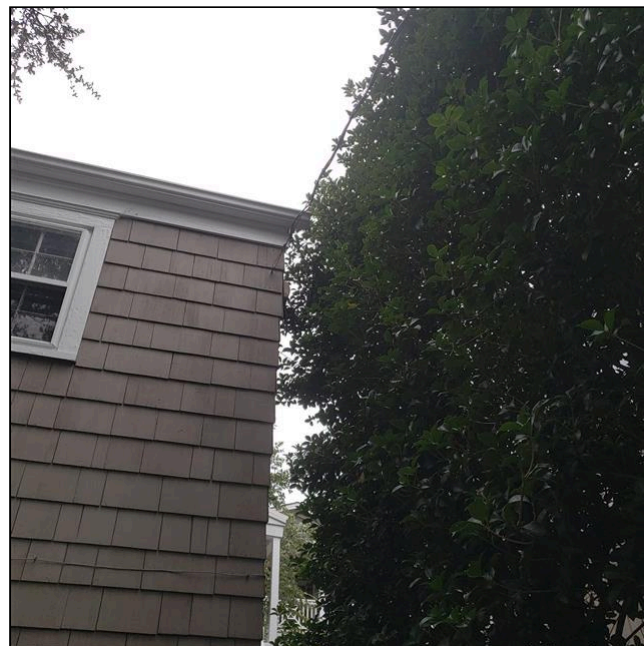
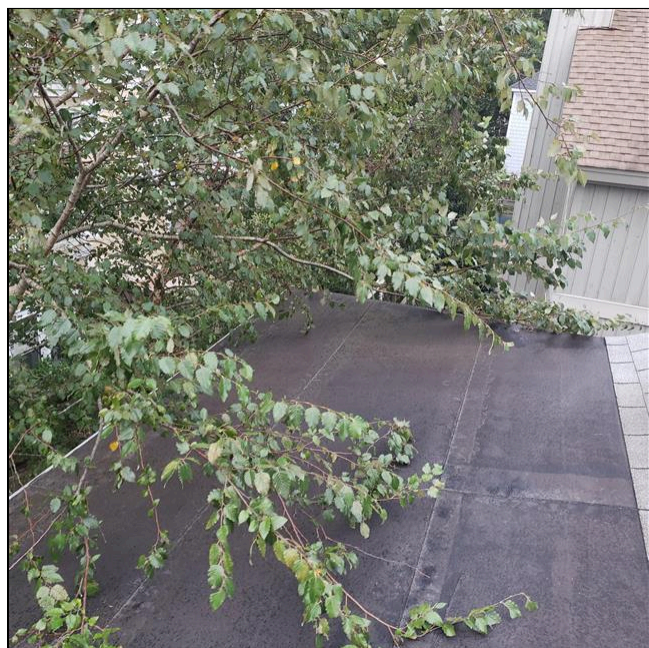
**2.20** Large trees noted close to structure, prune and maintain as required to avoid damage the roofs, siding, foundations, and/or underground utilities from limbs or roots.
