INSPECTION REPORT  
210 81st St  
Virginia Beach VA 23451

INSPECTED BY  
John Burke  
Beacon  
Inspections -  
OBX, LLC

INSPECTION DATE  
📅 9/28/2023  
🕒 09:00 AM

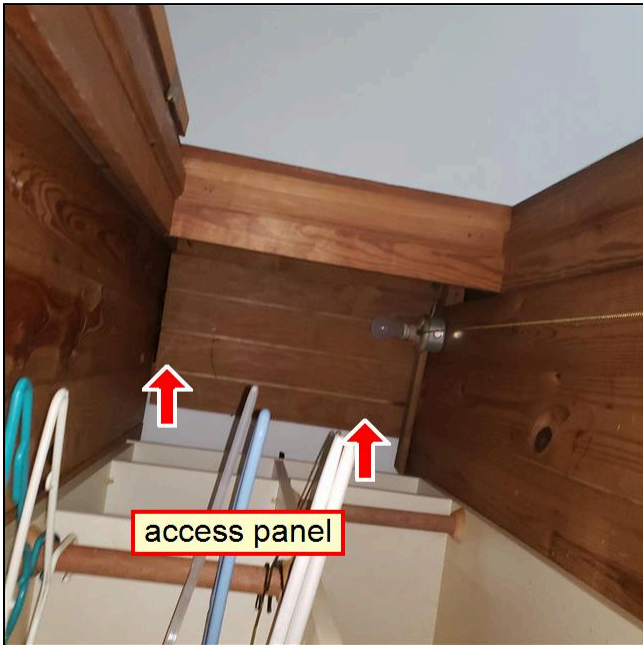
4.0 Item 2 (Picture)

**4.0** (2) Please Note: the attic space above the Main House MBR and MBA was inaccessible at the time of inspection. The access is obstructed by a shelving unit. Buyer should have the closet shelving unit removed to gain access and have this space inspected prior to closing.

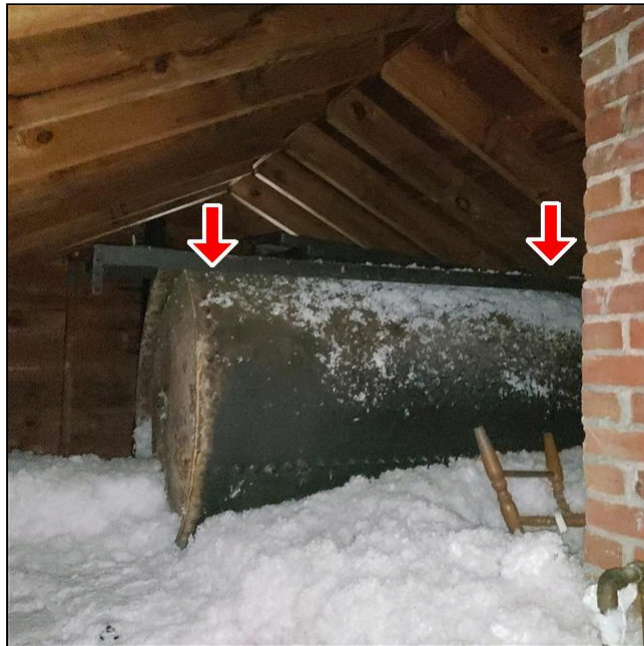
4.14 Item 1 (Picture)

**4.14** A very large abandoned expansion tank for an old steam heating system was observed in the Guest House attic, consider having removed.

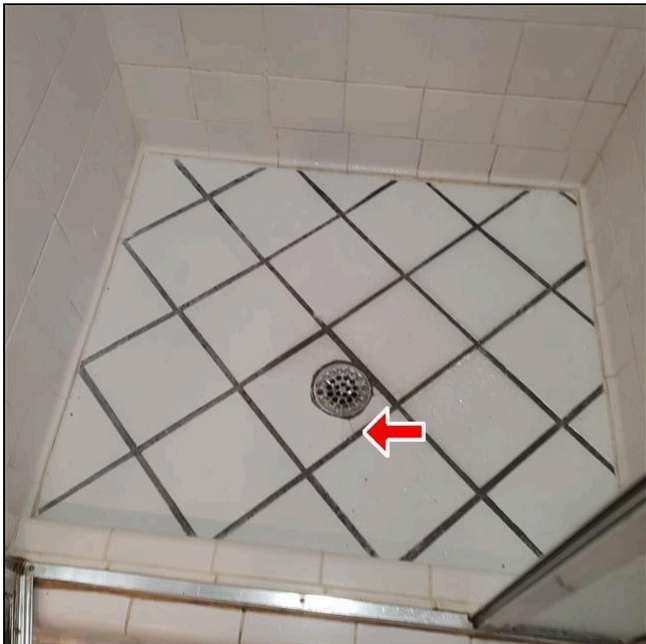
5.4.A Item 1 (Picture)

**5.4.A (2)** Minor cracking was observed in the tile on the shower pan by the drain, correct as desired.

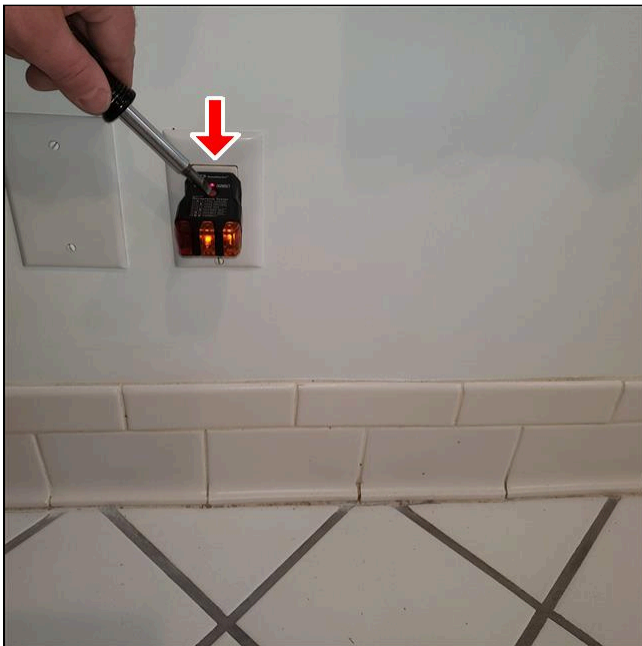
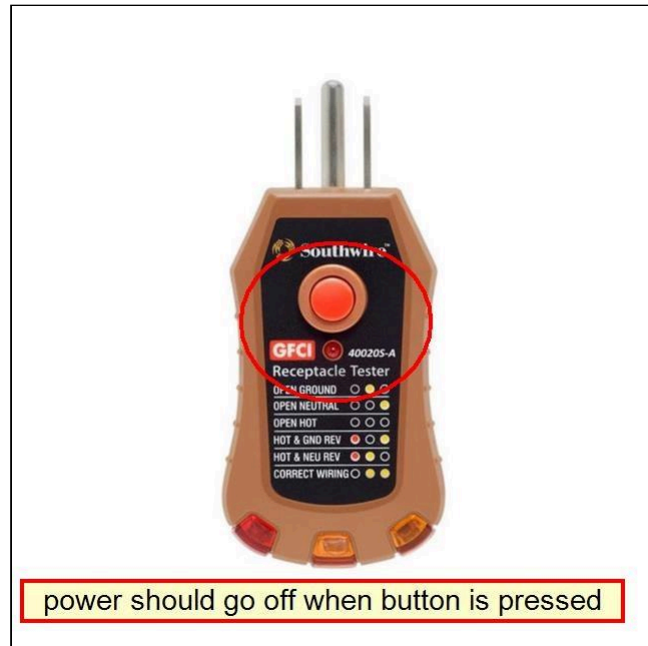
**5.10.A** The receptacle outlet in this location is not GFCI protected, have checked and corrected as needed by a licensed Electrical Contractor to ensure safety when wet conditions are present.

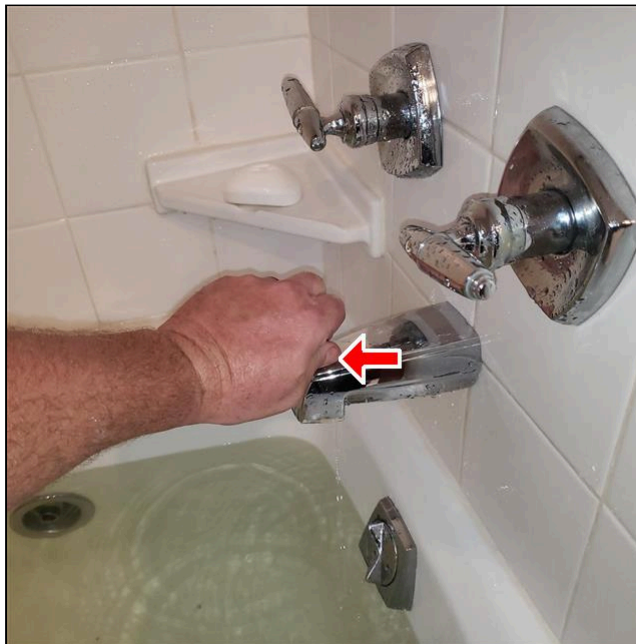
5.5.B Item 1 (Picture)

**5.5.B (1)** The shower diverter was stuck open / inoperable at the time of inspection, correct as needed.

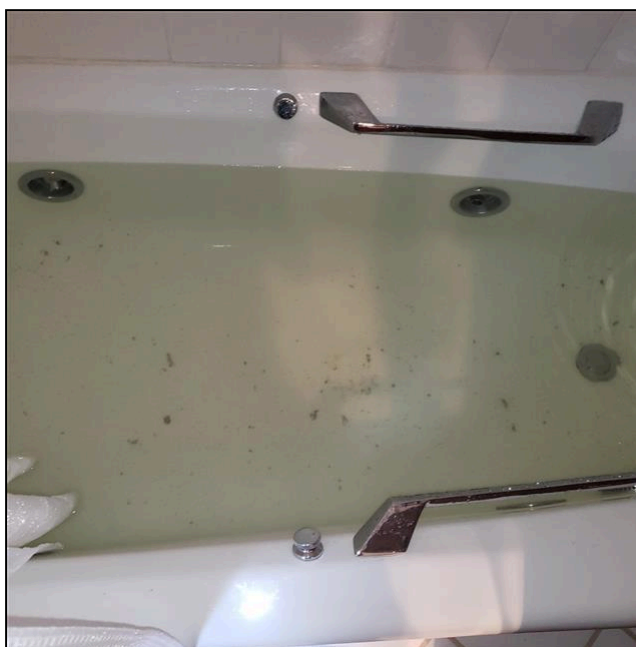
5.5.B Item 2 (Picture)

**5.5.B (2)** The Jetted Tub functioned as intended, but debris was observed in the water after operating jets for several minutes. This indicates infrequent use and/or cleaning. Consult manufacturers specifications regarding use of cleaning agents and perform cleaning as needed prior to next use.

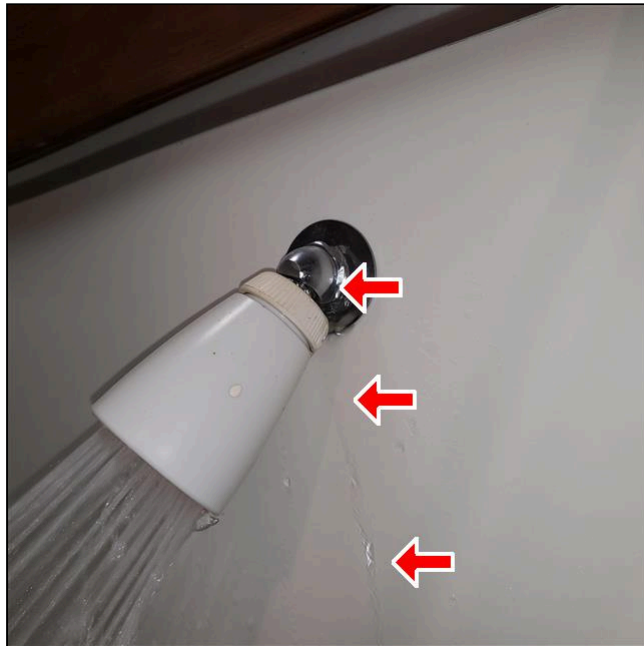
5.4.C Item 2 (Picture)

**5.4.C (2)** Leakage was observed at the shower head fitting, repair or replace as needed.

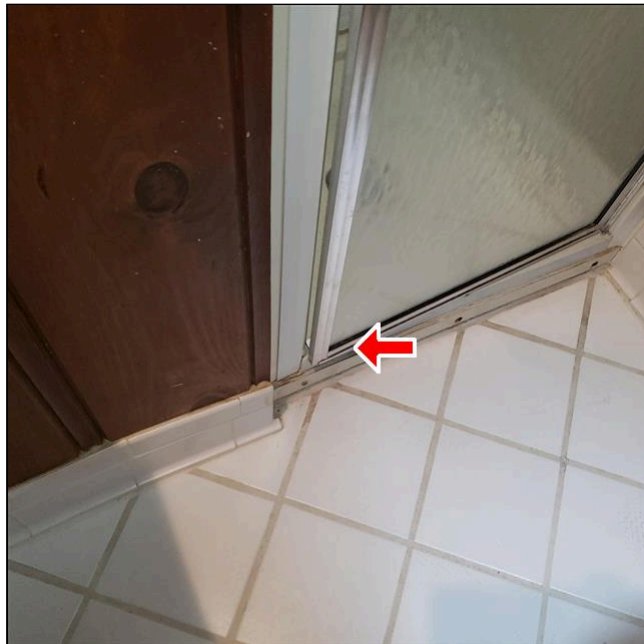
5.6.C Item 1 (Picture)

**5.6.C** The shower door hangs up on the threshold, adjust as needed for proper function and safety.

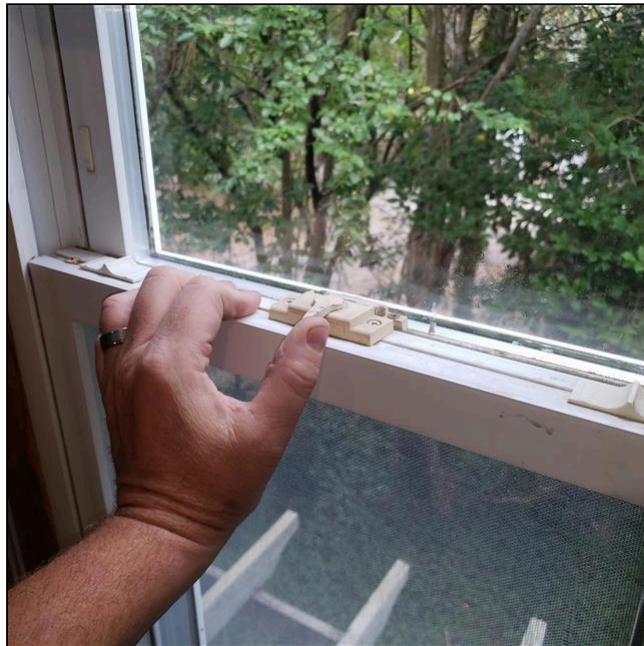
5.9.C Item 1 (Picture)

**5.9.C** (1) The window does not latch properly, adjust as needed.

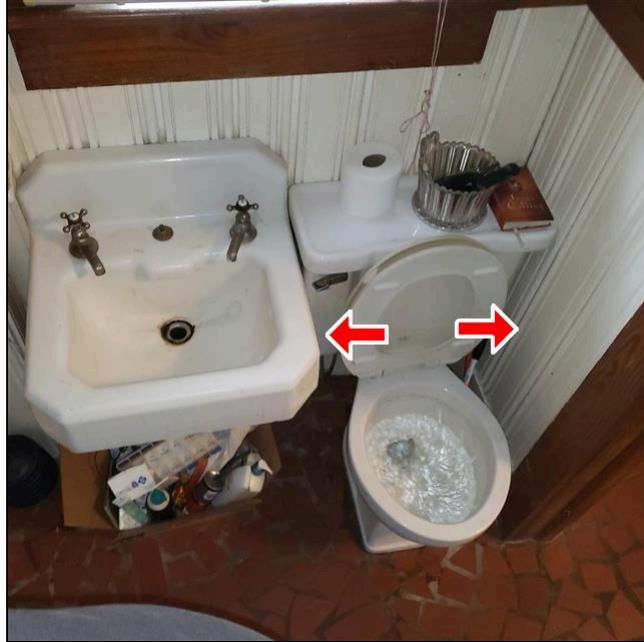
5.1.D Item 1 (Picture)

**5.1.D** (1) The toilet does not have the minimum clearance to the sides of 15" from the center line as required by current standards, consider having bath reconfigured for improved comfort.

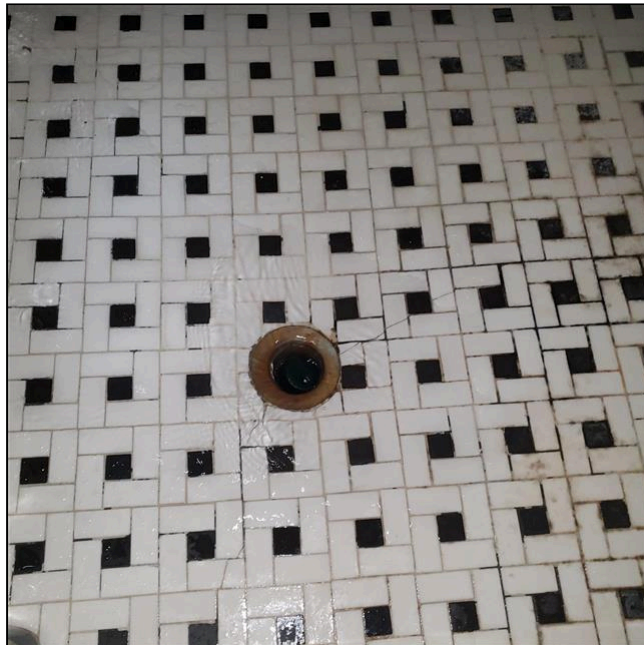
5.4.D Item 1 (Picture)

**5.4.D** (1) Cracking was observed in the tiles on the shower pan, consider correcting.

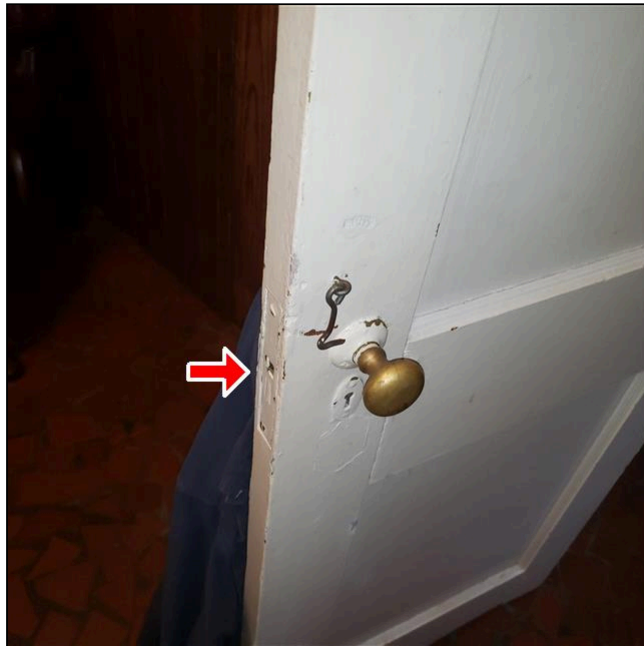
5.7.D Item 1 (Picture)

**5.7.D** The door to the rear BR does not latch, repair or replace the hardware as needed.

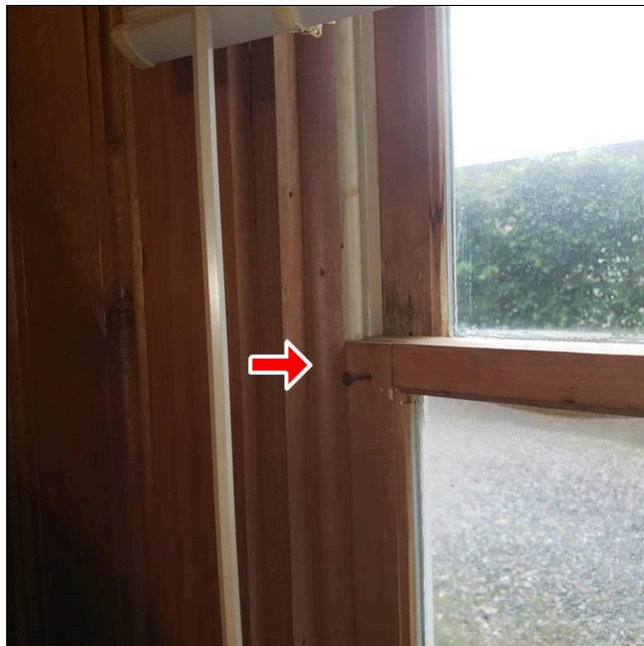
5.9.D Item 1 (Picture)

**5.9.D** The window was nailed shut at the time of inspection, release as required for proper function. The window is the only source of ventilation. Consider installing an exhaust fan for added convenience, and to comply with current standards.

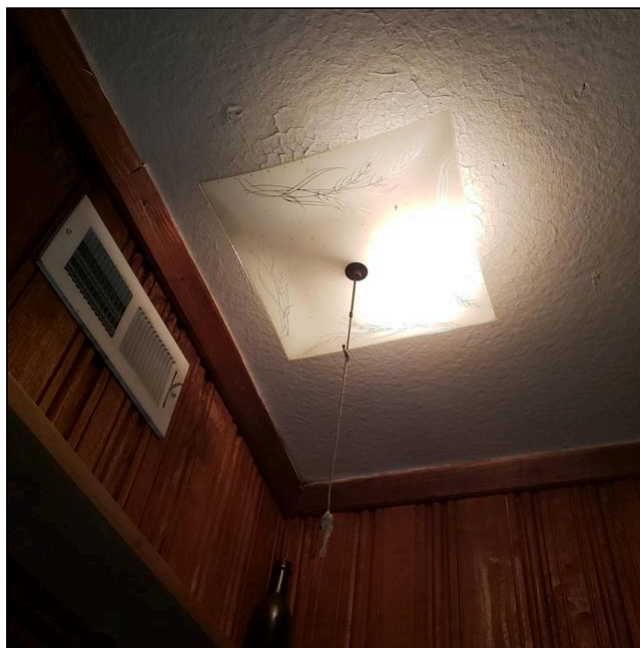
5.10.D Item 1 (Picture)

**5.10.D (1)** The light is controlled by a pull-chain switch, we recommend having a 3-way switch installed by each door for improved safety and convenience.

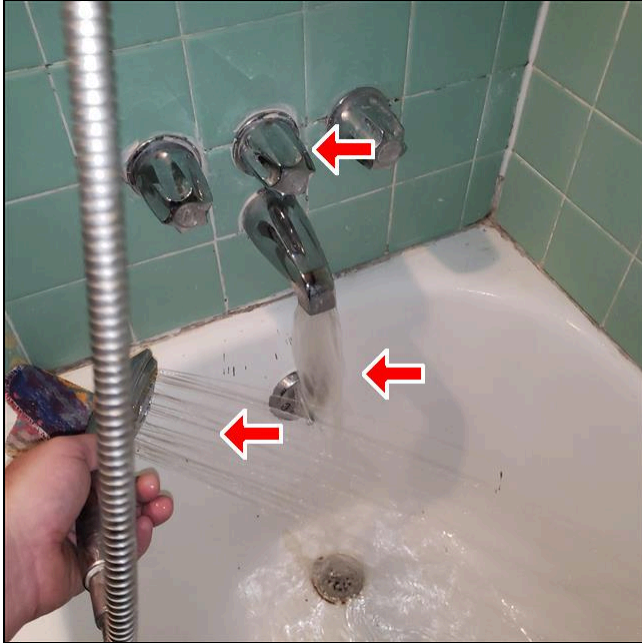
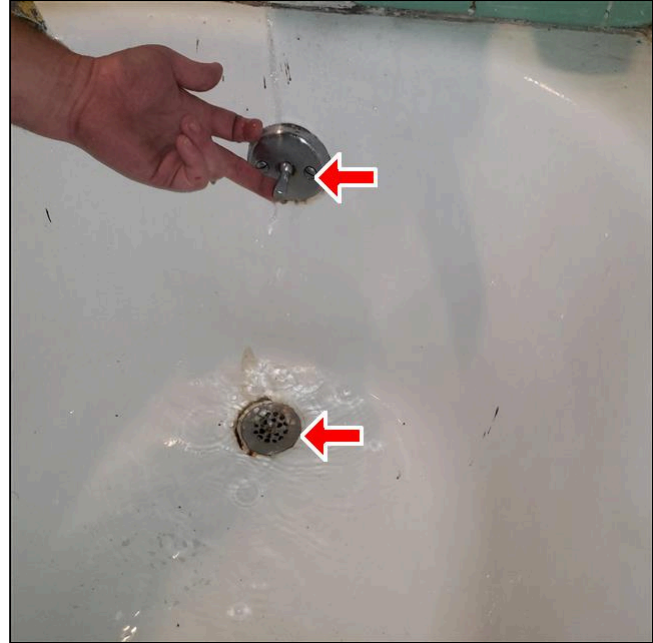
**5.3.E** The shower diverter valve is defective, as it will not completely shutoff flow to the shower head.

The built-in drain stopper mechanism is defective as well. Have checked and corrected as needed by a licensed Plumbing Contractor.

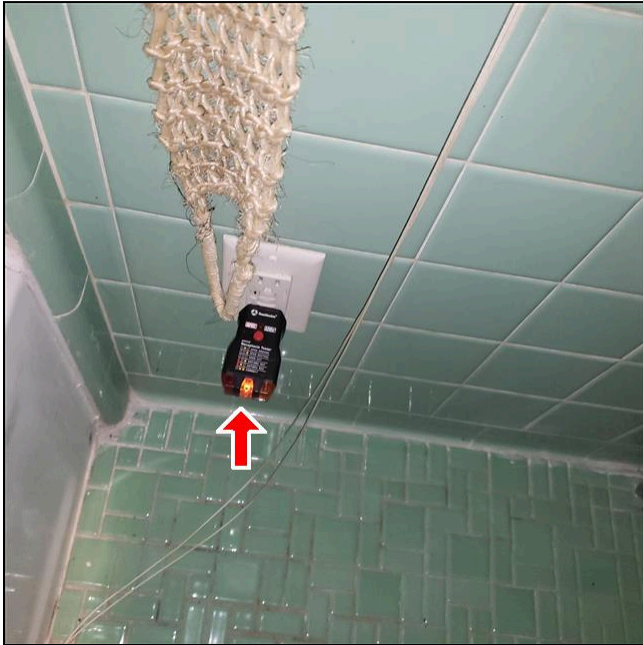
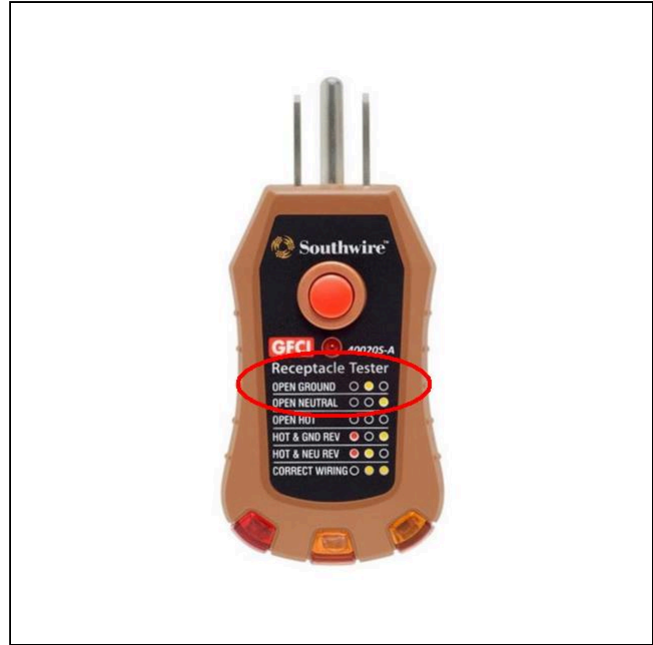
**5.10.E (2)** An open ground connection was noted at the GFCI outlet. Un-grounded GFCI's are generally permitted, but they should be labeled as having "No Equipment Ground". We recommend adding the label as needed.

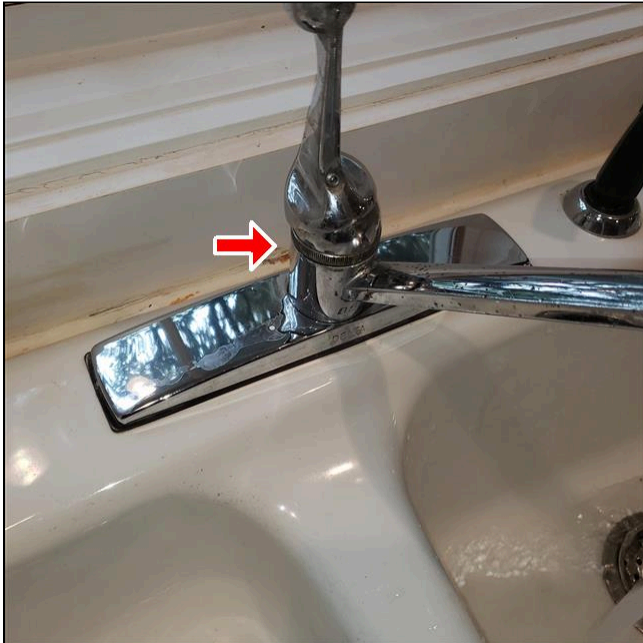
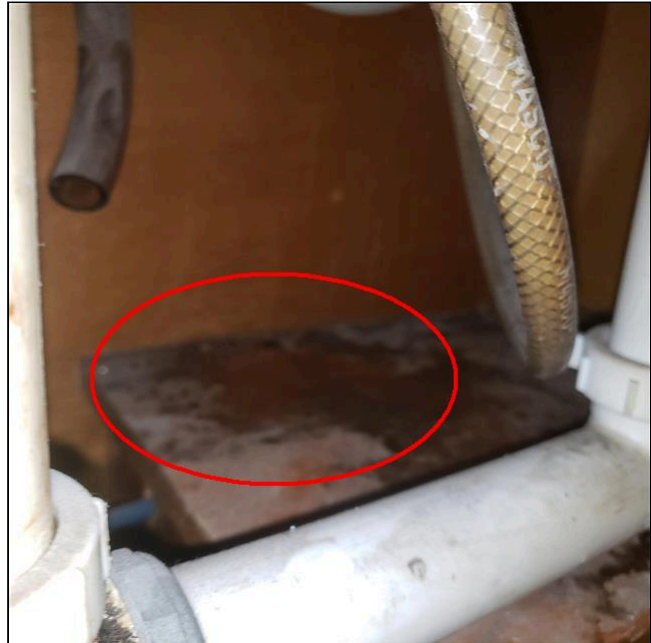
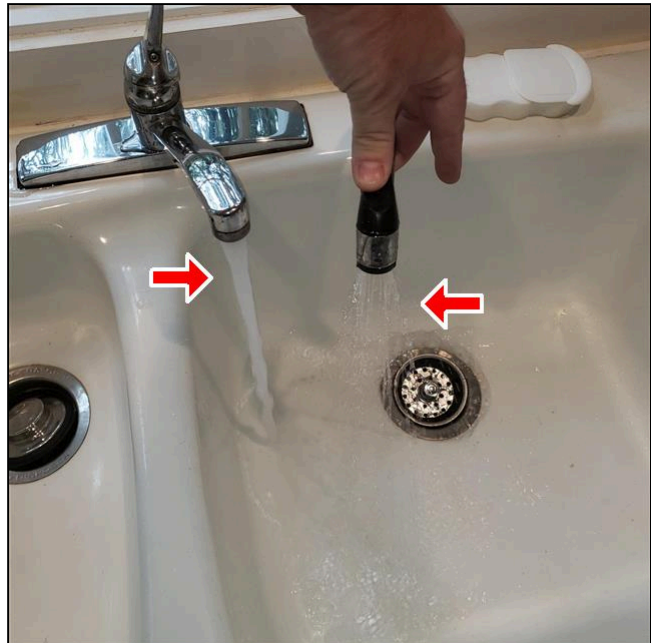
**6.0.A** Leakage was observed at the spray attachment and at the faucet valve stem. The diverter for the spray attachment did not function properly as well. Have checked and corrected as needed by a licensed Plumbing Contractor.

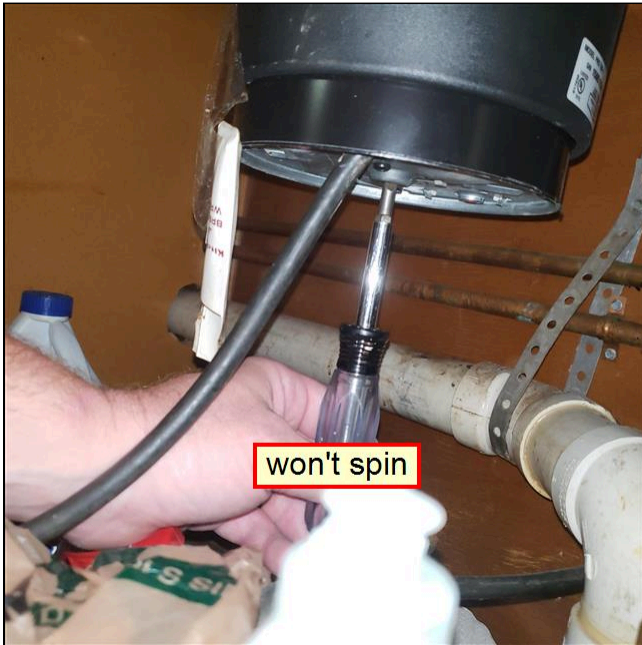
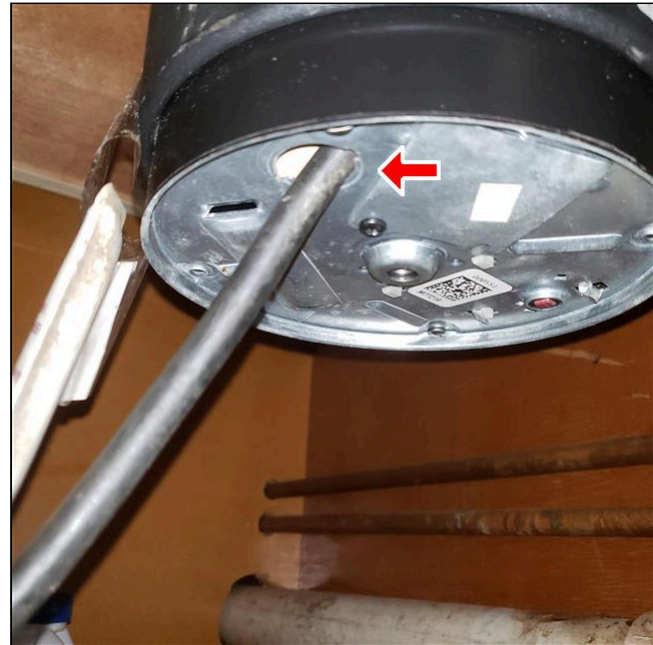
**6.4.A** Disposal was jammed / inoperable at the time of inspection, and its power cord is not properly secured / clamped where it enters the unit. Have checked and repaired or replaced as needed by a qualified contractor.

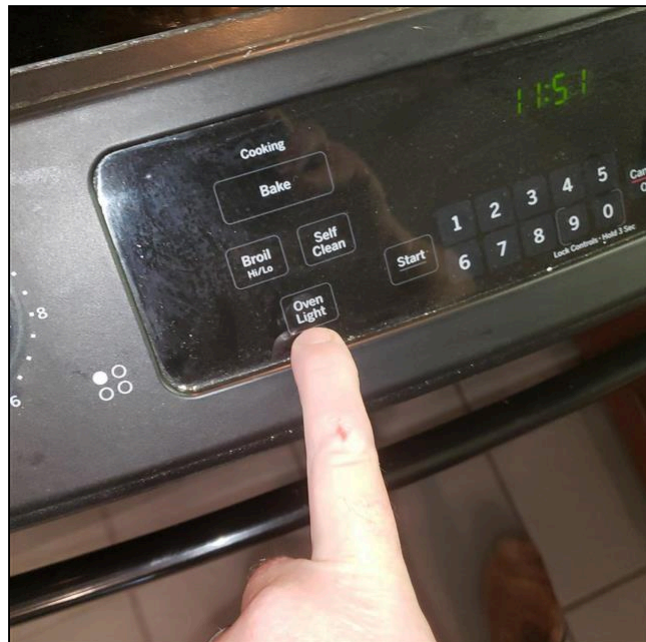
6.5.A Item 1 (Picture)

**6.5.A** Oven light did not function, replace bulbs and re-check prior to closing.

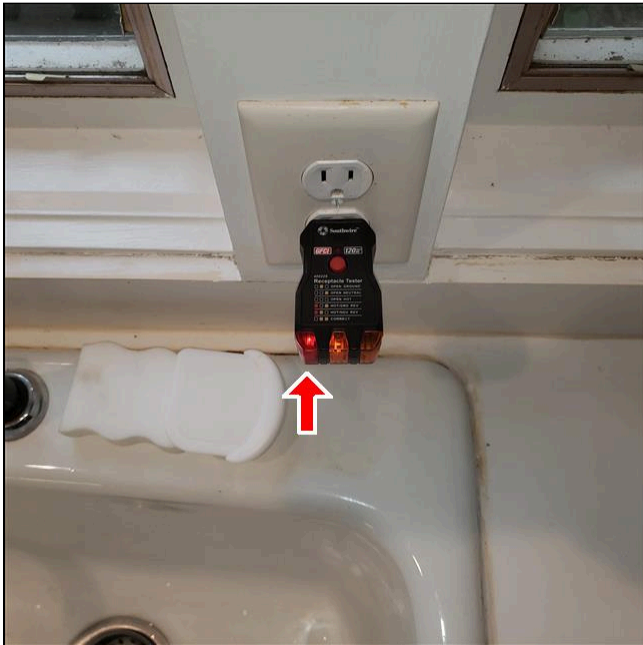
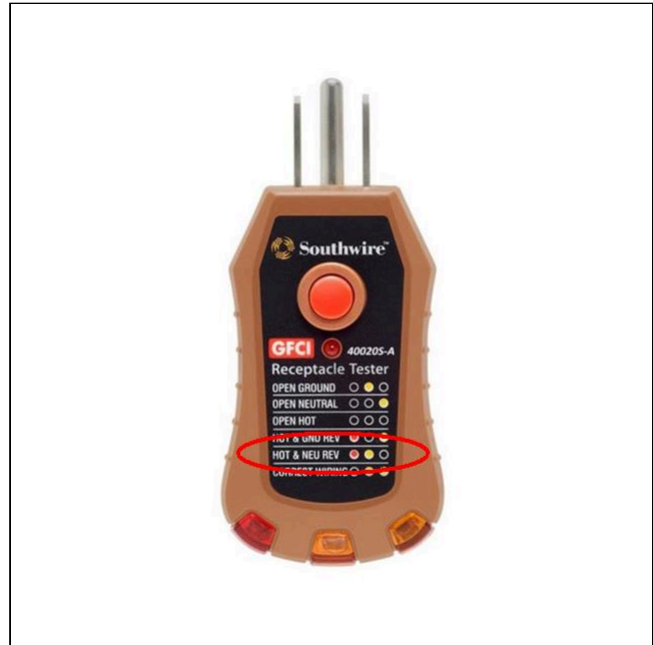
6.13.A Item 1 (Picture)

6.13.A (1) The receptacle outlet to the right of the sink is wired with reversed polarity, increasing the potential for a shock hazard, have checked and corrected as needed by a licensed Electrical Contractor.

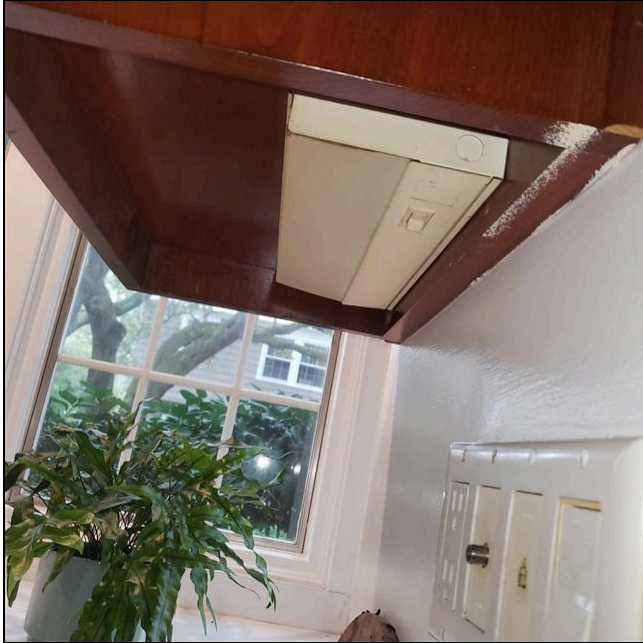
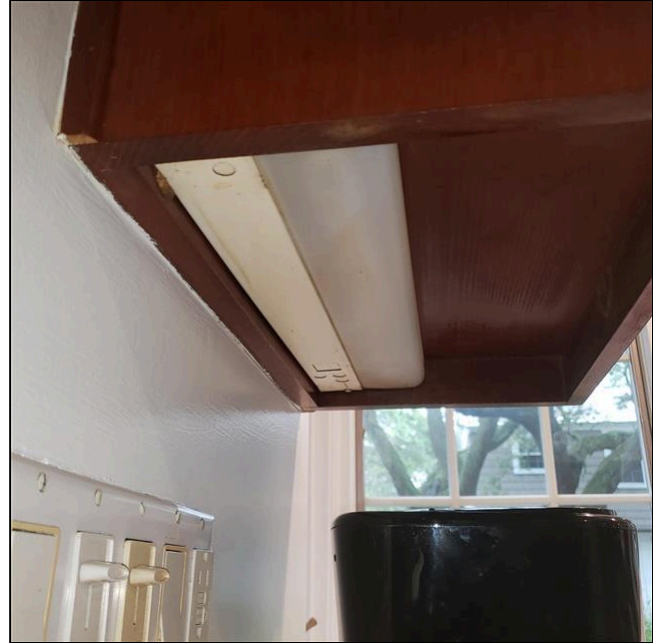
6.13.A Item 3 (Picture)

**6.13.A (2)** Some of the under-counter lights were inoperable at the time of inspection, replace the bulbs and/or starter capacitors as needed and verify proper operation prior to closing.

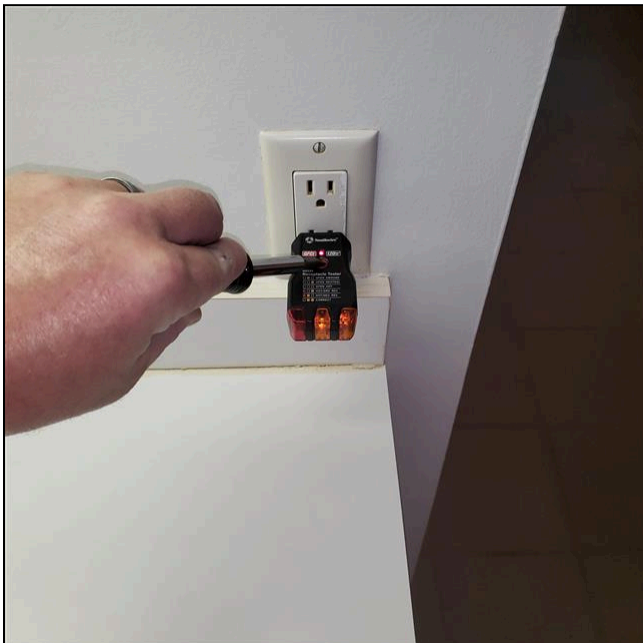
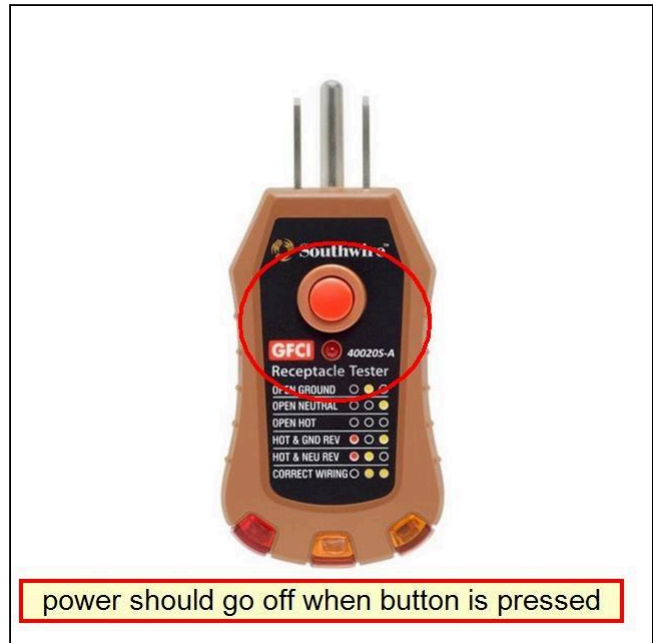
6.13.A Item 5 (Picture)

**6.13.A (3)** Receptacles near sink are protected by GFCI and appear to be functioning as intended. However, the remainder of the counter accessible outlets are not protected as required by current standards. Consider protecting these remaining outlets with GFCI(s) for improved safety.

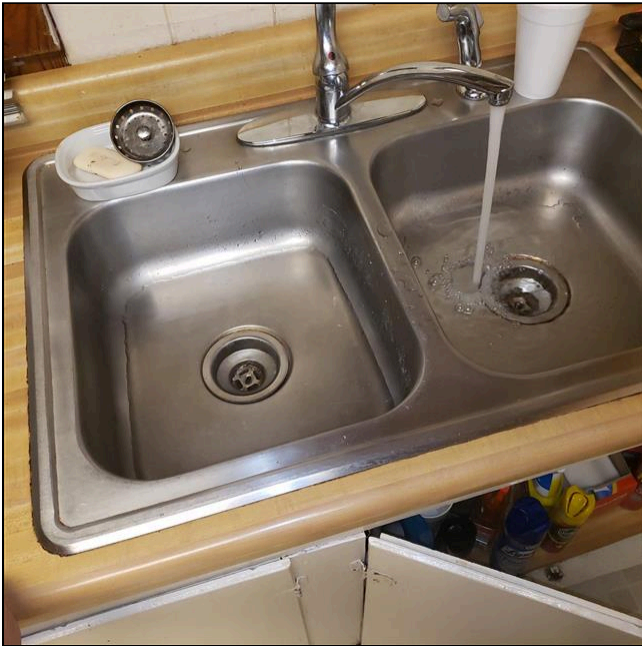
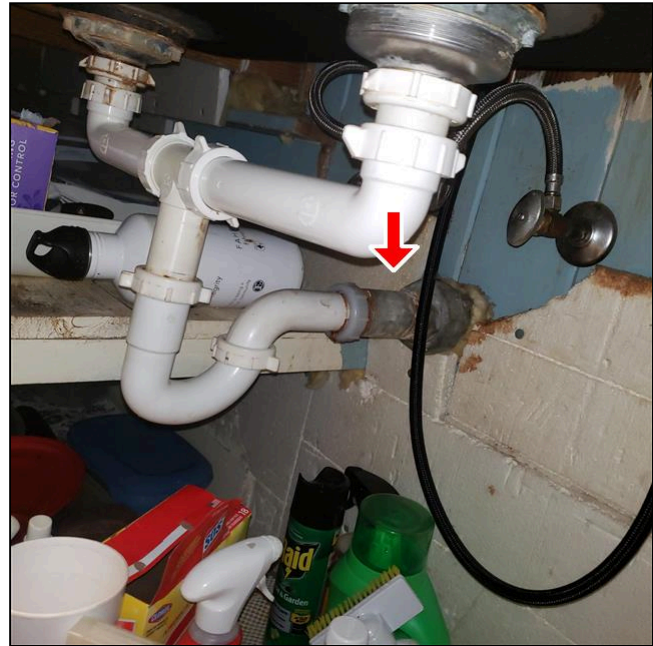
6.0.B Item 1 (Picture)

**6.0.B** Drainage was slightly slow at the time of inspection, possibly due to the buildup of rust within the galvanized steel drain pipes. Monitor conditions closely and anticipate future repair needs.

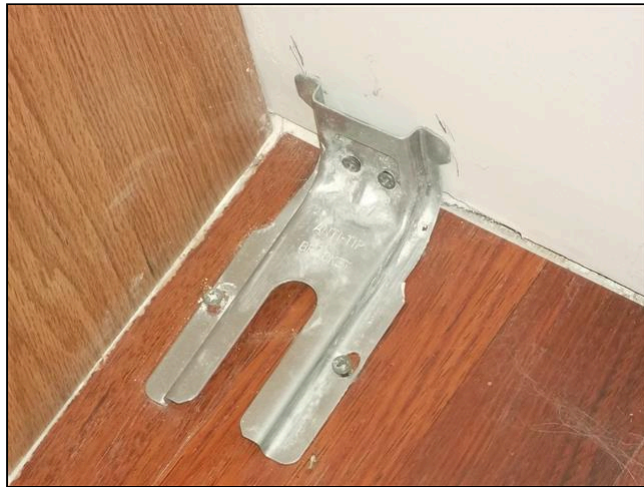
6.5.B Item 2 (Picture)

**6.5.B** (2) The anti-tip bracket is missing. We recommend installing for added safety. (Placing heavy items, such as a turkey, on an open door can cause entire range to tip forward. Several children have been injured using the door of a range as a step to access cabinets above. The anti-tip bracket prevents unit from tipping forward.)

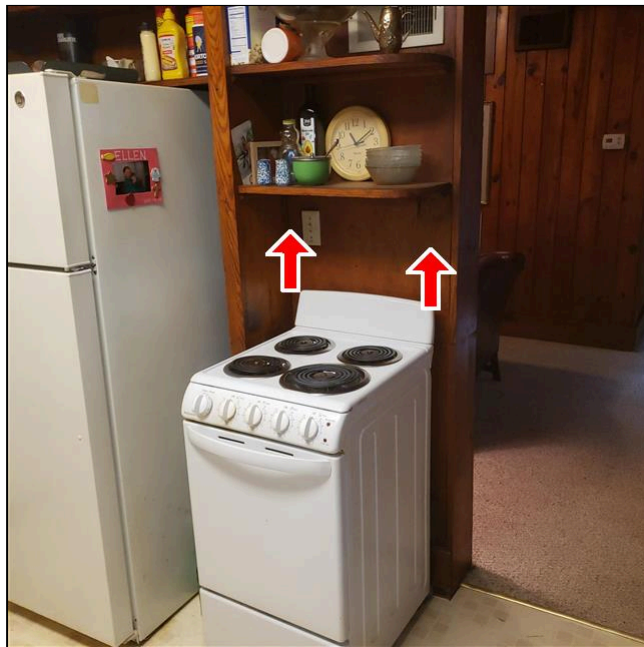
6.7.B Item 1 (Picture)

**6.7.B** No ventilator is present, we recommend installing a proper range hood.

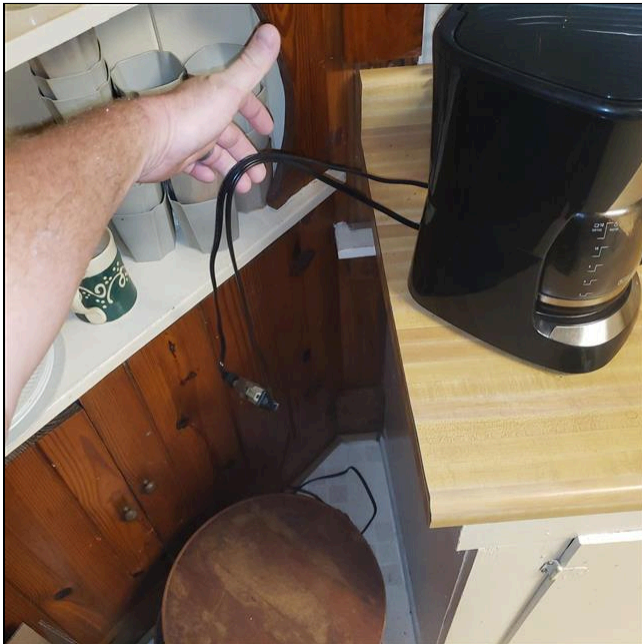
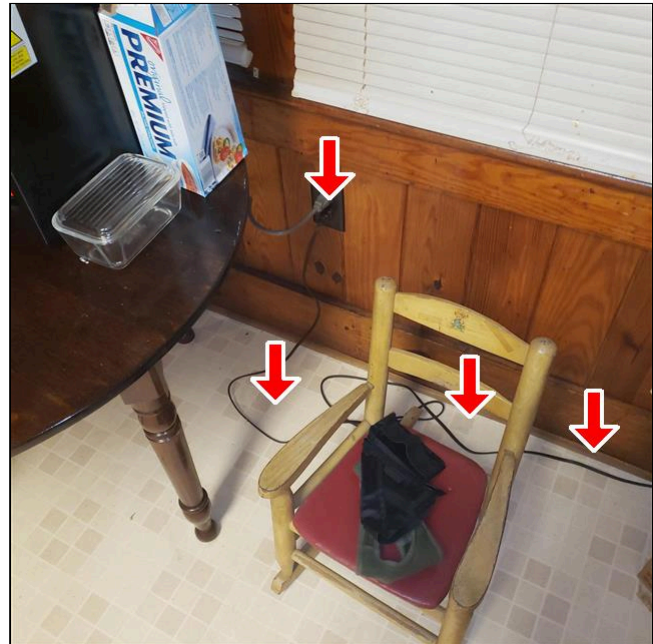
6.13.B Item 1 (Picture)

**6.13.B** There are no counter accessible receptacle outlets, have GFCI outlets installed as needed by a licensed Electrical Contractor so that no point on a counter is more than 24" laterally from a receptacle to ensure safety and convenience.

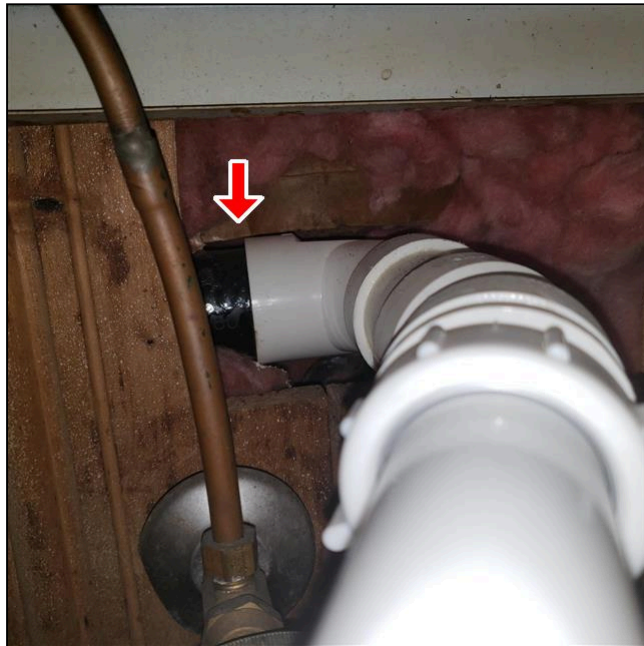
6.0.C Item 2 (Picture)

**6.0.C (2)** Improperly glued PVC to ABS connections were found in the drain line below the sink. While they appear similar, PVC (white plastic) and ABS (black plastic) have different chemical compositions and require different adhesives at the fittings. In recent years, a (green) PVC to ABS transition cement has come on the market, but that does not appear to have been used here. As a result, these fittings may fail over time. Monitor conditions and anticipate future repair needs.

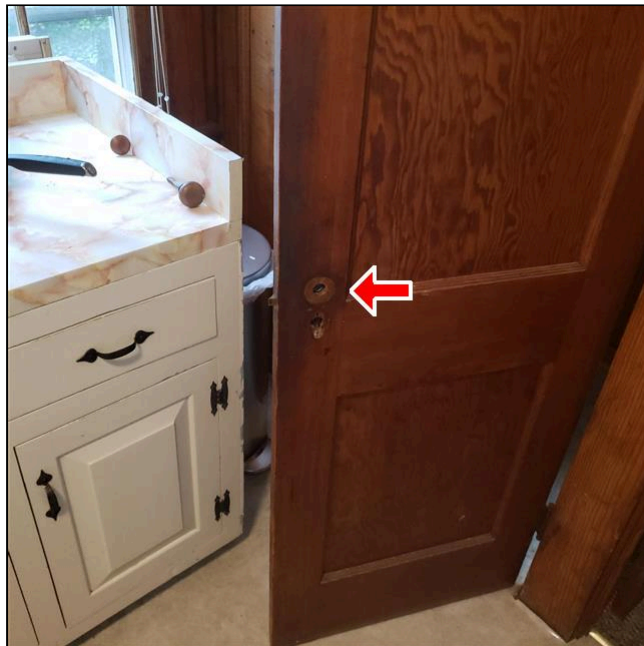
6.2.C Item 1 (Picture)

**6.2.C** The door knob is missing at the Pantry, replace as needed.

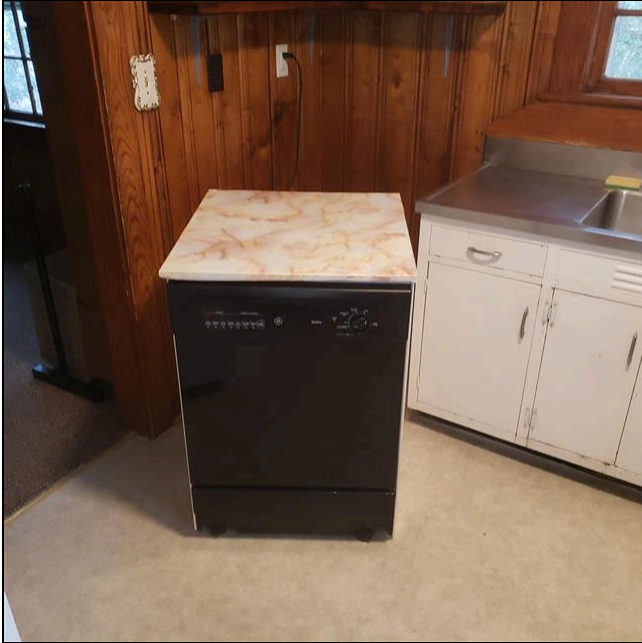
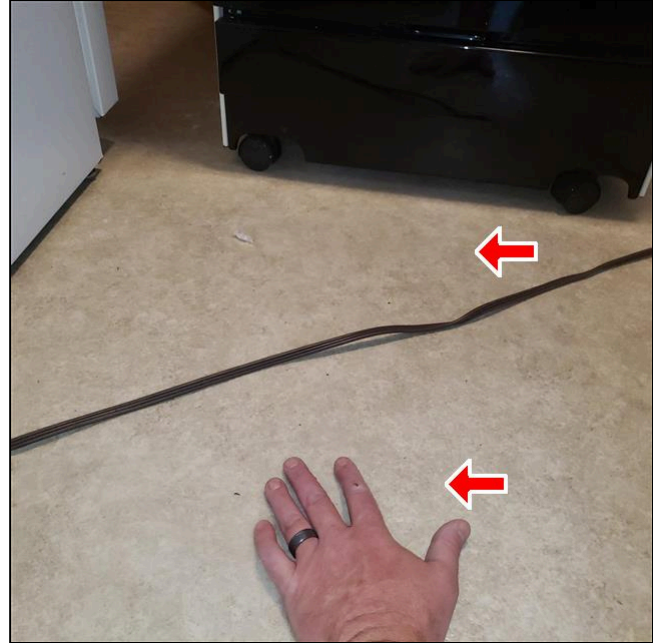
6.3.C Item 1 (Picture)

**6.3.C** The portable dishwasher leaked when operated, have checked and repaired as needed by a qualified appliance repair specialist.

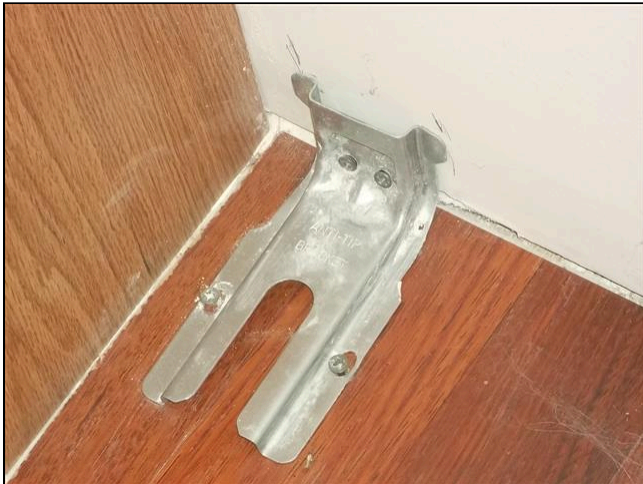
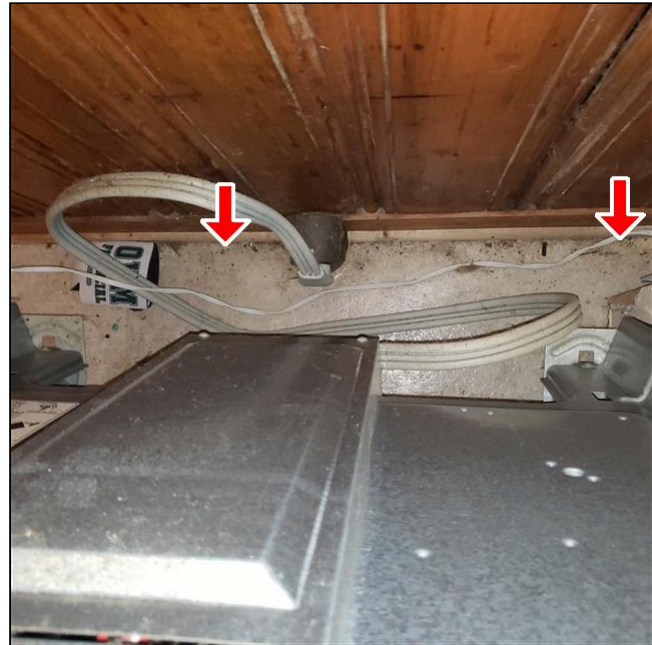
6.5.C Item 2 (Picture)

**6.5.C (2)** The anti-tip bracket is missing. We recommend installing for added safety. (Placing heavy items, such as a turkey, on an open door can cause entire range to tip forward. Several children have been injured using the door of a range as a step to access cabinets above. The anti-tip bracket prevents unit from tipping forward.)

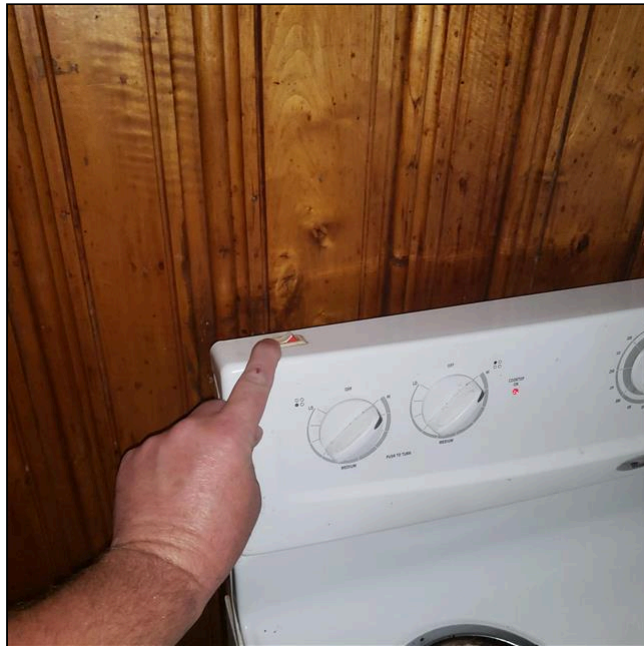
6.5.C Item 5 (Picture)

**6.5.C** (4) Oven light did not function, replace bulbs and re-check prior to closing.

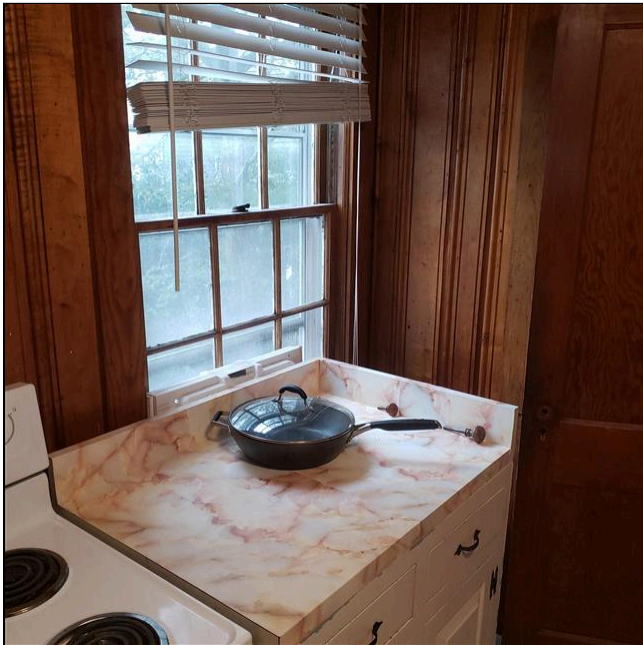
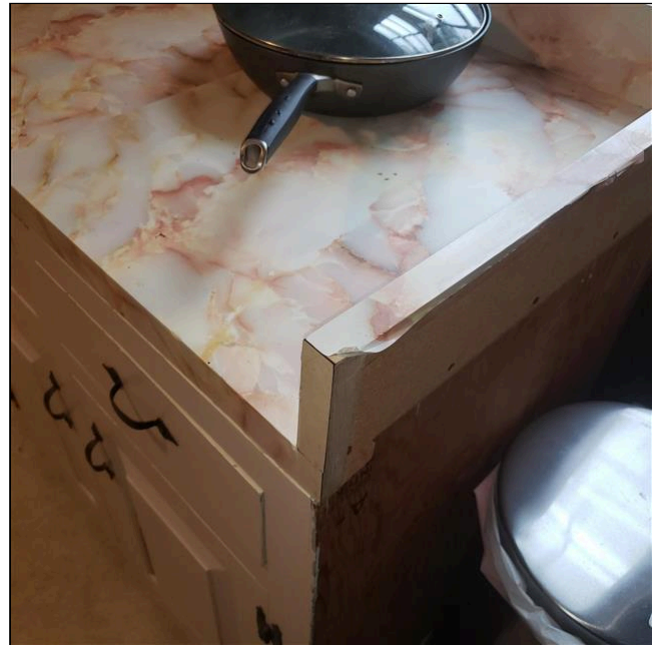
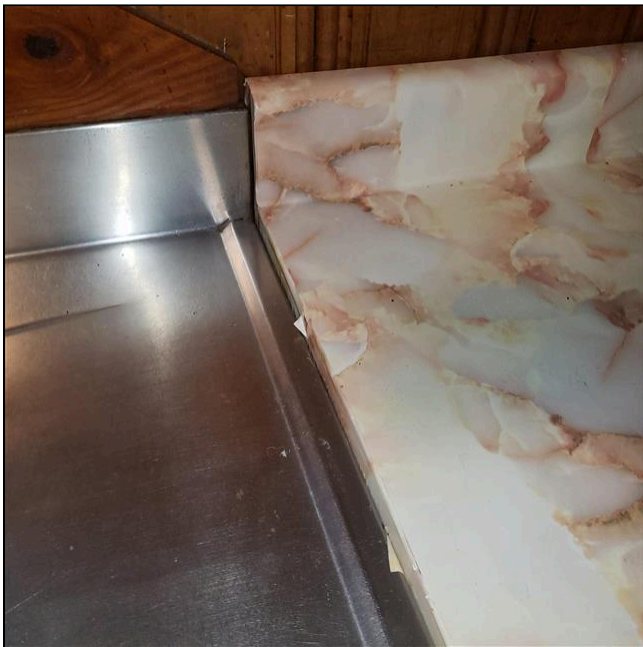
6.12.C Item 1 (Picture)

6.12.C (1) The counters were improperly covered with contact paper, replace as needed / desired.

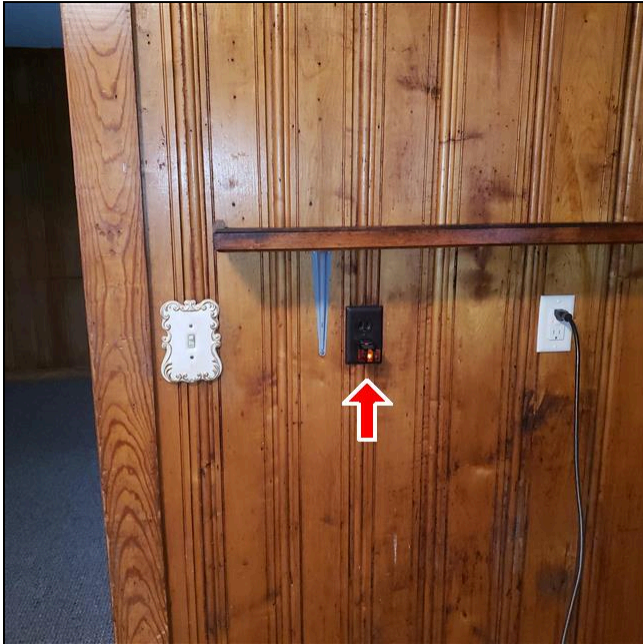
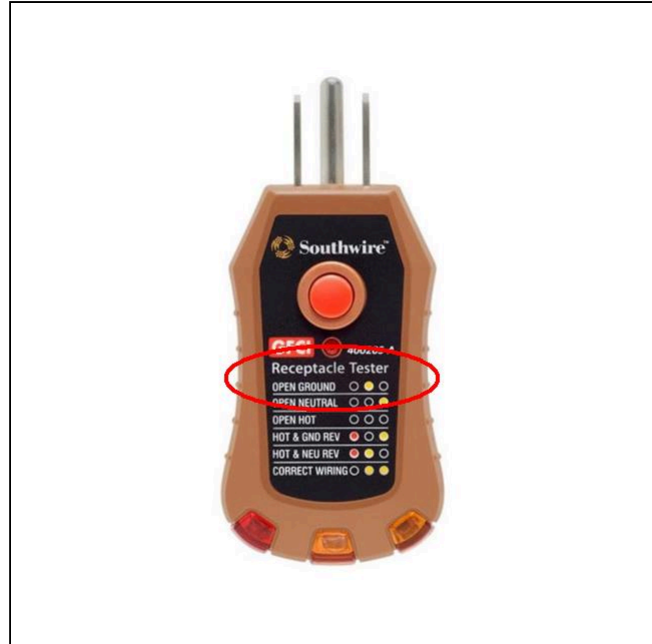
6.13.C Item 1 (Picture)

6.13.C (1) An open ground connection was detected at the receptacle outlet by the light switch, have checked and corrected as needed by a licensed Electrical Contractor to ensure safety.
