INSPECTION REPORT  
210 81st St  
Virginia Beach VA 23451

INSPECTED BY  
John Burke  
Beacon  
Inspections -  
OBX, LLC

INSPECTION DATE  
📅 9/28/2023  
🕒 09:00 AM

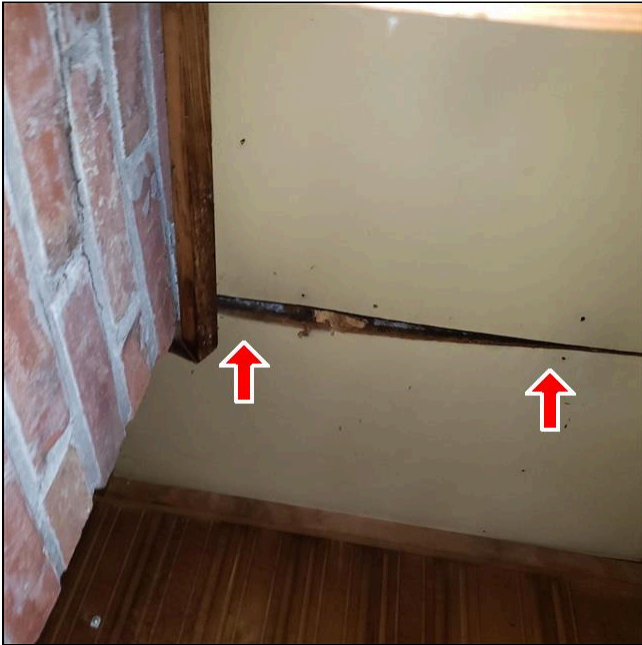
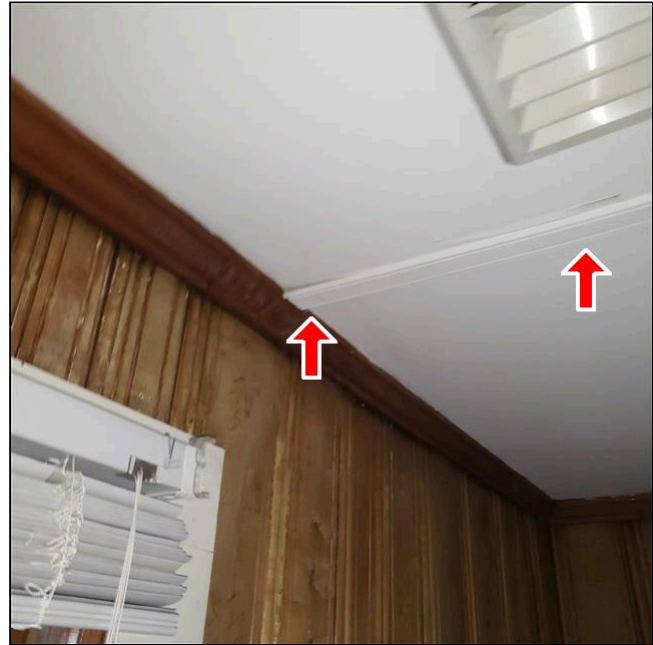
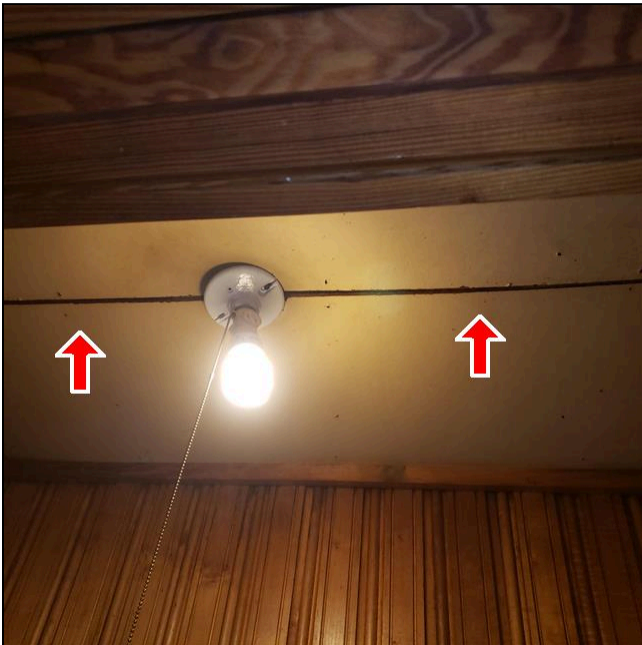
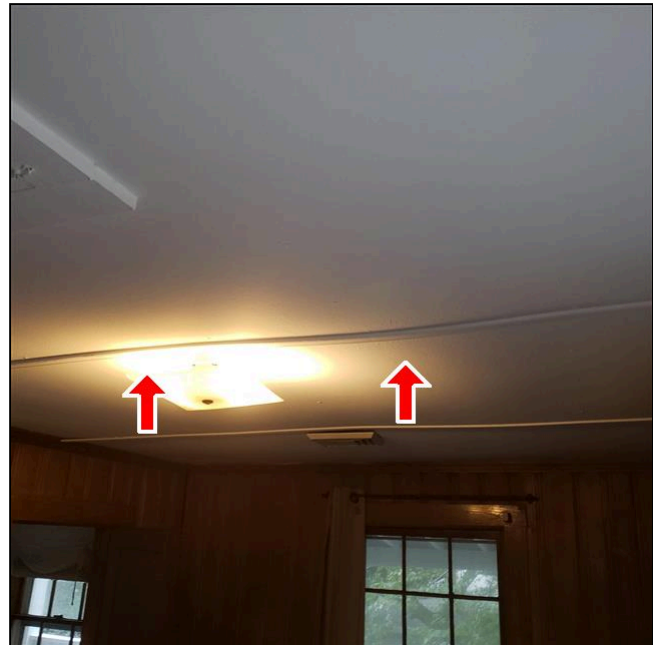
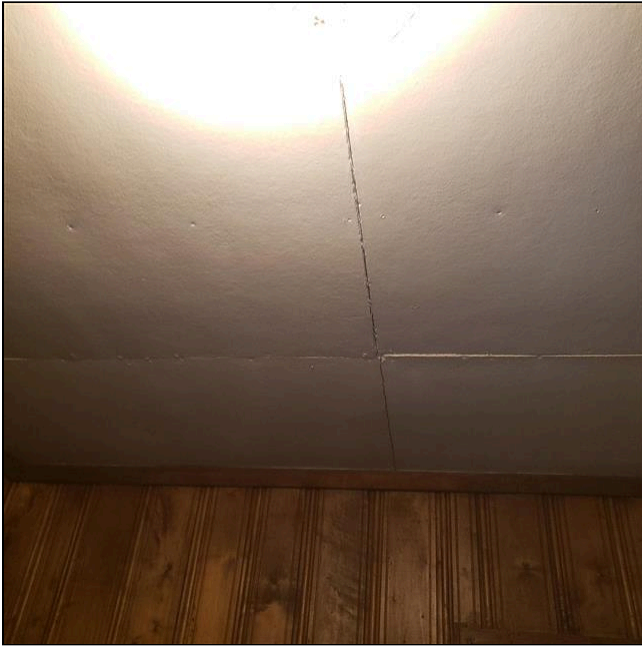
7.0 Item 1 (Picture)

**7.0** The ceilings in the main house are in generally good condition. The pressboard / cellulose coverings in the Guest house are sagging and/or missing the trim strips at the seams in multiple locations. We recommend having checked and corrected as needed by a licensed Contractor.

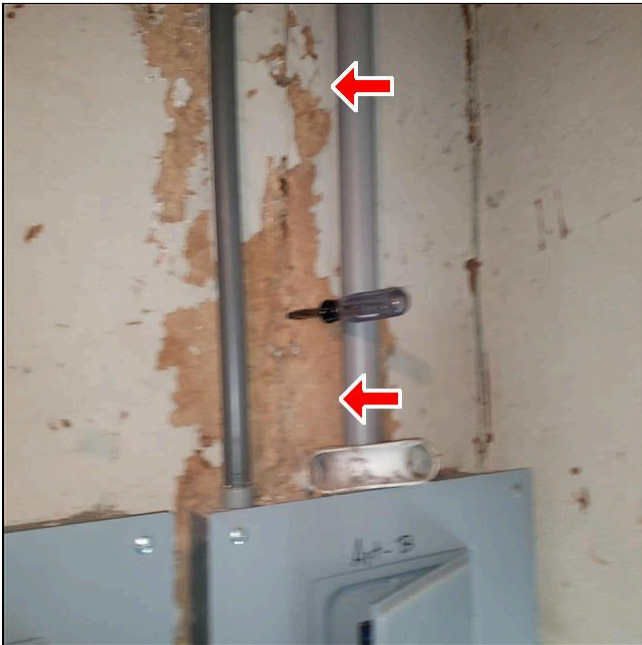
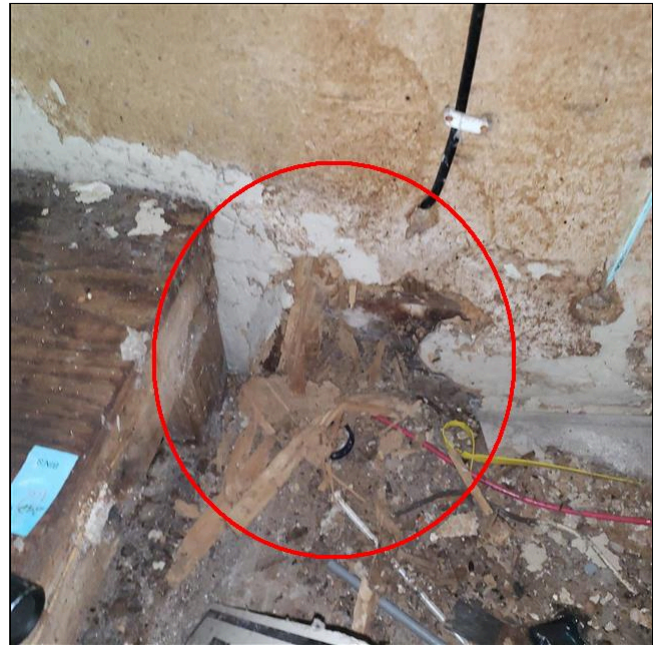
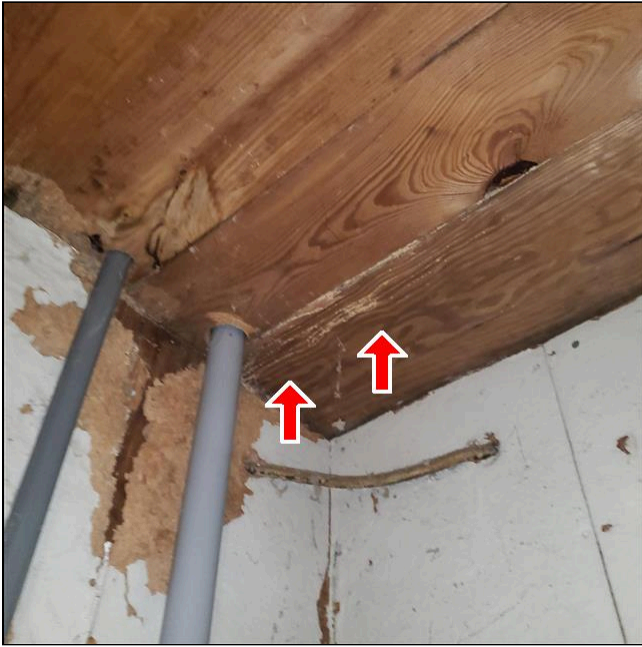
7.1 Item 1 (Picture)

**7.1** Termite damage was found in the pressboard coverings and in some of the wall studs in the Guest House Laundry Rm. Additional hidden damage is likely present as well. Have checked by a licensed Termite & Moisture Control Specialist and repairs performed as needed by a licensed Contractor prior to closing.

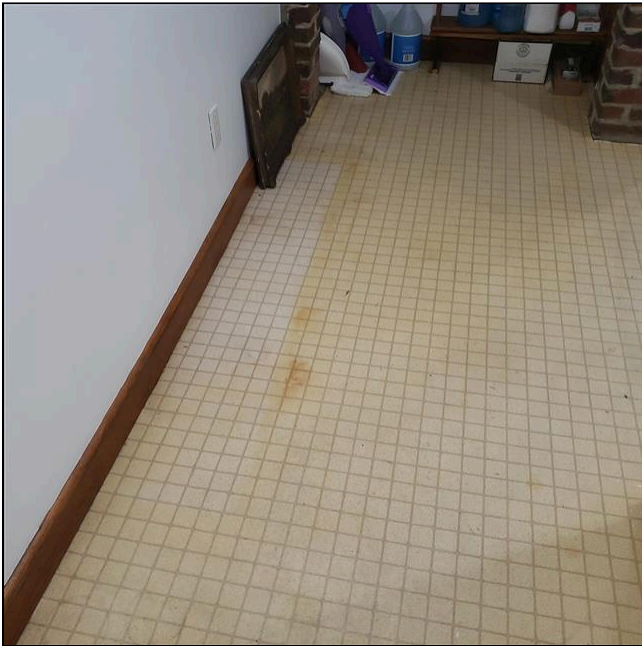
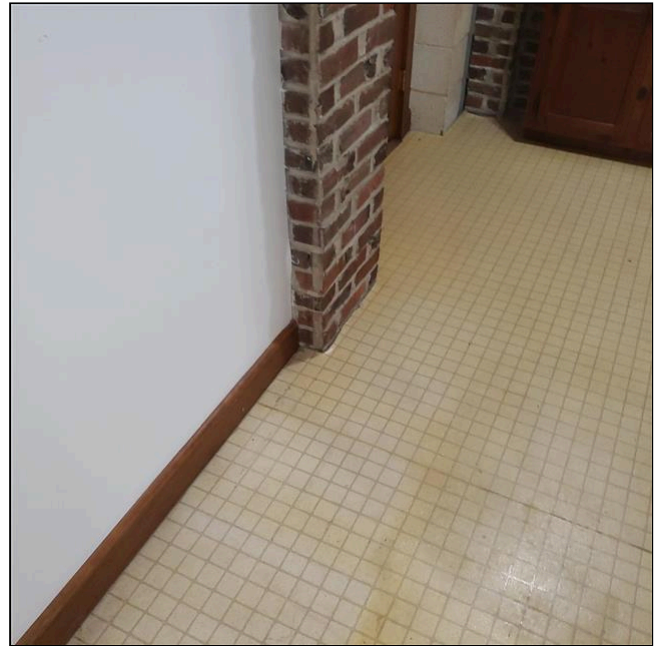
7.3 Item 1 (Picture)

**7.3 (1)** The vinyl flooring in the Laundry Rm of the main house is stained and discolored, plan for replacement.

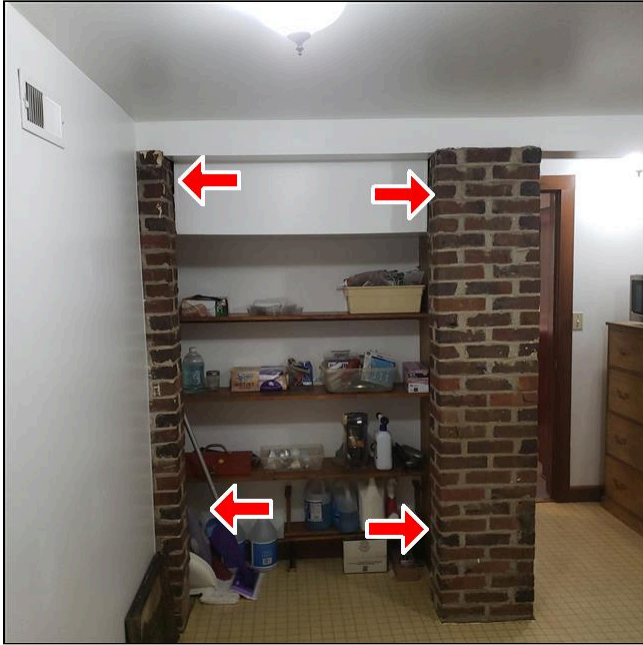
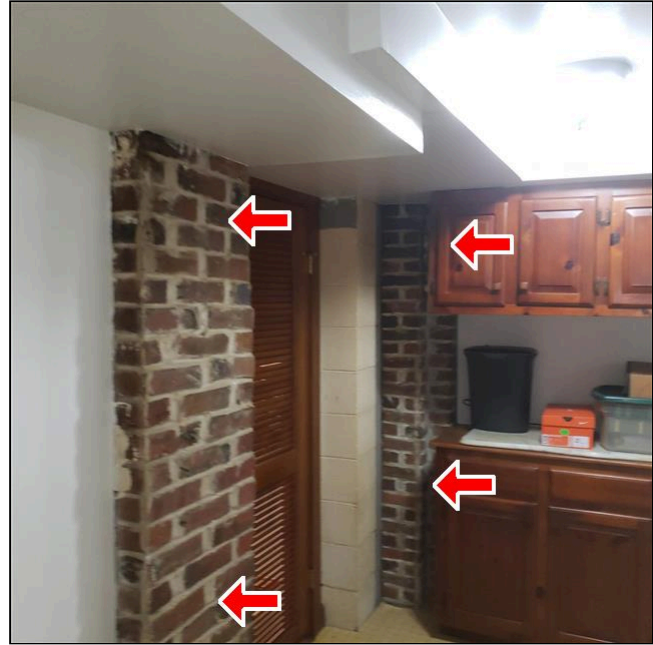
7.3 Item 3 (Picture)

**7.3** (2) Please Note: The main house appears to have originally a small 1-story bungalow, which was raised and placed on tall piers, before the living space of the 1st Fl was added below. That work appears to have been performed in the mid to late 1980's. Buyer should attempt to obtain a permit history from the City Building Department as a precaution.

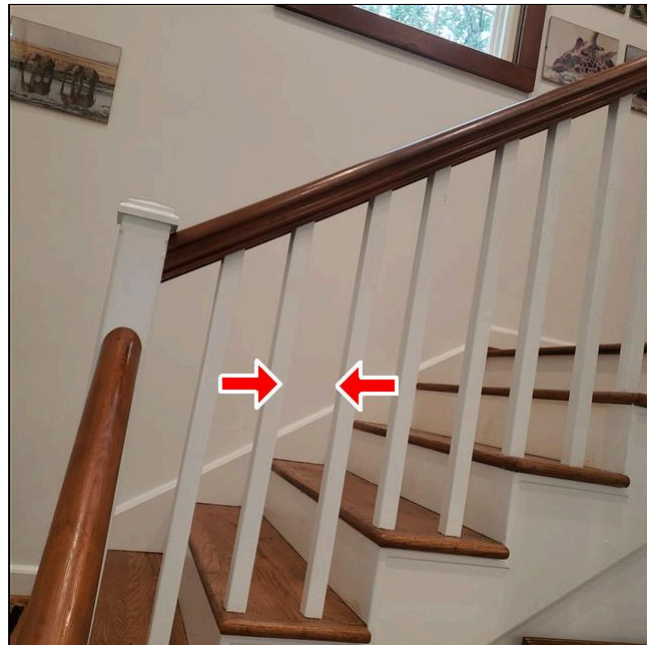
7.4 Item 1 (Picture)

**7.4** The guardrails do not meet current child safety standards. The balusters / spindles are spaced too far apart, with openings wider than 4". Consider correcting for added safety.

*A 4" ball should not fit through the space between the balusters; and a 6" ball should not fit through the space between a railing and a stair tread, (if a bottom rail is present) or between stair treads when riser plates are not present.*

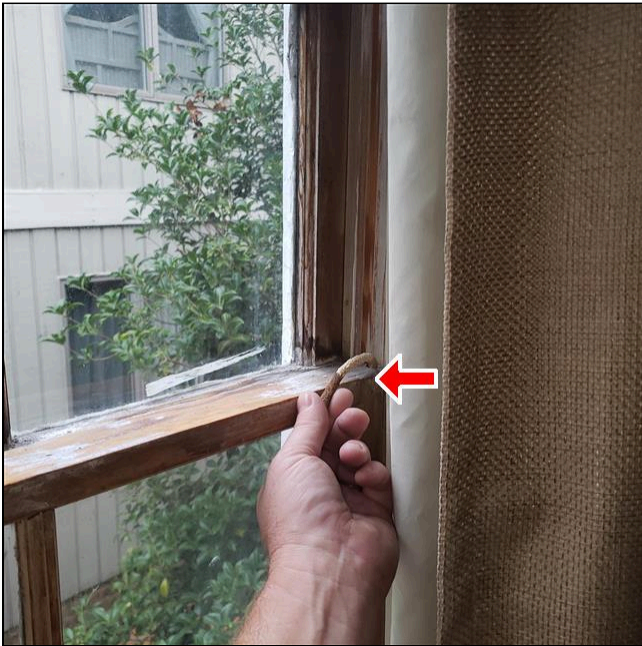
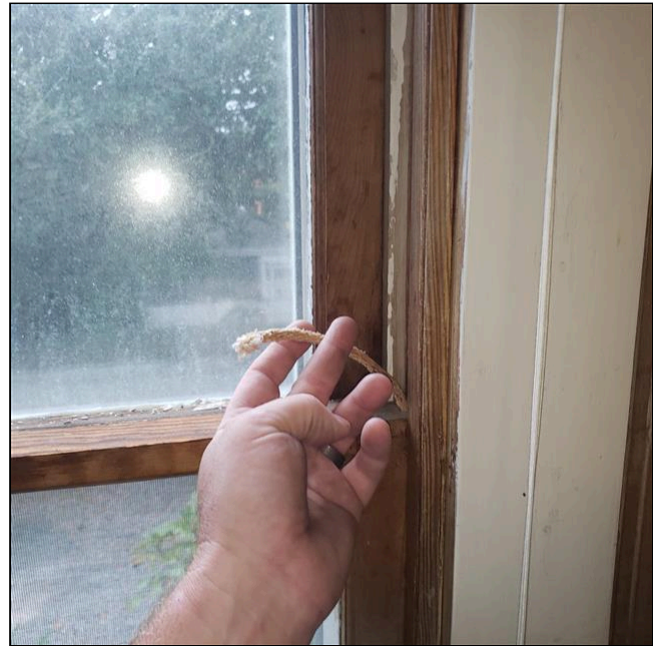
7.5 Item 1 (Picture)

**7.5 (1)** In addition to the concerns noted in the Exterior Section, many of the windows do not function properly. In particular, the original windows at the Guest House mostly have broken sash cords, and at least three of the windows at the rear of the Main House 2nd Fl Sunroom have defective spring balancers as well. Defective and missing latches were observed in a few locations as well. Have all of the windows checked and corrected as needed by a licensed Contractor.

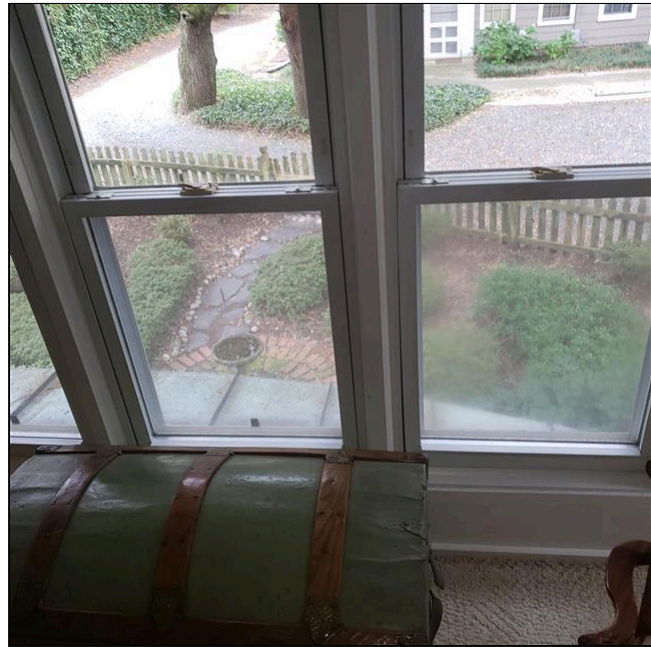
7.5 Item 7 (Picture)

**7.5 (2)** Windows with sills within 18" of the floor like those in the Main House Sunroom should have tempered glass by current standards, consider upgrading for improved safety.

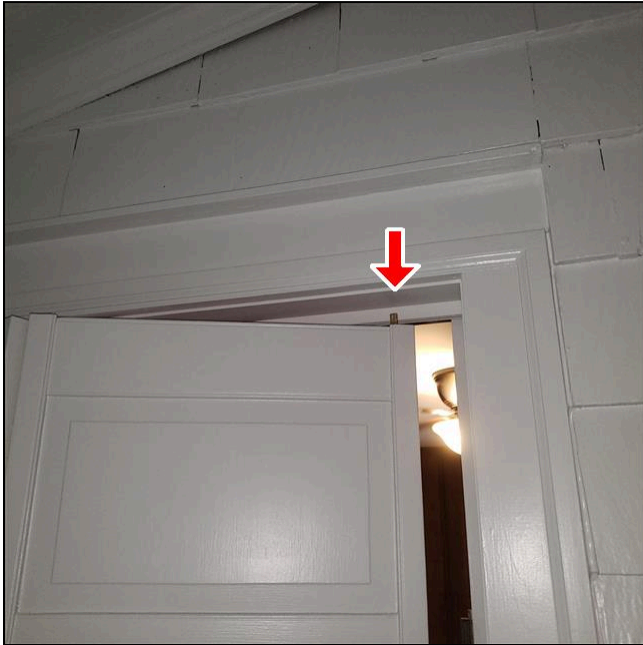
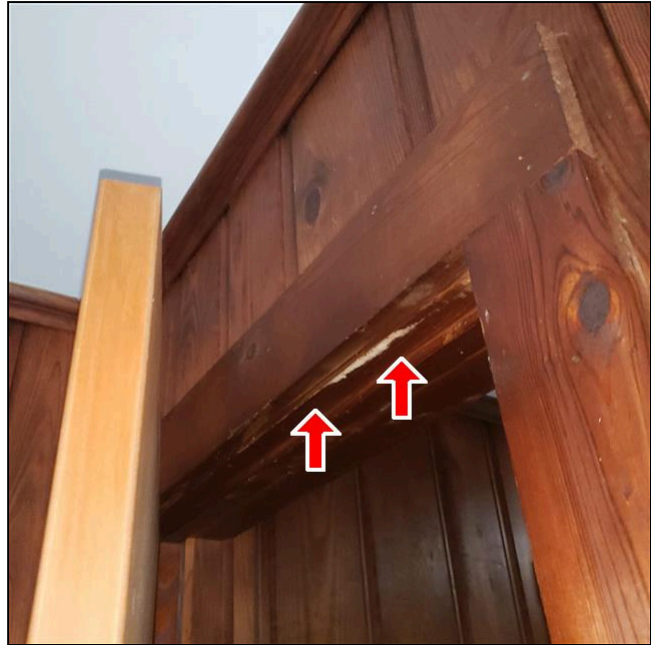
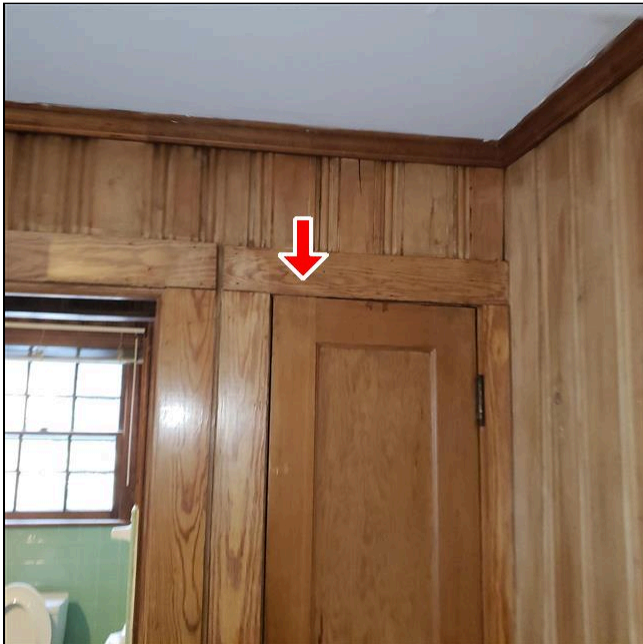
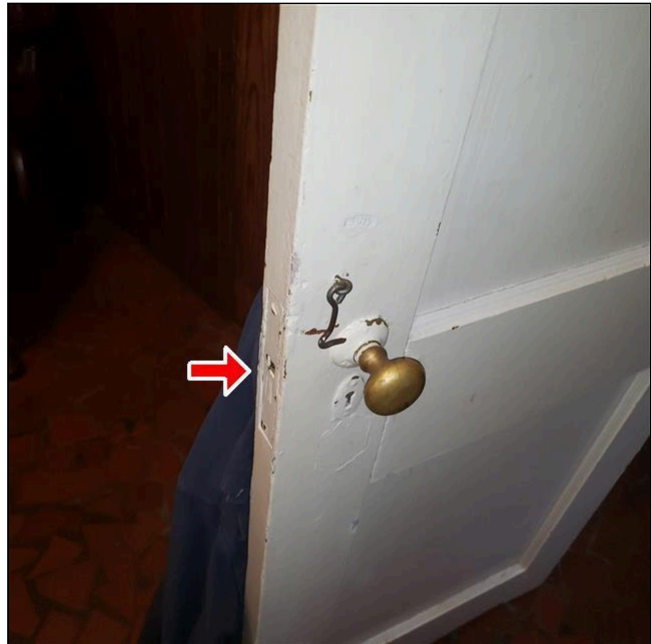
**7.6** (1) The bi-fold doors to the back-right BR in the main house was off the track at the time of inspection; and a few of the doors stick / rubs the jambs, such as the door to the front BR, and the right closet door in large BR of the 2nd Fl Guest House apartment; adjust as needed / desired.

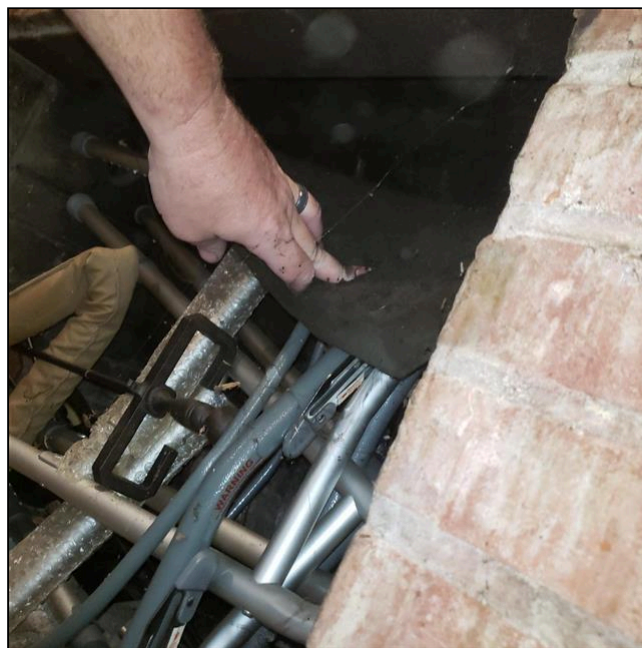
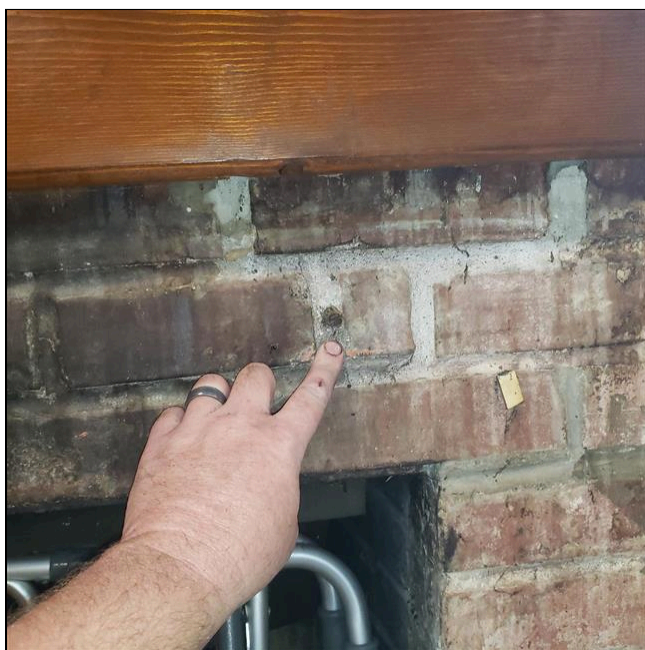
**7.8** Inspection of the fireplace in the Main House 1st Fl Family Rm was limited by the presence of storage and obstructions, requiring further evaluation. The knob to operate its flue damper is missing, requiring repair. As noted in the Roofing Section, there are concerns at both fireplace chimneys, and a Level 2 inspection by a (CSIA) Certified Chimney Sweep is recommended prior to closing.

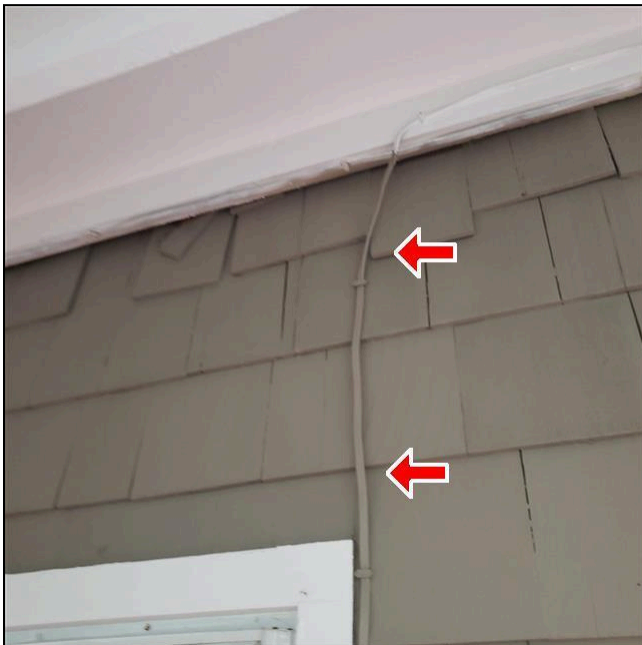
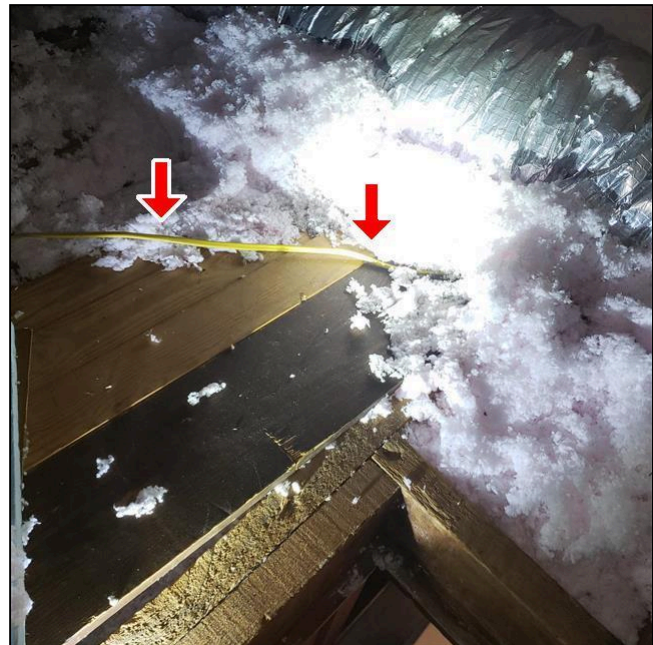
9.5 (1) Some 2 wire (ungrounded) circuits were noted in both buildings. We recommend adding grounds and/or GFCI protection where needed for improved safety.

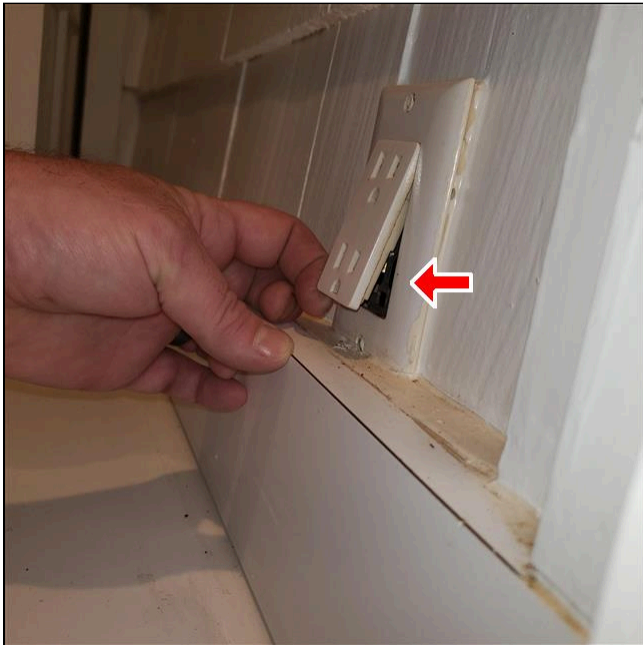
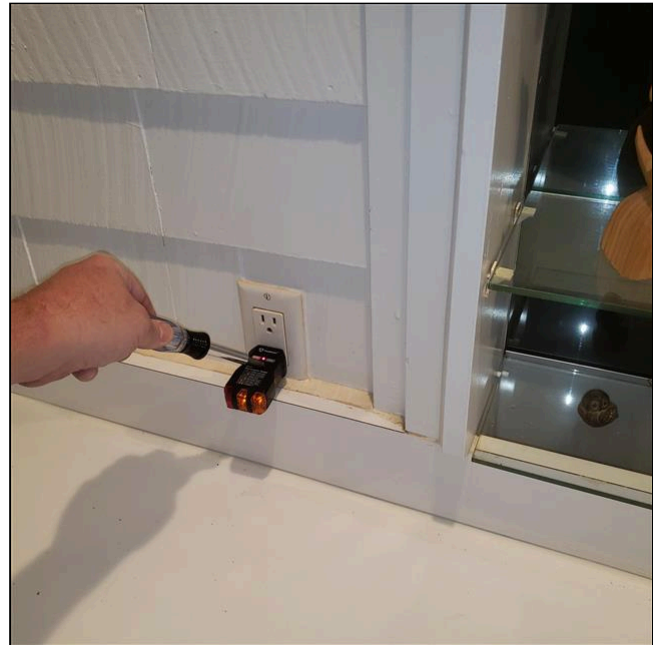
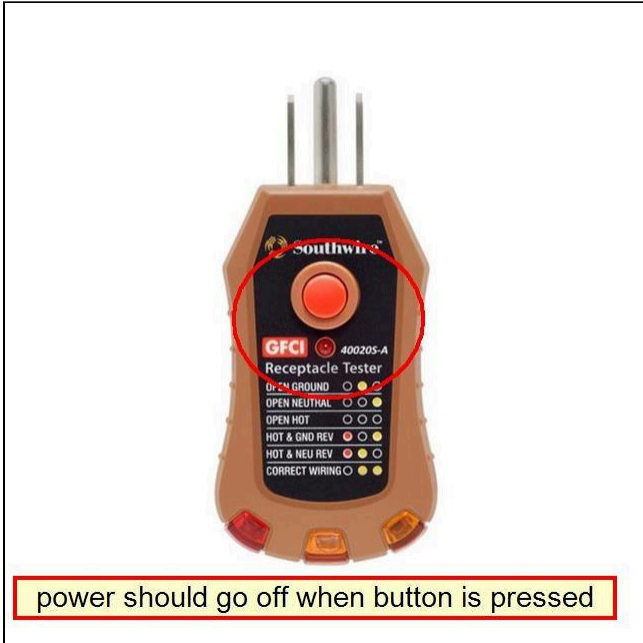
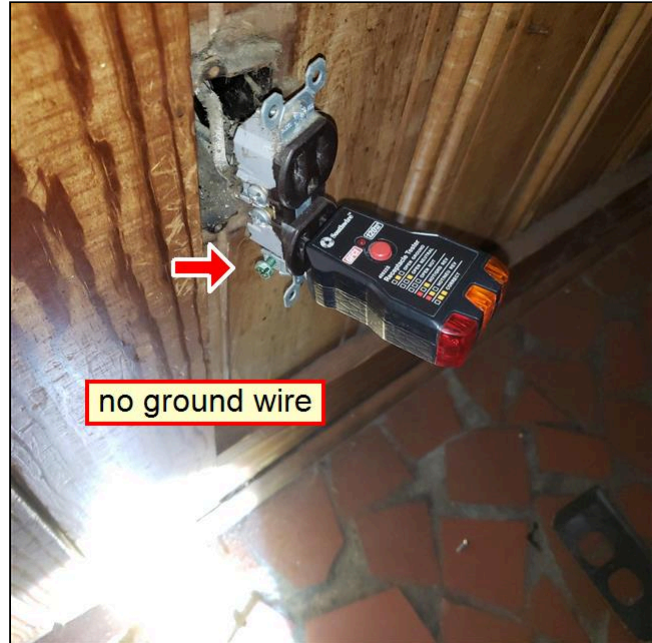
**9.6 (1)** A broken receptacle outlet was found by the wet bar sink in the Main House Sunroom. That outlet lacks GFCI protection as well. Have checked and corrected as needed by a licensed Electrical Contractor.

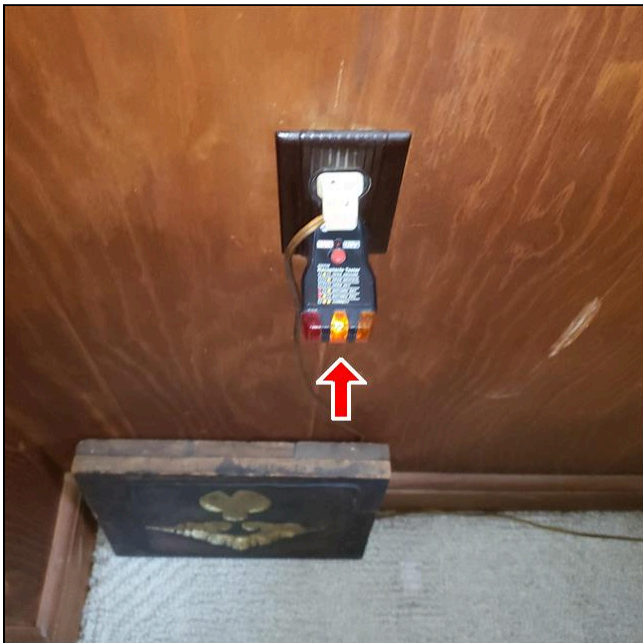
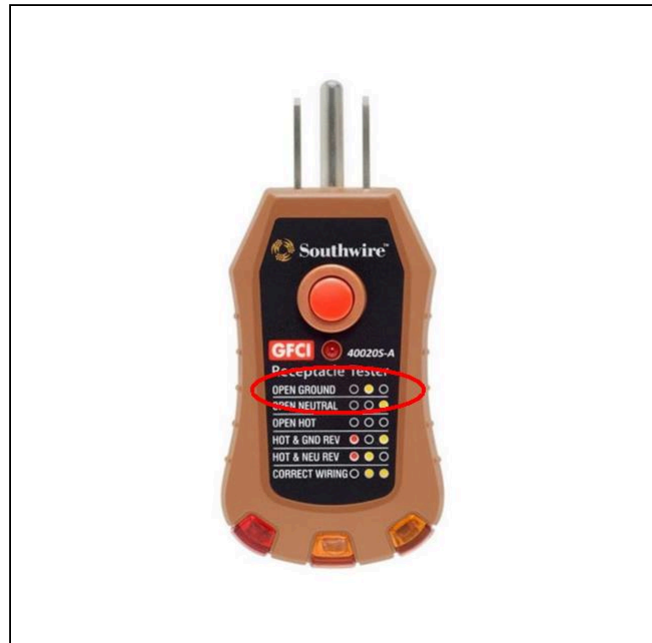
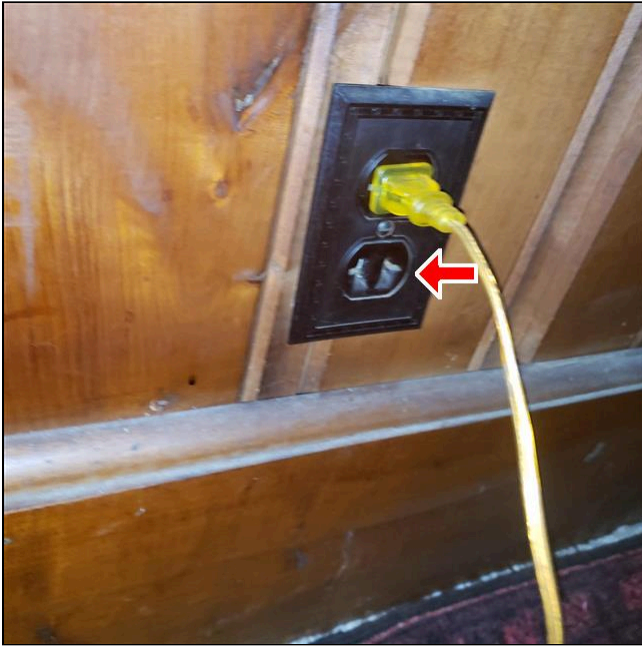
**9.6 (2)** Ungrounded 3-prong and 2-prong receptacles were found in multiple locations in the Guest House and in the original portion of the Main House. GFCI protection appears to have been added on some of the ungrounded circuits in the Guest House, but the receptacles were not properly labeled as being GFCI Protected and as having No Equipment Ground. Have all of the receptacles checked and corrected as needed for proper function and safety by a licensed Electrical Contractor.

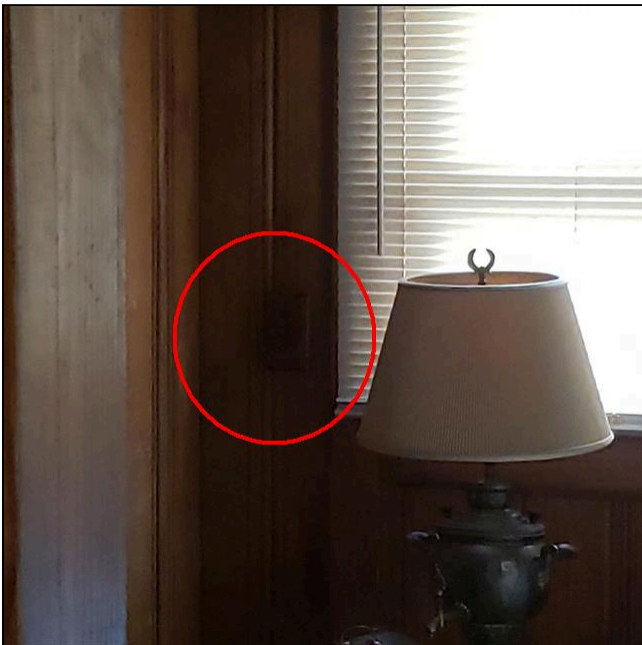
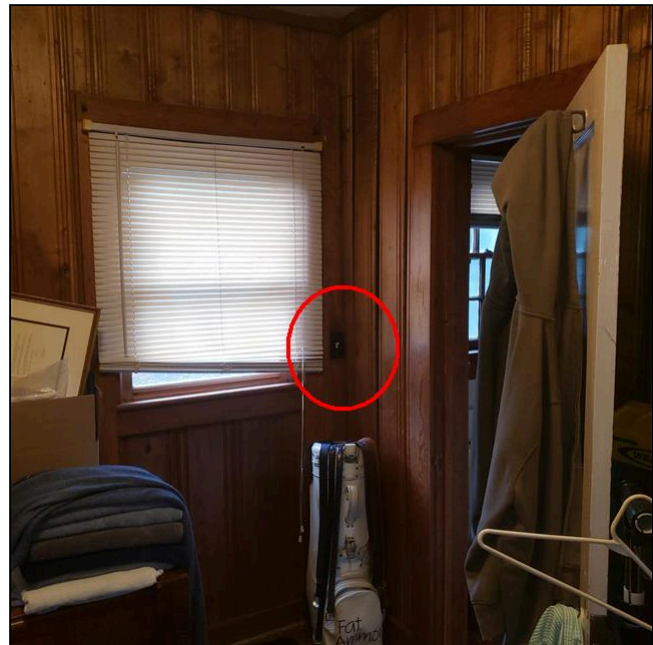
**9.6 (3)** The light switches in the BR's in the 1st Fl Guest House apartment are located on the exterior wall, so one must walk through a dark room to turn on a light; and the fixtures in the Guest House baths are not controlled by switches. As noted in the Exterior Section, exterior light fixtures are not installed by the doors of the Guest House as well. We recommend upgrading for improved function, safety, and convenience.

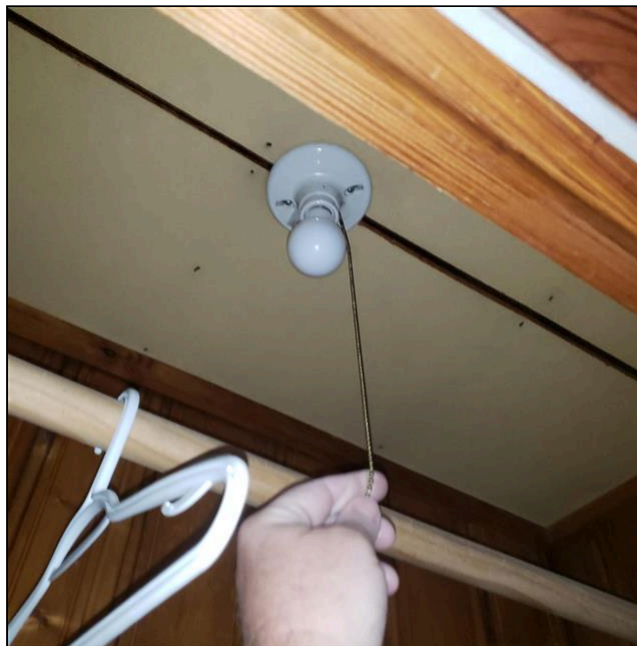
9.6 Item 10 (Picture)

**9.6 (4)** Light fixtures with exposed bulbs are no longer permitted in clothes closets, consider replacing / upgrading.

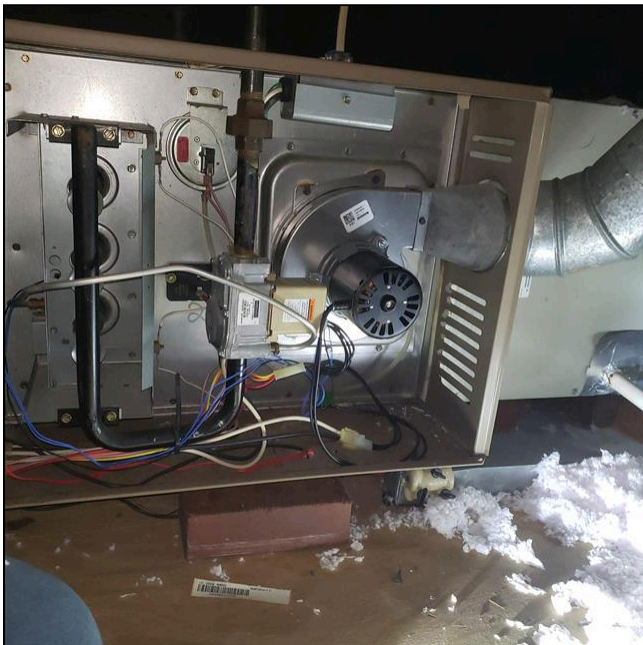
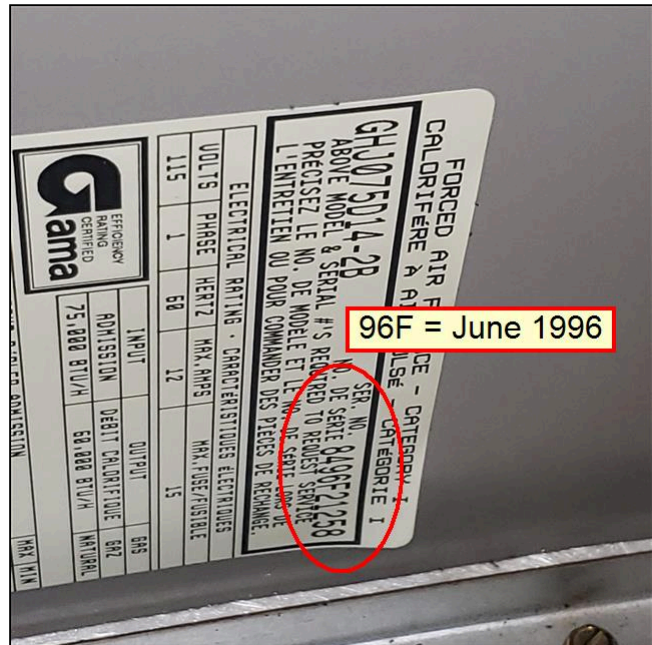
**10.0 (1)** The 2nd Fl Guest House furnace is beyond its intended service life, and it could not be operated during the inspection due to the lack of gas service (which was off at the meter) at the time of inspection. Have checked by a licensed HVAC Contractor prior to closing and anticipate future replacement needs.

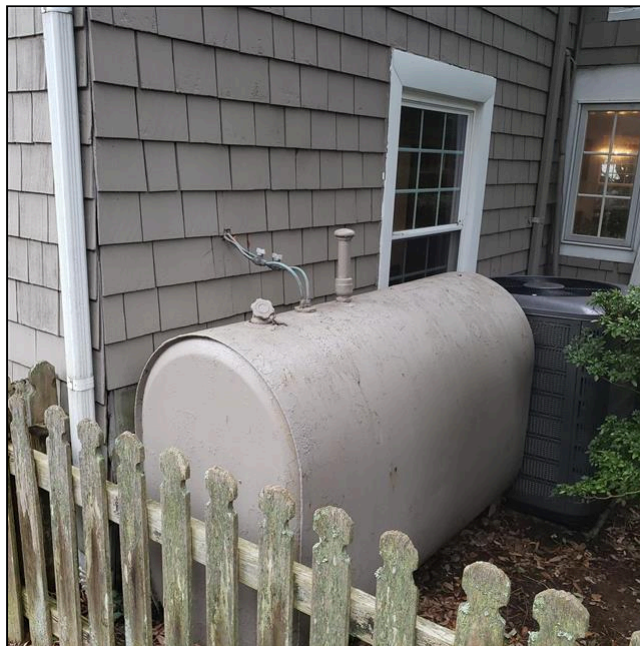
10.16 Item 1 (Picture)

**10.16** Oil storage tanks are not inspected during a standard home inspection, consider having inspected by a qualified heating oil distributor as a precaution.

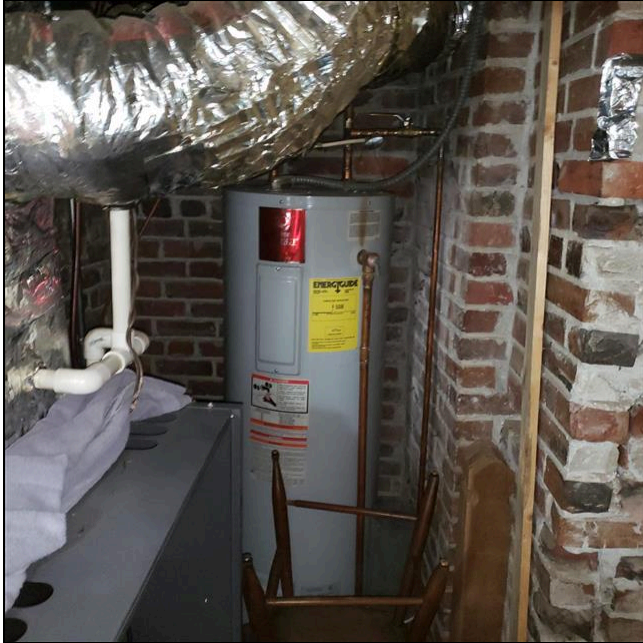
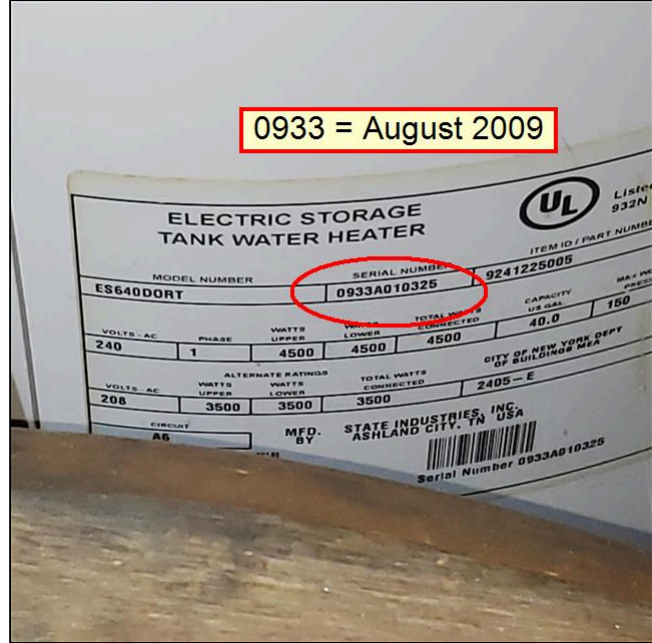
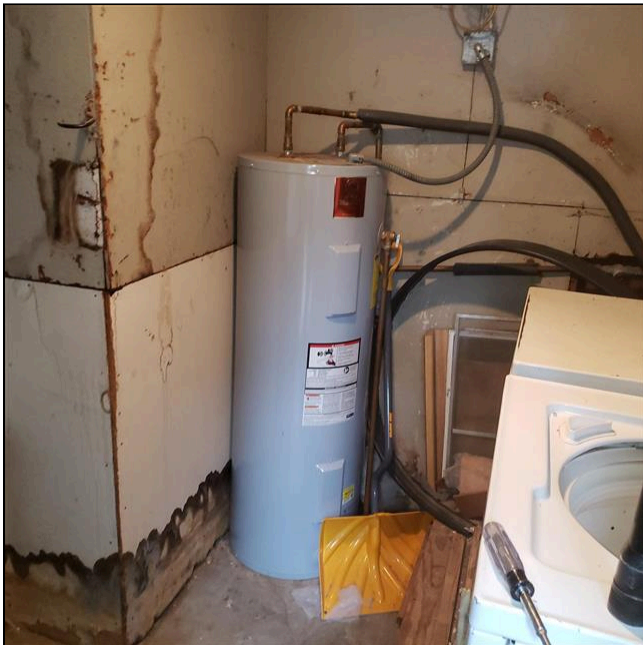
**11.5** (1) Units appear to be nearing the end of their design life, monitor and anticipate future replacement needs. (No signs of leakage or excess wear noted. Electric tanks generally hold up much

better than gas units, but tend to have heating coils burn and other components wear out as they age, requiring repairs.)

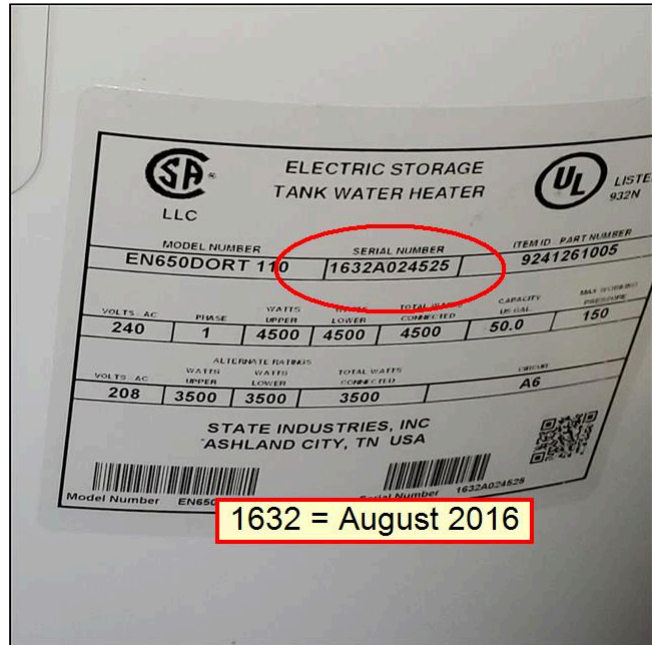
11.5 Item 4 (Picture)

**11.5 (2)** The wiring for the Water Heater complies with standards of when home was built, but current standards require that an emergency cutoff be present near unit, or it's breaker be fitted with a "lockout" device. (unless Electrical Panel is nearby) Consider correcting for added safety and convenience.

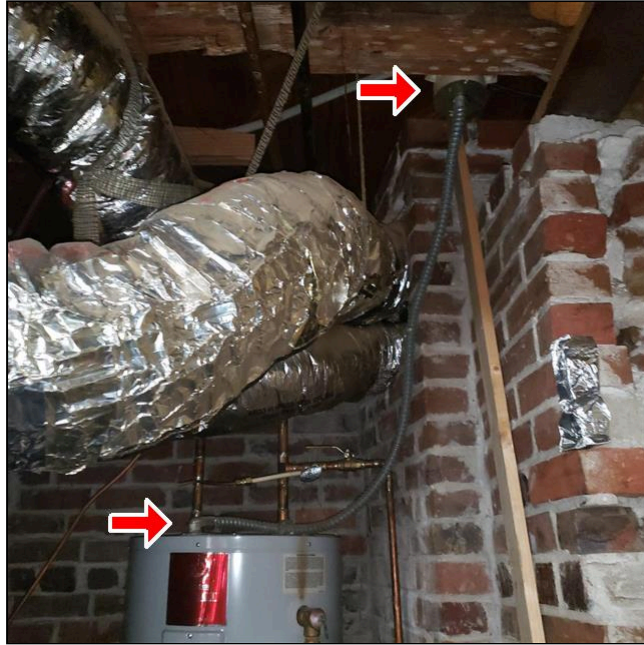
11.5 Item 5 (Picture)

**11.5 (3)** Current standards require that the heating elements be at least 18" from the floor of any garage or utility area location. Consider placing the Guest House Water Heater on a proper stand to reduce the risk of fire resulting from the spill of a combustible material.

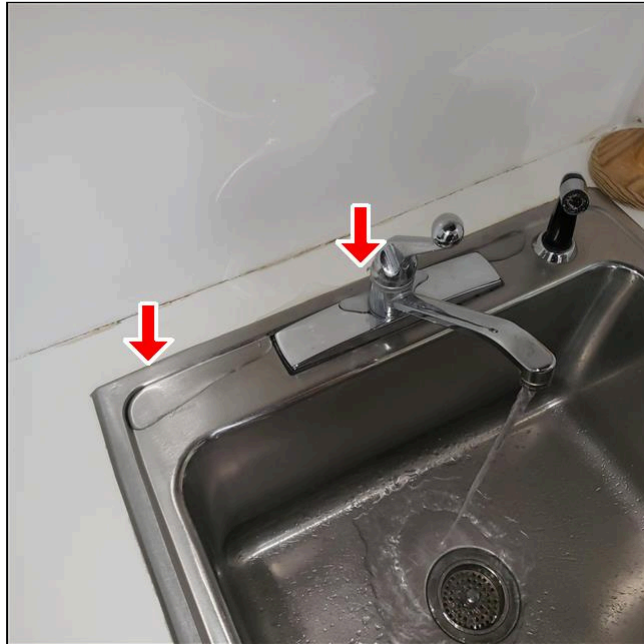
11.9 Item 1 (Picture)

**11.9** Leakage was observed at the faucet valve stem when operated, have checked and corrected as needed by a licensed Plumbing Contractor.

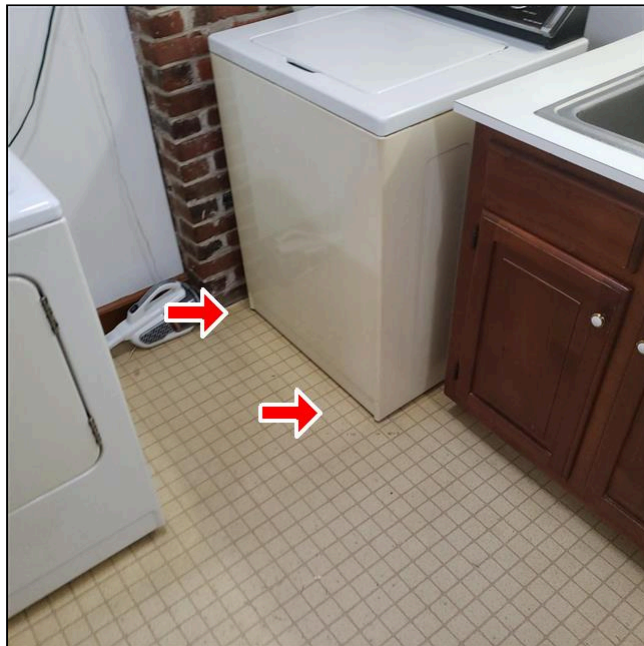
11.10 Item 1 (Picture)

**11.10** (1) Consider installing an overflow pan at the washer location in the Main House and/or emergency water shutoff valves and sensors to reduce the potential for damage from a leak.

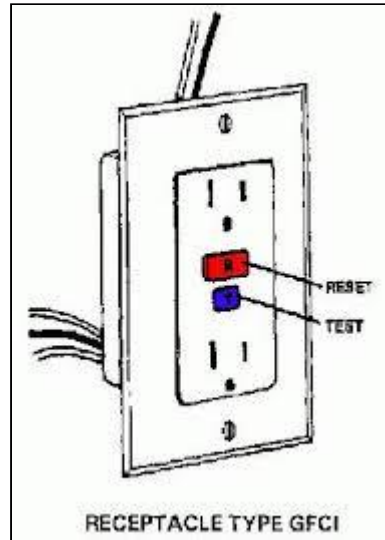
11.10 Item 2 (Picture)

**11.10** (2) By current standards, the receptacle outlet for the clothes washer should be GFCI protected, consider upgrading for improved safety.

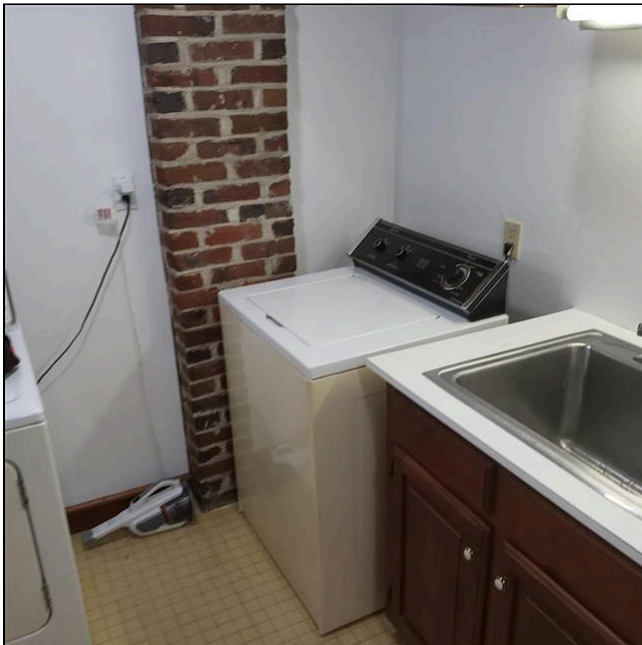
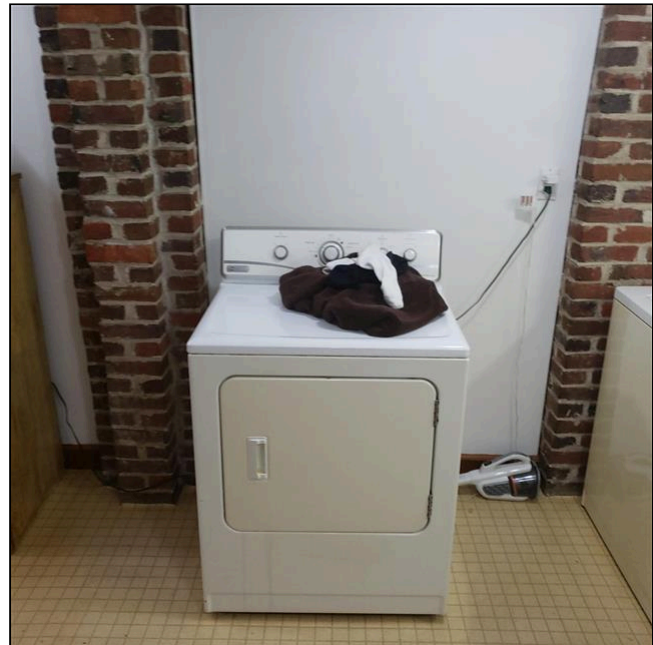
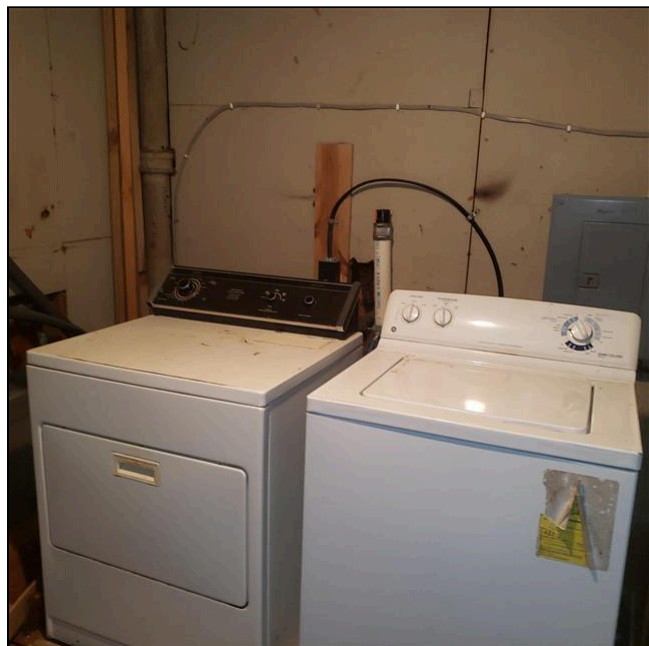
**11.11** Older equipment noted. Operated as intended at time of inspection, but no determination can be made with respect to future service life.
