Home Inspection Report

600 Lotz Dr
Yorktown, VA 23692

Inspected by:
Andy Call
Peninsula Property Inspections Inc

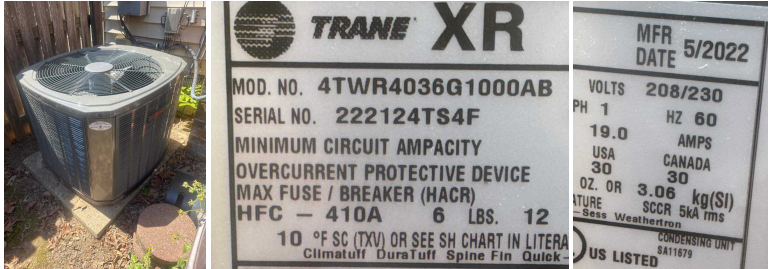
3. Exterior Unit: Pad mounted
4. Manufacturer: Trane

5. Area Served: Whole building Approximate Age: 4 years
6. Fuel Type: 220 VAC Temperature Differential: 16 degrees
7. Type: Heat pump Capacity: 3 Ton
8. Visible Coil: Copper core with aluminum fins
9. Refrigerant Lines: Serviceable condition
10. Electrical Disconnect: Tumble switch

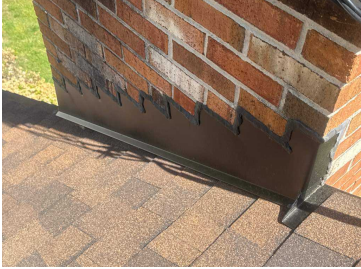
15. Chimney Flashing: Aluminum

14. Flue/Flue Cap: Mortar - [Crown cracked , Repair chimney mortar crown](#)

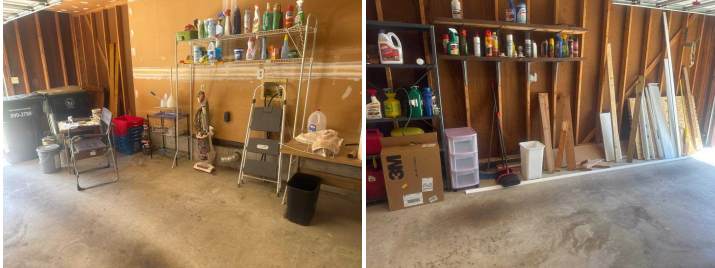
Walls: (continued)

6. Ceiling: Drywall
7. Walls: Exposed framing, Drywall - [Inspection does not cover any damage concealed by personal items](#)

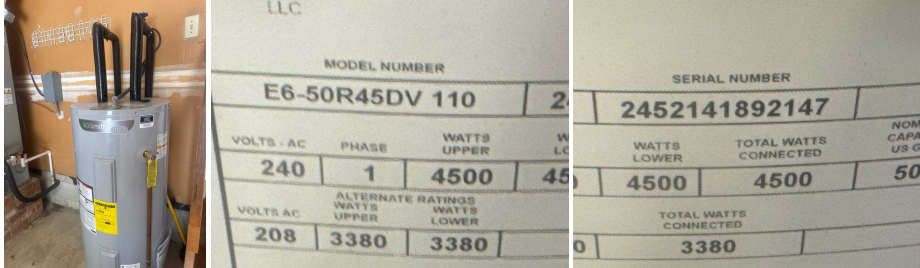
9. Manufacturer: A.O. Smith

10. Type: Electric Capacity: 50 Gal.

11. Approximate Age: 2 years Area Served: Whole building

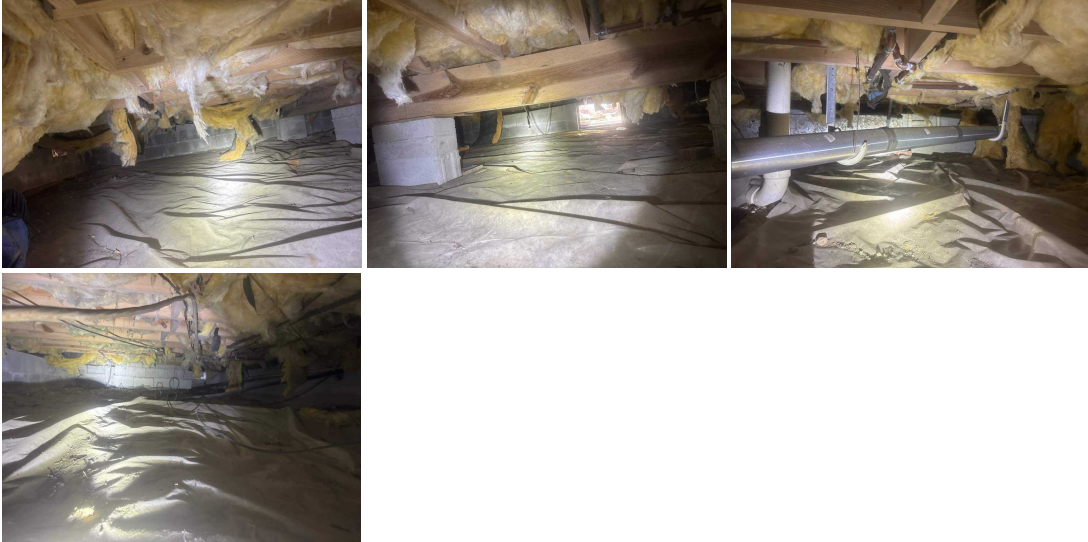
2. Unable to Inspect: 10%

8. Insulation: Fiberglass - [Falling down in areas, recommend correction](#)
