HOME INSPECTION REPORT

Zach Johnson
2227 Gideon Grove Church Rd
Stokesdale, NC 27357

On 5/14/2025, HomeTeam Inspection Service made a visual inspection of the property referenced above. Enclosed please find a written, narrative report of our findings in accordance with the terms of our Home Inspection Agreement. Although maintenance items may have been addressed verbally at the time of the inspection, they may not be included in the enclosed report.

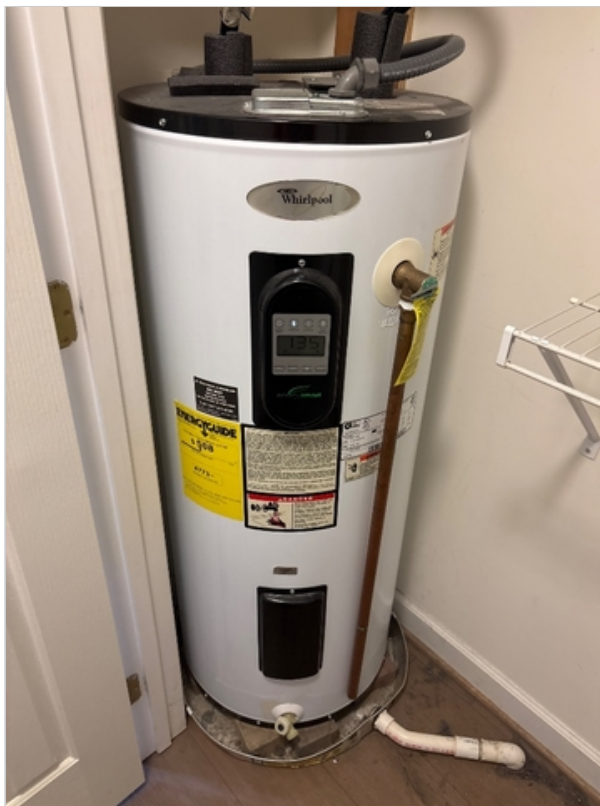
There were no concerns observed with the water heater.

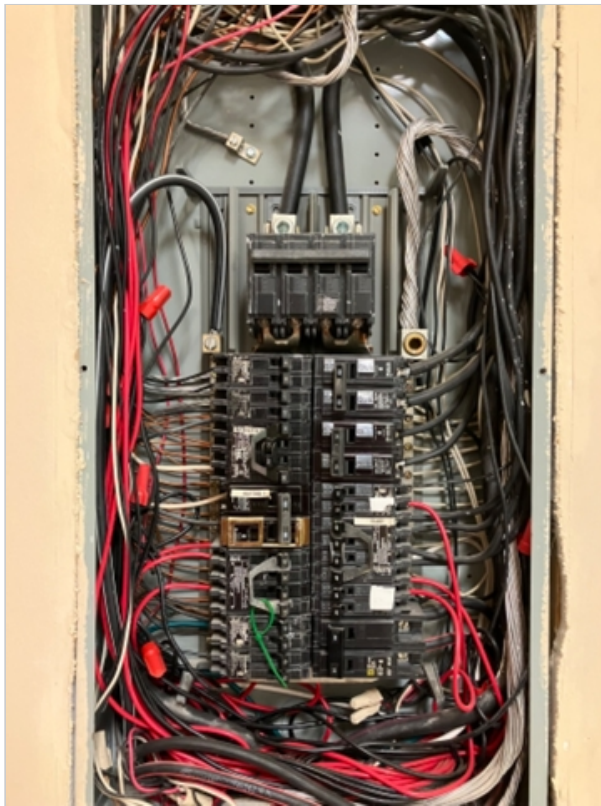
The main service panel is located on the interior wall with an estimated 200 amp and 240 volt rated capacity. 120v branch circuits were copper. 240v branch circuits were aluminum and copper. The branch circuits were connected to breakers. There were concerns observed within the main panel.

White wires typically used for the common, are being used for power in the main electric panel. Although using white or "common" wires for power is allowed, they should be marked accordingly with black markings or tape. This is a safety concern. Recommend repairs by qualified person.

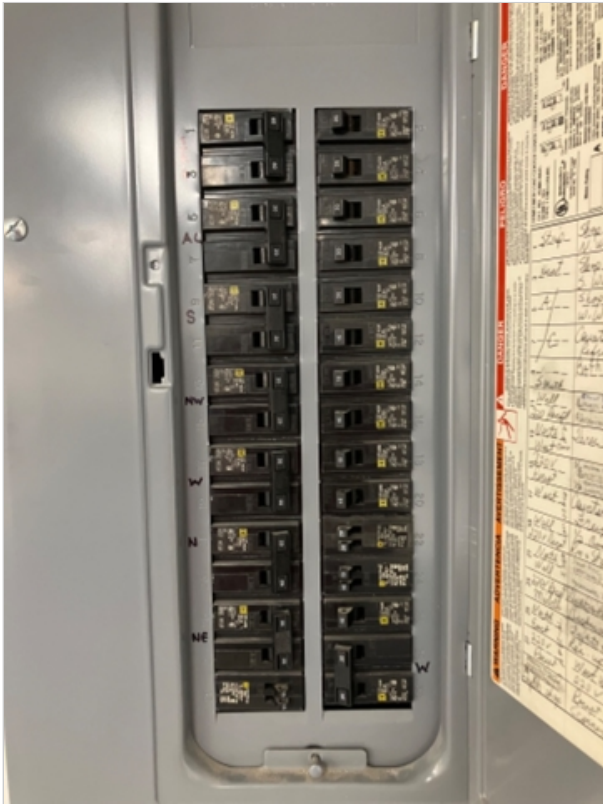
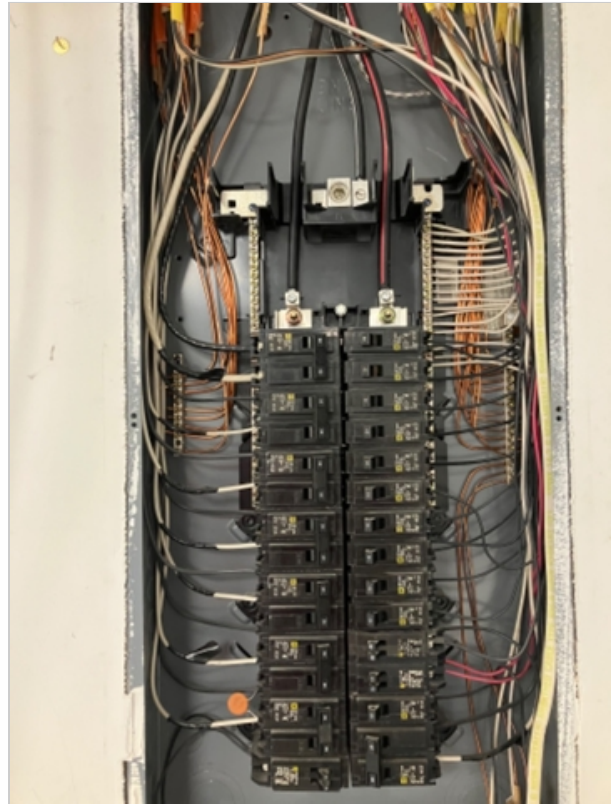
A subpanel is located on the basement wall with an estimated 90 amp and 120/240 volt rated capacity. 120v branch circuits were copper. 240v branch circuits were aluminum and copper. These branch circuits were attached to breakers. There were no concerns observed within the sub panel.

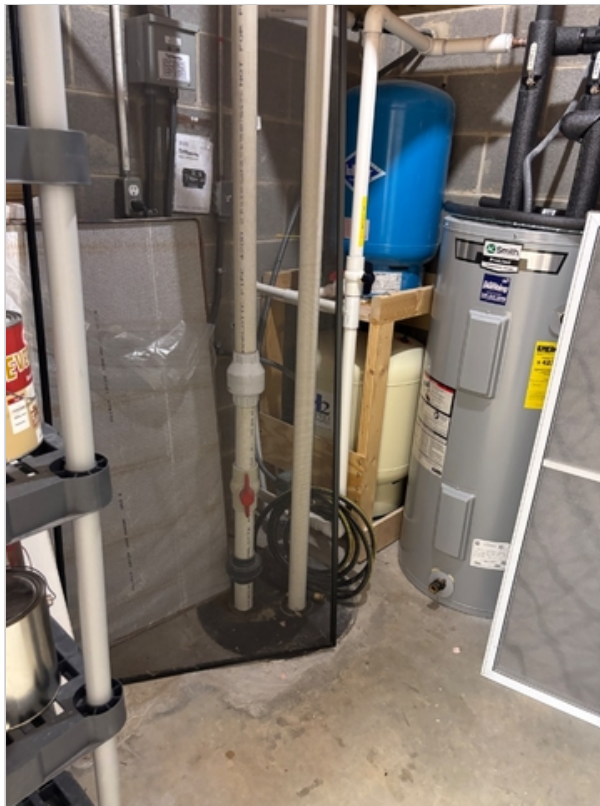
MAIN WATER SHUT OFF

The main water shutoff valve for the home was in the crawlspace at the captive air tank. Water shutoff valves are visually inspected only. No attempt is made to operate the main or any other water supply shutoff valves during the inspection. These valves are infrequently used and could leak after being operated. This is for your information.

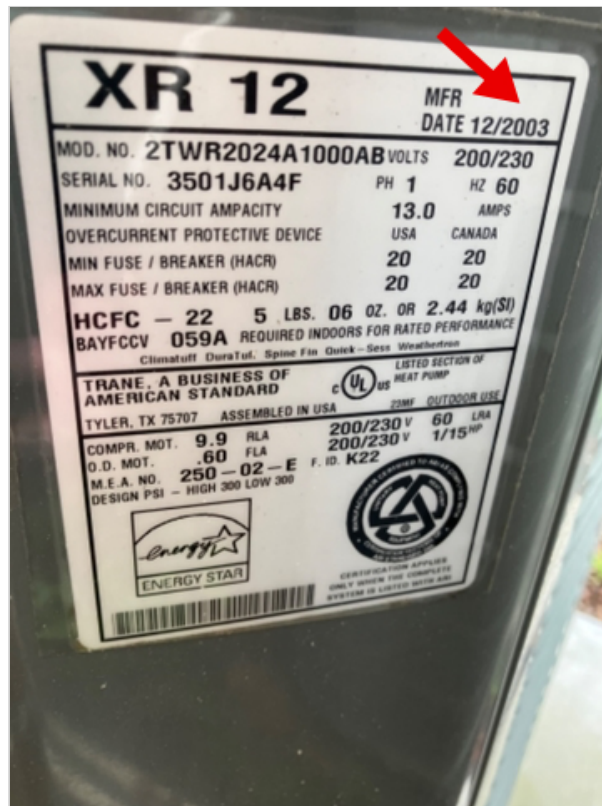
HVAC System 1

System 1 was heated by a Trane electric heat pump, distributed through the house by a duct system. Unit appeared to be manufactured in 2003.
