Structural Engineering Investigation
For
Joe Gribbins
Estate of Dr. Robert Sexton, Jr.
10410 Forest Garden Lane
Louisville, KY 40223
Job No. 2022-534

By
Nathan Grimes, P.E., P.L.S., C.F.E.I., C.F.I.I., R.H.I.

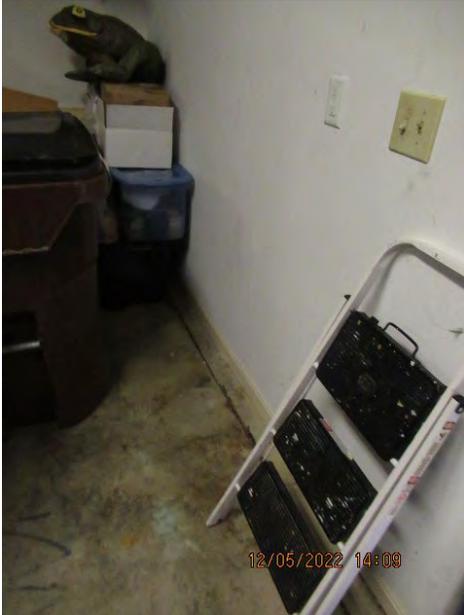
19. There is an offset in joint in garage floor slab near rear wall of garage. This offset is ½” height at the joint in the concrete floor slab.
20. Most of the reinforced basement and foundation walls are not visible on exterior of the house due to the finished grade of the soil.
21. The visible garage and basement concrete slab floors were not cracked except as listed above.

Offset Joint in Garage Floor

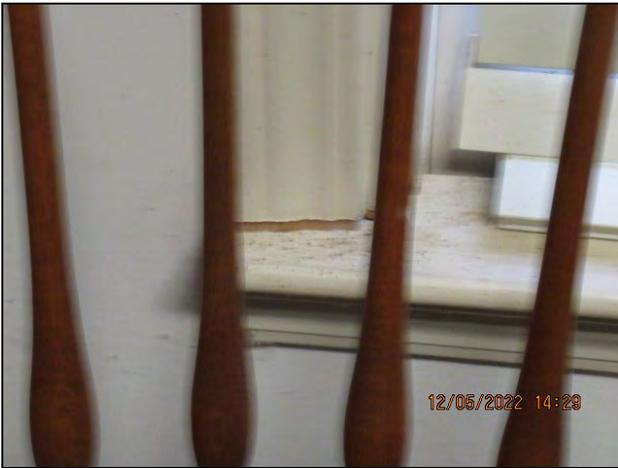
13. There are repaired cracks in concrete driveway slab that were up to ¾” in width.
14. The interior garage window trims have separated on front wall of house.

Separated Wood Window Sill and Garage Front Wall

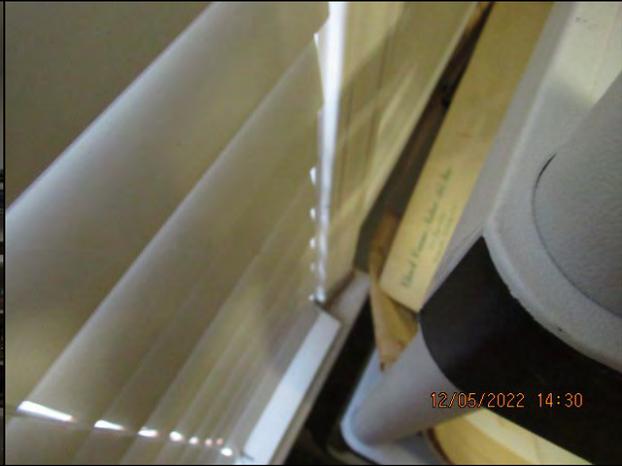
Separated Wood Window Sill and Garage Front Wall

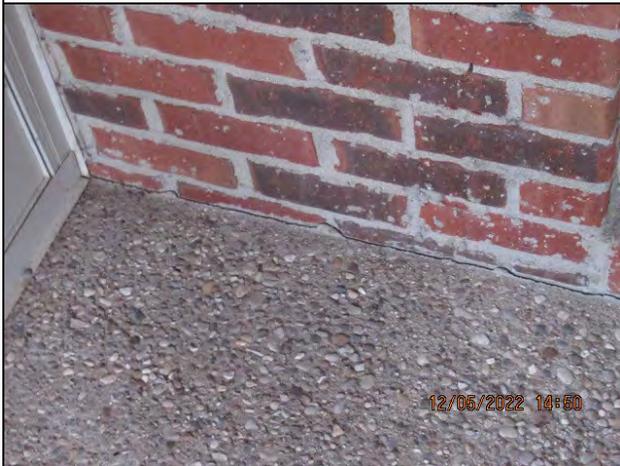
15. All windows and doors were operable.
16. There is a crack in joint connection of rear concrete patio to the brick veneer and also a crack in the patio slab itself in one location. Neither of these are offset.

Rear Patio/Wall Connection Detail

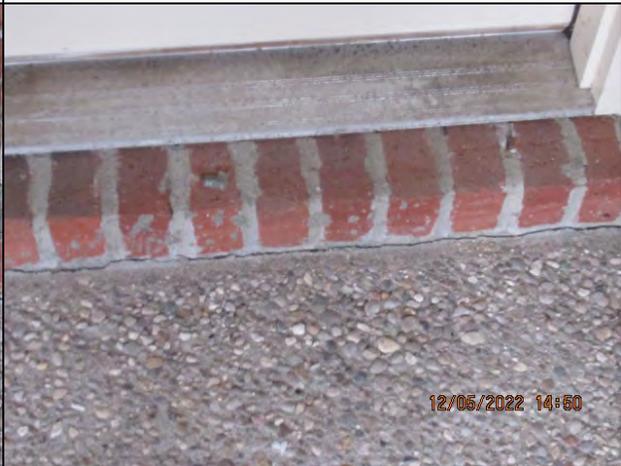
Rear Patio/Wall Connection Detail

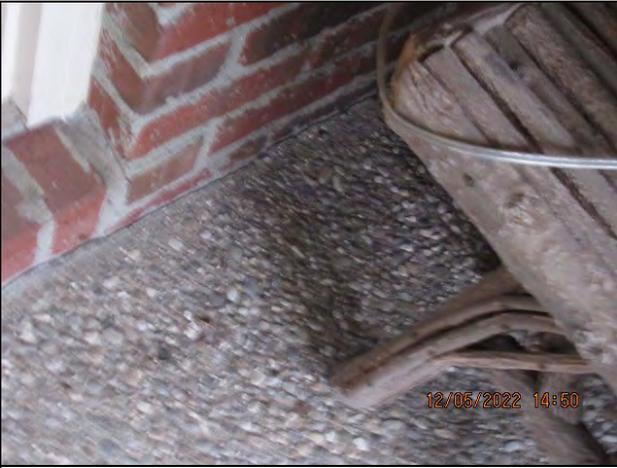
Rear Patio/Wall Connection Detail

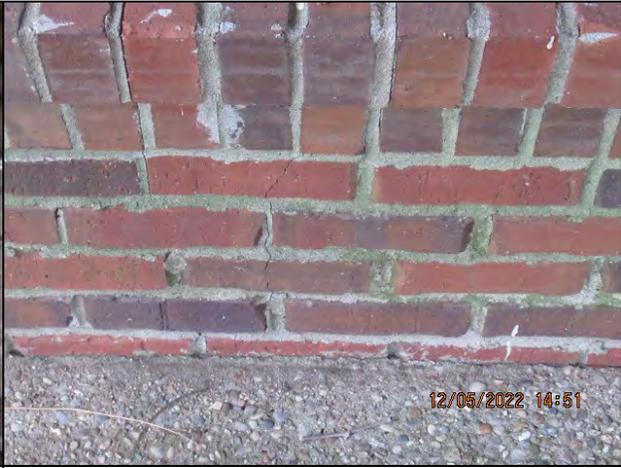
Rear Patio/Wall Connection Detail

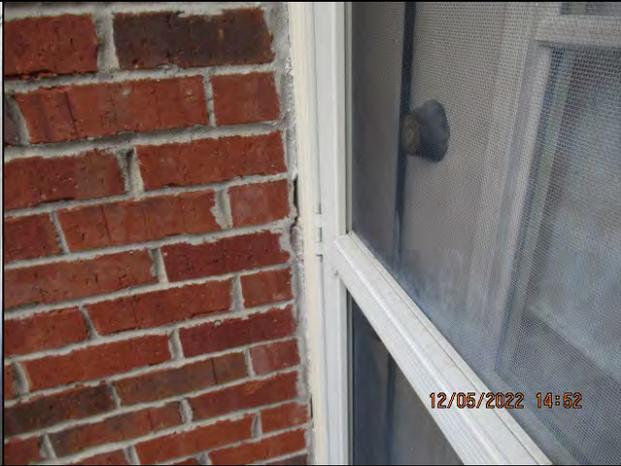
17. The caulking seam has failed at rear wood deck where the Hardi-Board wall connects the brick veneer wall.
18. There are several loose nails on wood deck that connect deck boards to framing on the rear deck.

Caulking Seam Cram at 2nd Floor Deck
