SENTRY INSPECTION SERVICES, LLC / SENTRY HOME INSPECTIONS

RESIDENTIAL PROPERTY INSPECTION

112 Loblolly Rd SW
Moultrie, GA 31768

MARCH 17, 2023

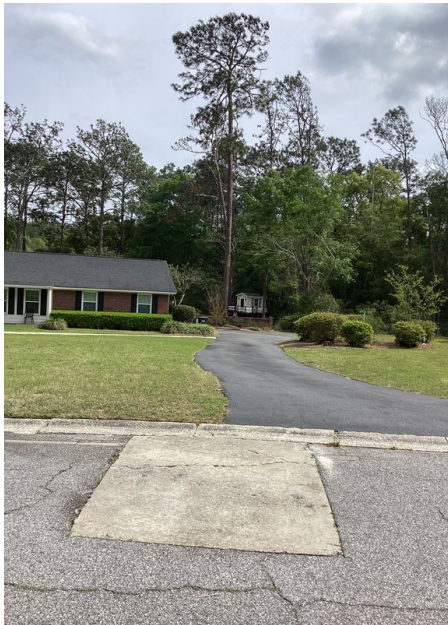
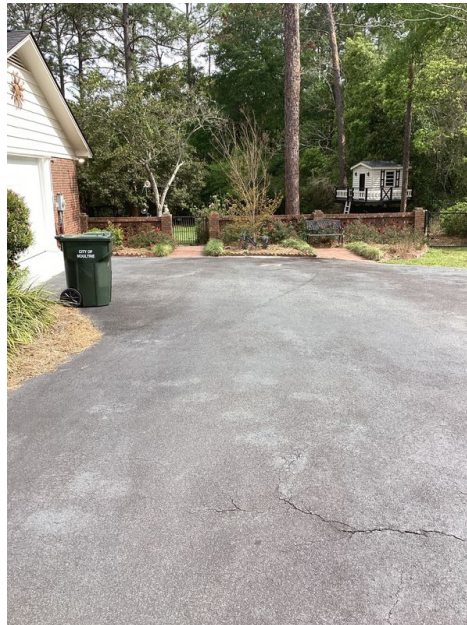
Driveway and Walkway Condition: Typical Settlement / Shrinkage Cracks

Settlement / shrinkage cracks were present on the concrete surface (<1/4 inch wide). These can typically be from standard settlement, from admixtures or the composition of the concrete, or weather conditions when the concrete was poured. I recommend sealing these cracks at a minimum, to prevent further damage.

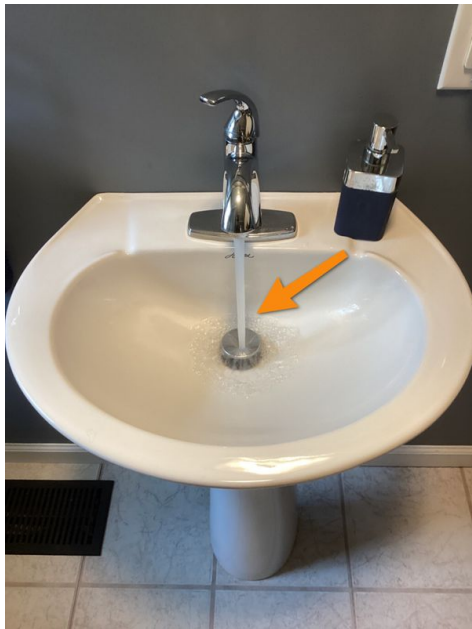
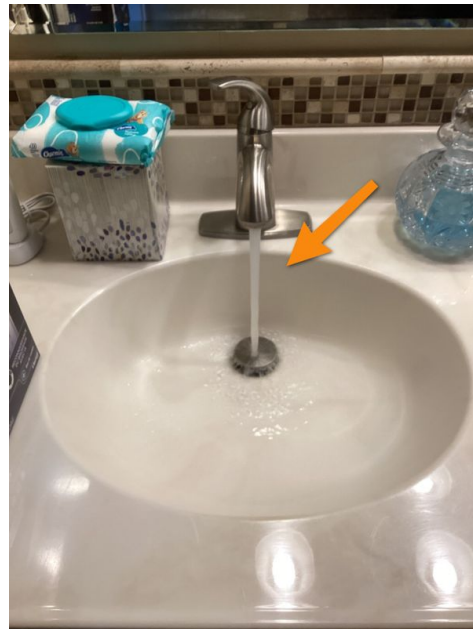
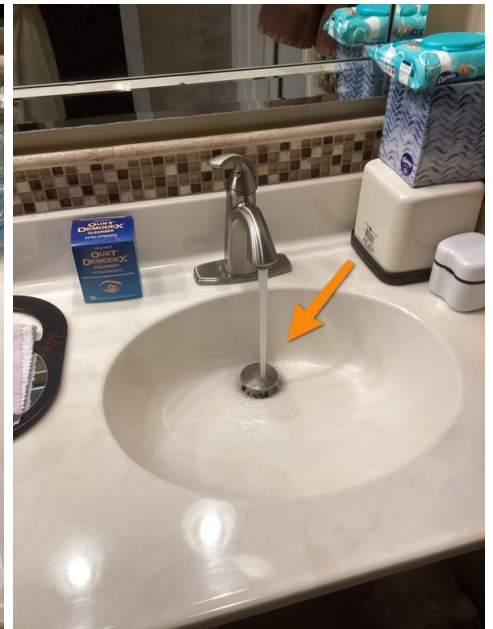
There was a foul odor when the water was turned on to the sinks at the time of inspection. Recommend evaluation by a qualified plumber.

Contact a qualified professional.

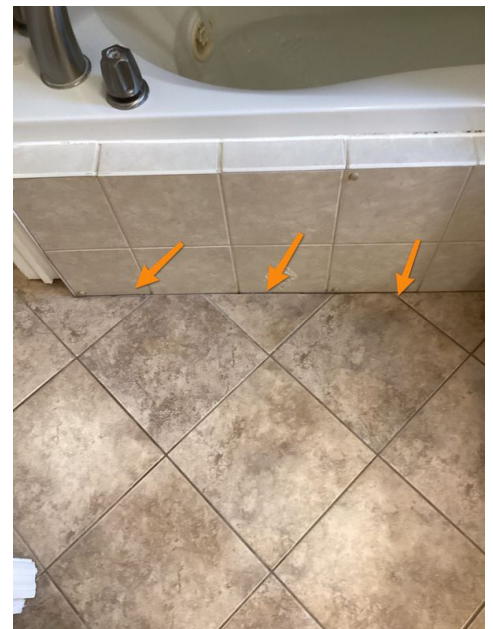
Master Bathroom

Gaps were present where the floor transitions to the tub. Sealing the area where the floor transitions to the bathtub is recommended by a qualified person to prevent water intrusion to the subfloor below.

Contact a qualified professional.

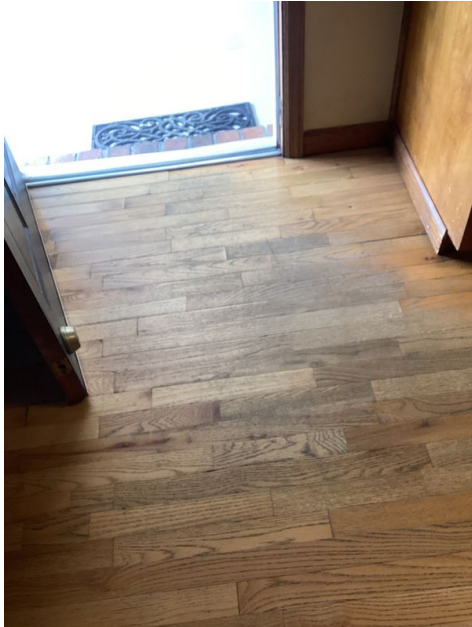
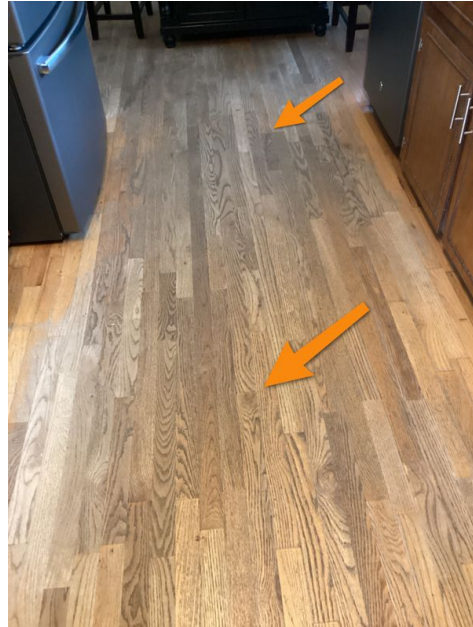
Kitchen

HEAVY WEAR TO HARDWOOD FLOORS

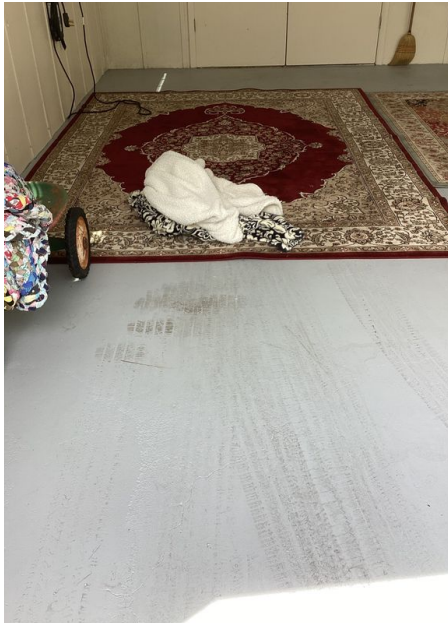
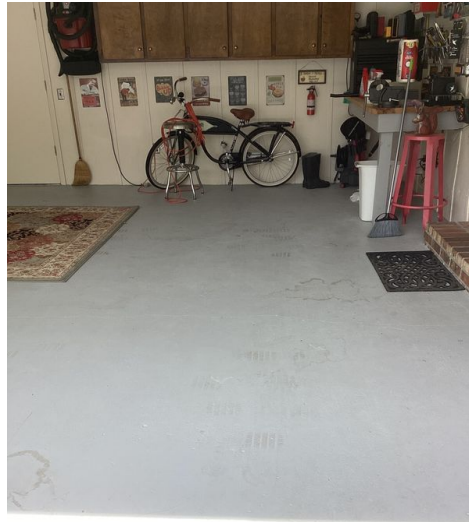
9.13.1 Garage Slab

Minor Defect, Maintenance Item, or FYI Item

NORMAL SETTLEMENT CRACKING ON SLAB

Recommendation

Contact a qualified professional.

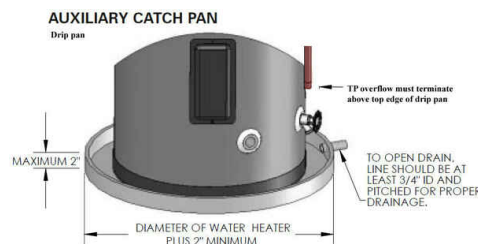
11.1.1 Water Heater Condition

Minor Defect, Maintenance Item, or FYI Item

DRAIN PAN MISSING

A water heater drain pan was not present. Drain pans also called "Smitty pans" are recommended when the water heater is installed in an area where leaks from the unit could cause damage to framing components and/or interior areas. The installation of a drain pan is recommended to be conducted by a qualified person.

Recommendation

Contact a qualified plumbing contractor.

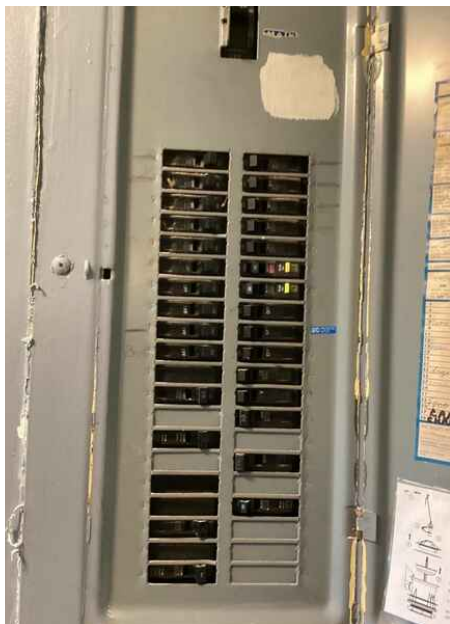
Service Equipment / Electrical Panel: No Hot Spots Observed with IR Camera

No hot spots or anomalies were observed in the electrical panel, under current loading conditions, during the inspection.

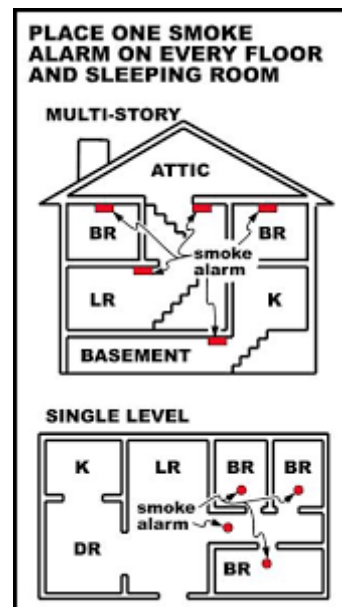
Smoke alarms were not present in each bedroom, this is a Safety Hazard. Current safety standards require a smoke alarm in each bedroom (sleeping area) for fire safety. Dual sensor alarms incorporating both an ionization sensing chamber and photoelectric eyes are recommended.

Contact a handyman or DIY project

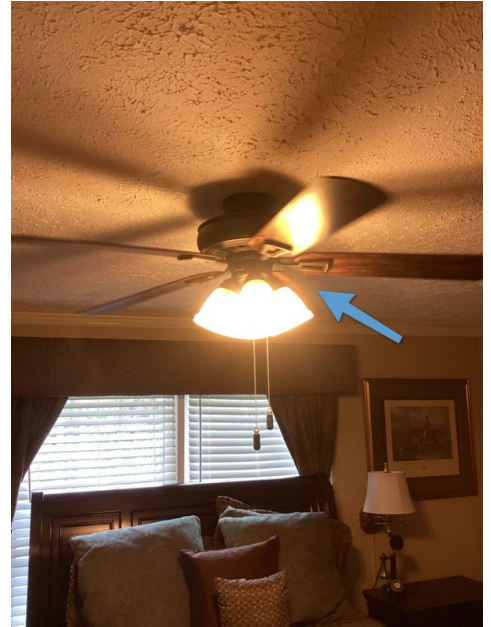
Master Bedroom

The ceiling fan wobbled slightly during operation. The fan may be out of balance. Repairs are recommended to be conducted as needed by a qualified person to eliminate any wobbling.

Contact a qualified handyman.

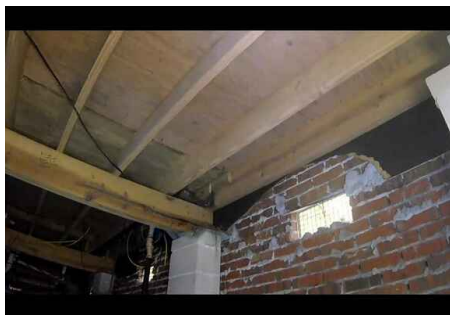
Foundation Walls: Cracking Present - Within Normal Tolerances

FYI - Cracking was present on the referenced wall(s). The crack(s) appeared to be within normal tolerances at the time of inspection. *Please read the information & limitations in regards to cracking above.

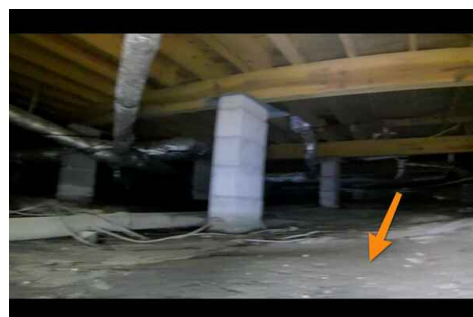
CRAWLSPACE

The vapor barrier in the crawl space lacked full coverage. Current standards require that vapor barriers cover the entirety of the soil in crawl spaces. Evaluation and modifications to achieve full coverage of the vapor barrier is recommended to be conducted by a qualified contractor.

Contact a qualified professional.

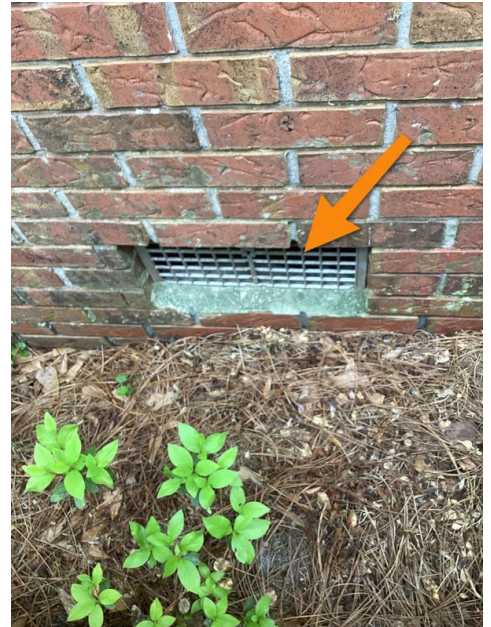
DAMAGED VENTS

FOUNDATION WALLS

There were damage foundation vents present at the time of inspection. I recommend repairs or replacements of all damaged vents to include screens and exterior open/closure handles by a qualified individual as needed.

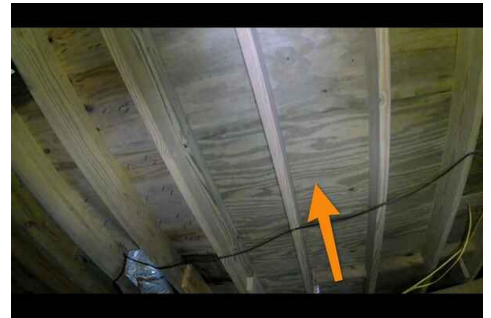
15.13.1 Insulation

INSULATION NOT PRESENT BETWEEN JOISTS
