Property Inspection Report

Southern Home Consultants, Inc.

Report #: 021326WO8.

2813 Shamrock N.
Tallahassee, FL 32309.

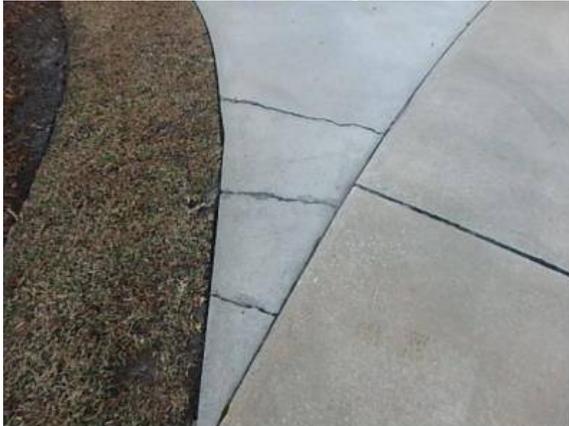
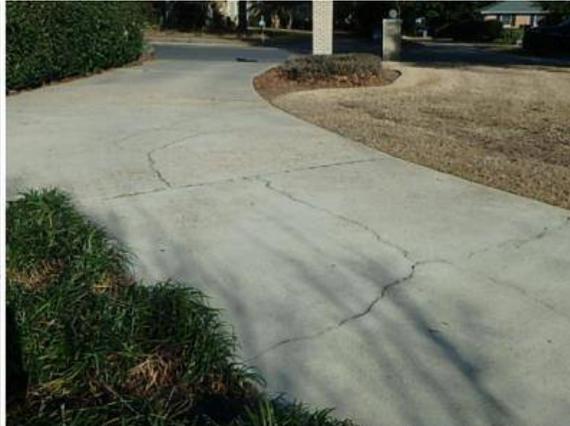
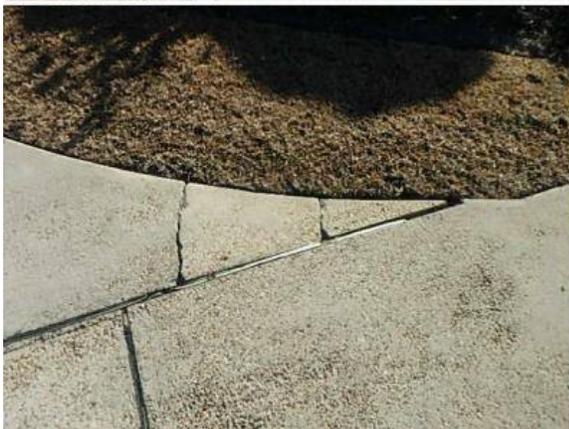
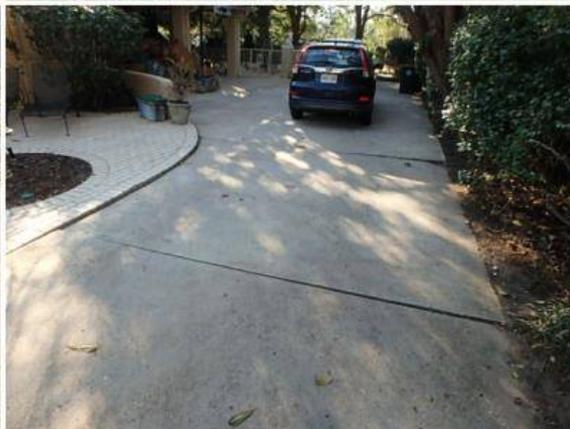
3. Driveway has areas of cracking and settlement.

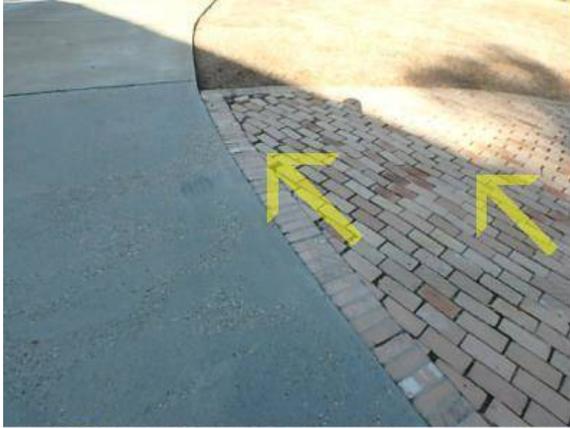
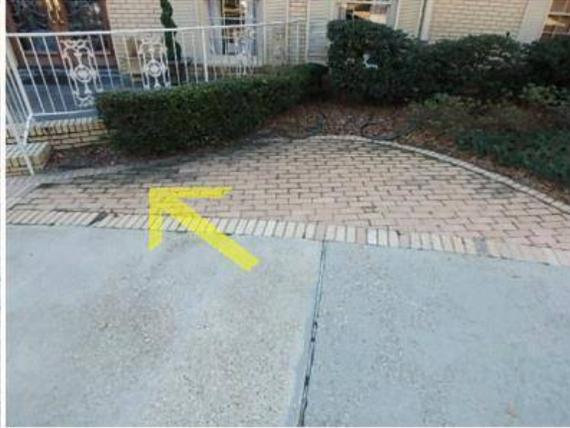
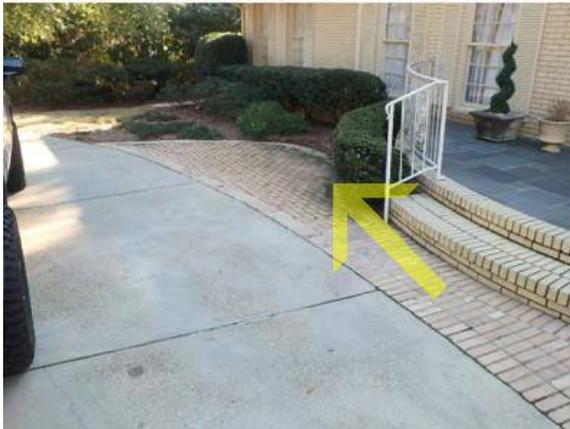
4. Areas of raised and settled brick pavers noted at the front driveway and walk areas. Some areas appear to hold or trap water during rain events.

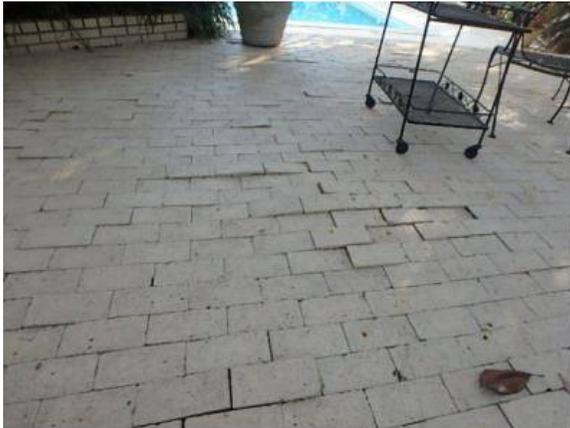
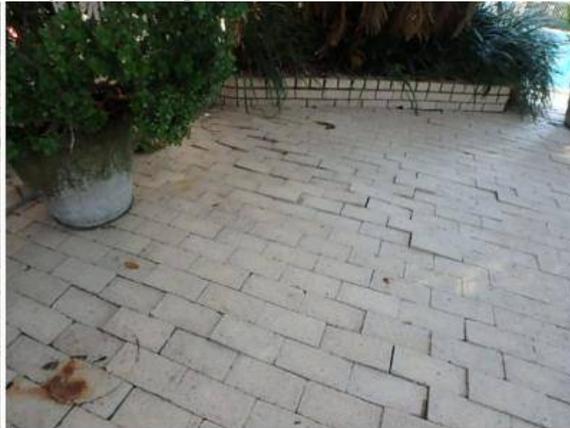
5. Various areas of raised and settled bricks noted at the right side rear patio.

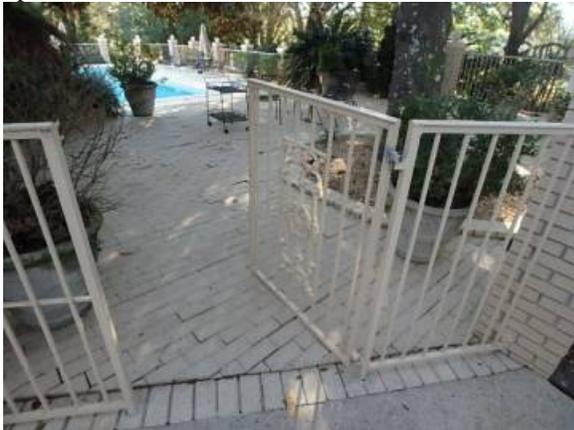
8. The right side pool area Gate needs adjustment to operate properly. This gate currently conflicts with the brick pavers when operated.

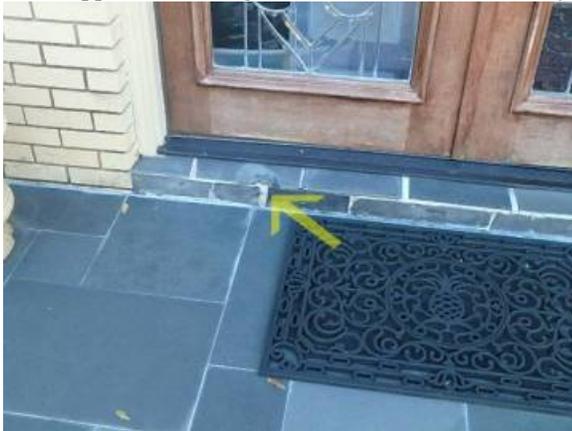
11. Chipped and damaged tile noted at the front entry door threshold.

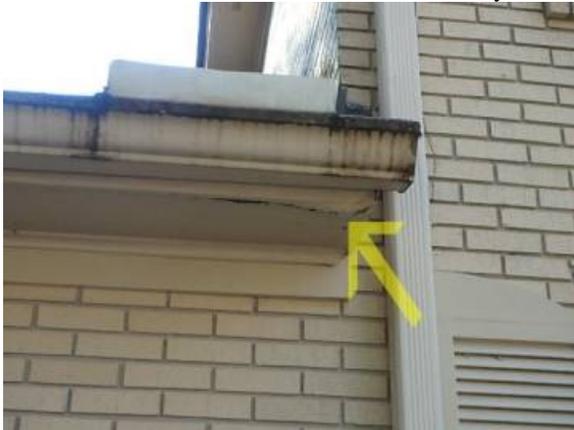
14. Rot at front soffit trim left of the front entry. Damage appears to be from roof leakage.

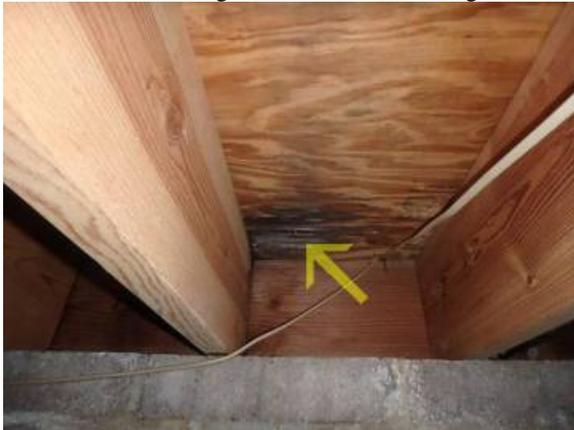
17. Moisture staining and evidence of leakage noted at the subfloor under the front exterior entry transition to the main wall.

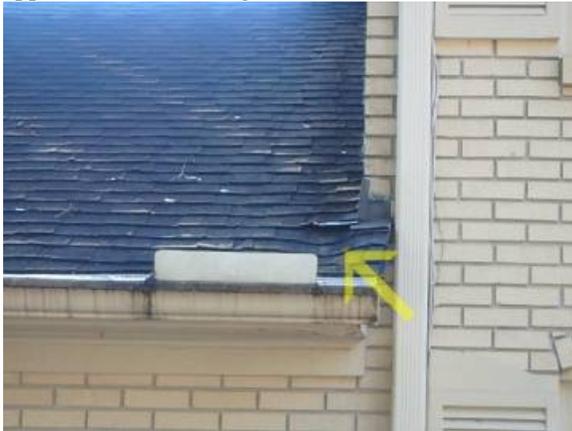
20. Low / depressed area and evidence of leakage noted at the front roof here. Wood rot noted below this area. Active leakage appears to be occurring.

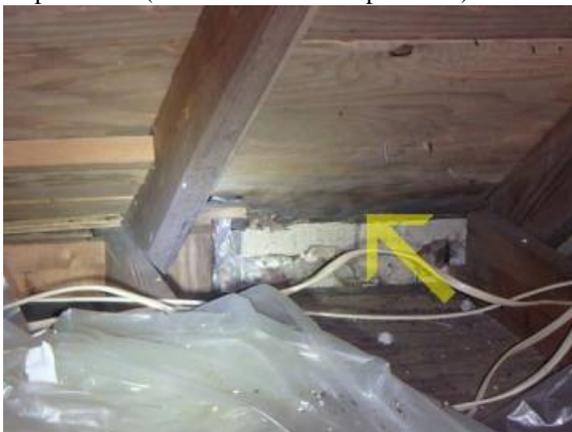
23. See notes above. Areas of staining, damage and evidence of leakage noted at the roof decking adjacent to the rear, low sloped roof. (Visible from the carport attic)

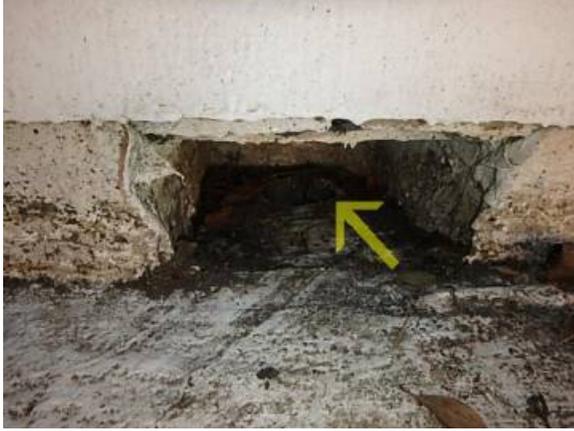
24. This roof drains by downspouts that are concealed inside of the rear brick wall. Location of discharge is not known. Recommend ensuring that these pipes are maintained and kept clear of debris. Inspection limited.

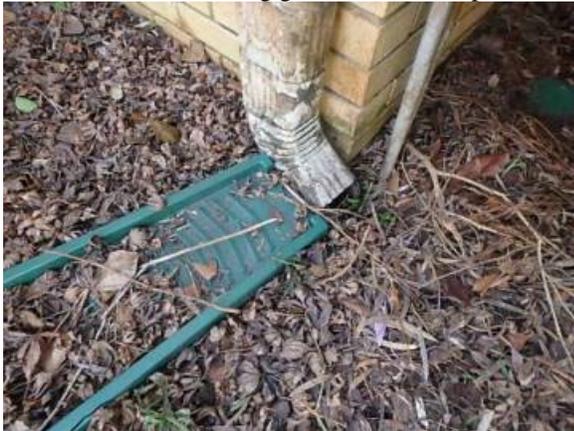
28. Recommend cleaning gutters and downspouts and properly extending downspouts away from the foundation.

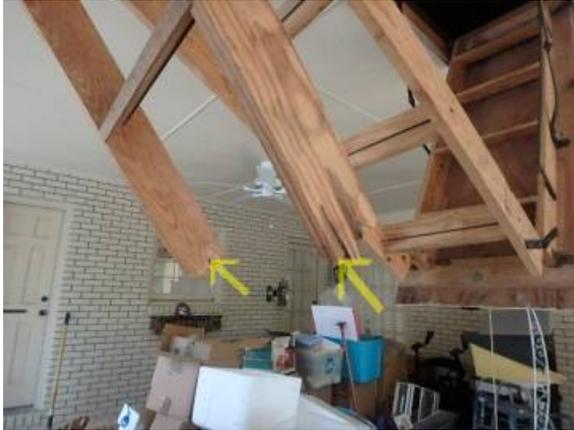
32. Damage noted at the bottom of the attic, pull downstairs in the carport.

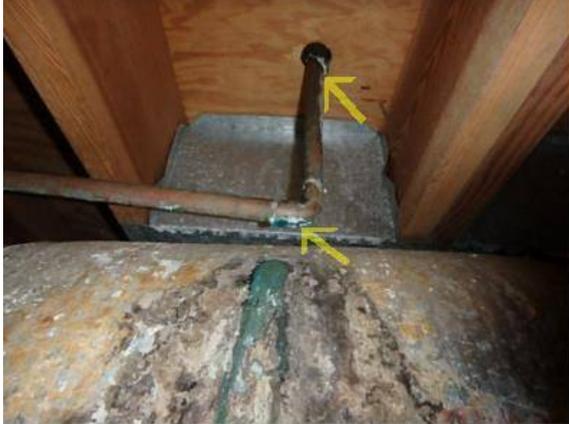
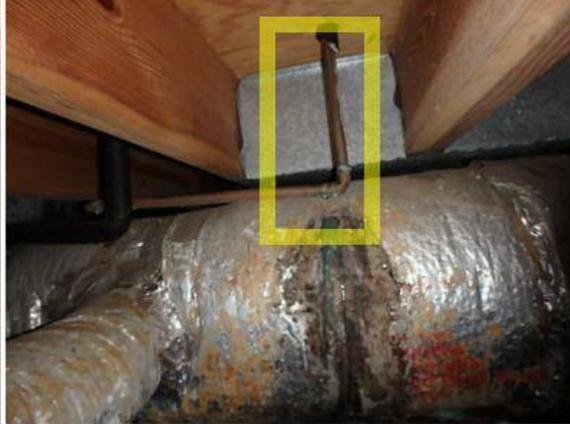
33. Dripping noted from the supply line in the crawlspace under the water heater that is in the closet adjacent to the front entry foyer.

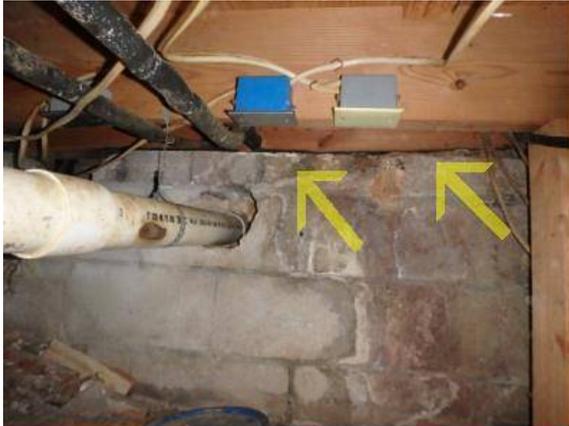
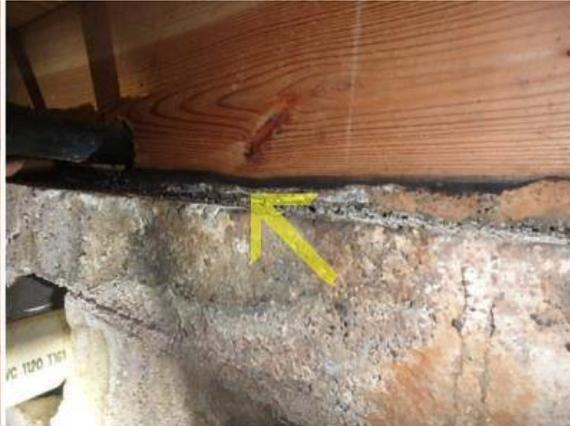
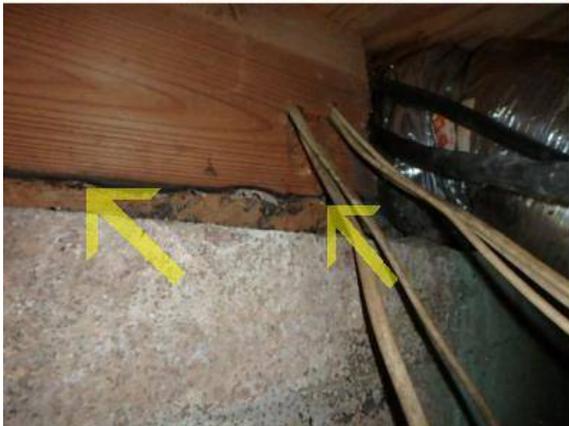
34. Evidence of leakage noted around the sewer line in the crawlspace that protrudes from the slab area under the laundry room and carport bathroom. Staining and rot noted at the Framing in this location.

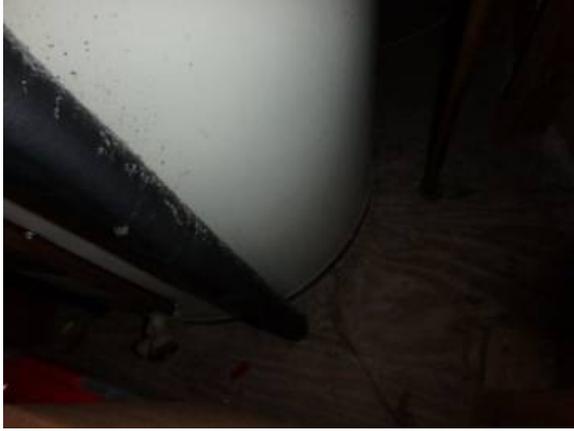
36. FYI: The water heater is not resting inside of a pan. Although this may have not been a requirement when the home was constructed, a pan under the unit is recommended.

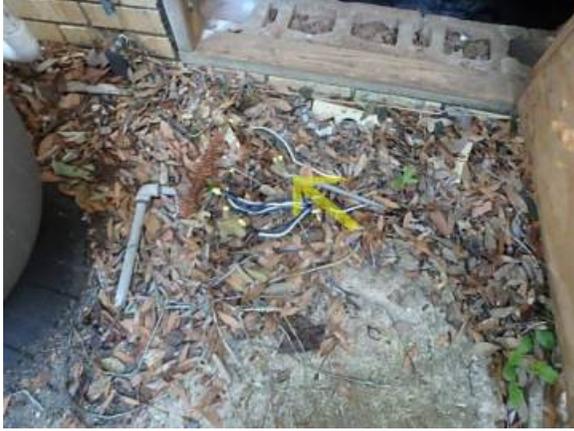
42. Exposed wiring noted adjacent to the crawlspace access door. The Gray wire tested for being energized at time of inspection.

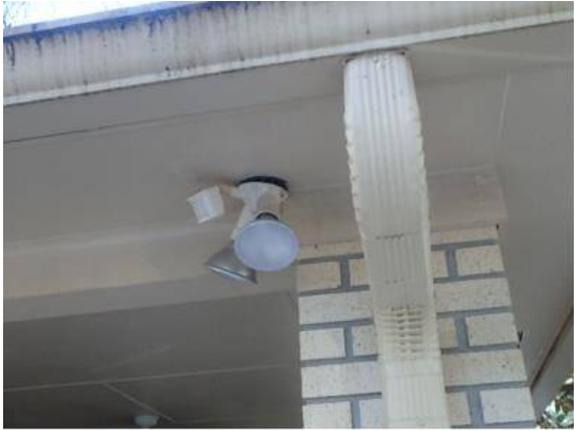
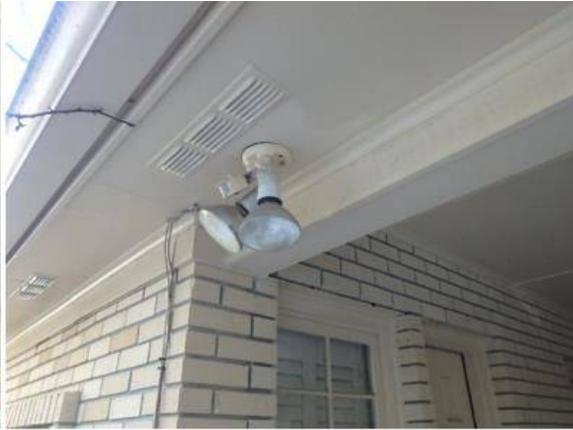
43. Loose / damaged exterior flood fixtures noted at the right side.

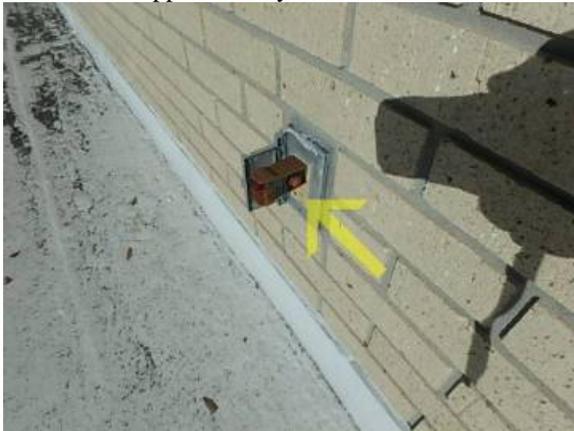
44. The rear upper balcony exterior electrical outlet here did not have power at time of inspection.

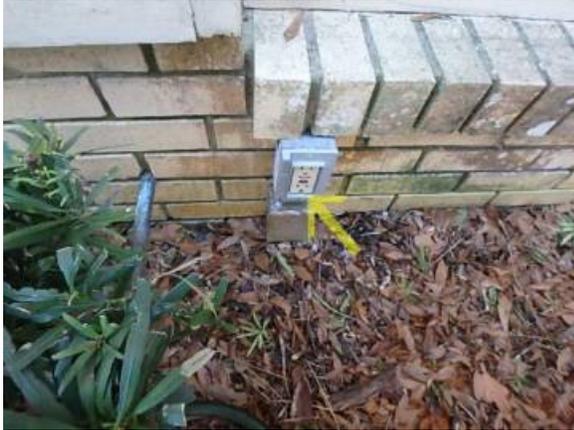
46. The front exterior electrical outlet is missing the weather resistant cover.

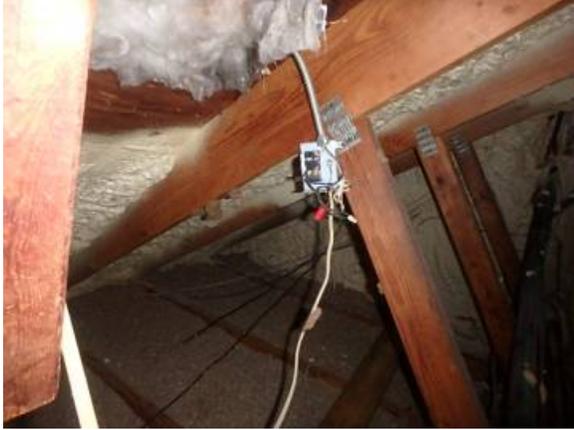
47. Exposed wiring at junction box for vent fan in attic area.

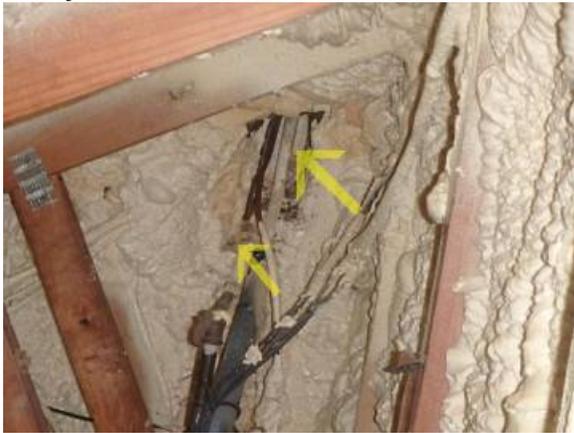
50. Staining and evidence of condensation dripping from the HVAC lines that run from the attic air handler unit down through the adjacent attic below.

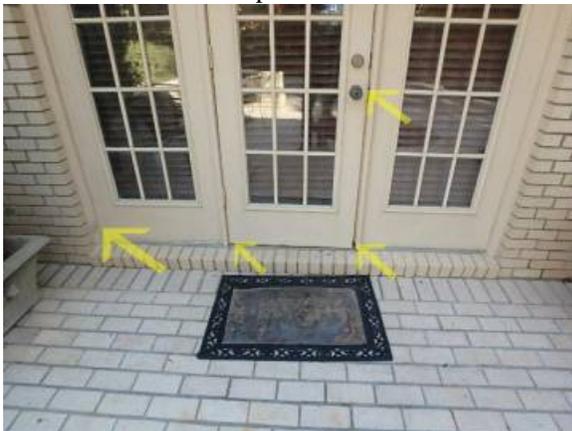
58. Rust damage noted at the right side courtyard exterior French door. Wood rot noted at the door frame and trim. Damage noted at the door strike plate area.

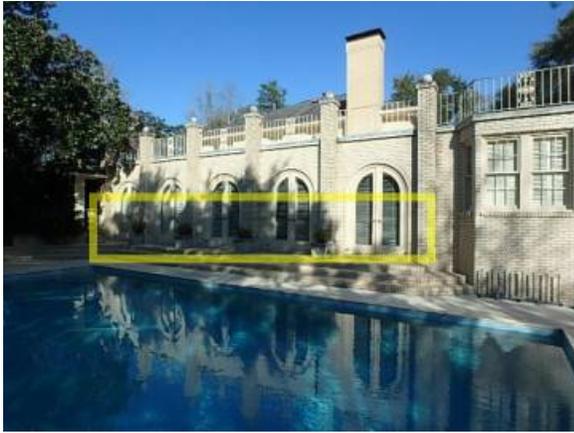
59. General rot and damage noted at the rear French doors to the pool area. There are five sets of these doors. Doors that were tested were difficult to operate. Various doors were unable to be tested due to occupants belongings.

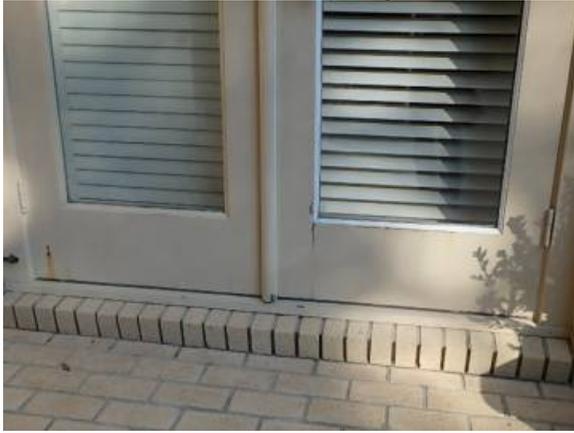
61. See notes above. General damage / rot noted at the rear doors.

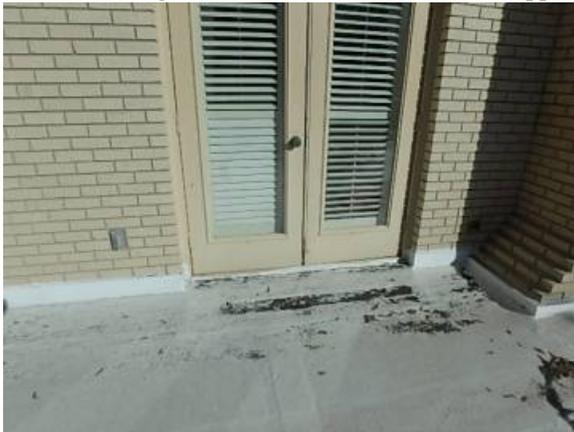
62. Rust damage and wood rot noted at the rear upper balcony exterior door.

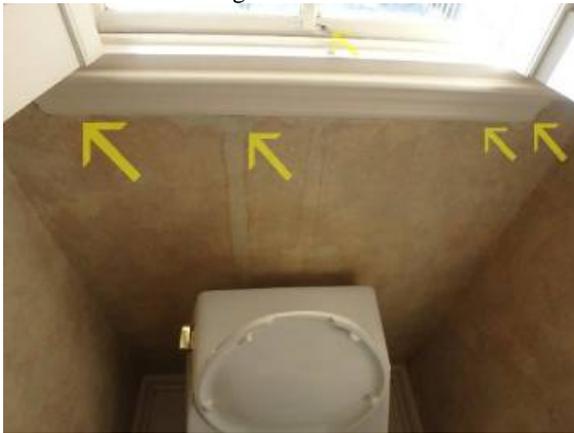
67. Evidence of leakage noted at the window above the toilet in the upstairs master bathroom. Rot noted at window.

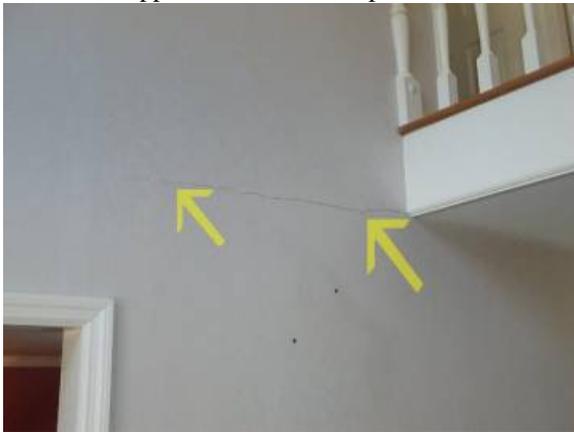
71. Cracking and evidence of settlement noted at the wall adjacent to the front entry foyer area. See also notes regarding additional support added in crawlspace area. Some settlement appears to have occurred.

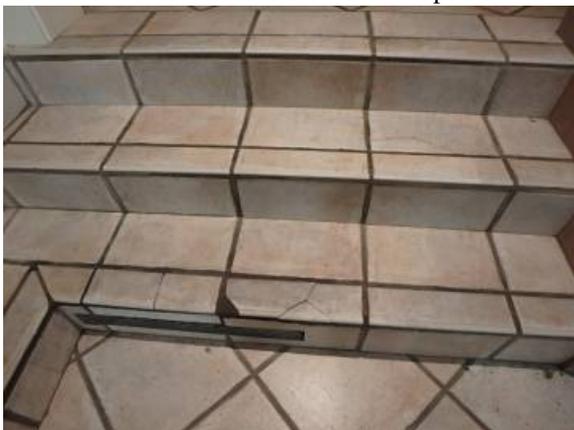
73. Various cracked tiles noted at the steps from the rear sunroom to the kitchen and living area.

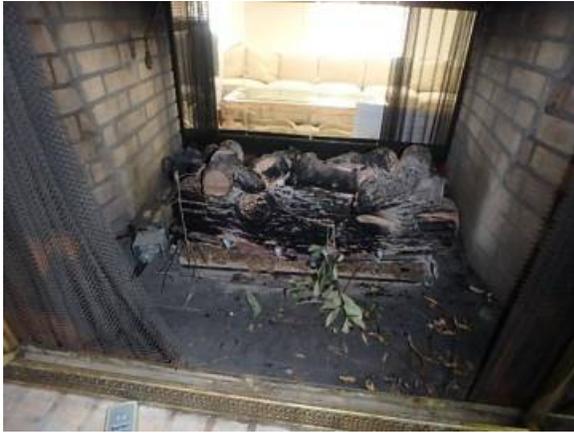
74. Gas log set and remote were not operational at time of inspection.

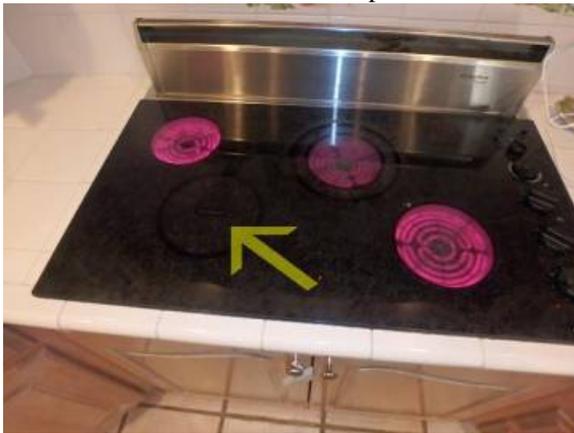
76. The front left burner was not operational at time of inspection.

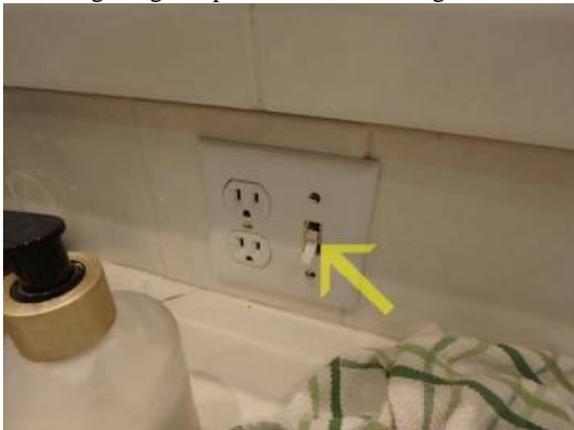
77. The garbage disposal switch is damaged.

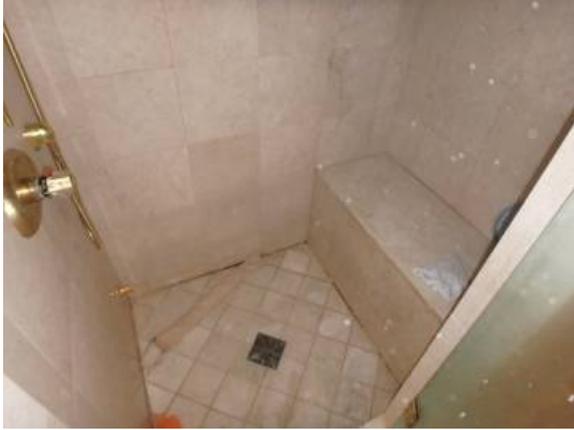
79. Areas of cracking / chipping tile grout noted in the shower.

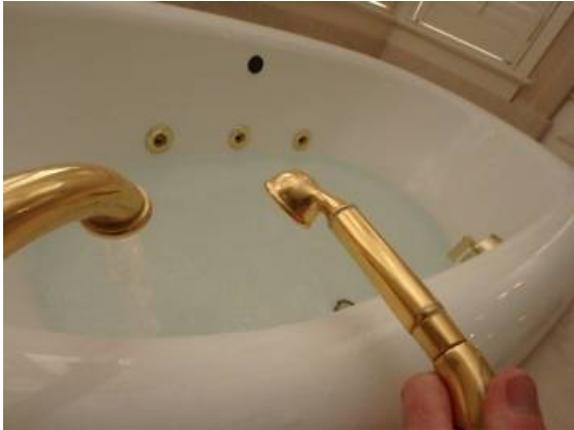
80. Dripping and leakage noted from the tub faucet diverter and Spray handle when operated. Whirlpool Jets were unable to be tested due to tub not being filled. Tub was not filled due to water leaking from faucets / handles when operated.

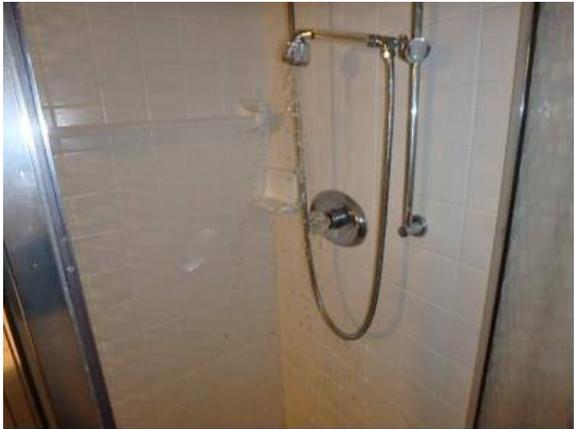
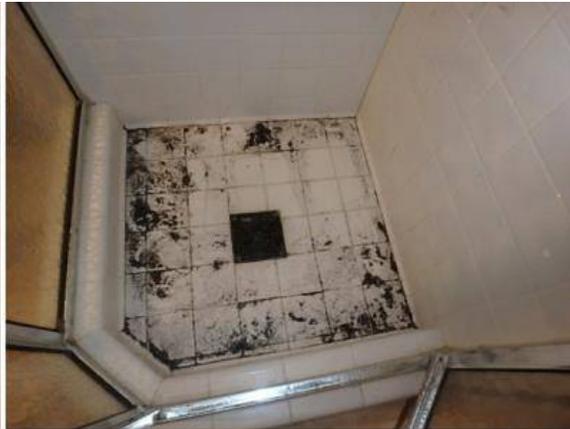
81. The shower controls were difficult to operate. Evidence of water backing up in the shower area. Debris noted at the base of the shower.

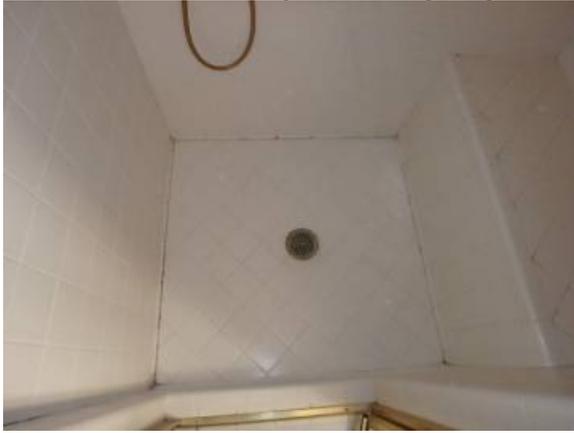
84. Various areas of damaged or missing tile grout noted in the shower.

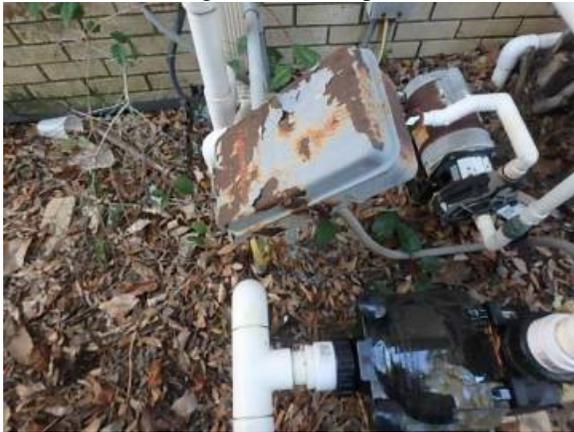
85. Rust and damage noted at the pool electrical timer box.

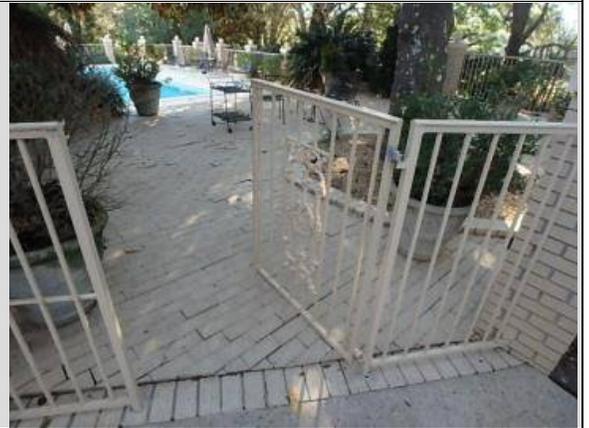
The right side pool area Gate needs adjustment to operate properly. This gate currently conflicts with the brick pavers when operated.

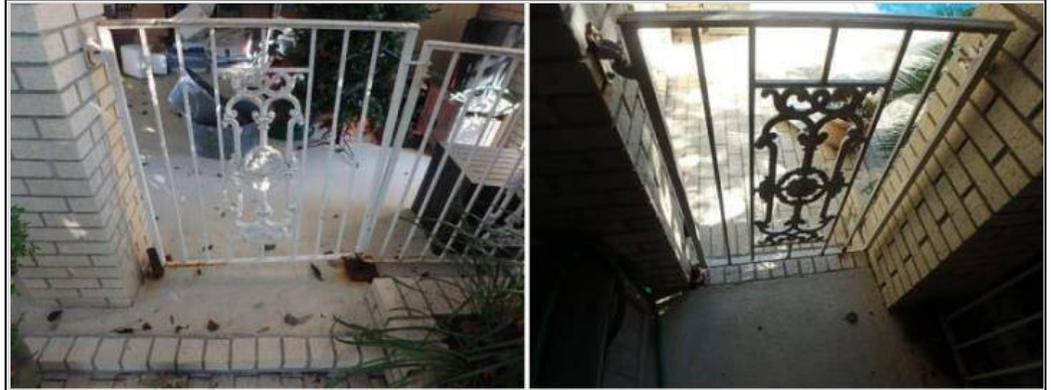
*Rust damage noted at the 2 gates from the carport to the rear patio.
Various areas of rust noted at the iron fencing.*

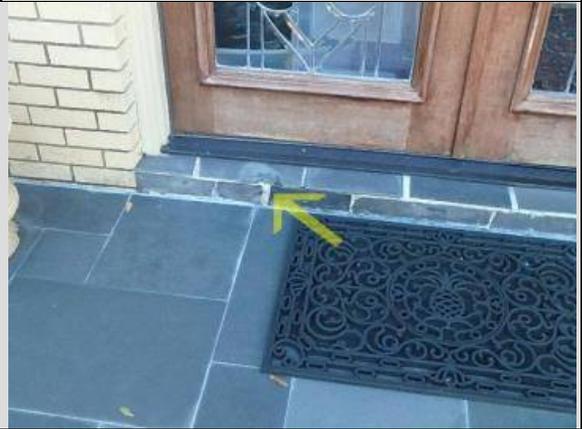
Chipped and damaged tile noted at the front entry door threshold.

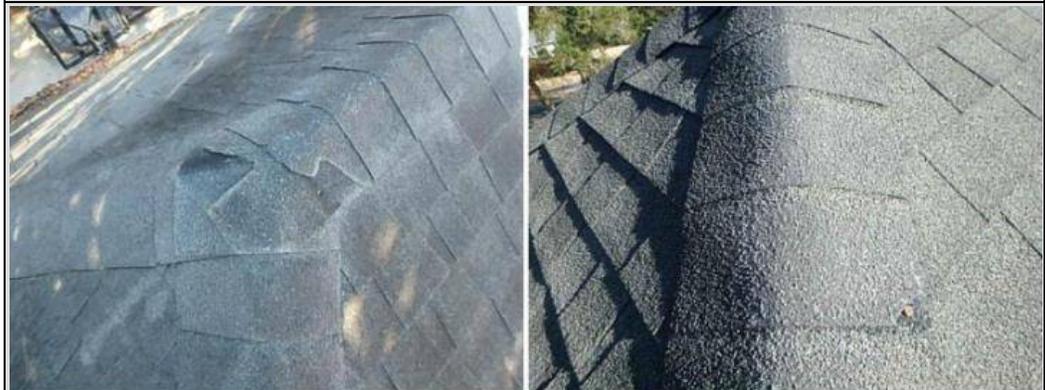
The roofing shingles show signs of aging with loss of aggregate, brittleness and exposed fiberglass mesh. Roof shingles appear to be nearing the end of their useful life.

ESTIMATED REMAINING LIFE:	Less than 5 years.
VALLEY TYPE:	Closed Laced.
VALLEY FLASHING:	Valley flashing is in place and appears to be functioning properly.

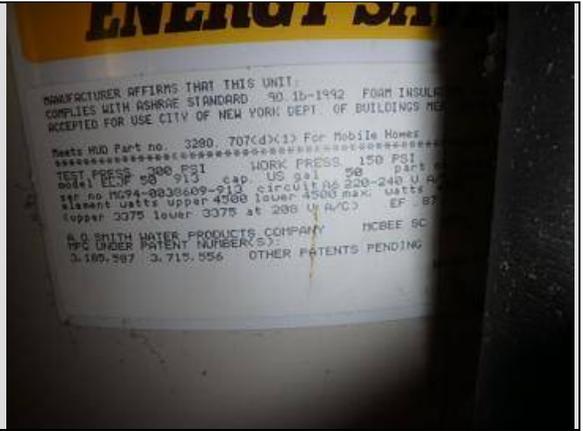
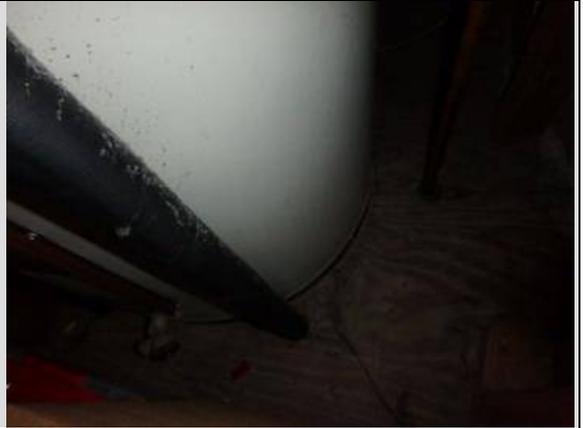
Water heater is older and has performed beyond its normal life expectancy. Replacement should be anticipated in the not too distant future. Unit was operational at time of inspection.

FYI: The water heater is not resting inside of a pan. Although this may have not been a requirement when the home was constructed, a pan under the unit is recommended.

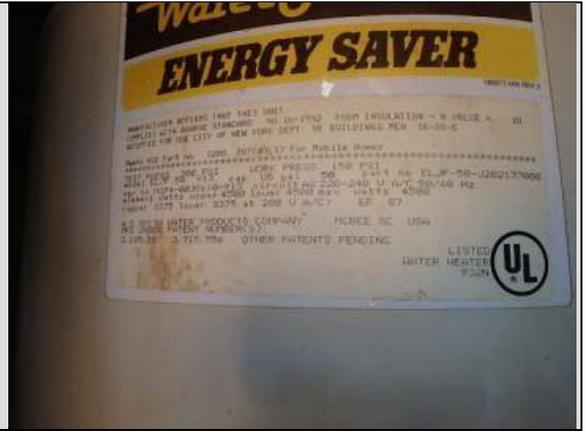
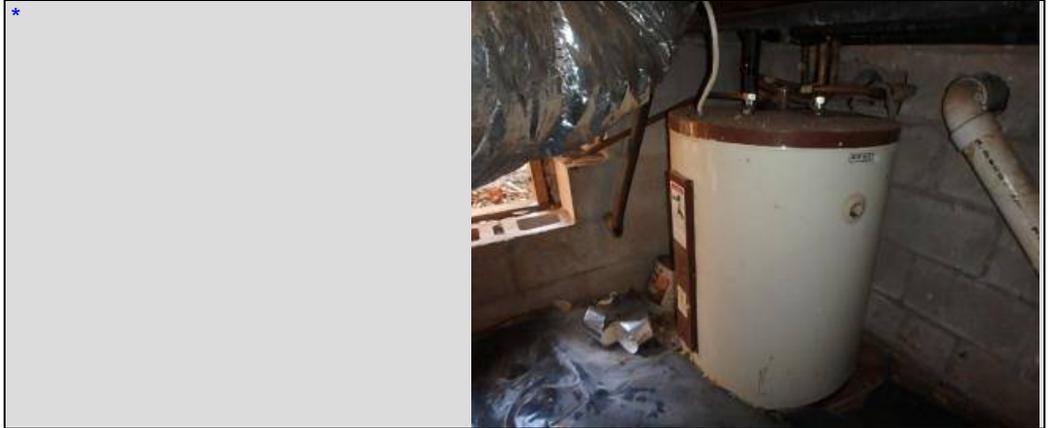
WATER HEATER CONDITION: *Water heater is older and has performed beyond its normal life expectancy. Replacement should be anticipated in the not too distant future. Unit was operational at time of inspection.*

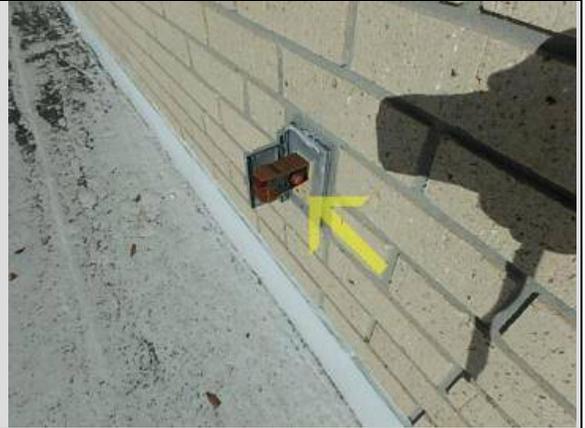
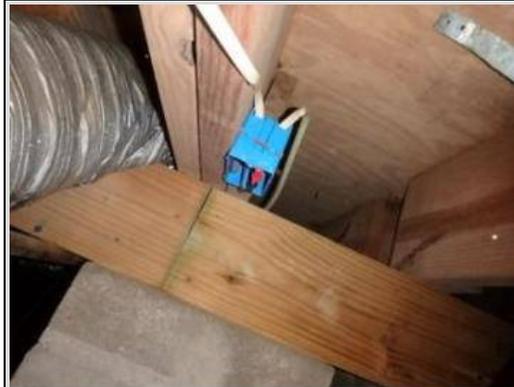
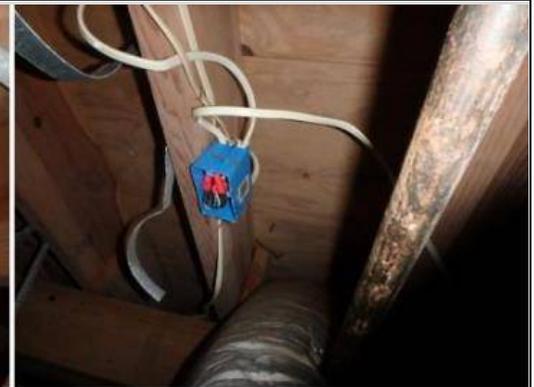
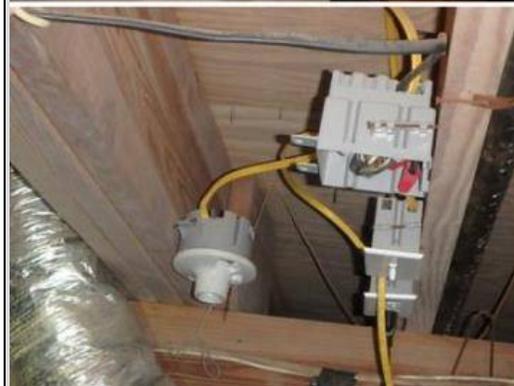
Loose / damaged exterior flood fixtures noted at the right side.

The rear upper balcony exterior electrical outlet here did not have power at time of inspection.

Recommend properly capping all junction boxes in the crawlspace that are currently without a cover.

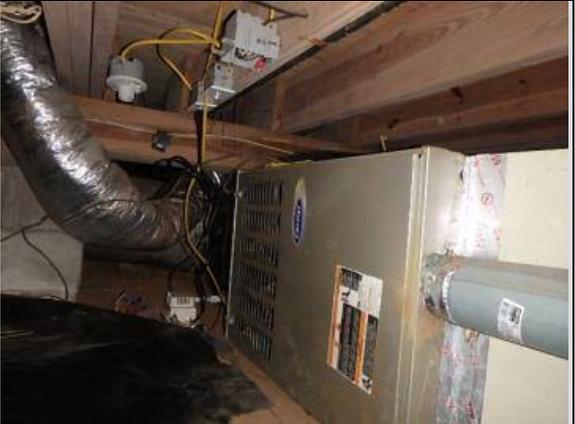
LOCATION:	Crawl space.
HEAT SYSTEM TYPE:	Forced Air.
FUEL TYPE AND NOTES:	Natural Gas.
DATA PLATE INFORMATION:	Carrier.
HEAT SYSTEM AGE:	2010.
HEAT SYSTEM CONDITION:	<i>The HVAC air handler is older and is nearing the end of its normal life expectancy. Replacement should be anticipated in the not too distant future. Unit was operational at time of inspection.</i>
PICTURE OF HVAC AIR HANDLER:	<div style="display: flex; align-items: center;"> <div style="background-color: #cccccc; width: 150px; height: 150px; margin-right: 10px;">*</div>

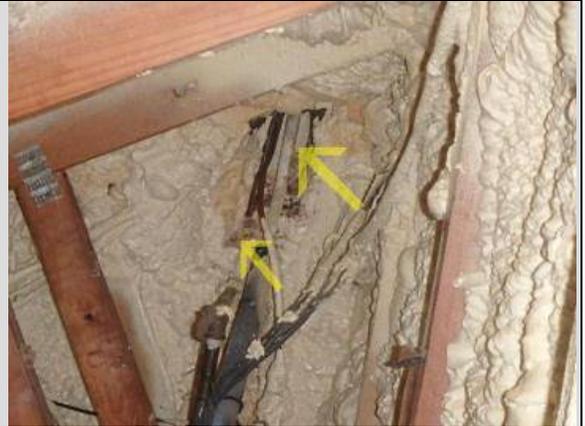
Staining and evidence of condensation dripping from the HVAC lines that run from the attic air handler unit down through the adjacent attic below.

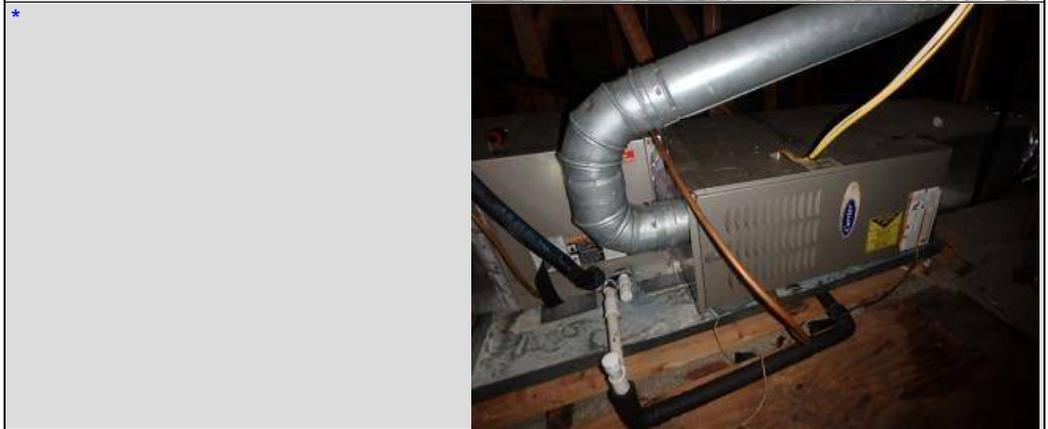
PICTURE OF HVAC AIR
HANDLER:

The HVAC air handler is older and has performed beyond its normal life expectancy. Replacement should be anticipated in the not too distant future. Unit was operational at time of inspection.

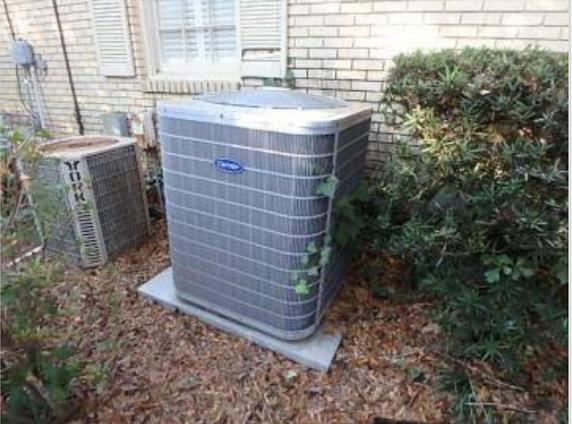
5 ton.
HVAC condensing unit is older and is nearing the end of its normal life expectancy. Replacement should be anticipated in the not too distant future. Unit was operational at time of inspection.

Condensate line installed.
Appear serviceable.
Freon line insulation at the outside HVAC condensing unit is deteriorated or missing.
*

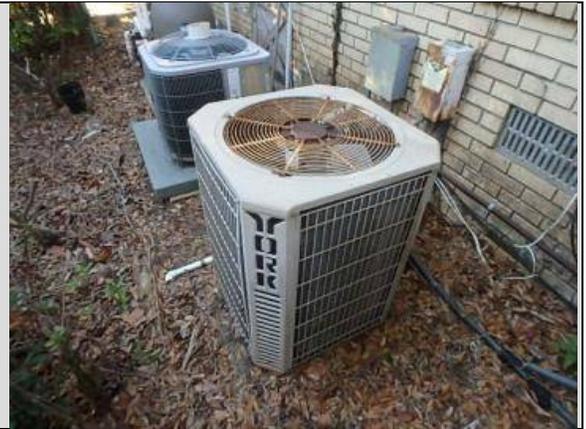
PICTURE OF HVAC
CONDENSING UNIT:

2 ton.
HVAC condensing unit is older and has performed beyond its normal life expectancy. Replacement should be anticipated in the not too distant future. Unit was operational at time of inspection.
Condensate line installed.
Appear serviceable.
Freon line insulation at the outside HVAC condensing unit is deteriorated or missing.

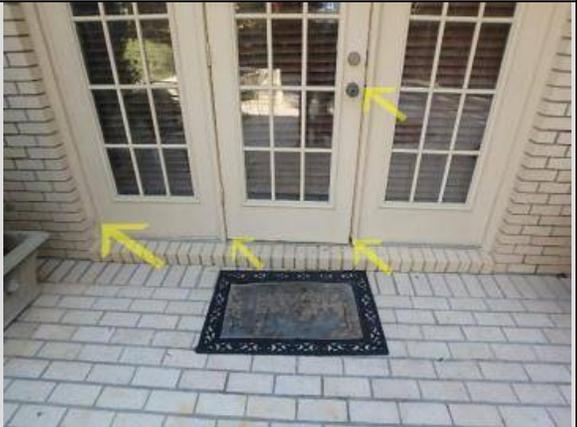
Rust damage noted at the right side courtyard exterior French door. Wood rot noted at the door frame and trim. Damage noted at the door strike plate area.

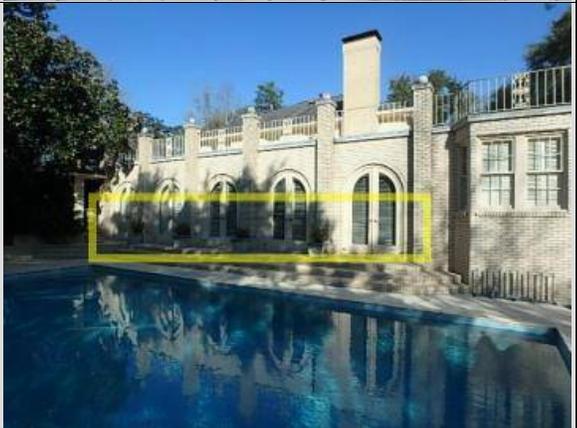
General rot and damage noted at the rear French doors to the pool area. There are five sets of these doors. Doors that were tested were difficult to operate. Various doors were unable to be tested due to occupants belongings.

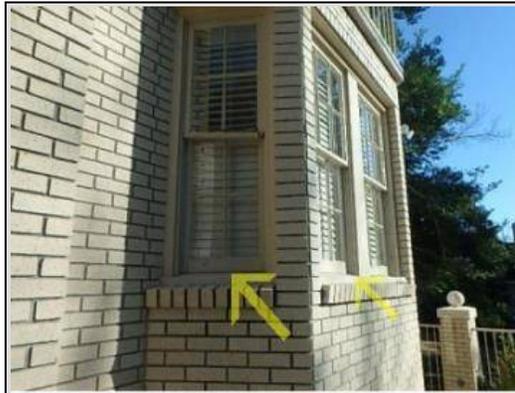
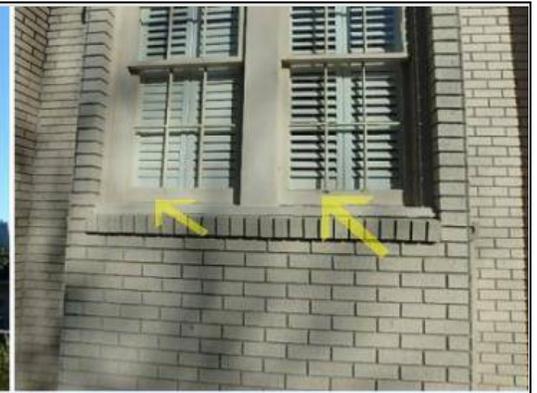
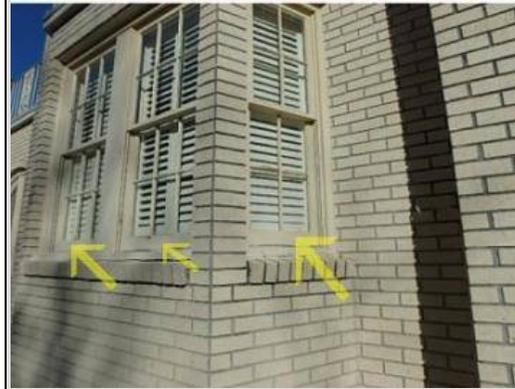
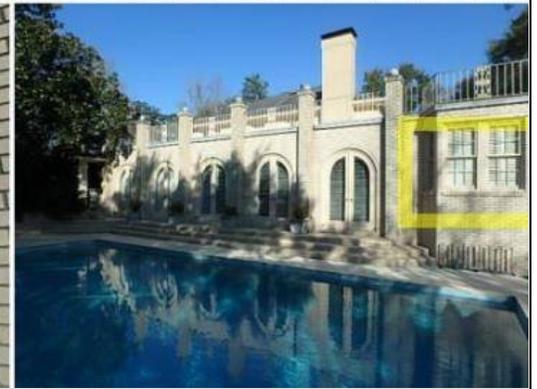
Windows are older and difficult to operate in various locations. Various areas of damaged or deteriorated glazing noted around window panes. Representative pictures.

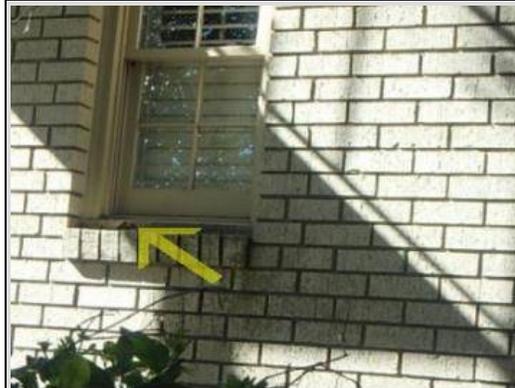
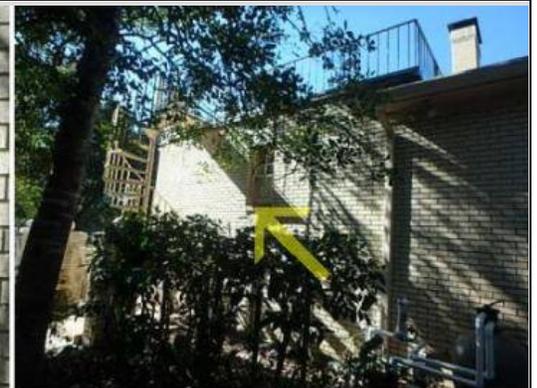
Significant rot and damage noted at the rear facing windows adjacent to the pool patio here.

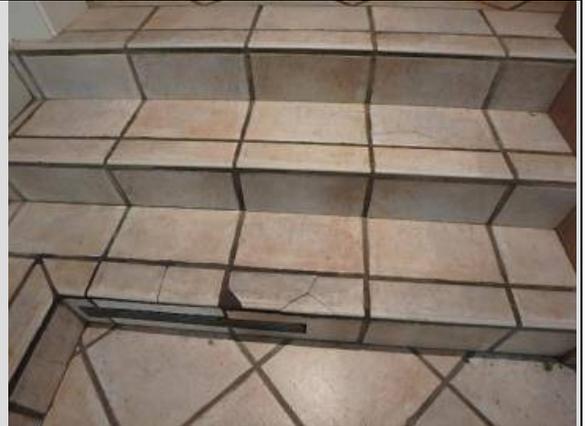
Various cracked tiles noted at the steps from the rear sunroom to the kitchen and living area.

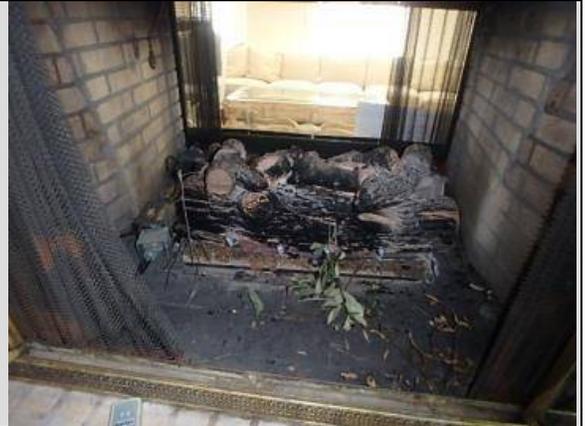
Gas log set and remote were not operational at time of inspection.

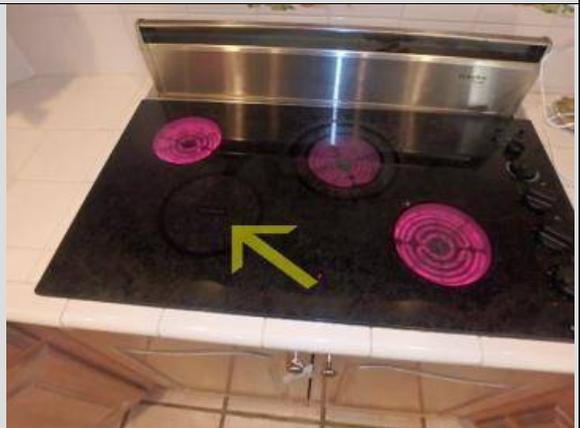
The front left burner was not operational at time of inspection.

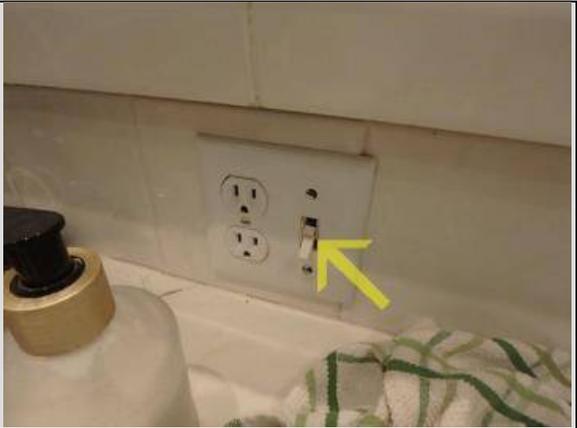
CONDITION: *The garbage disposal switch is damaged.*

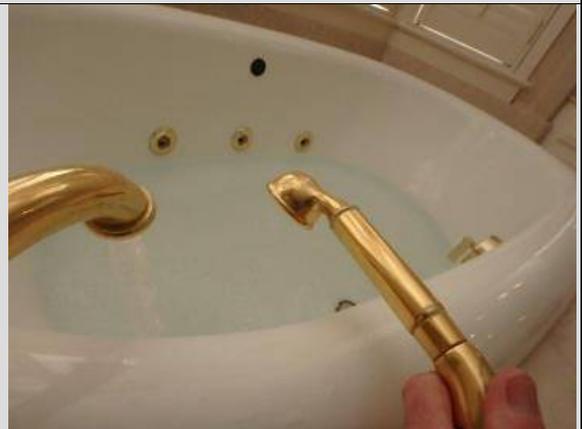
Dripping and leakage noted from the tub faucet diverter and Spray handle when operated. Whirlpool Jets were unable to be tested due to tub not being filled. Tub was not filled due to water leaking from faucets / handles when operated.

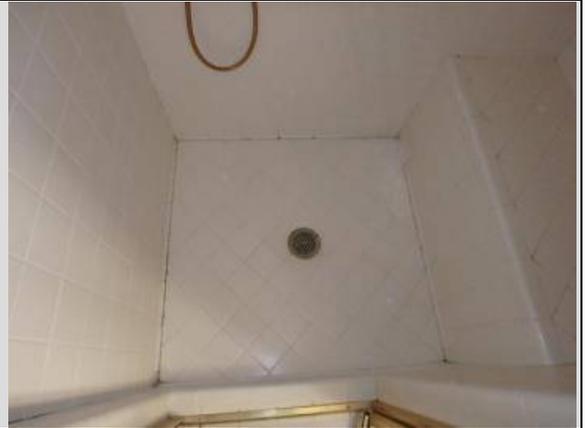
Various areas of damaged or missing tile grout noted in the shower.
