Test\_3

DAVIDSON COUNTY  
HEALTH DEPARTMENT  
Protecting, Caring, Serving Our County

## Parcels

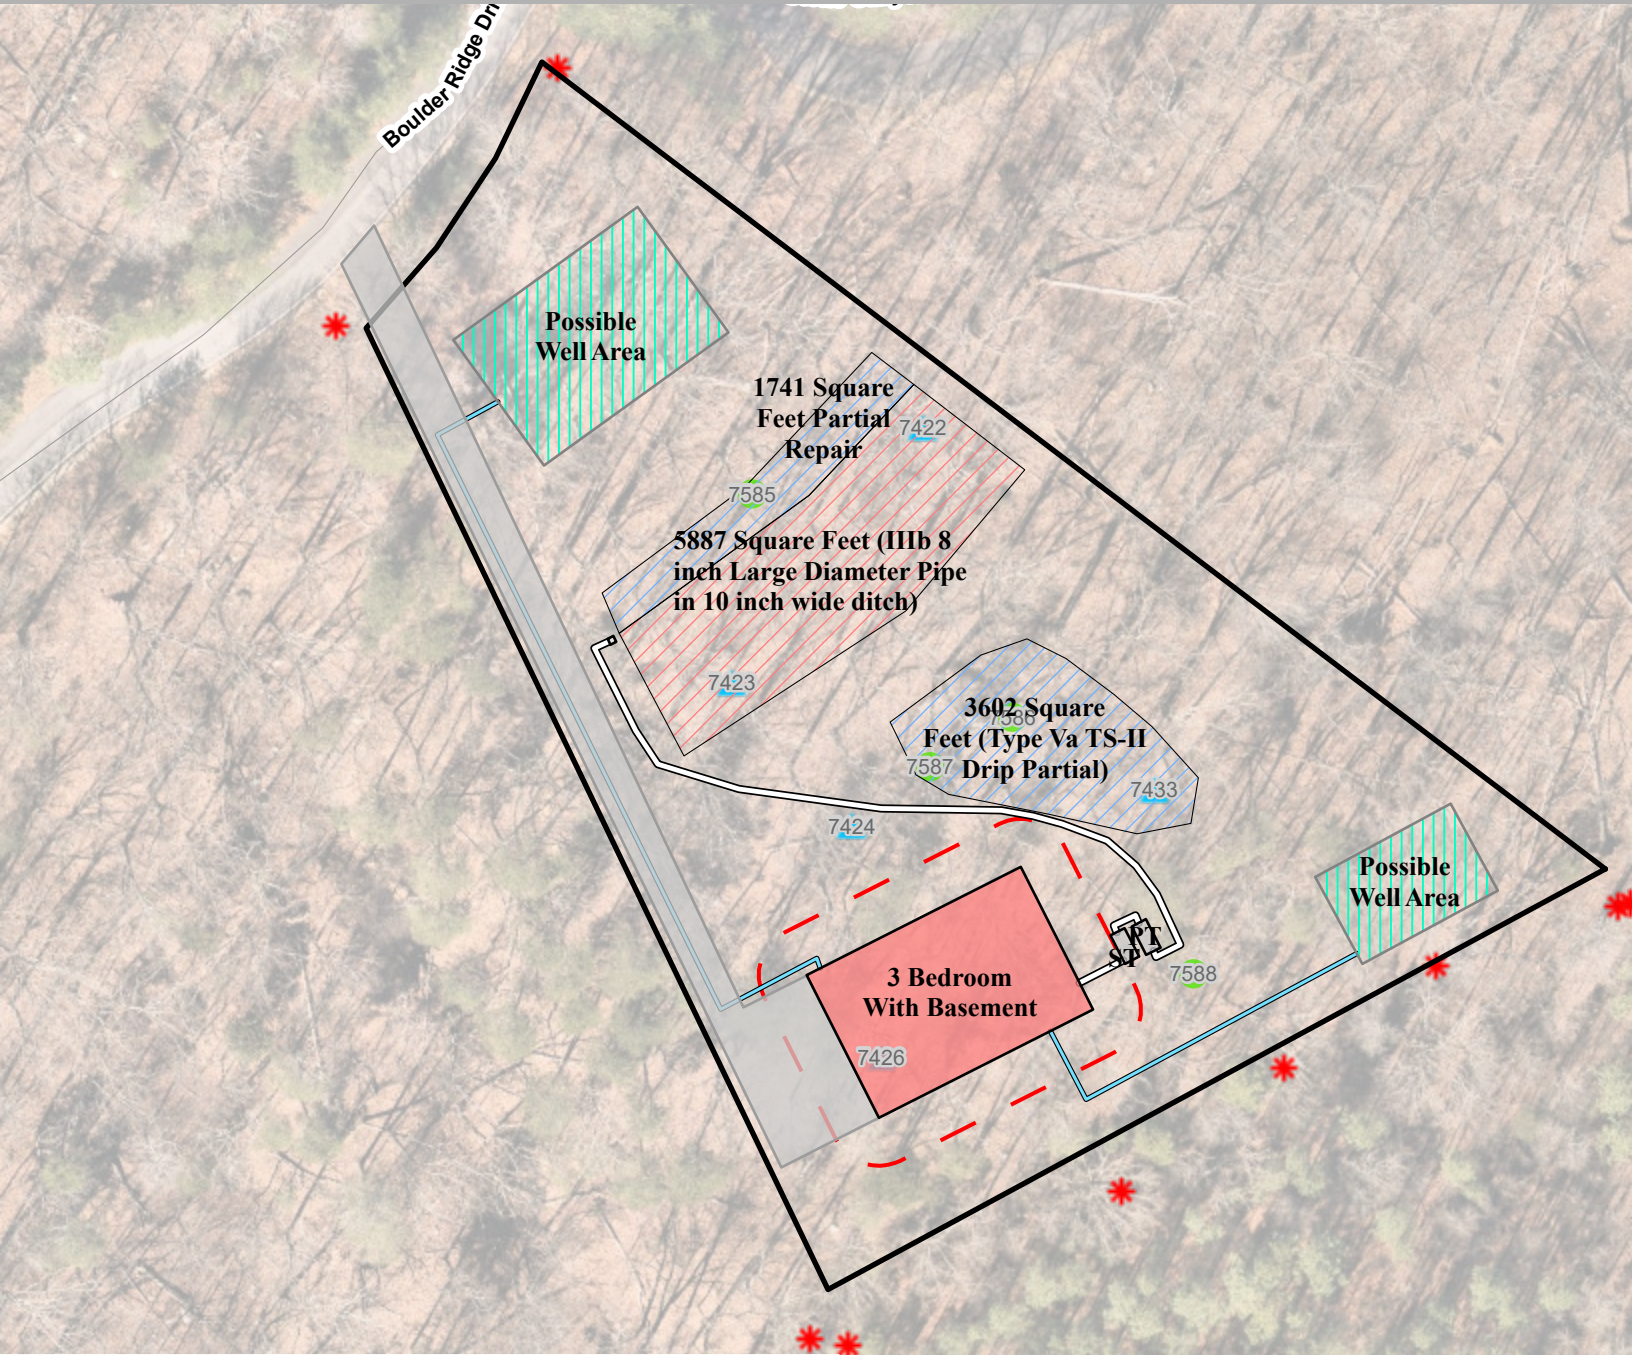
Disclaimer: This map is the best representation of field data based on the information supplied to Davidson County Environmental Health and is accurate within the limits of our GPS equipment. This is not a survey map. Property lines must be clearly marked in the field by the property owner prior to work on the well and/or septic system. The information contained on this map is furnished by government and private industry sources and is believed to be accurate but accuracy is not guaranteed. Map information is a representation of various data sources and is not a substitute for information that would result from an accurate land survey. The information contained on this map does not replace information that may be obtained by consulting the official source of the information. In no event shall Davidson County, NC or the consultants of Davidson County, NC be liable for any damages, direct or consequential, from the use of the information contained on this map.
