Jun 18th, 2024

146 Schultz Road, Telford, PA, 18969

# Right Way Home Inspection Plus

Alderfer Auction

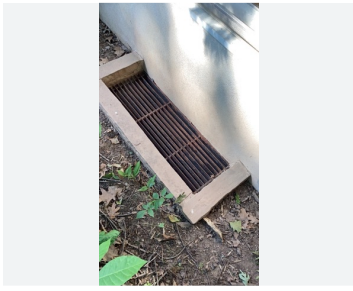
Marginal

Dryer discharge hose is in this window well

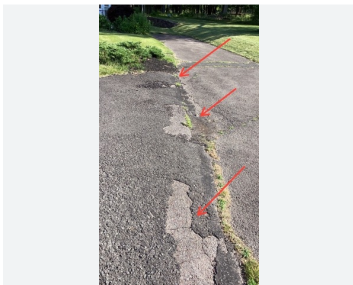
Damaged or deteriorated, recommend estimate for repair or replacement by a qualified Asphalt contractor

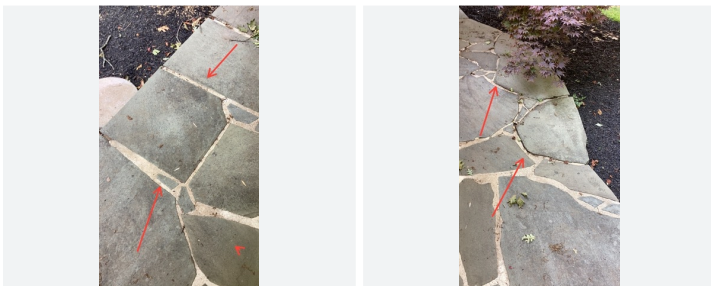
Loose flag stone, Recommend further evaluation from a qualified landscape contractor

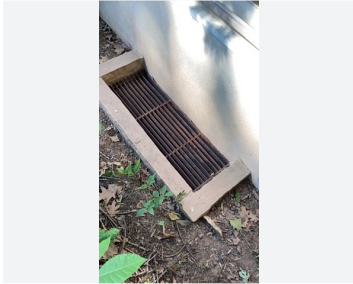
Dryer discharge hose is in this window well

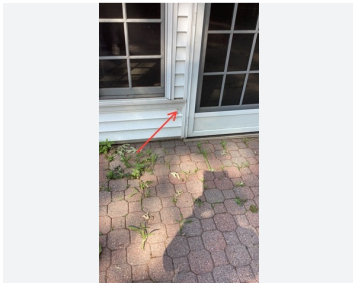
Improper siding, Recommend further evaluation from a qualified siding contractor

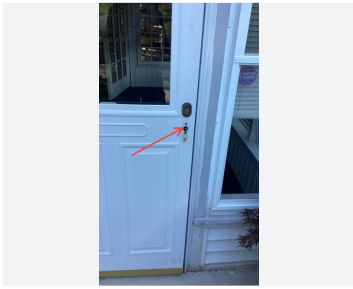
Missing hardware at the rear door. Recommend further evaluation from a qualified handyman

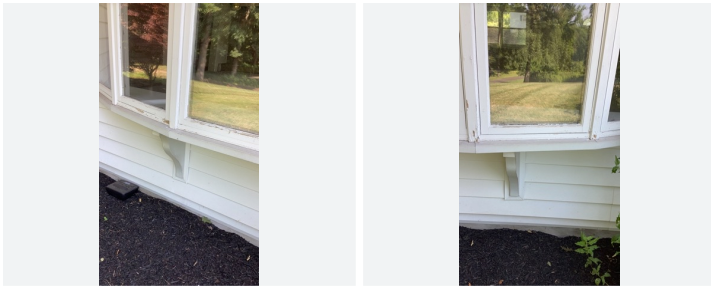
Peeling paint, recommend repairing to prevent wood rot, Recommend further evaluation from a qualified painting contractor

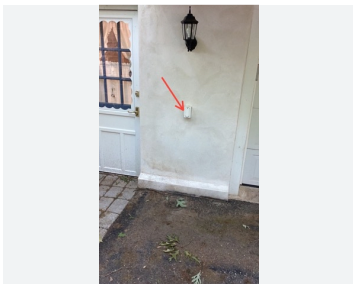
Faulty GFCI Receptacle, Recommend further evaluation from a qualified electrical contractor

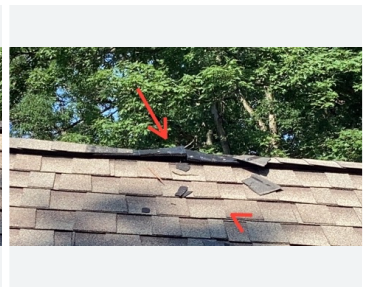
Loose missing or damaged shingles, Recommend further evaluation from a qualified roofing contractor

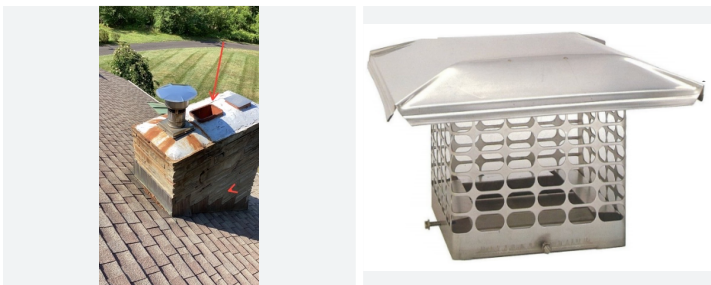
Recommend adding rain/snow cap to prevent water penetration, recommend further evaluation from a qualified chimney sweep

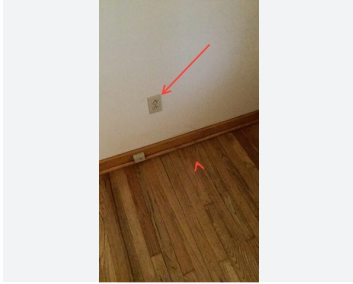
Location - Front Center

Reversed polarity, Recommend further evaluation from a qualified Electrician

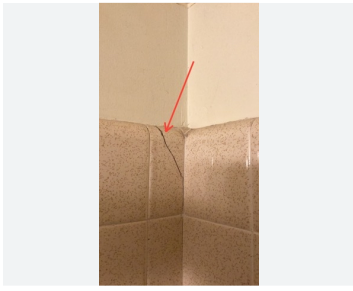
Cracked tile

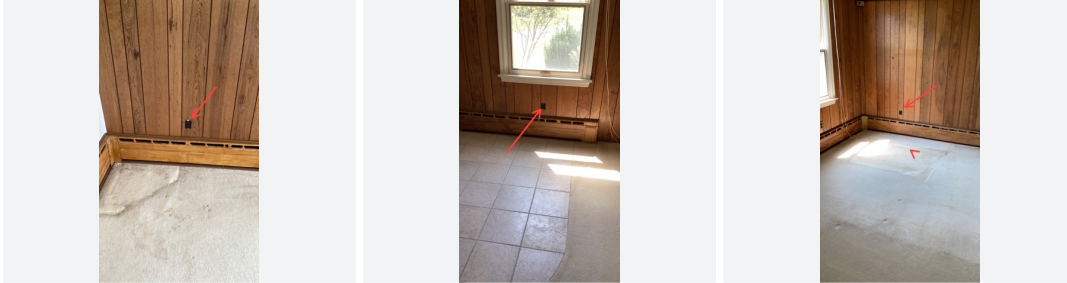
Location - Family Room

Missing Receptacle cover plates

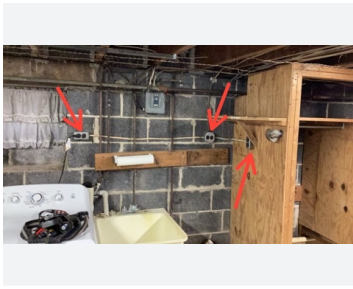
Non-GFCI circuit, It is recommended that all Receptacles in a Laundry Room be GFCI Protected, Recommend further evaluation from a qualified Electrician

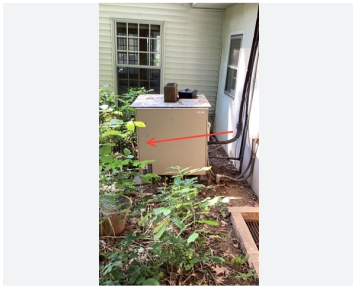
Defective

Unit is not level, to maximize efficiency it is recommended that the unit be Level, recommend further evaluation from a qualified hvac contractor

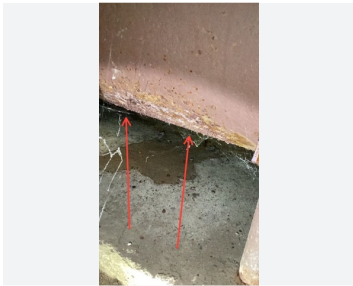
Defective

Tank is showing signs of rust, No leaks noted at time of inspection, recommend further evaluation from a heating contractor
