**I Spy Inspections**  
7550 Don Bruce Ct  
Christiana TN 37037  
615-828-2617  
ispyinspections@mail.com

**Inspection reference: 2427**

# **Confidential Inspection Report**

**4021 Old Nashville Hwy**  
**Murfreesboro TN 37129**

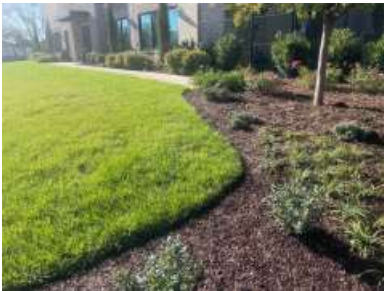
**Bushes and Shrubs Condition:**

Functional - The shrubs and/or bushes have a good appearance.

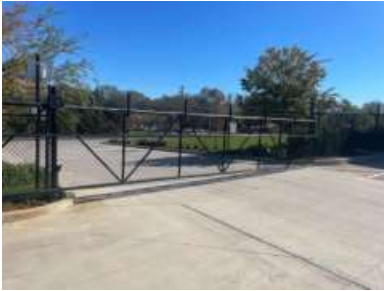
**Gates and Latches:**

The gates and latches are performing as intended.

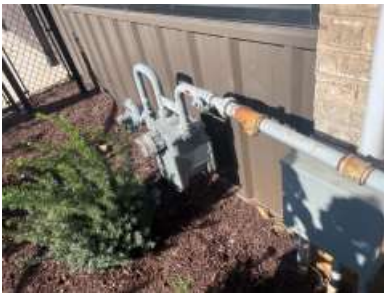
**Location of Meter:**

Left side of the house.

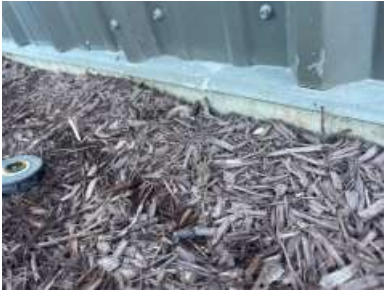
**Foundation Materials:**

Poured in place concrete, 8 inches or more thick.

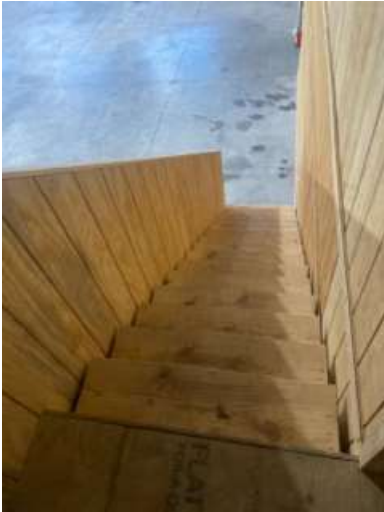
**Attic Access Location:**  
Garage Stair Access.

**Attic Accessibility:**  
Large stairway.

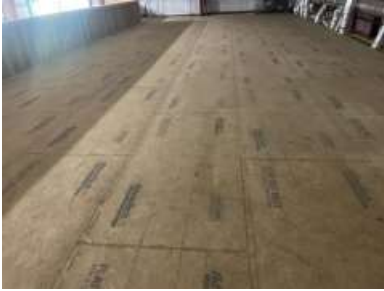
**Attic Cavity Type:**  
Expandable - The attic cavity appears large enough and framed so that living space could be expanded. Be sure to contact an engineer or licensed contractor for a thorough evaluation of feasibility.

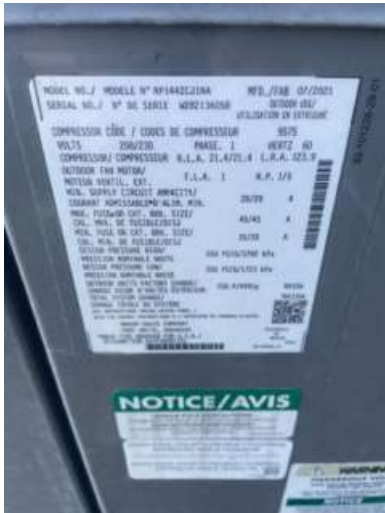
**Model/ Serial Number/ Size:**

System is Ruud brand. Manufactured in 2021.

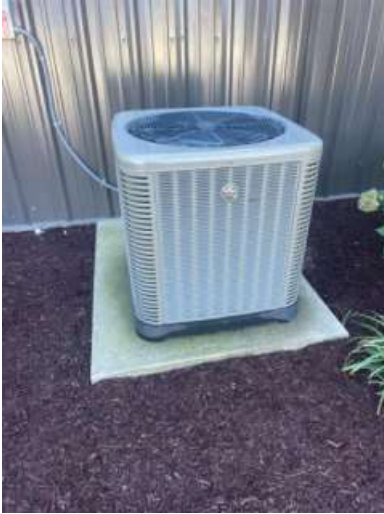
**Type and Location:**

Refrigerator/Split System. Electricity-powered.

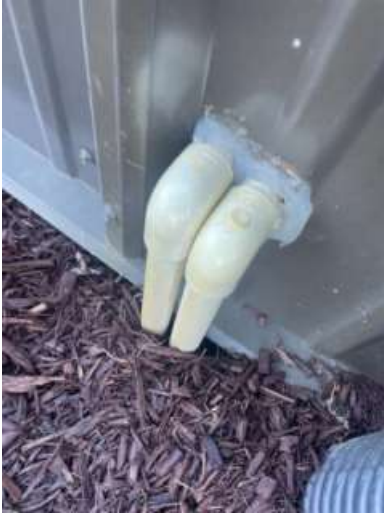
**Condensate Line:**

The condensate drain line appears to be adequately installed. Periodic checking to make sure that the line is clear will help to maintain the system.

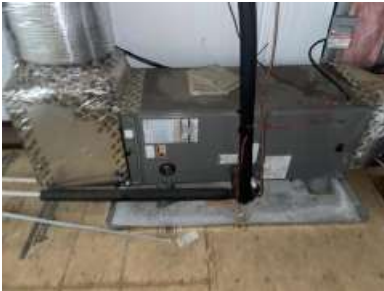
**Heating System Type:**

Electric air handler with heat pack installed for warm air.

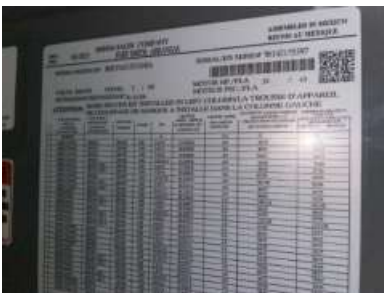
**Equipment Description:**

System is Rheem brand.

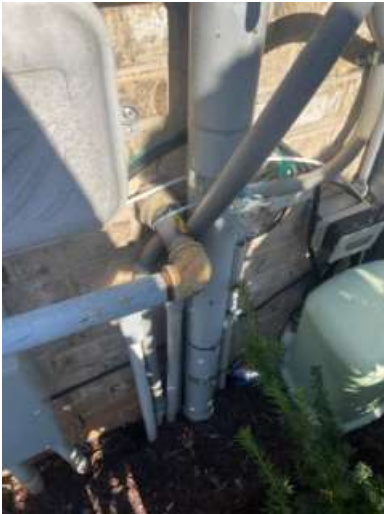
**Main Service Ground Verified:**

Yes - The main service ground wire was located by the inspector. Grounding provided by a driven rod.

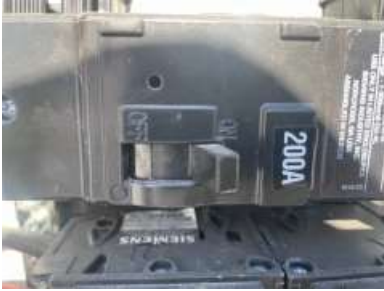
**Main Circuit Rating:**

2 200 amp - The ampacity of the main power panel appears to be more than adequate for the structure as presently used with room for expansion.

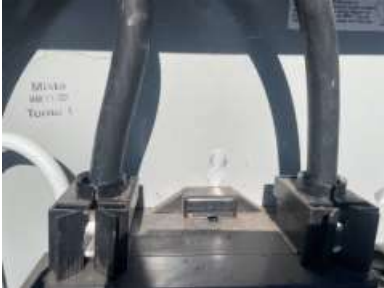
**Entrance Cable Size:**  
4/0 Aluminum.

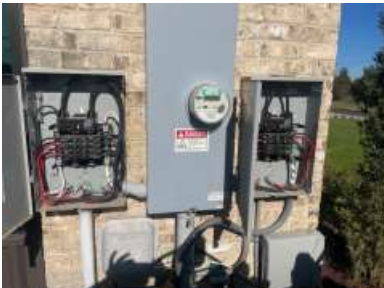
**Main Panel Observations:**

Circuit and wire sizing correct so far as visible, The power panel, as a container for safely covering electrical circuitry and components, is functioning as intended, minimizing the risk of electrical shock. Electrical circuitry wiring in the panel appears neatly arranged with no unallowable splices. Grounding system is present.

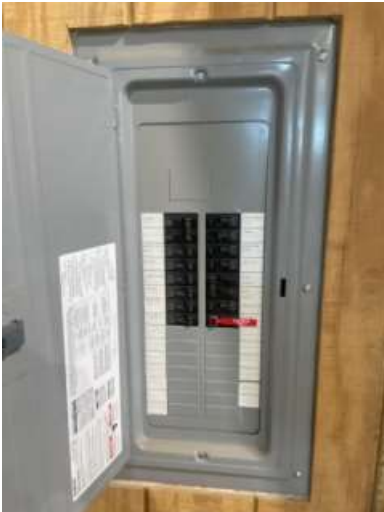
**Subpanels- Garage 1:**

This subpanel is wired correctly and functional. The electrical panel cover is correctly installed protecting the wiring.

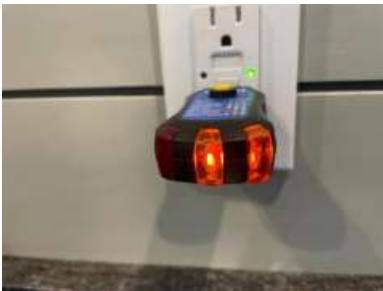
**Master Bathroom:**

There is a grounded outlet correctly installed.

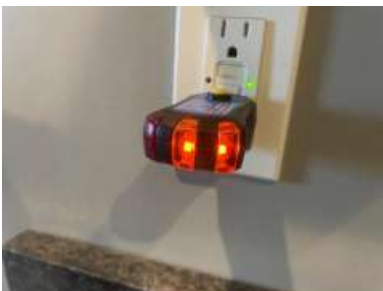
**Bathroom #2:**

There is a grounded outlet correctly installed.

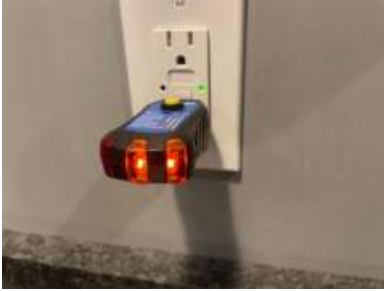
**Bathroom #3:**

There is a grounded outlet correctly installed.

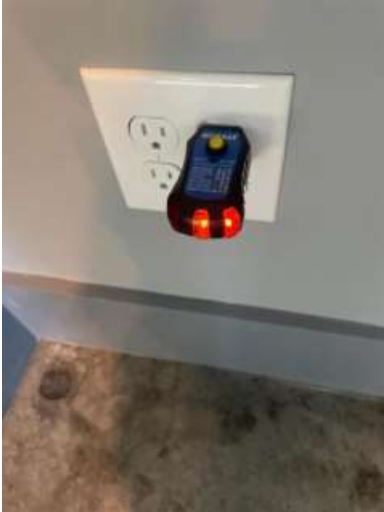
**Office 1:**

Functional - The outlets tested in this room are correctly wired and grounded.

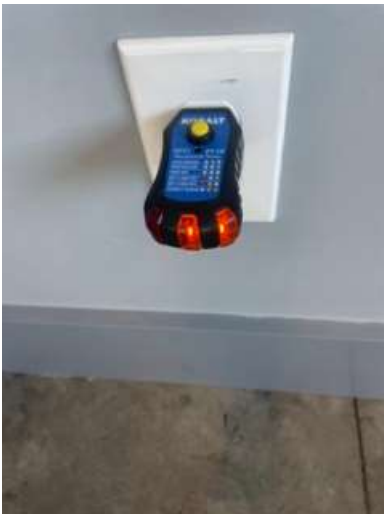
**Office 2:**

Functional - The outlets tested in this room are correctly wired and grounded.

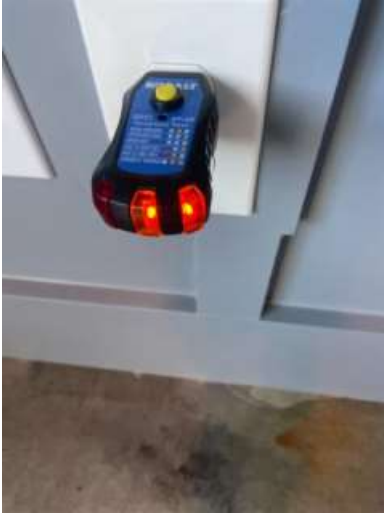
**Office 3:**

Functional - The outlets tested in this room are correctly wired and grounded.

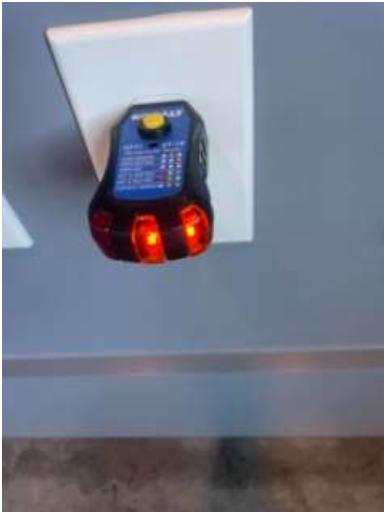
**Office 4:**

Functional - The outlets tested in this room are correctly wired and grounded.

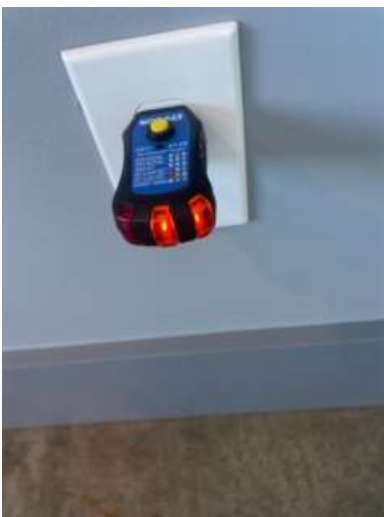
**Office 5:**

Functional - The outlets tested in this room are correctly wired and grounded.

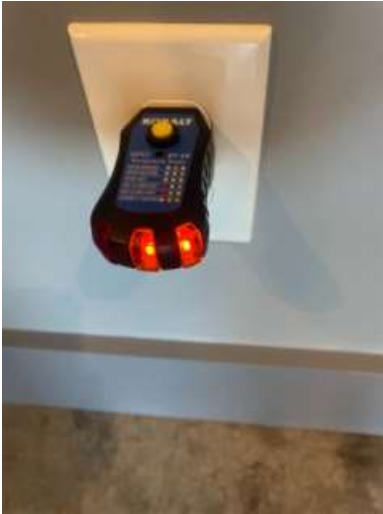
**Office 6:**

Functional - The outlets tested in this room are correctly wired and grounded.

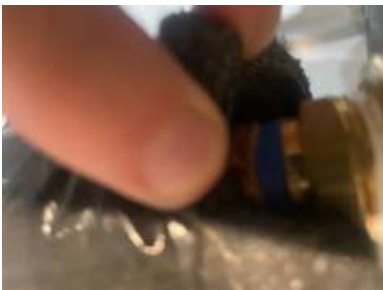
**Plumbing Service Piping Size to Structure:**

3/4" water service line from the meter to the main cutoff.

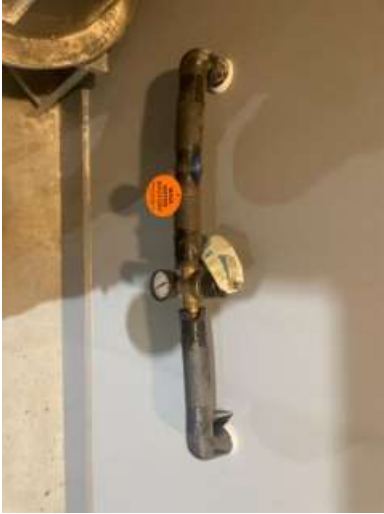
**Main Water Line Cutoff Location:**

Water Heater utility closet.

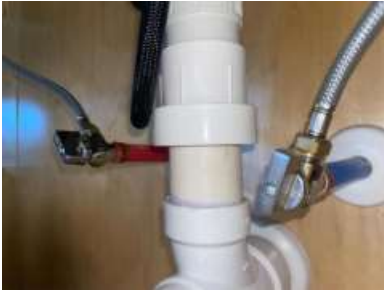
**Interior Supply Piping Material:**

PEX plastic piping.

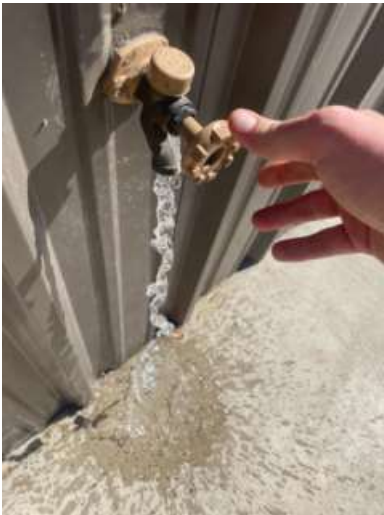
**Exterior Hose Bibs Functional:**

The exterior hose bib(s) appeared to function normally.

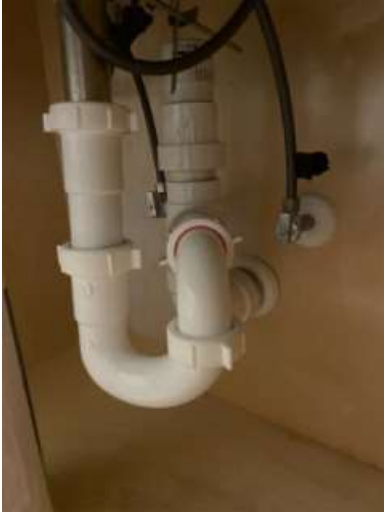
**Waste Line Materials**

The predominant waste line material is plastic.

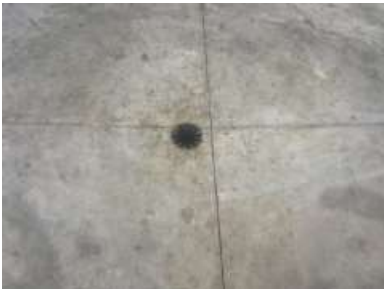
**Location of Noted Floor Drains:**

Garage floor.

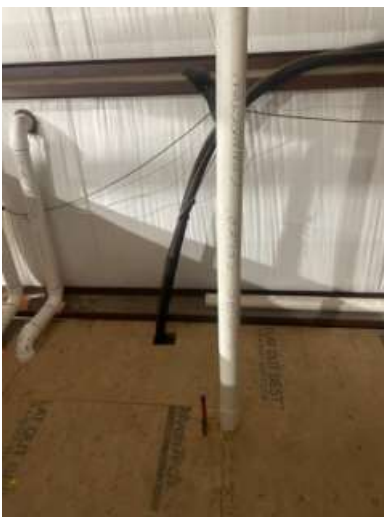
**Expandable Plumbing Option:**

Noted: There is a supply line and drain line setup in the loft area. This gives the option to add a bathroom in this area.

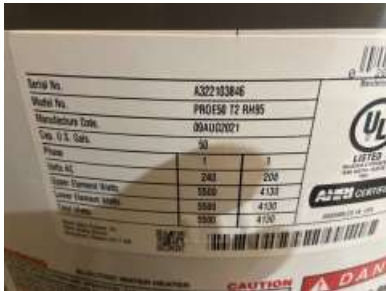
**Model/ Serial Number/ Size:**

System is Rheem brand. Manufactured in 2021.

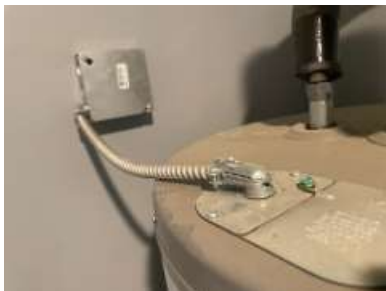
**Electric Service to Water Heater:**

The electric service to the water heater appears to be installed in an acceptable manner.

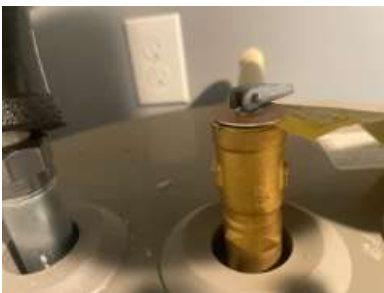
**Temperature & Pressure Relief Valve:**

The temperature and pressure relief valve is of the correct rating for the water heater.

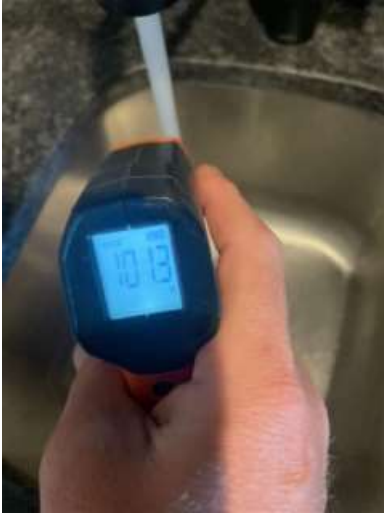
**Water Heater Output:**

101 F. Good heating at the plumbing fixtures.

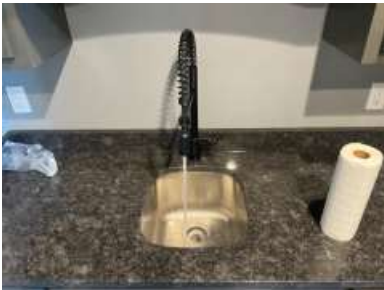
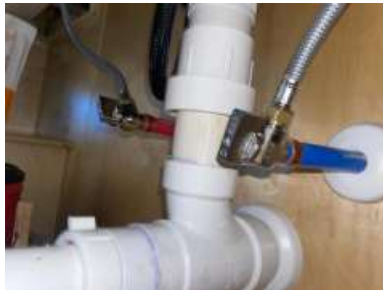
#### Faucet and Supply Lines:

Faucets and supply lines appear functional with no leaks noted. There are shutoffs installed for both hot and cold water pipes under the basin.

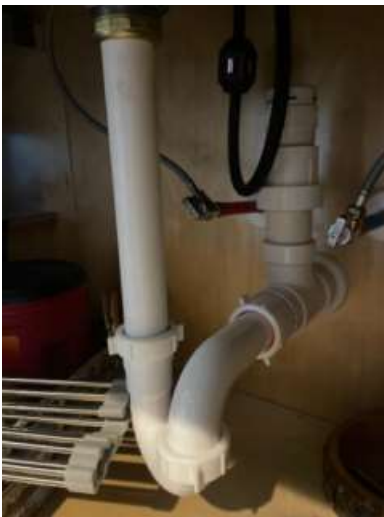
#### Sink and Drain Lines:

The sink and drainage lines appear to be functional.

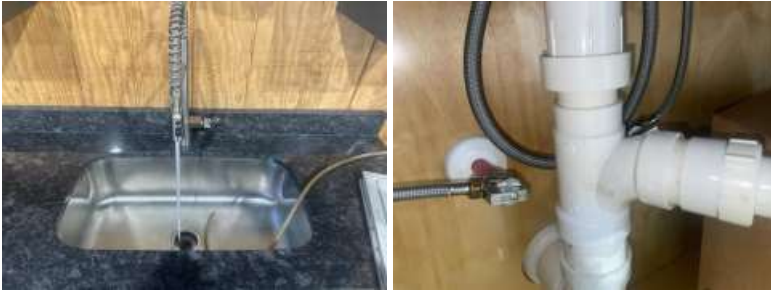
**Faucet and Supply Lines:**

Faucets and supply lines appear functional with no leaks noted. There are shutoffs installed for both hot and cold water pipes under the basin.

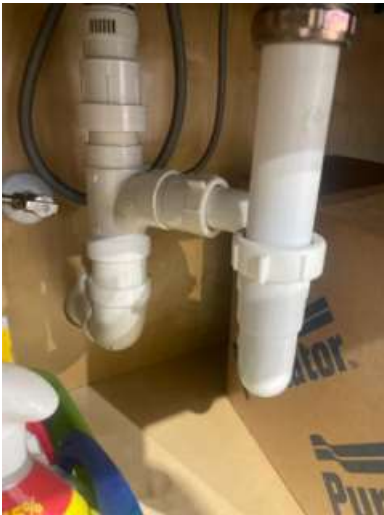
**Sink and Drain Lines:**

The sink and drainage lines appear to be functional.

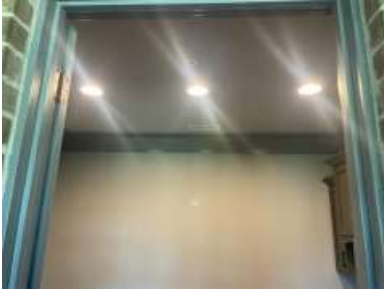
**Walls:**

The walls in the kitchen appear to be without significant issues.

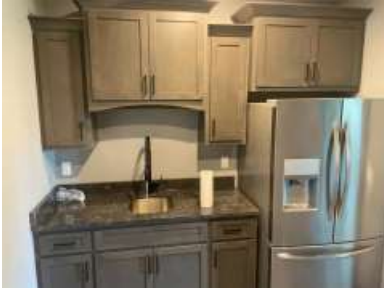
**Countertops:**

The countertops in the kitchen appear to be new, and they should provide years of service.

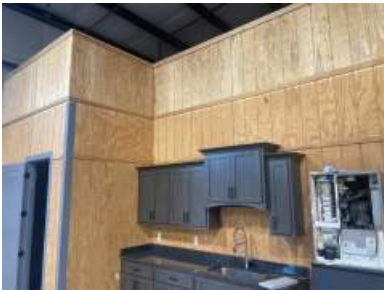
**Walls:**

The walls in the kitchen appear to be without significant issues.

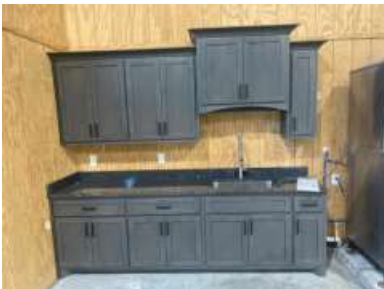
**Countertops:**

The countertops in the kitchen are functional.

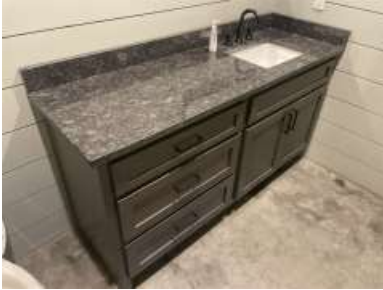
#### **Vanity Cabinet:**

The vanity cabinet and top in this bathroom are functional.

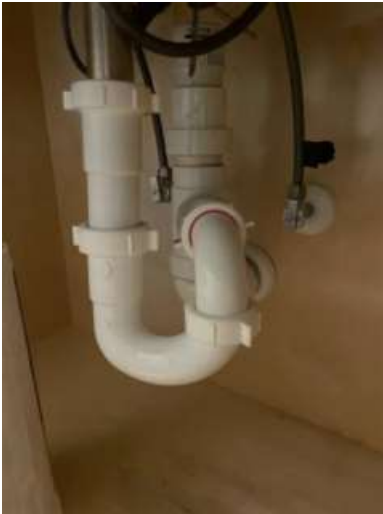
#### **Basin and Drain Fixture:**

The basin and drainage fixture appear to be fully functional.

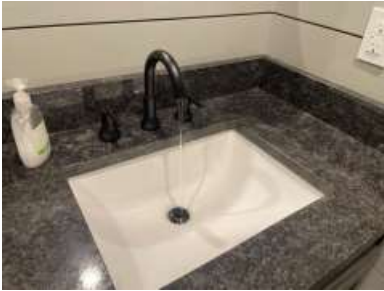
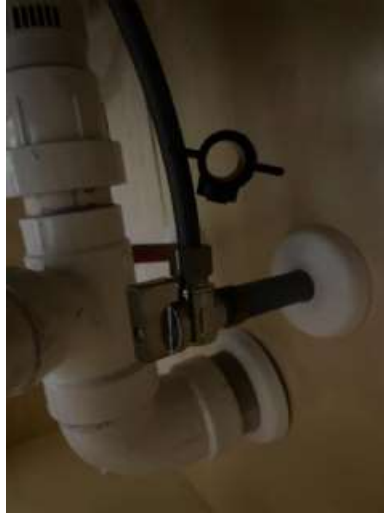
#### **Faucet and Supply Lines:**

Faucets and supply lines appear functional. There are shutoffs installed for both hot and cold water pipes under the basin.

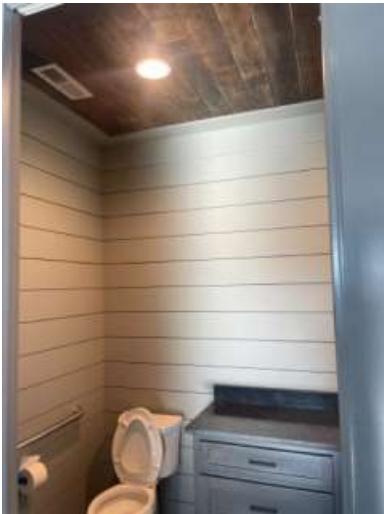
**Walls:**

The walls in this bathroom are functional.

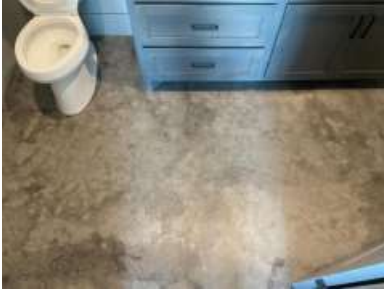
**Floor:**

The flooring in this bathroom is functional.

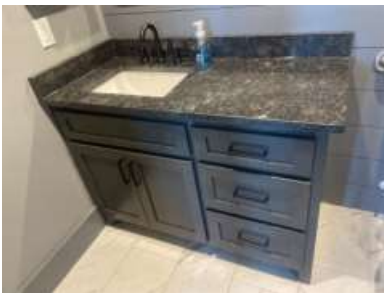
**Vanity Cabinet:**

The vanity cabinet and top in this bathroom are functional.

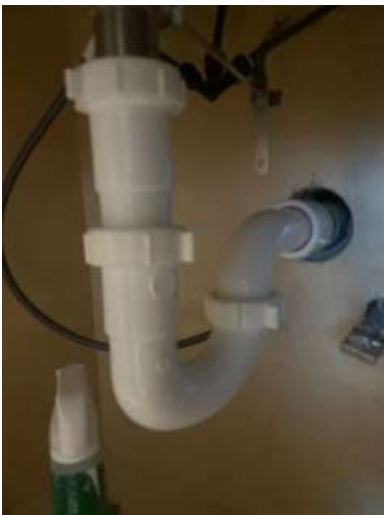
**Basin and Drain Fixture:**

The basin and drainage fixture appear to be fully functional.

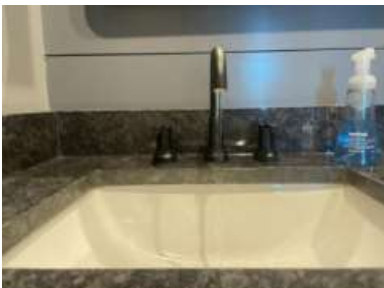
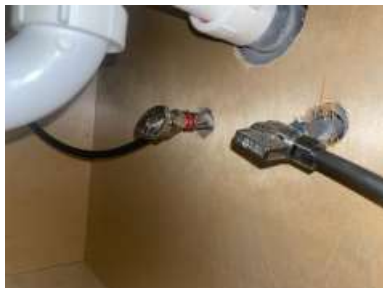
**Faucet and Supply Lines:**

Faucets and supply lines appear functional. There are shutoffs installed for both hot and cold water pipes under the basin.

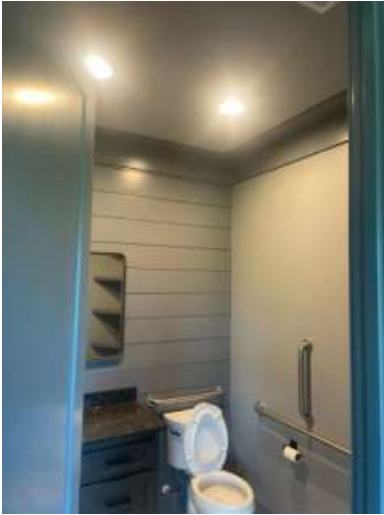
**Walls:**

The walls in this bathroom are functional.

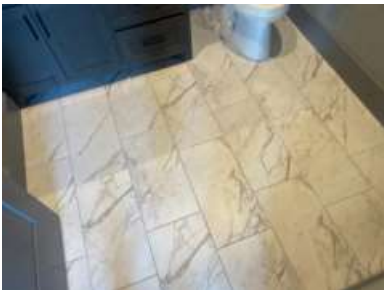
**Floor:**

The flooring in this bathroom is functional.

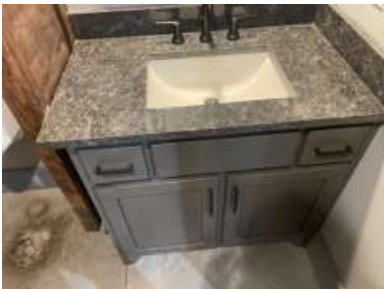
**Vanity Cabinet:**

The vanity cabinet and top in this bathroom are functional.

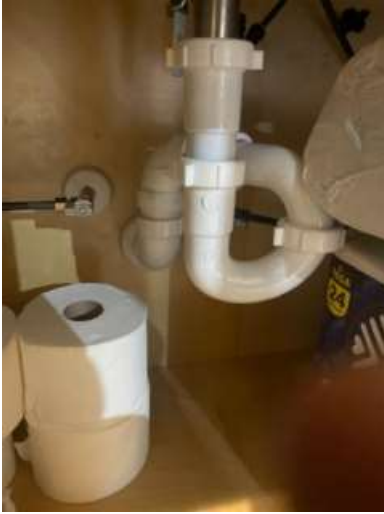
**Basin and Drain Fixture:**

The basin and drainage fixture appear to be fully functional.

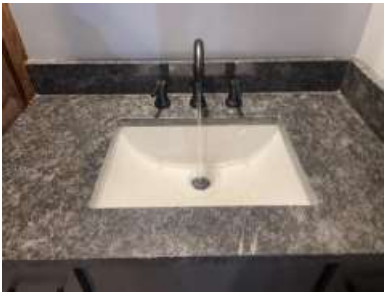
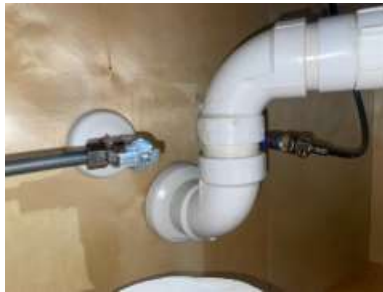
**Faucet and Supply Lines:**

Faucets and supply lines appear functional. There are shutoffs installed for both hot and cold water pipes under the basin.

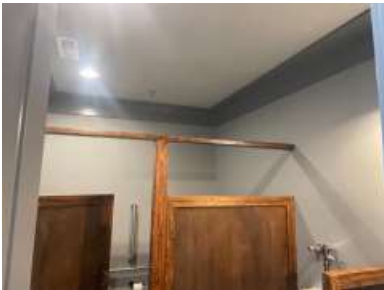
**Walls:**

The walls in this bathroom are functional.

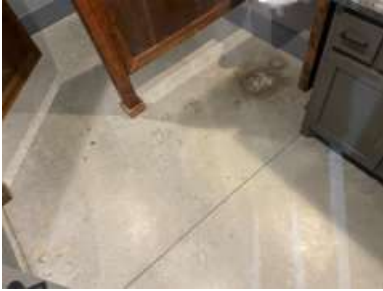
**Floor:**

The flooring in this bathroom is functional.

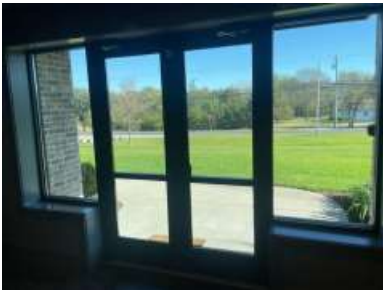
**Front Entry & Main Hallway:****Front Entry Door:**

The main entry door to the structure is in functional condition.

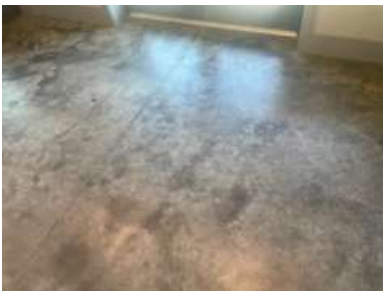
**Entry Floor:**

The entry floor material appearance is good and material is functional.

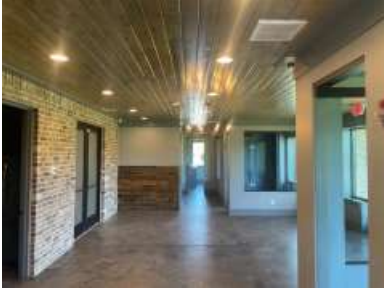
**Main Lobby:**

The main hallway walls and floor are without significant issues.

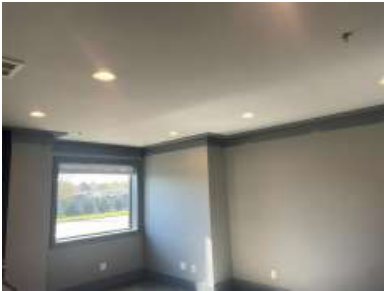
**Walls:**

The walls in the room appear to be functional.

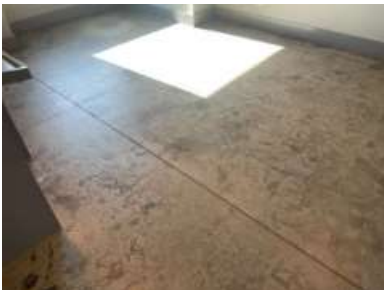
**Floor:**

The floors are in functional condition.

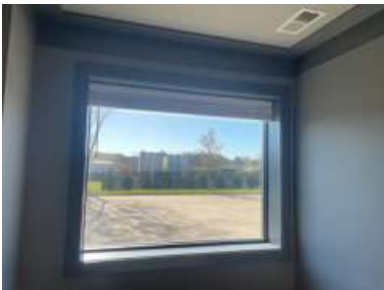
**Windows:**

The windows and associated hardware in this room are all functional.

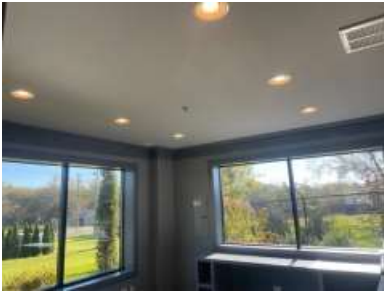
**Walls:**

The walls in the room appear to be functional.

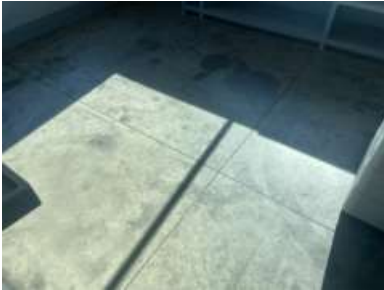
**Floor:**

The floors are in functional condition.

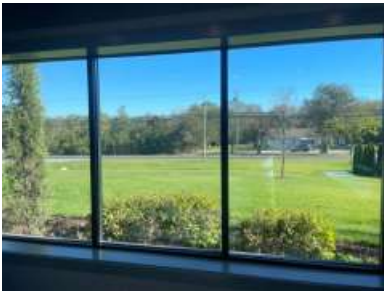
**Windows:**

The windows and associated hardware in this room are all functional.

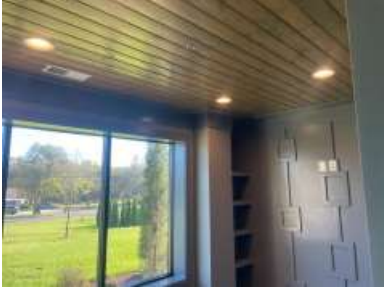
**Walls:**

The walls in the room appear to be functional.

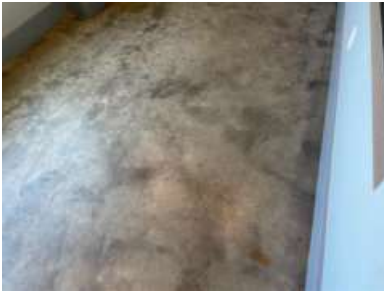
**Floor:**

The floors are in functional condition.

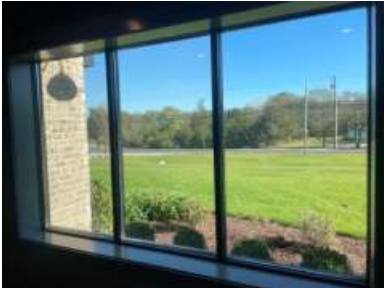
**Windows:**

The windows and associated hardware in this room are all functional.

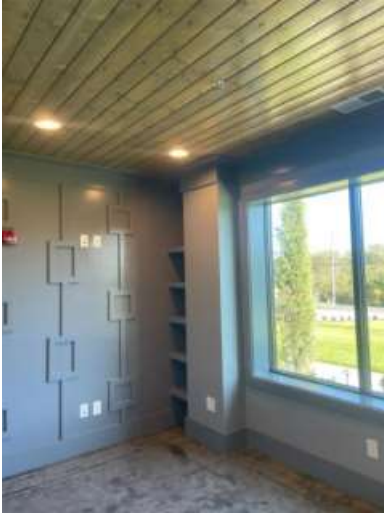
**Walls:**

The walls in the room appear to be functional.

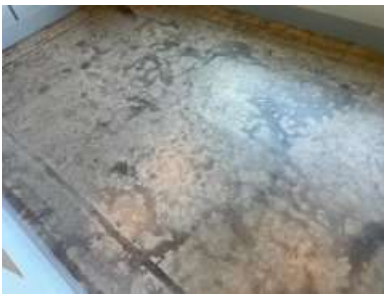
**Floor:**

The floors are in functional condition.

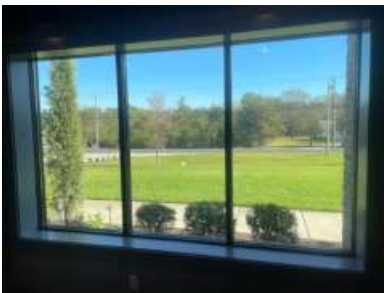
**Windows:**

The windows and associated hardware in this room are all functional.

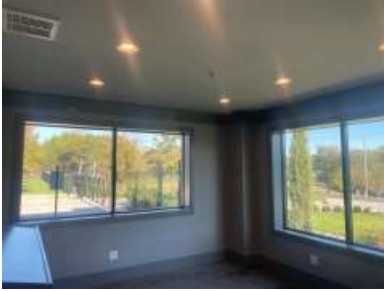
**Walls:**

The walls in the room appear to be functional.

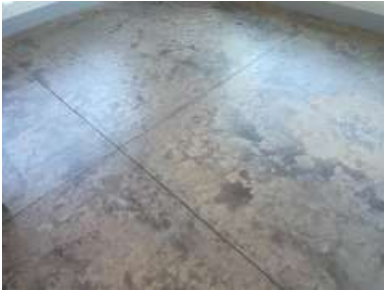
**Floor:**

The floors are in functional condition.

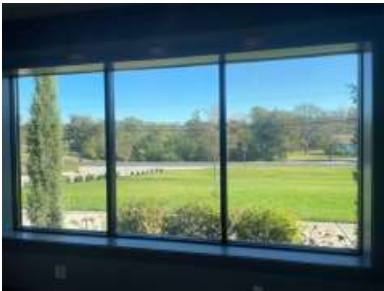
**Windows:**

The windows and associated hardware in this room are all functional.

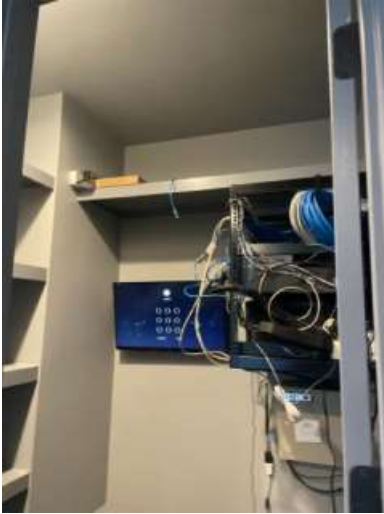
**Closet:**

The closet is functional and of average size. The closet is lighted.

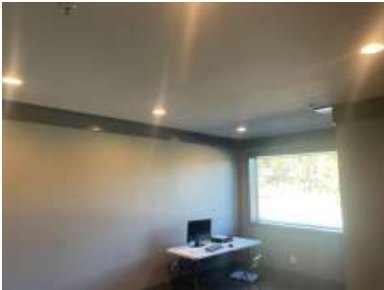
**Walls:**

The walls in the room appear to be functional.

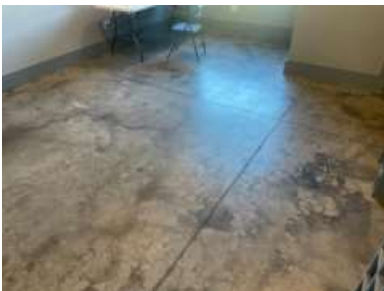
**Floor:**

The floors are in functional condition.

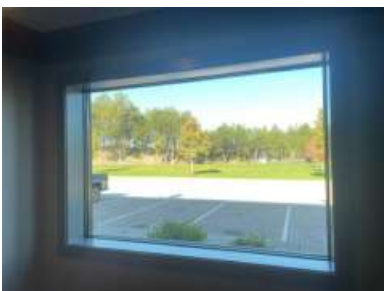
**Windows:**

The windows and associated hardware in this room are all functional.

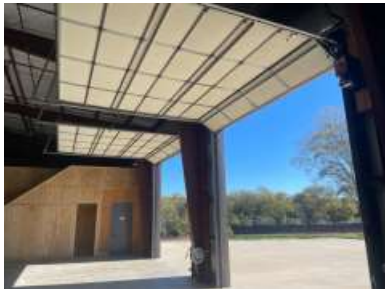
**Automatic Overhead Door Opener:**

The overhead door opener appears to function appropriately.

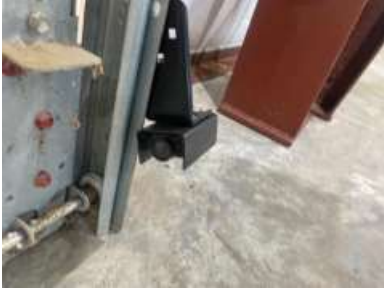
**Safety Reverse Switch on the Automatic Opener:**

There is an electronic beam safety reverse system installed. It appears to be functional.

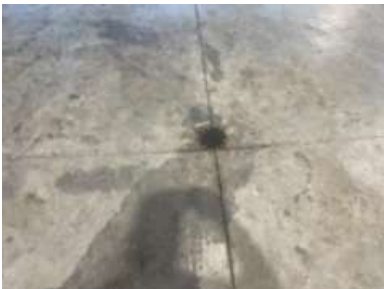
**Floor Drain:**

Yes - There is a floor drain installed. This is a handy feature for easier cleanup from rain and snow dripping off the cars.

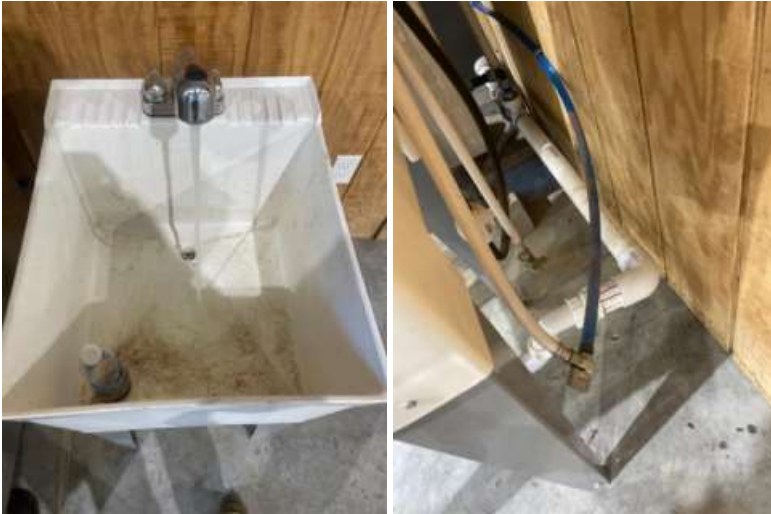
**Water Source Installed:**

Yes - There is a water source installed in the garage.

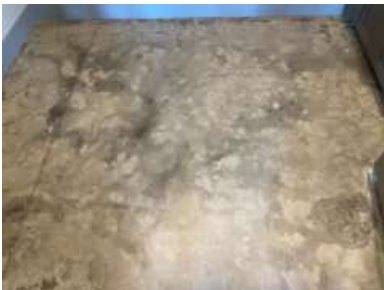
**Kitchen Interior**

General condition appears serviceable.

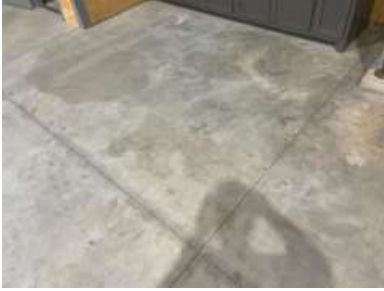
**Garage Kitchen Interior:**

General condition appears serviceable.

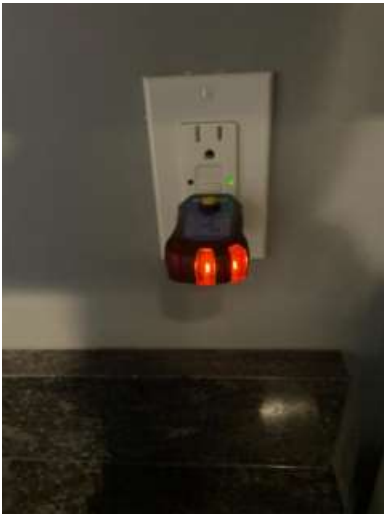
**Kitchen Interior**

The outlets tested in the kitchen are correctly wired and grounded. As a whole, outlets throughout the room are in serviceable condition. There is a Ground Fault Circuit Interrupt outlet installed and functional above the kitchen countertop. It is in the area within a 6 foot reach of the sink.

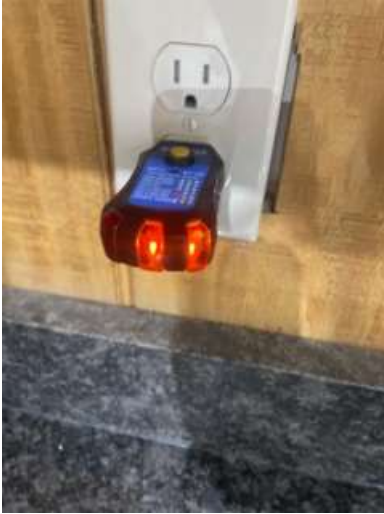
**Garage Kitchen Interior:**

The outlets tested in the kitchen are correctly wired and grounded. As a whole, outlets throughout the room are in serviceable condition. There is a Ground Fault Circuit Interrupt outlet installed and functional above the kitchen countertop. It is in the area within a 6 foot reach of the sink.
