Property Inspection Report

Cover Page This report is marked up by executor of the estate Mike Matre to show the repairs that have been done. Repair invoices are attached., 229-869-1111, mike@matreforestry.com

1231 Hilltop Drive, Albany, GA 31707
Inspection prepared for: Mike Matre
Date of Inspection: 4/17/2025 Time: 0900 Hours
Weather: Sunny
Inspection Fee Paid CK#2217

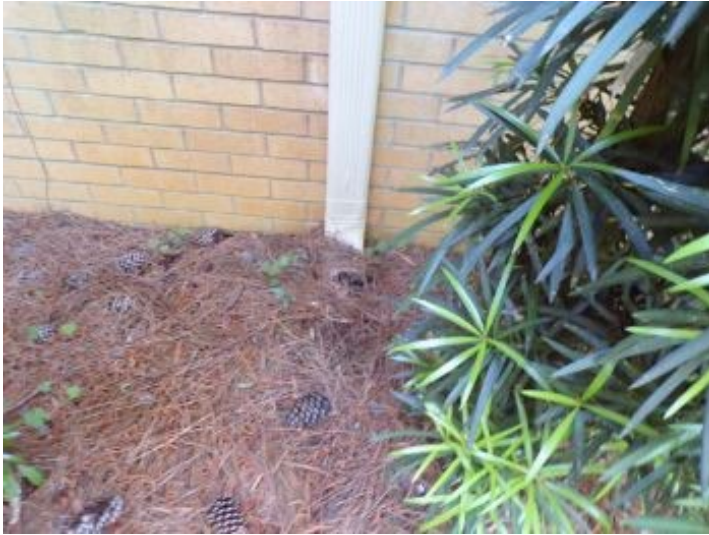
Downspouts are clogged

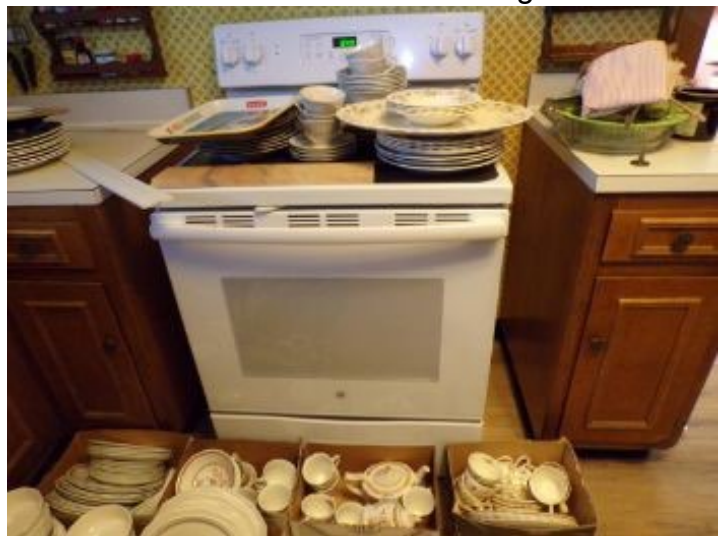
- 1.4. The stove was not tested due to large amount of dishes present. Recommend testing stove once items have been removed.
- 1.5. Broken kitchen sink strainer basket. Recommend replacement of sink strainer basket. **Sinker strainer were replaced by Metro plumbing.**

Stove not tested

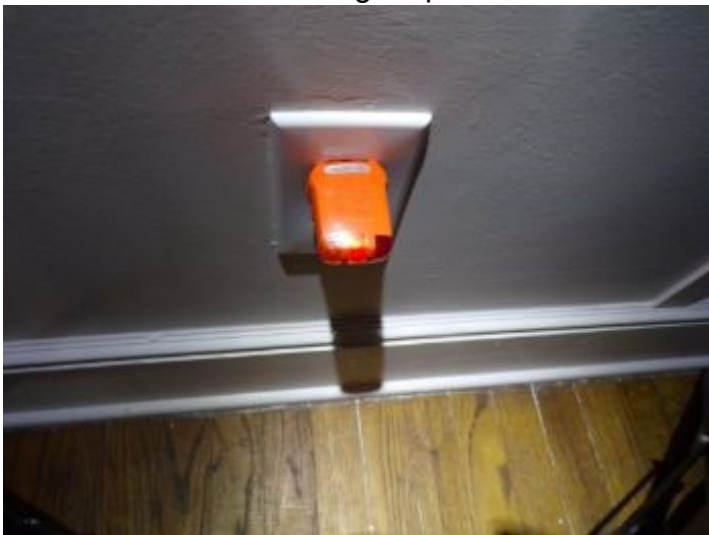
- 1.11. Some outlets tested with open equipment grounds. This is common for a structure of this age.
- 1.12. Worn and damaged carpets. The carpet is well past its life expectancy. It is possible that the original floors may be hardwood.

No equipment ground on some outlets

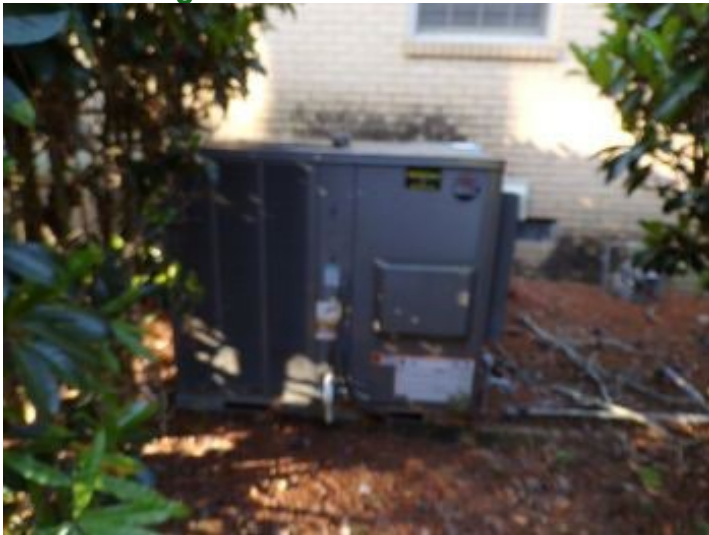
1.1. RUUD 5 ton gas package system manufactured September 2015. System was tested in heat and cool modes with a temperature difference greater than 15 degrees. It is my opinion the system was operational at time of inspection. **The HVAC system has been serviced by AirPro heating and cooling as of 4/24/2025.**

RUUD 5 ton gas package September 2015

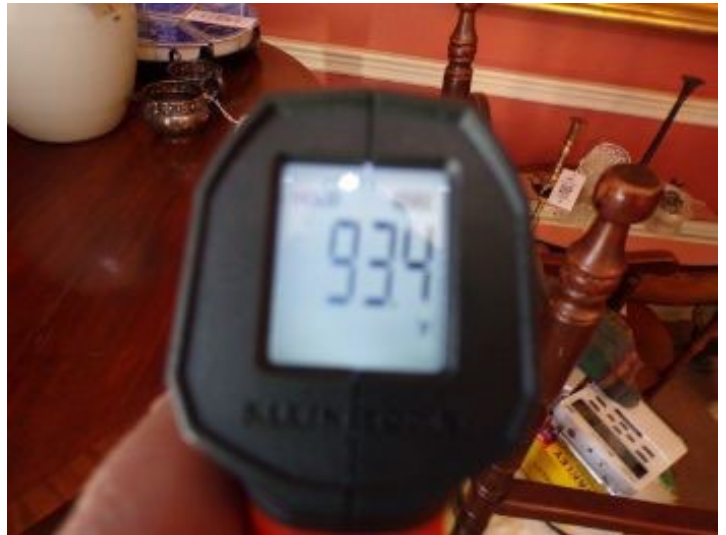
93.4 degree supply air heat

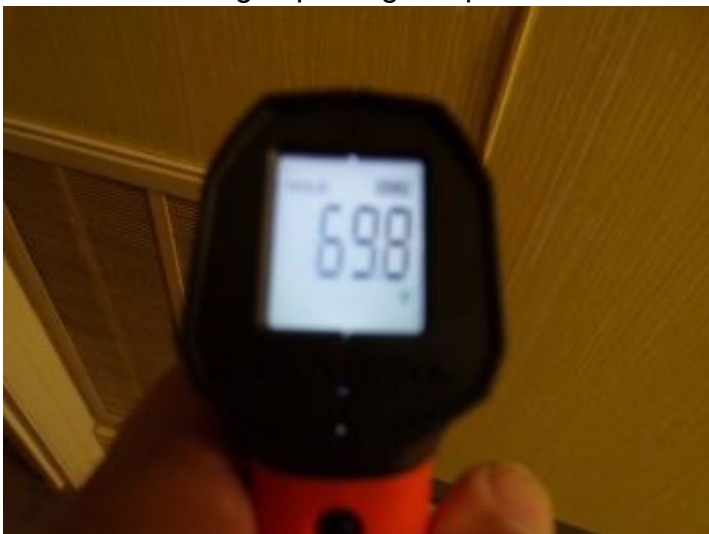
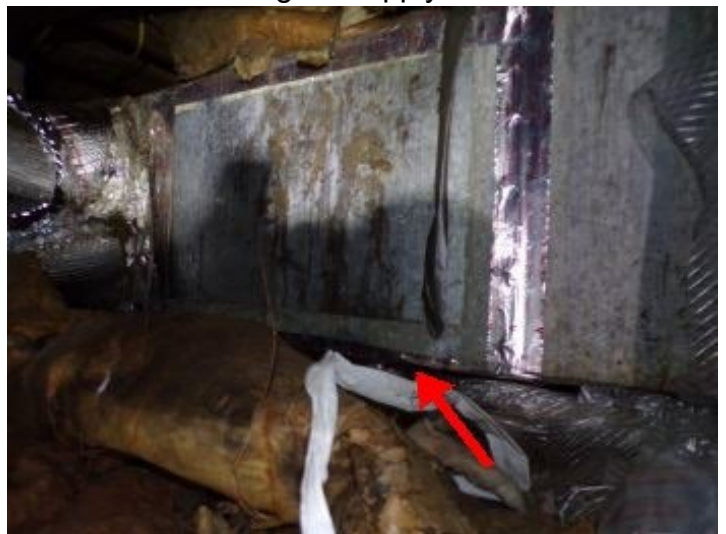
69.8 degree return air

Air leak on bottom of supply plenum

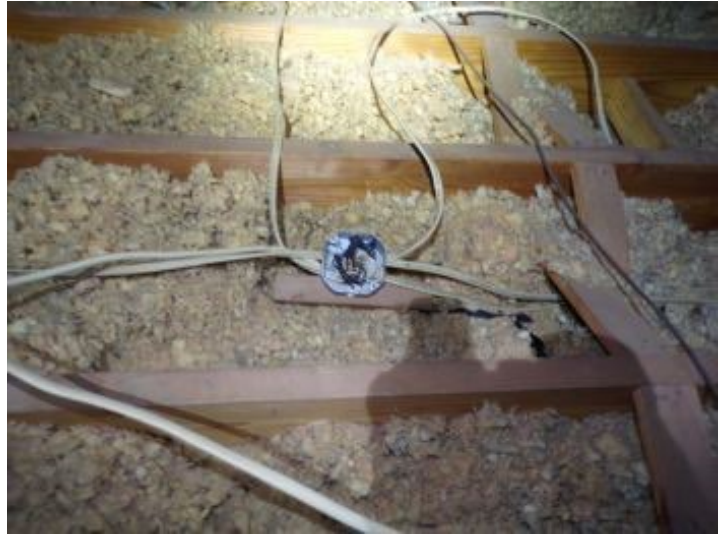
Open junction box

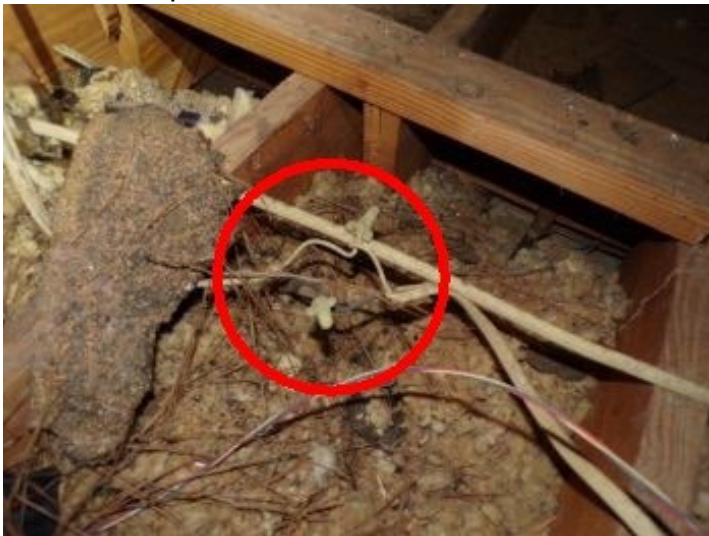
Wire splice no junction box

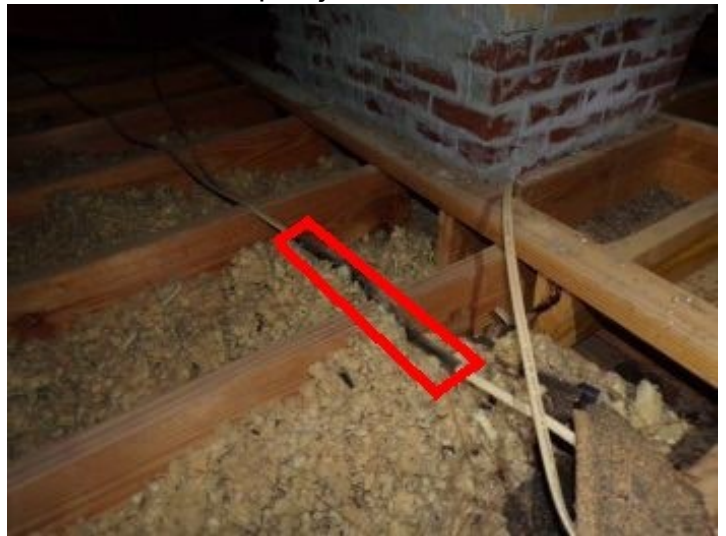
Wire splice wrapped in electrical tape

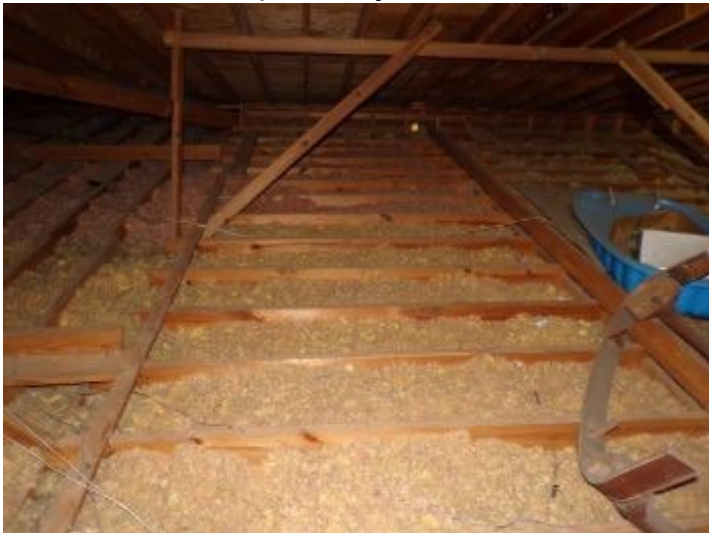
Settled insulation

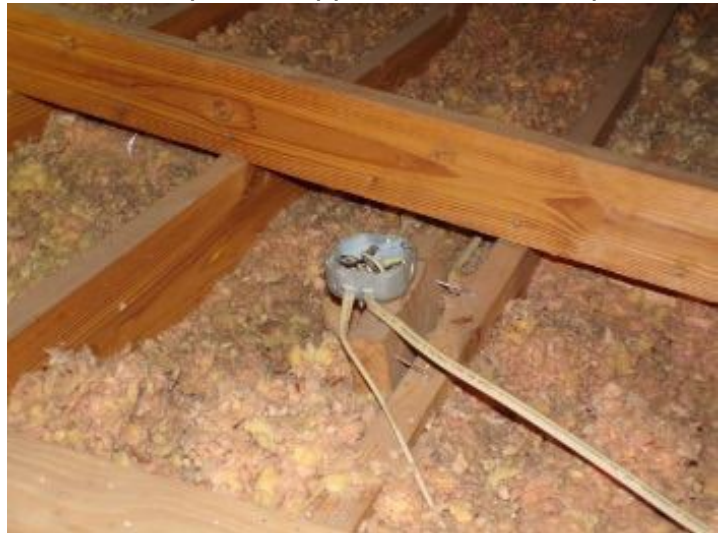
Open junction box

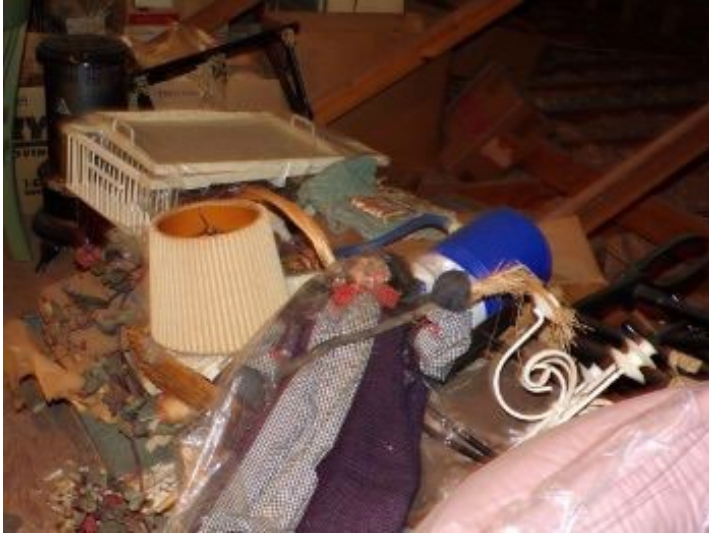
Property in attic

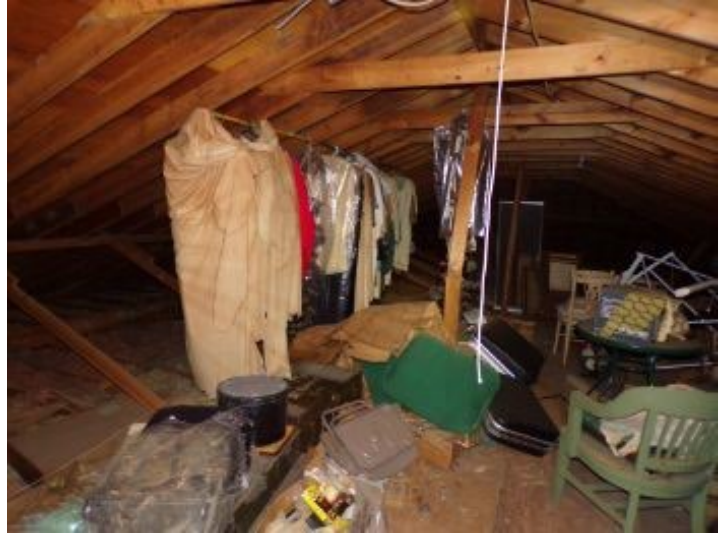
Property in attic

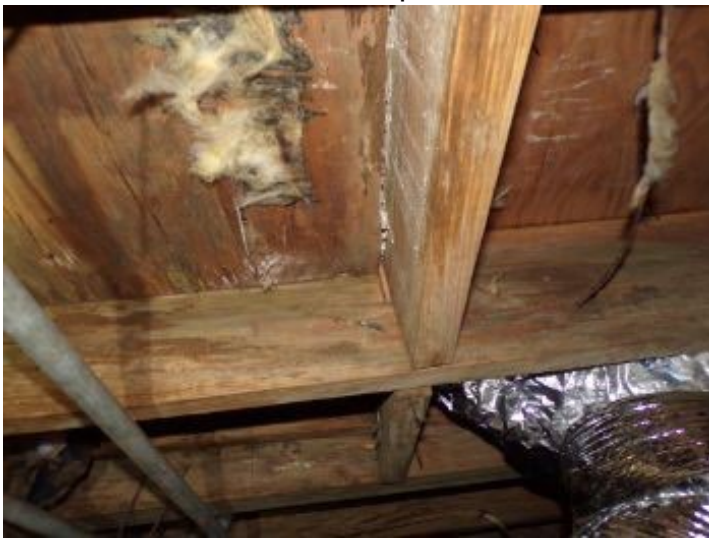
Old fungus issues

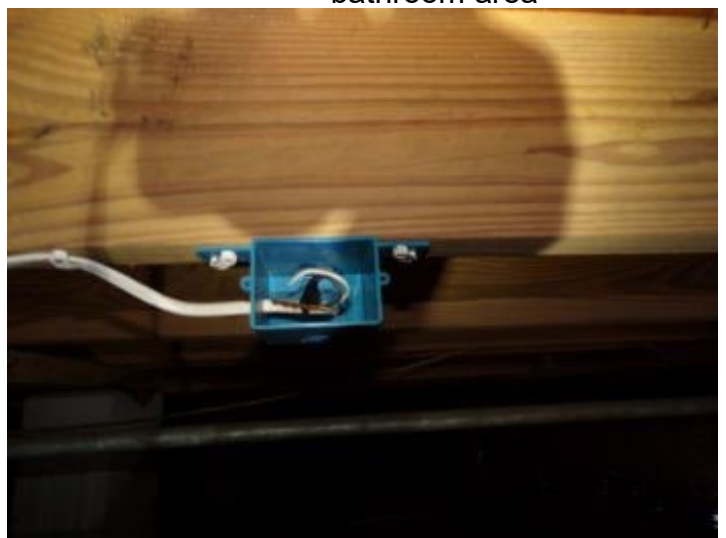
Exposed wiring no wire nuts

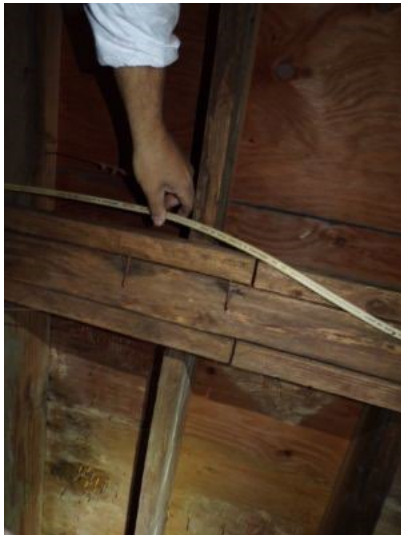
Old fungus issue

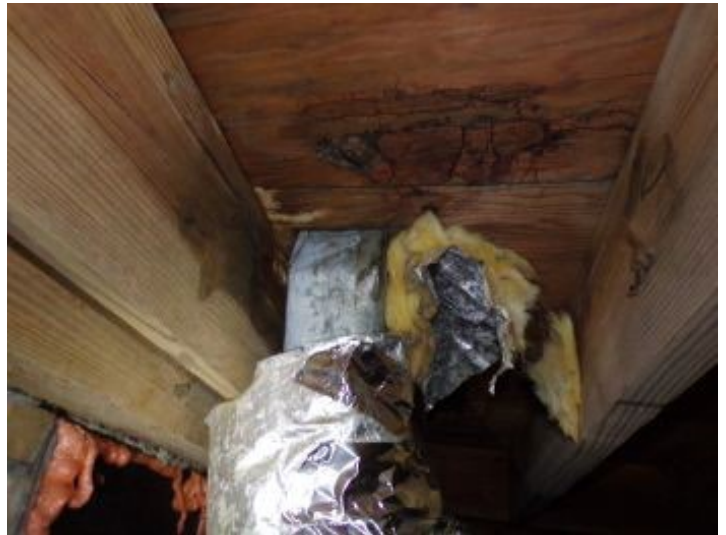
Uninsulated floor boot

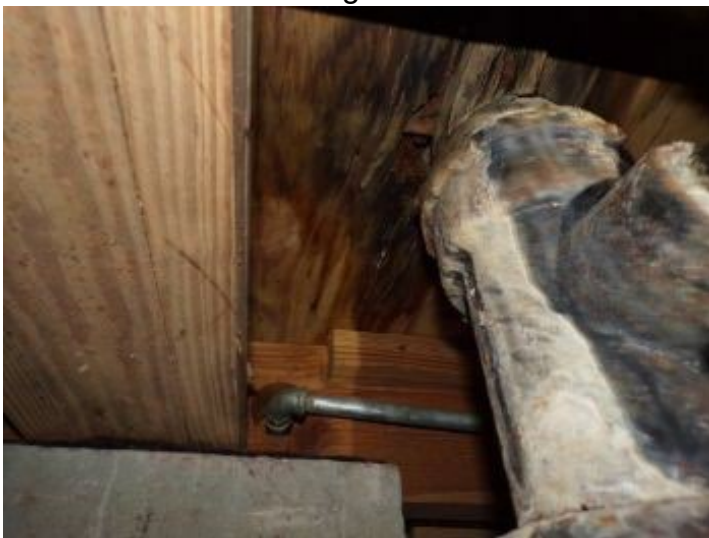
Damp sub-floor under hall bathroom area

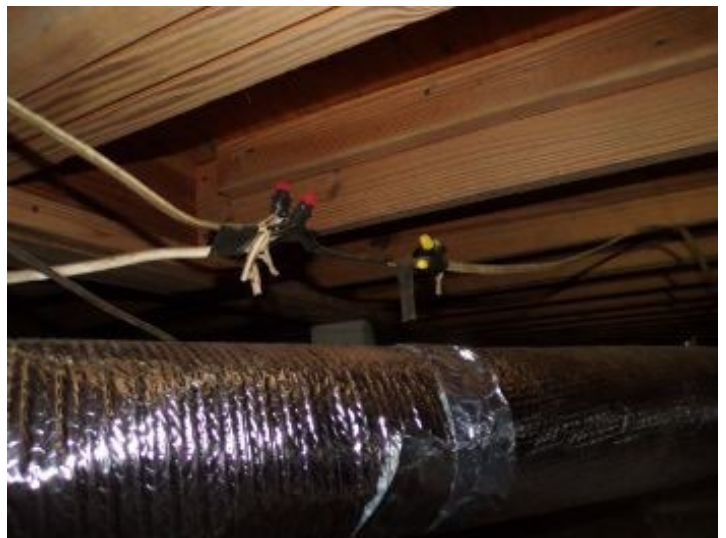
Wire splice no junction box

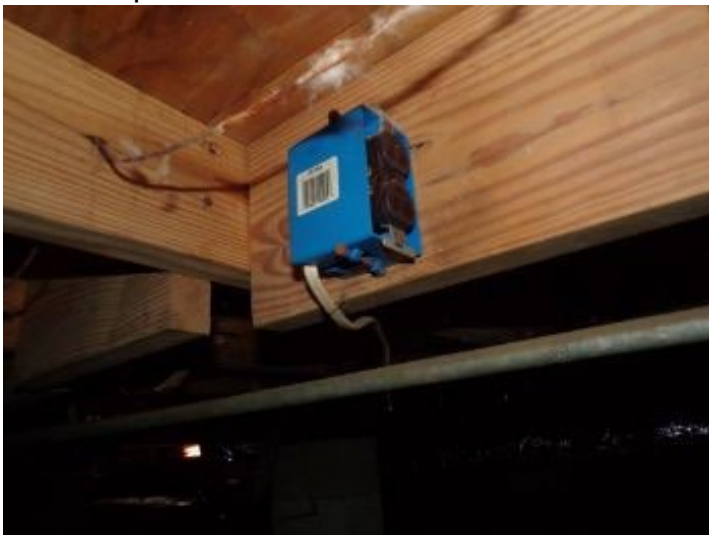
Exposed outlet

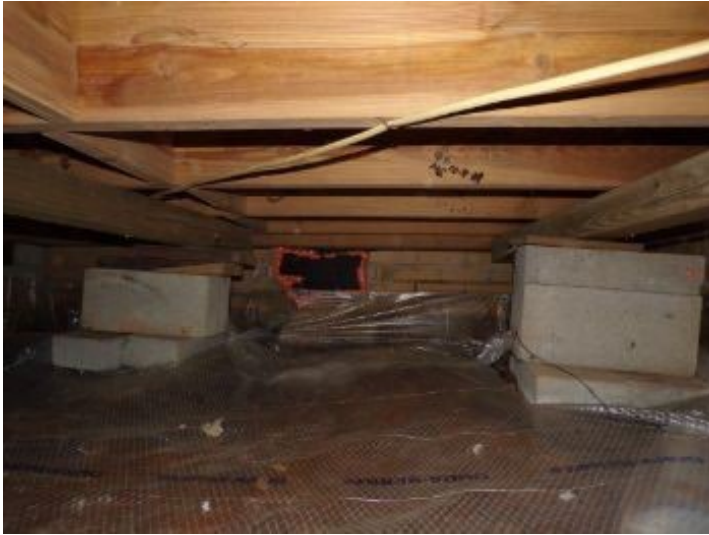
Beams added under master bedroom no longer tight

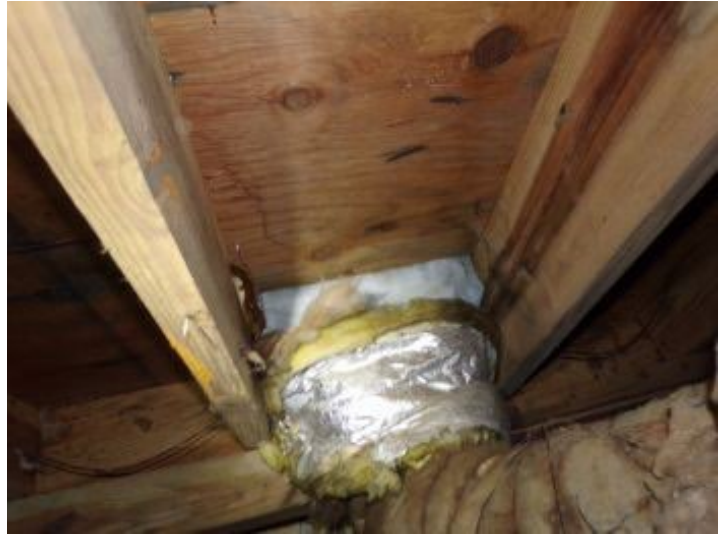
Uninsulated floor boot

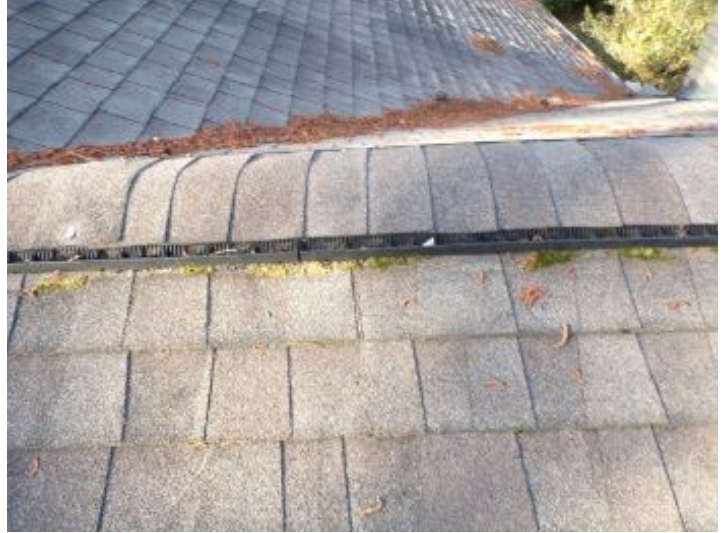
Moss growing on shingles

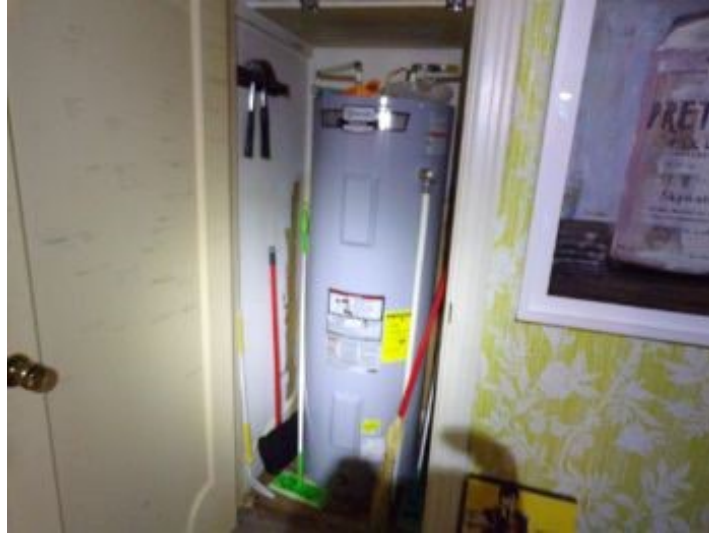
1.1. A.O. Smith 50 gallon system manufactured November 2018. System is located in hallway closet. Heated water was received at all tested faucets.

A.O. Smith
